# JORDAN POND DAM : D3532

## Dams Preliminary Inspection Form

Inspector: Kaitlin Mahoney

Start Date: 09/28/2018      Completed Date: 10/24/2018

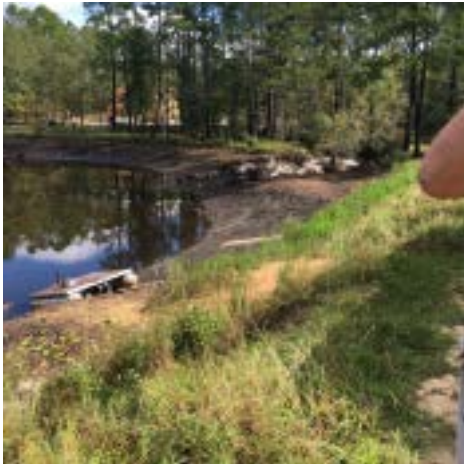
1. Estimate the current level of the water in the reservoir:	Breached

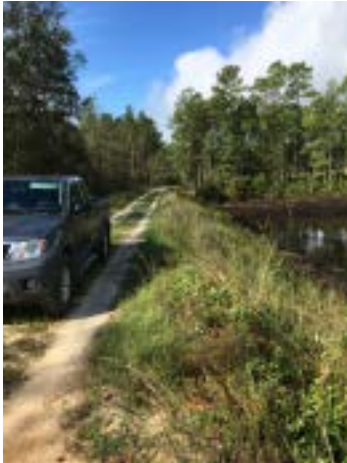
<b>Observation/Instrumentation</b>	
<i>7b. Type of Spillways Present</i>	Stop-Log/Boards, Earthen Overflow/Runaround
Primary spillway is flowing	
<i>8. Other:</i>	
<i>9. Additional Comments (Refer to item number if applicable)</i> Aux spillway breached	
<b>Embankment: Crest</b>	
<i>Is this section applicable for this dam?</i>	<input checked="" type="checkbox"/> Yes <input type="checkbox"/> No
<i>1. Grass Cover</i>	Monitor
Plant grass as needed. Dirt road over top of dam

Photo Taken: 9/28/2018 10:21:31 AM GPS Latitude: 34.4229194444444 GPS Longitude: -79.9949583333333 GPS Altitude: 49.1296023564065 meters GPS Azimuth: 269.134502923977 degrees
<i>2. Deleterious Vegetation</i>	Monitor
Keep vegetation mowed to make it easier to identify problems such as animal activity and erosion.	
<i>3. Trees</i>	Action Required
Remove trees around aux spillway - tree management plan by SC license professional engineer required & permit application

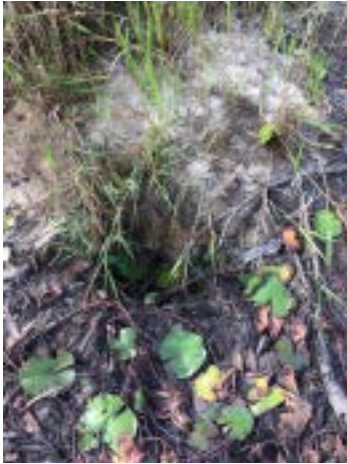
<b>Embankment: Crest</b>	
<i>8. Sinkhole</i>	No Deficiency
<i>9. Erosion</i>	Monitor
<div style="border: 1px solid black; padding: 5px;"> <p>Breach in aux spillway. Keep an eye out for minor erosion (less than 12" deep) and fill as necessary</p> <div style="display: flex; justify-content: space-between; align-items: flex-start;"> <div style="width: 45%;">

</div> <div style="width: 50%;"> <p>Photo Taken: 9/28/2018 10:20:53 AM                      GPS Latitude: 34.4229305555556                      GPS Longitude: -79.9948972222222                      GPS Altitude: 45.6819727891156 meters                      GPS Azimuth: 204.73673870334 degrees</p> </div> </div> </div>	
<i>10a. Are Alterations/Repairs Present?</i>	<input type="checkbox"/> Yes <input checked="" type="checkbox"/> No
<i>10b. (If Present:) Alterations/Repairs Condition</i>	
<i>11. Other:</i>	
<i>12. Embankment: Crest Condition</i>	Needs Permitted Repair(s)

<div style="border: 1px solid black; padding: 5px;"> <p><b>Violation Determined: 9/28/2018</b>  <b>DAMMAINTREP</b>                      Trees need to be removed</p> </div>	
<i>13. Additional Comments (Refer to item number if applicable)</i>	
525 ft long	
<b>Concrete/Masonry Dams: Crest</b>	
<i>Is this section applicable for this dam?</i>	<input type="checkbox"/> Yes <input checked="" type="checkbox"/> No
<i>1. Surface Conditions</i>	
<i>2. Horizontal Alignment</i>	
<i>3. Vertical Alignment</i>	
<i>4. Condition of Joints</i>	
<i>5. Unusual Movement</i>

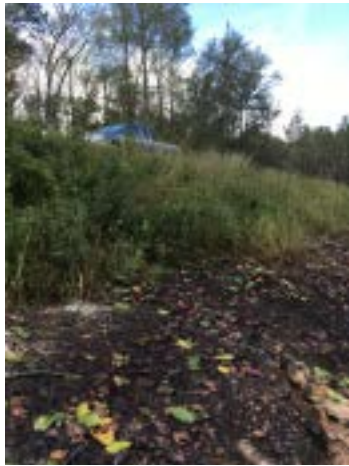
1. Grass Cover	Monitor
One area eroded a bit above spillway - owner will be putting in new spillway and will fix area	
2. Deleterious Vegetation	Monitor
Keep mowed

3. Trees	No Deficiency
4. Animal Activity	Investigate
Erosion possibly caused by beaver activity. Get rid of beavers as necessary	
5. Surface Cracking	No Deficiency

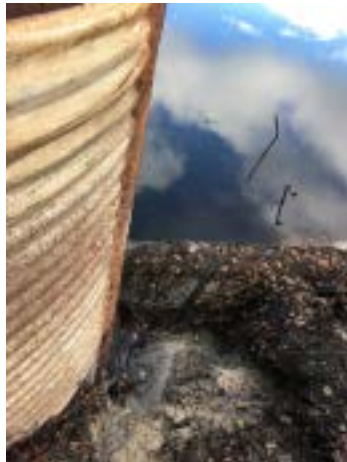
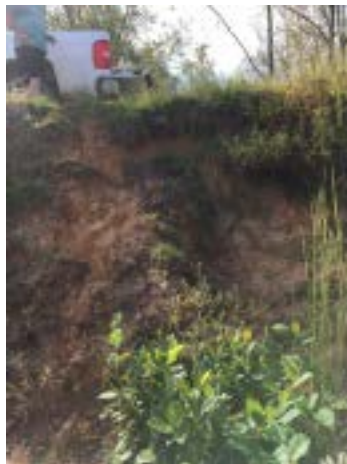
### 9. Erosion

Fix erosion above inlet pipe. Also some erosion around intake

<b>Embankment: Upstream Slope</b>	
13. <i>Embankment: Upstream Slope Condition</i>	Needs Maintenance
<div style="border: 1px solid black; padding: 5px;"> <p><b>Violation Determined: 9/28/2018</b>  <b>DAMMAINTREP</b>                      Some erosion above outlet pipe needs to be addressed. Owner said they will be replacing the spillway so this will be fixed</p> </div>

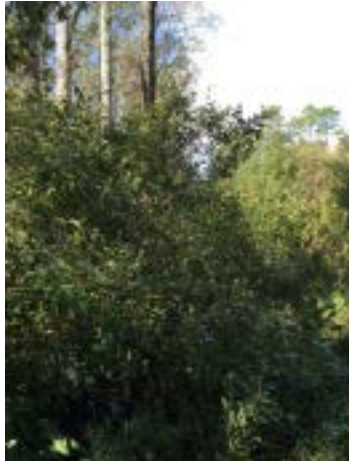
<b>Embankment: Downstream Slope</b>	
<i>2. Deleterious Vegetation</i>	Action Required
<div style="border: 1px solid black; padding: 5px;"> <p>Heavy vegetation on downstream slope. Owner says they spray every 2 years to keep it down</p> <div style="display: flex; justify-content: space-between; align-items: flex-start;"> <div style="width: 45%;">

15. Other:	
16. Embankment: Downstream Slope Condition	Needs Maintenance
<b>Violation Determined: 9/28/2018</b> <b>DAMMAINTREP</b> Vegetation should be cleared before inspection to be able to observe animal activity, erosion, seepage, etc.

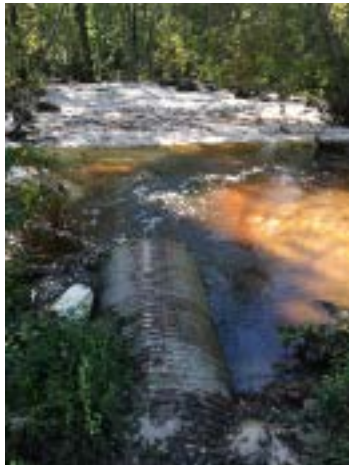
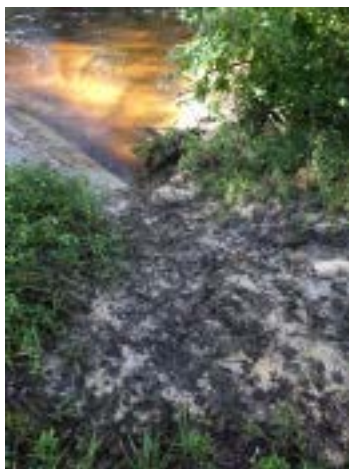
Sediment has been washed from the auxiliary spillway into the downstream area due to breach. No grass above outlet pipe - monitor for erosion

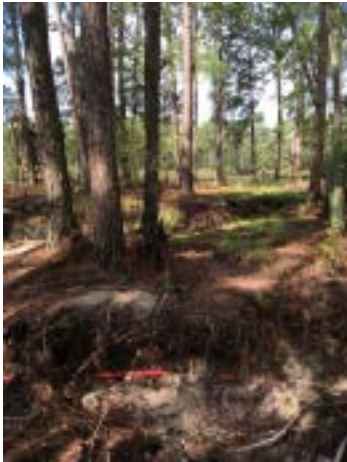
<b>Spillways: Erodible Channel</b>	
<i>1. Location</i>	
<i>2. Grass Cover</i>	No Deficiency
<i>3. Deleterious Vegetation</i>	No Deficiency
<i>4. Trees</i>	Action Required
<p>Large trees present around aux spillway need to be investigated by PE</p> <div style="display: flex; align-items: flex-start;">

<div style="margin-left: 20px;"> <p>Photo Taken: 9/28/2018 10:40:55 AM                      GPS Latitude: 34.4235638888889                      GPS Longitude: -79.9939333333333                      GPS Altitude: 50.3493917274939 meters                      GPS Azimuth: 258.107382550336 degrees</p> </div> </div>	
<i>5. Animal Activity</i>	No Deficiency
<i>6. Subsidence, Sinkhole</i>	No Deficiency
<i>7. Slide, Slough, Scarp</i>	No Deficiency
<i>8. Erosion</i>	Action Required
<p>Breach in aux spillway. Trench through dam has eroded out - possibly the cause of the breach. Owner explained that the power company trenched through the dam without his permission and did not have the equipment to properly compact the soil. Any trenching through the dam would require a permit from DHEC, but no permit application was submitted for the work.</p>

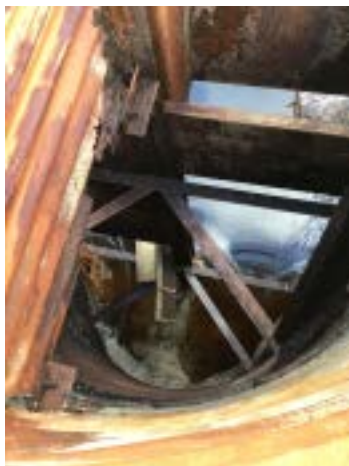
<b>Spillways: Inlet Structure</b>	
<i>2a. Intake Structure</i>	No Deficiency
<div style="border: 1px solid black; padding: 5px;"> <p>Spillway is flowing</p> <div style="display: flex; justify-content: space-between; align-items: flex-start;"> <div style="width: 45%;">

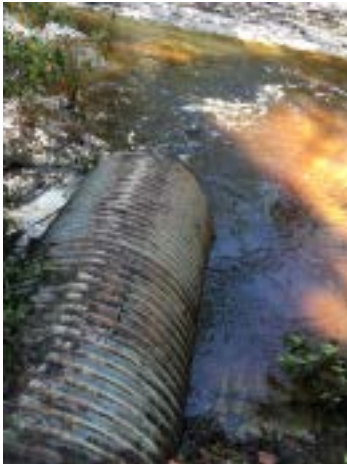
Photo Taken: 9/28/2018 10:22:21 AM GPS Latitude: 34.4228638888889 GPS Longitude: -79.9947888888889 GPS Altitude: 46.238188976378 meters GPS Azimuth: 135.339622641509 degrees
<i>3. Outlet Pipe</i>	No Deficiency
<i>4. Primary Closure/Control</i>	No Deficiency
<i>5. Secondary Closure/Control (If Applicable)</i>	
<i>6. Unusual Movement</i>	No Deficiency
<i>7a. Seepage</i>	<input type="checkbox"/> Yes <input checked="" type="checkbox"/> No <input type="checkbox"/> NA
<i>7b. (If Present): Seepage</i>	
<i>8. Stilling Basin</i>	No Deficiency
<i>9. Normal Flow Quantity</i>	No Deficiency
<i>10. Low-Level Flow Quantity</i>	No Deficiency
<i>11a. Alterations/Repairs Present</i>	<input type="checkbox"/> Yes <input checked="" type="checkbox"/> No <input type="checkbox"/> NA
<i>11b. (If Present:) Alterations/Repairs</i>	
<i>12. Other:</i>	Monitor

Monitor sediment on top of outlet pipe for erosion. Fill with soil as needed	
<i>13. Outlet Works Condition</i>	No Deficiencies Observed
<i>14. Additional Comments (Refer to item number if applicable)</i>	
Outlet appears to be in good condition. Please monitor soil above pipe for erosion. It is recommended that you plant grass as erosion protection.

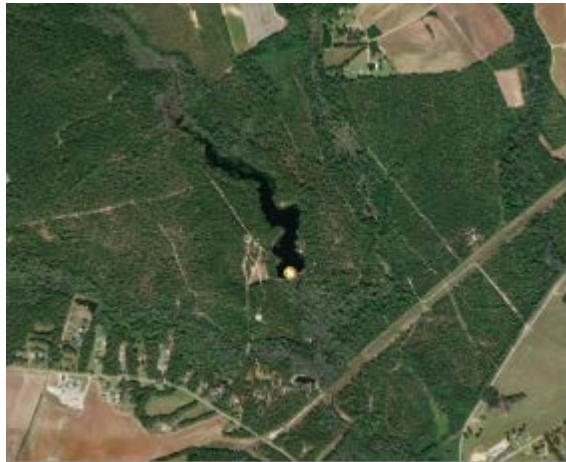
2. Inundation Map	<input checked="" type="checkbox"/> Yes <input type="checkbox"/> No <input type="checkbox"/> NA
3. Structures/Developments	<input checked="" type="checkbox"/> Yes <input type="checkbox"/> No <input type="checkbox"/> NA
Inundation map shows possible homes located within the inundation area

4. Roads/Railways	<input checked="" type="checkbox"/> Yes <input type="checkbox"/> No <input type="checkbox"/> NA
Possible overtopping of highway 15 and North Center Rd

5. Utilities	<input type="checkbox"/> Yes <input checked="" type="checkbox"/> No <input type="checkbox"/> NA
6. Consider For Reclass?	<input checked="" type="checkbox"/> Yes <input type="checkbox"/> No <input type="checkbox"/> NA
Consider reclass to High Hazard based on home(s) and road(s) located in inundation area
