DAVIDS MILLPOND DAM : D3450

Dams Preliminary Inspection Form

Inspector: Hannah Vinson

Start Date: 09/27/2018 Completed Date: 10/01/2018

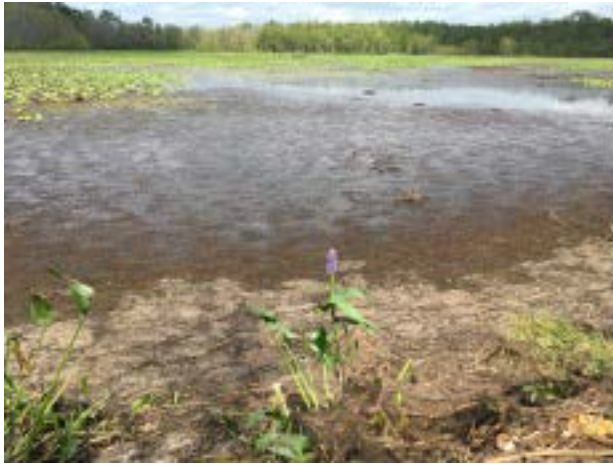
1. Estimate the current level of the water in the reservoir:	Drained

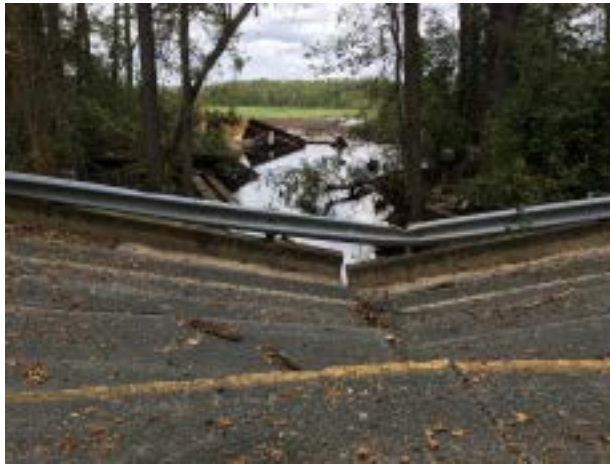
Primary spillway washed away during overtopping event. This was an old roadway bridge.

11. <i>Other:</i>	Action Required
<div style="border: 1px solid black; padding: 2px;"> Section in center of dam where primary spillway was, is breached. </div>

Dam breach occurred at the location of the primary spillway.

Engage an engineer to develop a repair plan or a plan to decommission the dam if repairs are not going to be conducted.

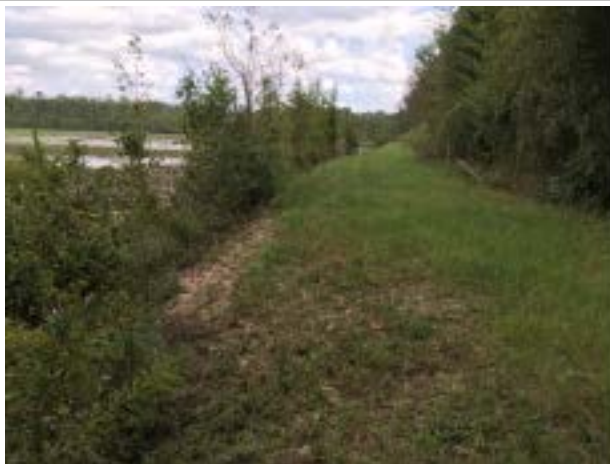
1. Grass Cover

No Deficiency

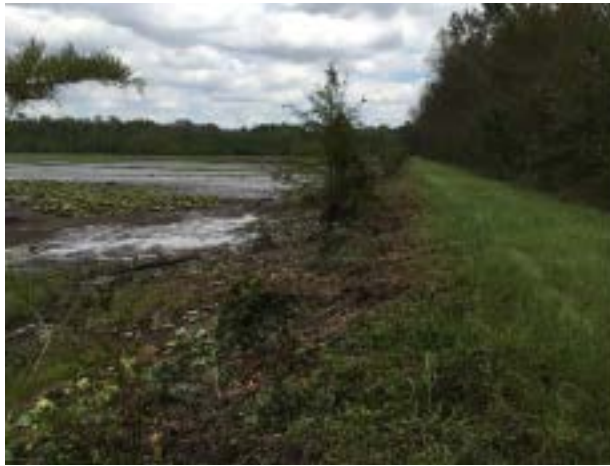
1. Grass Cover

Monitor

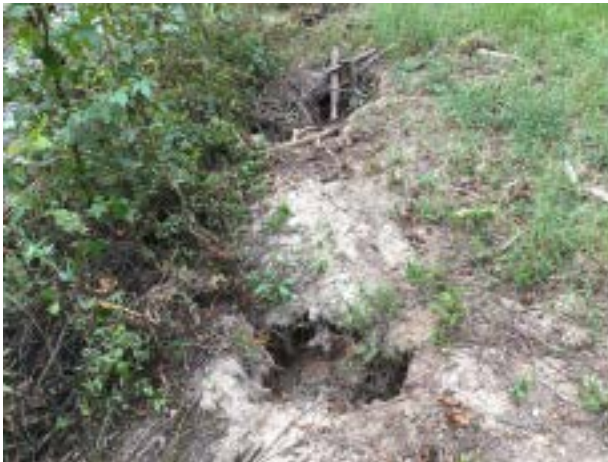
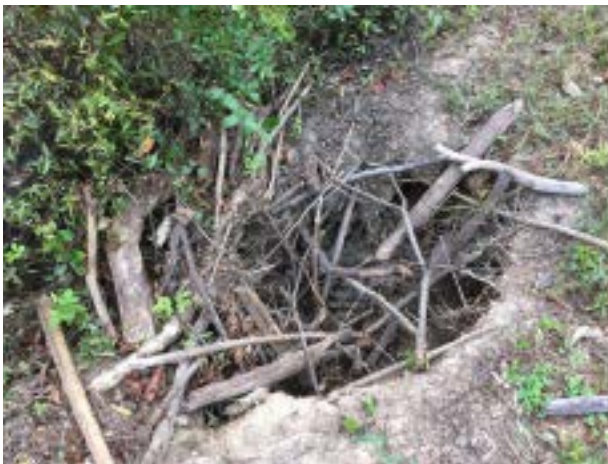
Evidence of beaver activity

Animal burrows were probably enlarged during overtopping event. These should be filled and compacted.

12. Other:	Action Required
Repair all holes caused by burrowing animals and overtopping	
13. Embankment: Upstream Slope Condition	Needs Maintenance, Condition Prevented Full Inspection
Violation Determined: 9/27/2018 DAMMAINTREP

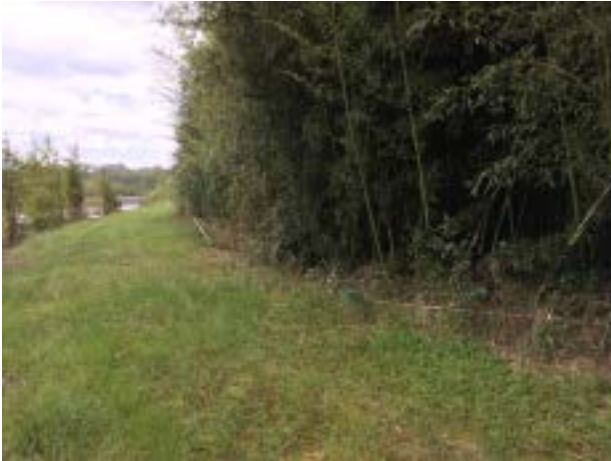
Embankment: Downstream Slope	
<i>2. Deleterious Vegetation</i>	Action Required
Bamboo on right side.

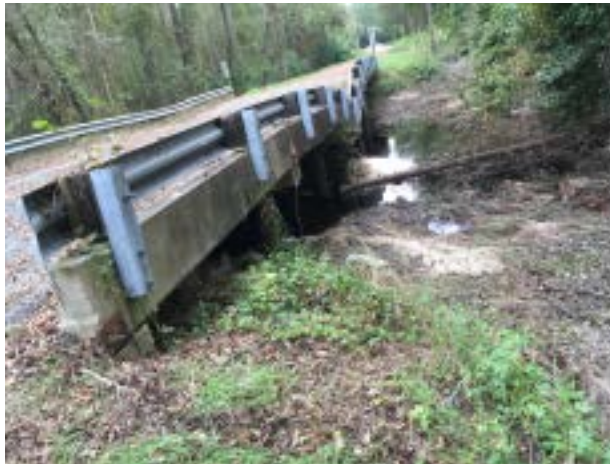
Paved road and associated ditch is located in downstream area.

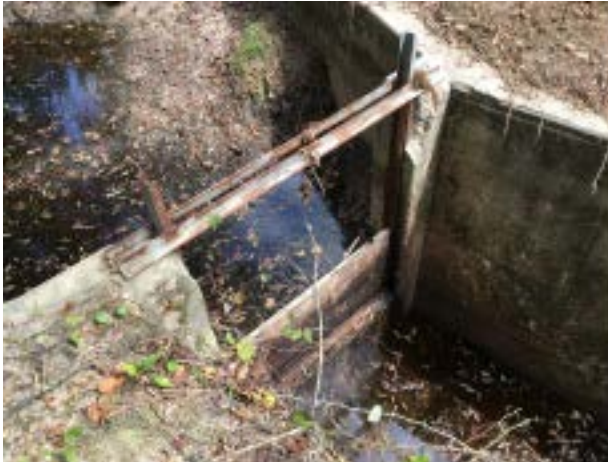
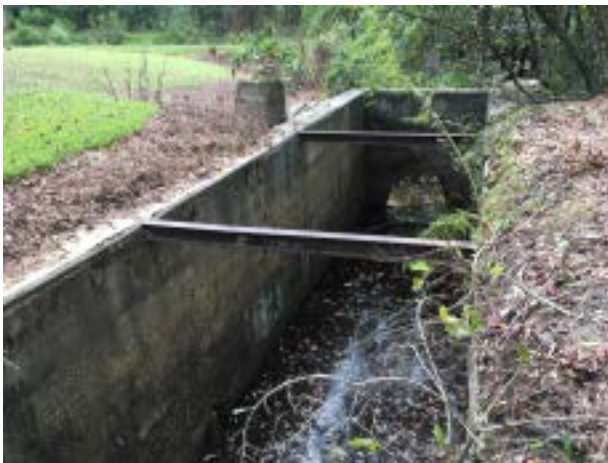
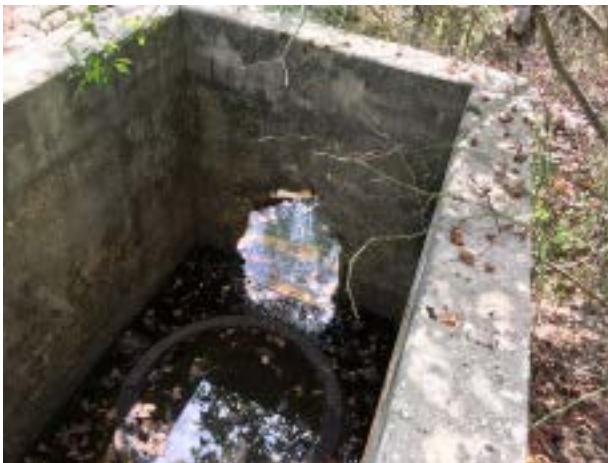
Auxiliary spillway is a concrete chute with stop boards at approach to help control water level. Owner had removed most boards prior to the arrival of Hurricane Florence.

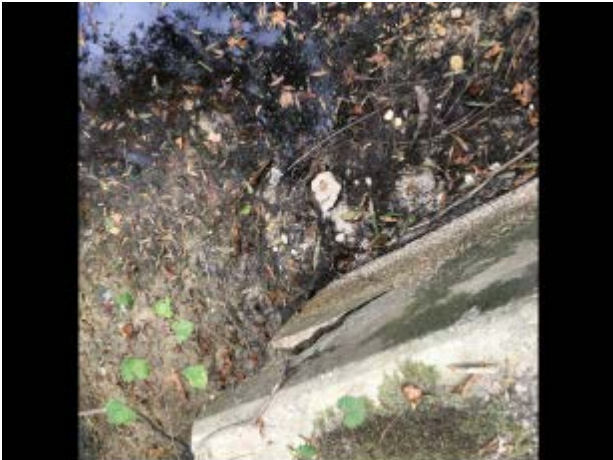
Spillways: Non-Erodible Channel	
1. Location	
2. Approach Area	No Deficiency
3. Weir/Control	No Deficiency
4. Sidewalls	Monitor
<p>Crack observed in wall on upstream side</p> <div style="display: flex; align-items: flex-start;">

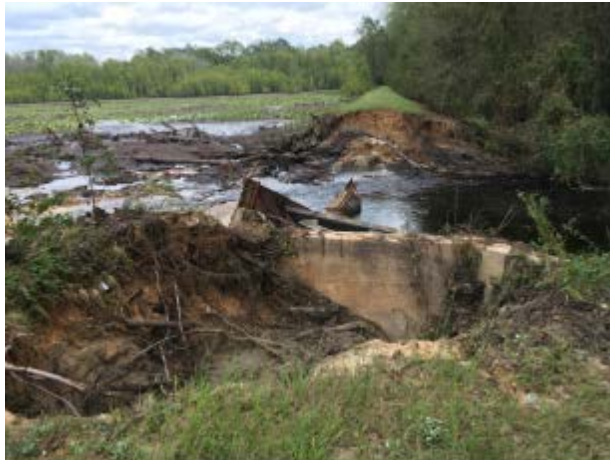
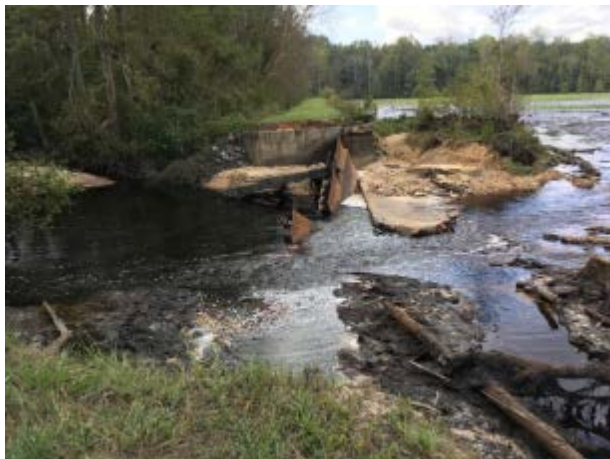
Prior to Hurricane Florence, the spillway was an old bridge. This bridge structure was washed away and has left an erodible channel as the primary spillway.

7. Other:	Action Required
8. Spillway: Inlet Structure Condition	Needs Permitted Repair(s), Condition Prevented Full Inspection
<div style="border: 1px solid black; padding: 5px;"> Violation Determined: 10/1/2018 DAMMAINTREP </div>
