LAKE DARPO DAM : D3530
Dams Preliminary Inspection Form

Inspector: Dani H Felkel

Start Date: 09/27/2018 Completed Date: 10/05/2018

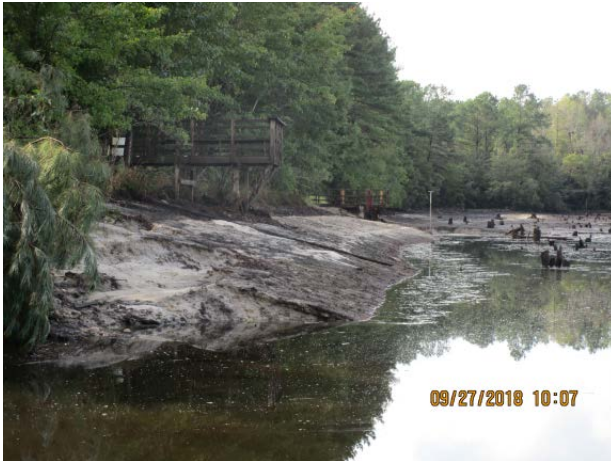
Photo Taken: 9/27/2018 10:07:49 AM

Breach prevented access to a large portion of the dam.

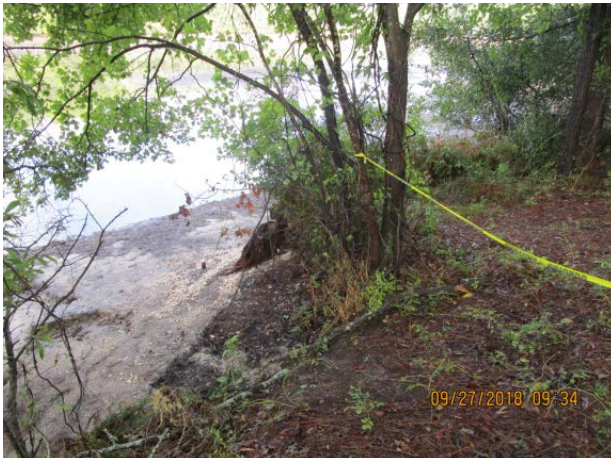
Photo Taken: 9/27/2018 9:34:07 AM

Little to no grass cover.

Weeds, brush, and small trees present.

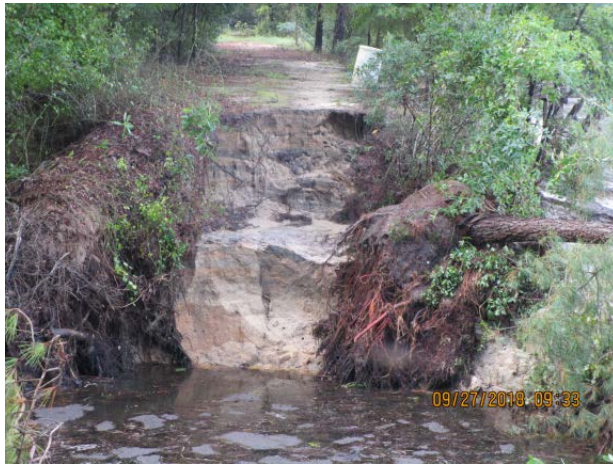
Photo Taken: 9/27/2018 9:33:32 AM

Some large trees present along the undamaged portion of the slope. Several fallen trees in the breached area.

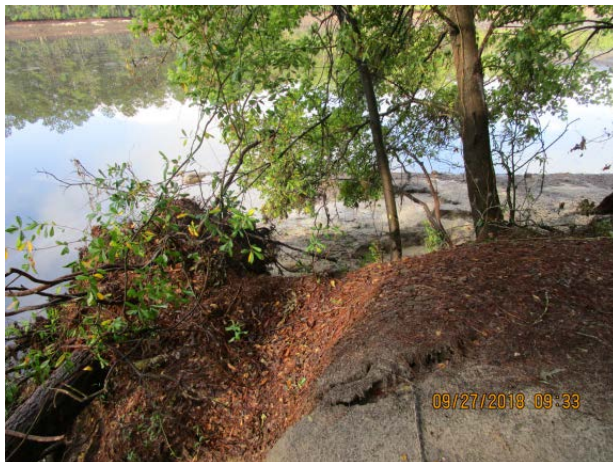
Photo Taken: 9/27/2018 9:33:22 AM

Some sloughing around the breach. Unable to fully observe. Breach prevented access to a large portion of the dam.

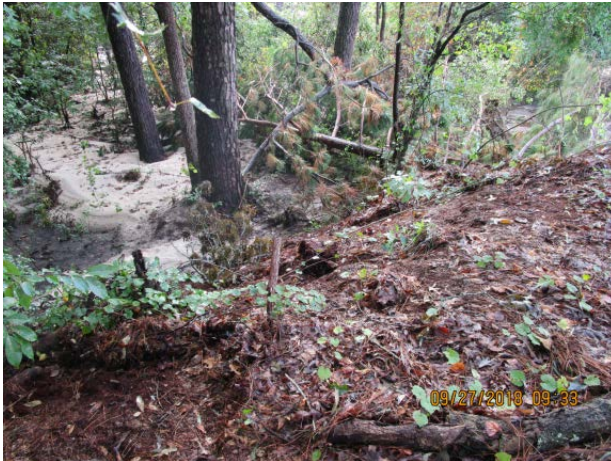
Photo Taken: 9/27/2018 9:33:54 AM

Breach prevented access to a large portion of the dam.

<i>1. Grass Cover</i>	Action Required
Little to no grass coverage.	
<i>2. Deleterious Vegetation</i>	Action Required
Weeds, brush, and small trees present.	
<i>3. Trees</i>	Action Required
Large trees observed along the downstream slope. Several fallen trees in and around the breached area.	
<i>4. Animal Activity</i>	Monitor
Unable to observe. Breach prevented access to a large portion of the dam.	
<i>5. Surface Cracking</i>	
Unable to observe. Breach prevented access to a large portion of the dam.	
<i>6. Subsidence, Sinkhole</i>	
Unable to observe. Breach prevented access to a large portion of the dam.	
<i>7. Slide, Slough, Scarp</i>	
Unable to observe. Breach prevented access to a large portion of the dam.	
<i>8. Groins</i>	
Unable to observe. Breach prevented access to a large portion of the dam.

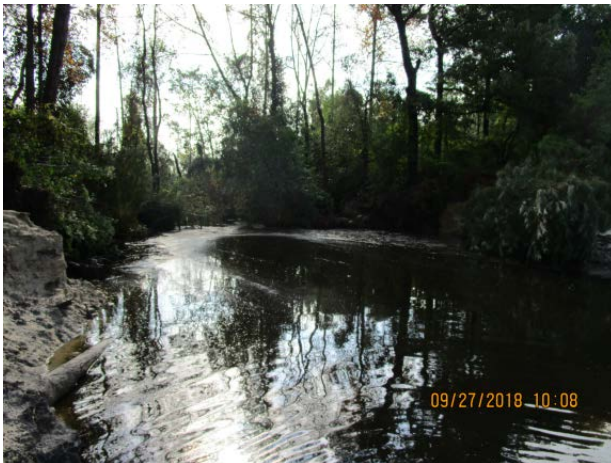
Photo Taken: 9/27/2018 10:08:12 AM

Debris from flooding and dam failure immediately downstream.
Cleared power line just below the downstream area.

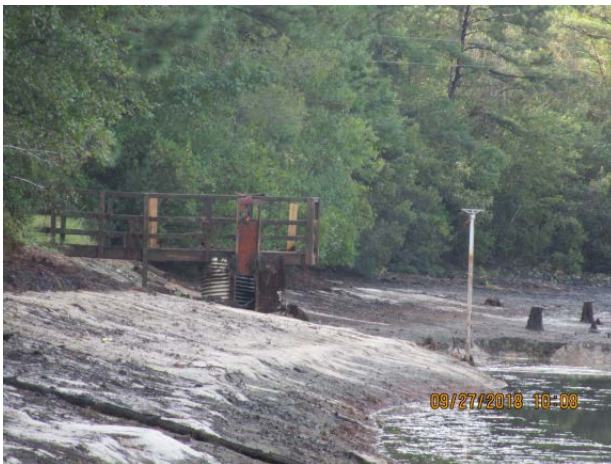
Photo Taken: 9/27/2018 10:08:29 AM

Breach prevented access to the primary inlet

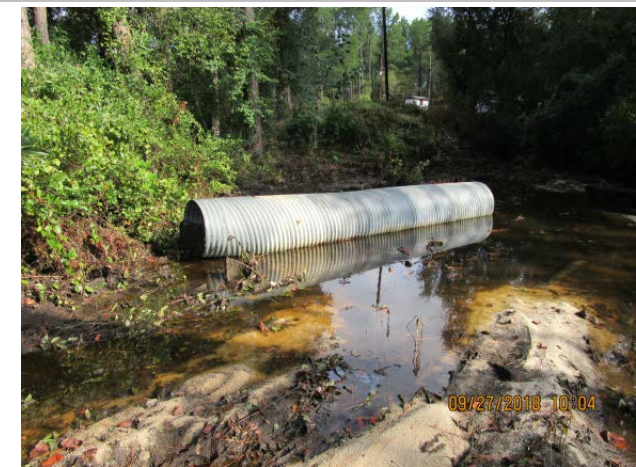
Photo Taken: 9/27/2018 10:04:40 AM

9. *Additional Comments (Refer to item number if applicable)*
Secondary spillway was a 36" CMP extending horizontally through the dam. Location from Google Earth: (34.457768, -79.880445). Failure of the dam occurred at this location and washed the pipe downstream.

Dam was breached as a result of Hurricane Florence. Failure occurred near the left abutment, where an auxiliary spillway (horizontal CMP) was placed through the dam. A large portion of the dam was inaccessible as a result of the location of the failure and impassible roads in the area surrounding the dam.

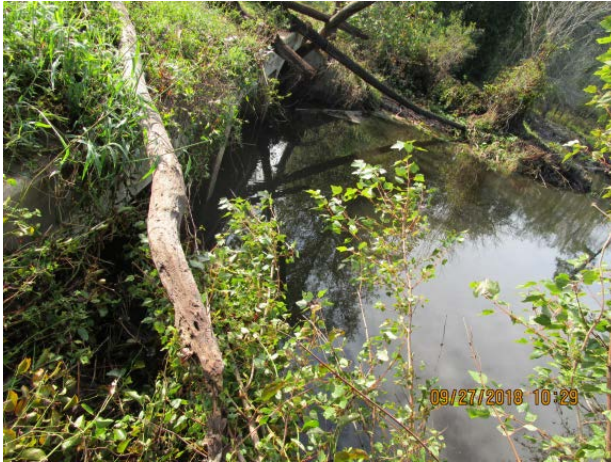
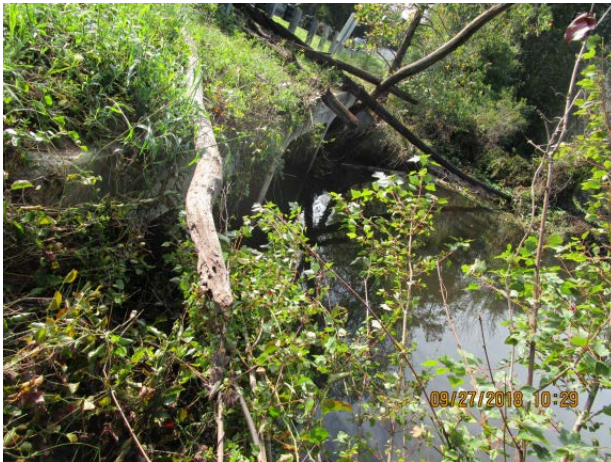
US Highway 52 is approximately 0.4 miles downstream. Debris in culvert (see photos).
Society Hill Road is 2.3 miles downstream (below D3539).
