**Subject: Summarization of Terracon Geotechnical Report and WSP's Recommendations
Senate Street Pavement Investigation, Congaree River Remediation Project
Columbia, South Carolina**

Geotechnical Engineering Report

Congaree River Remediation – Senate Street Pavements
Columbia, SC

October 18, 2021

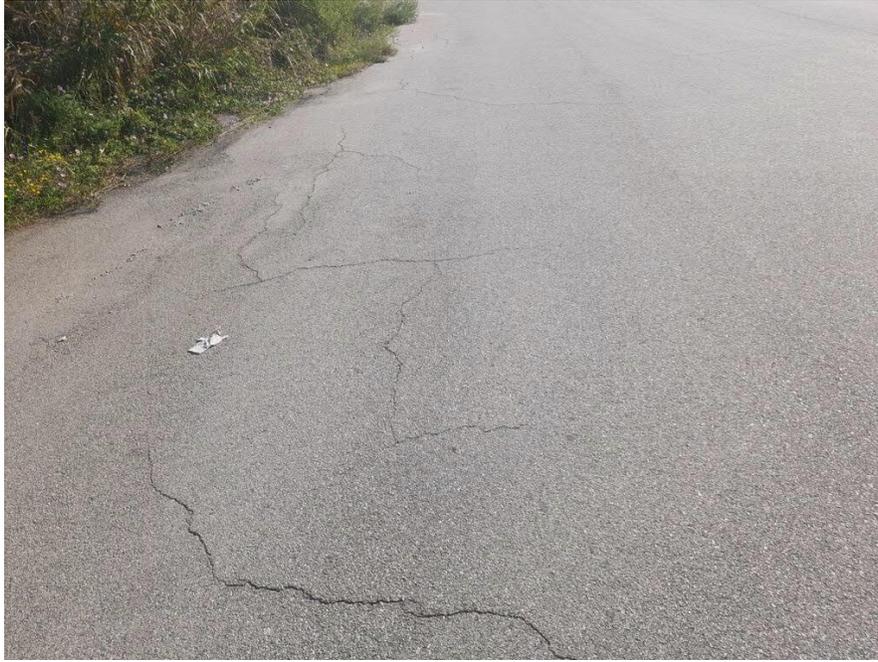
Existing Pavements	Based on our recent observations of the roadway, the existing pavement appears to be in fair condition. The primary distresses observed included low- to medium-severity transverse/longitudinal cracking at the east end of the roadway segment near the Huger Street intersection. Medium severity

Photo 1: Longitudinal/Transverse cracks near Boring B-1

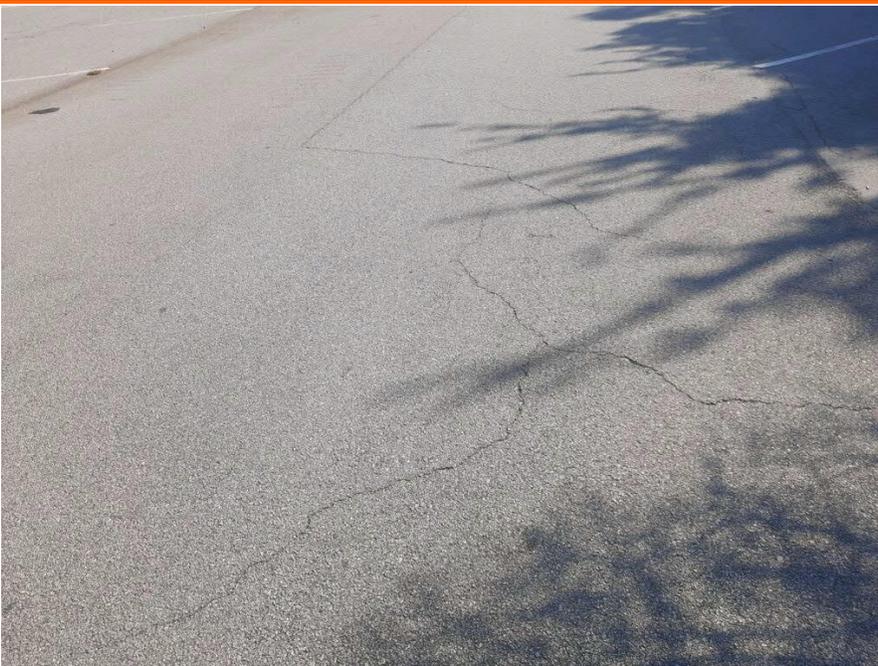
Photo 2: Longitudinal/Transverse cracks near Boring B-2

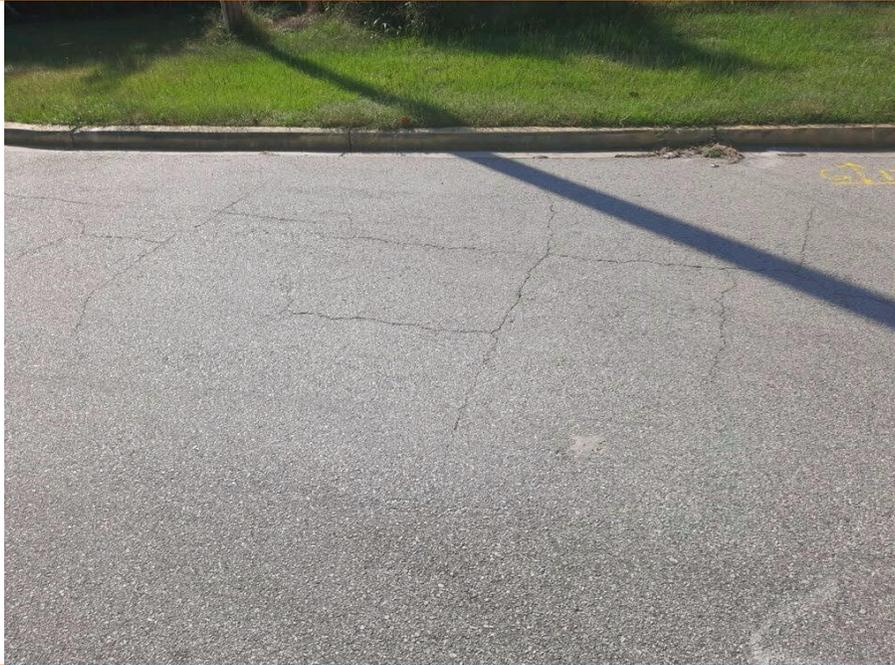
Item	Description
	block cracking was also observed near Borings B-2 and B-3. Moderate severity alligator cracking was observed at the intersection of Gist Street and Senate Street. See Photographs 1 through 4 in the Photography Log .

Photo 3: Block cracking near Boring B-3

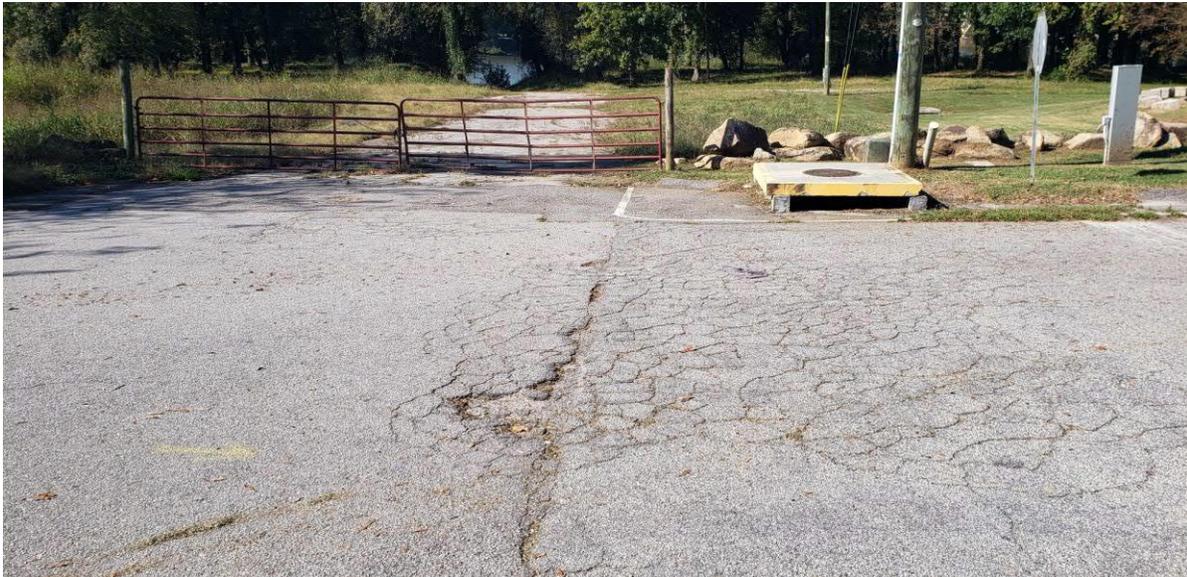
Photo 4: Alligator cracking near Boring B-5

1. Preventative Measures:
 - a. Complete preemptive patching and repair work at the intersection of Gist St and Senate St.
2. Maintenance During Construction

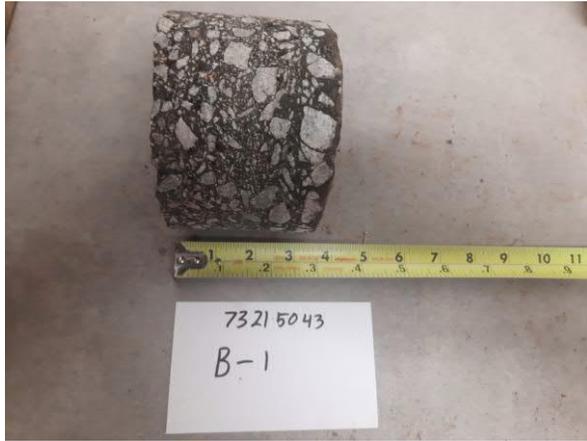
Photo 5: Core sample of Boring B-1

Asphalt encountered at 1.5'. Could not penetrate any further with a hand auger. Similar observations were noted in an offset boring 5 feet away.
Relative surface elevations obtained from available Richland GIS topographic information.

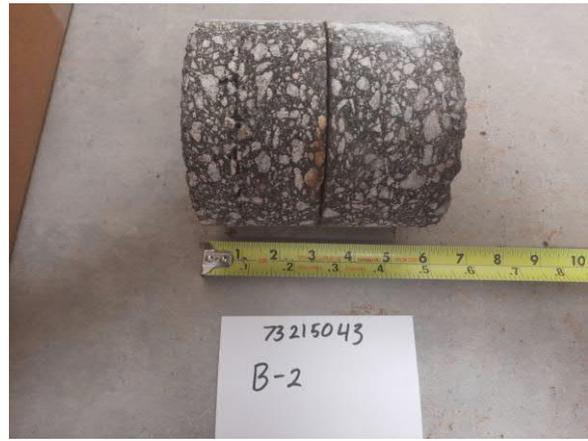
Photo 6: Core sample of Boring B-2

Asphalt encountered at 1'. Could not penetrate any further with a hand auger. Similar observations were noted in an offset boring 5 feet away.
Relative surface elevations obtained from available Richland GIS topographic information.

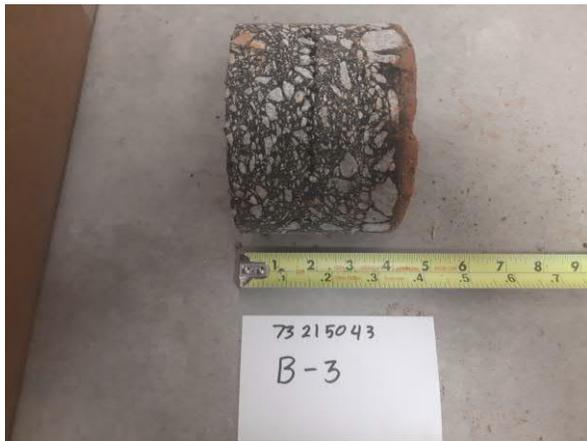
Photo 7: Core sample of Boring B-3

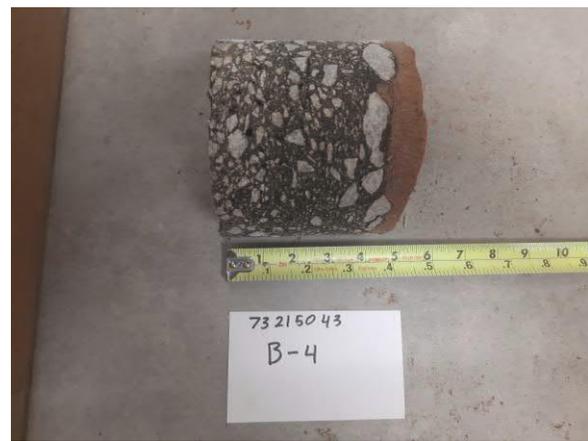
Photo 8: Core sample of Boring B-4

Asphalt encountered at 2'. Could not penetrate any further with a hand auger. Similar observations were noted in an offset boring 5 feet away.
Relative surface elevations obtained from available Richland GIS topographic information.

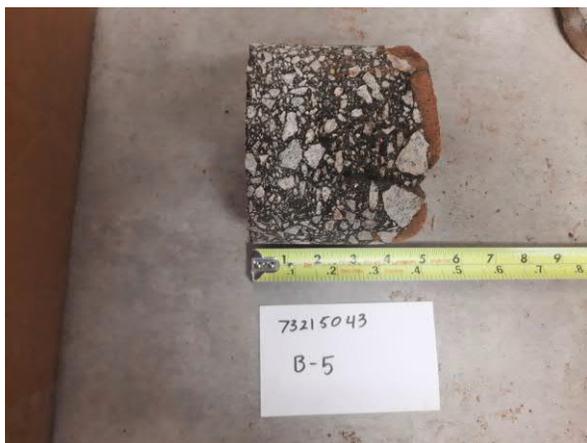
Photo 9: Core sample of Boring B-5

Asphalt encountered at 1'. Could not penetrate any further with a hand auger. Similar observations were noted in an offset boring 5 feet away.
Relative surface elevations obtained from available Richland GIS topographic information.
