**Results of the  
Comprehensive Performance Evaluation  
for the  
City of Denmark Water System  
Denmark, South Carolina**

**March 25 - 29, 2019**

**Process Applications, Inc.  
2627 Redwing Road, Suite 340  
Fort Collins, Colorado 80526**

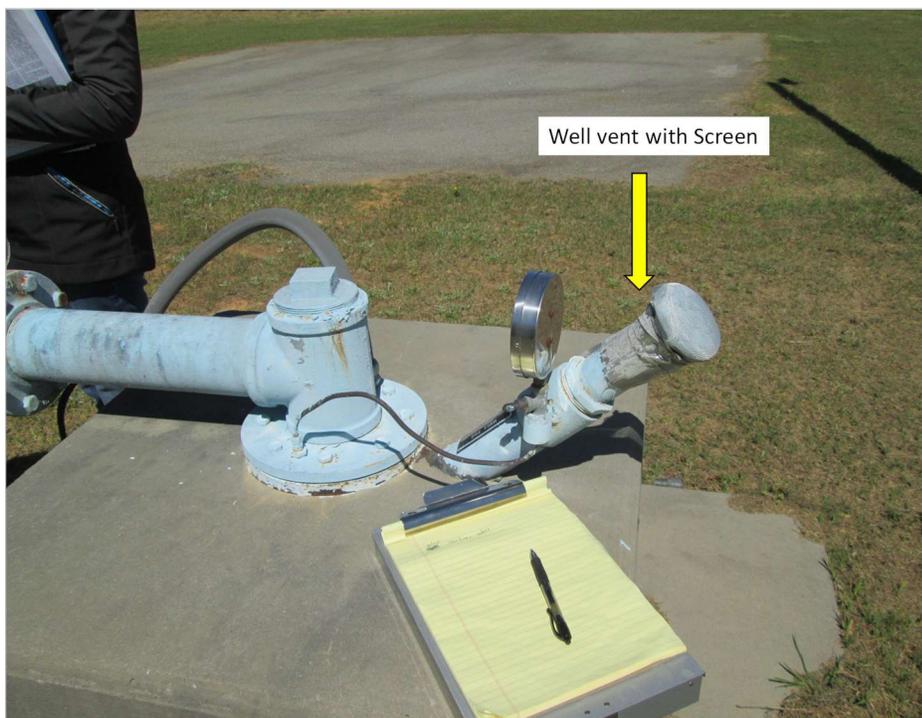
A lumberyard is located a few hundred feet from the well head, but there did not appear to be any activity on the day of the inspection that would increase the risk of contamination to the West Voorhees Well. The well appears to be vented through an old sounding tube that terminates at the well head (see Figure 3 below). The vent is not turned downward to prevent rain from entering the well and is screened with a mesh that is too large to prevent small insects from entering the well vent (#24 mesh screens are considered best for preventing insects from entering the well). Although the wells met the performance goal of no total coliform organisms present during the week of the CPE site visit, these sanitary defects could allow contamination of the well in the future.

**FIGURE 3. West Voorhees well head showing vent.**

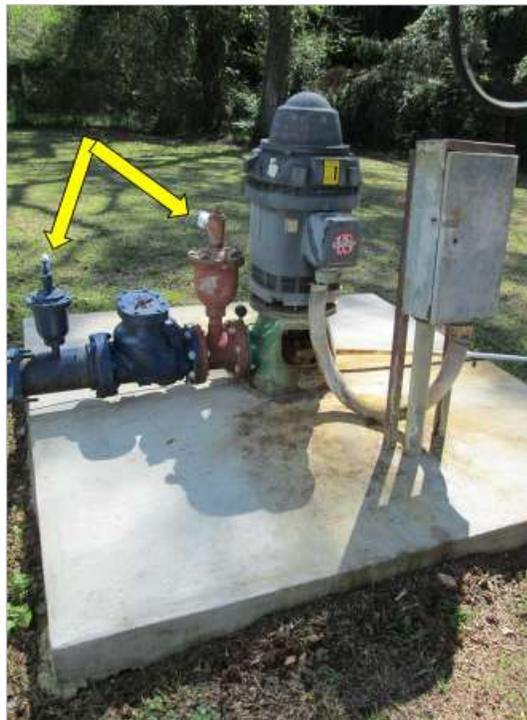
The East Voorhees well head and well seal sit virtually on top of the well pad (see Figure 4). Well casings should extend at least 12 inches above the top of the well pad to prevent runoff from entering the well and to prevent dust that collects on the well pad from entering the well. There appear to be vents on the well head on three of the four sides, the largest of which was screened but not

**FIGURE 4. East Voorhees well head and pad (casing does not extend 12 inches above pad and air relief valve discharge is not downturned and screened).**

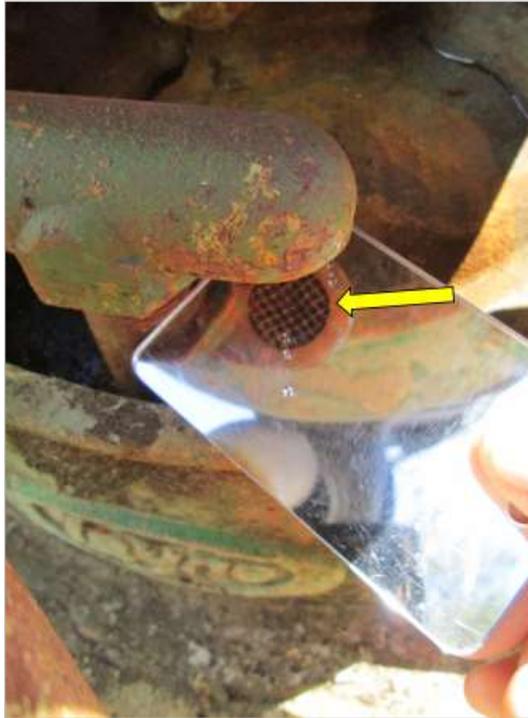
with a fine enough screen (larger than #24 mesh), and the others were not screened (see Figure 5 for a photo of the vent that was screened showing greater than #24 mesh). Also, at the East Voorhees well, there is a gap at one corner of the well head between the well head and the well pad (see Figure 6). The gap could allow runoff to seep into the well head area and potentially enter the well through the well head. The well head has two air relief valves just downstream of the well, each with an air vent that is not turned downward and not screened. Air relief valves open when air is blown off. They should be turned downward to prevent rain from entering and should be screened to prevent insects from entering. The air relief valves can be seen in Figure 4.

**FIGURE 5. East Voorhees well vent (well vent with screen mesh larger than #24).**

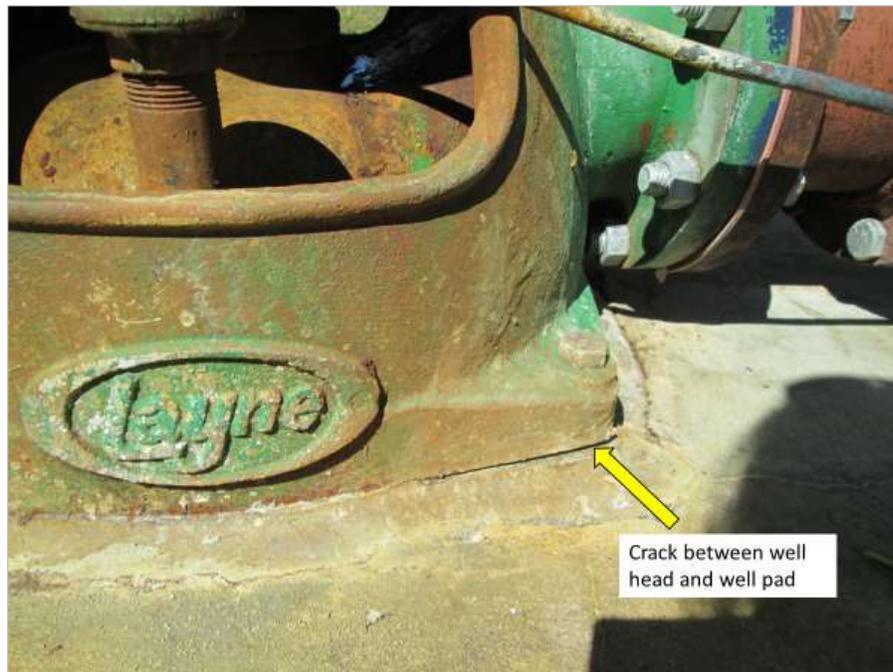
**FIGURE 6. East Voorhees well mounting (crack shown between well head and pad).**

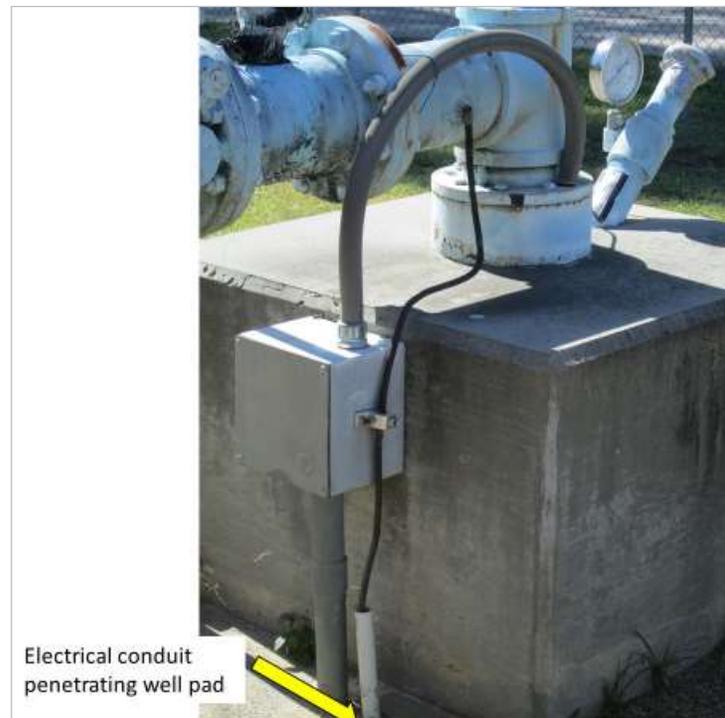
The Acacia well has a vent that is properly turned downward, but it is screened with a coarse mesh screen (larger than #24 mesh). A vent screen that is not as fine as #24 mesh can allow small insects to enter the well. There is an electrical conduit line that penetrates the well pad about 10 inches from the well, allowing a route of contamination to the well (see Figure 7).

**FIGURE 7. Acacia well site (electrical conduit shown penetrating well pad).**

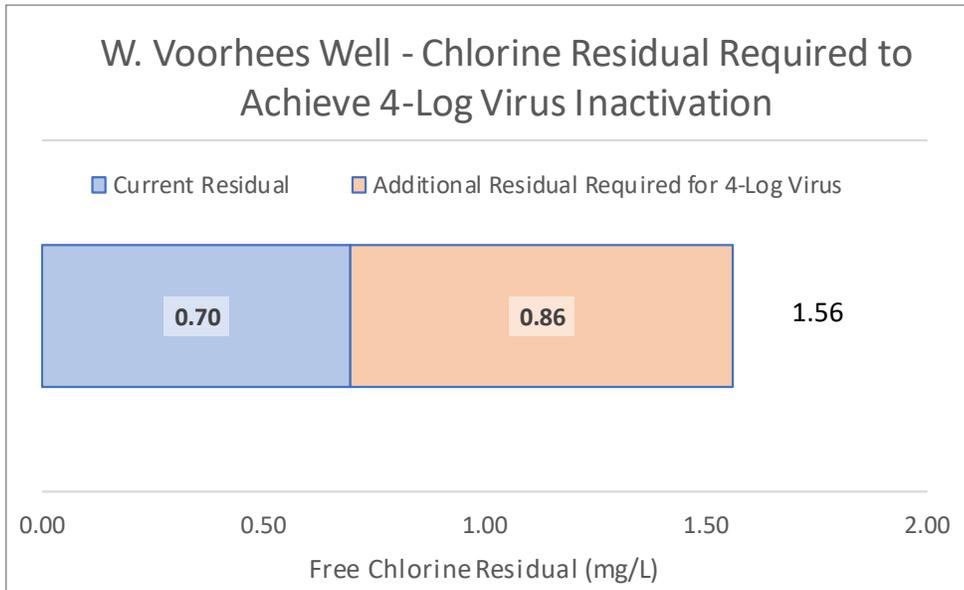
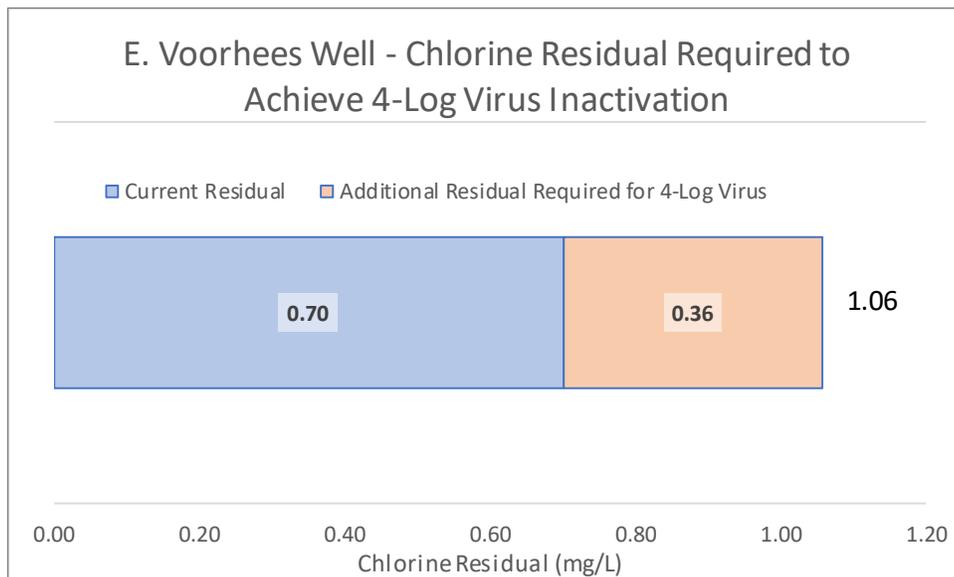
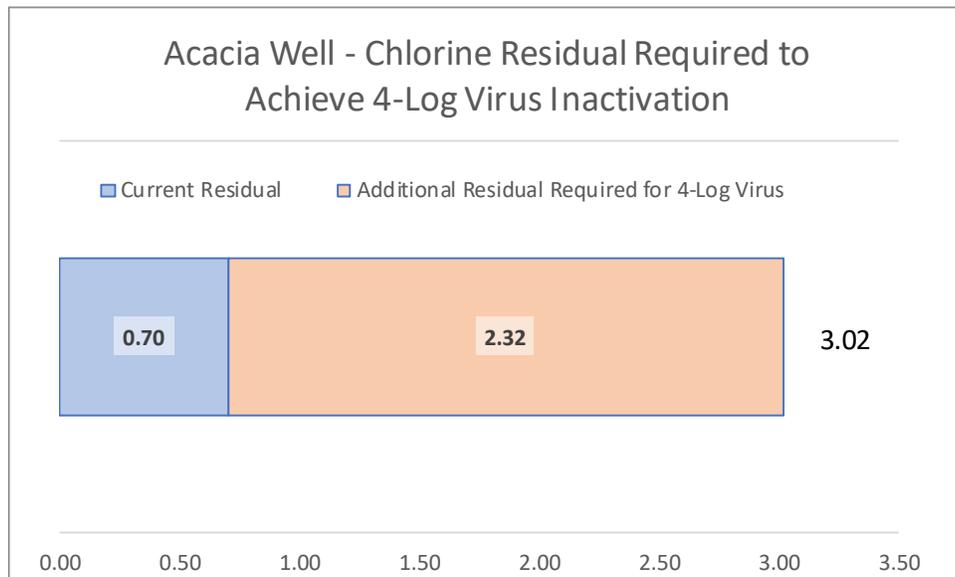
Figures 11, 12, and 13 show the results of Table 3 for each well in a graphical format. The portion of the bar graph shown in blue shows the free chlorine residual used for the evaluation. The portion of the bar graph shown in orange indicates the additional free chlorine residual that would be required to meet the disinfection goal of 4-log virus inactivation. The number shown to the right of the orange bar is the total free chlorine residual required to meet the required virus inactivation. The smallest increase in free chlorine residual necessary to achieve the disinfection optimization goal would be required at the East Voorhees well. Free chlorine residual would need to increase by more than 120% at the West Voorhees well, and by more than 430% at the Acacia well to meet the optimization goal for disinfection.

This analysis shows that, if the City of Denmark intended to adopt the optimization goal for disinfection, free chlorine residual would need to increase at each well, the contact time would need to be increased, or a combination of these options would be required.

- The current chlorine dosages are not sufficient to meet 4-log virus inactivation.

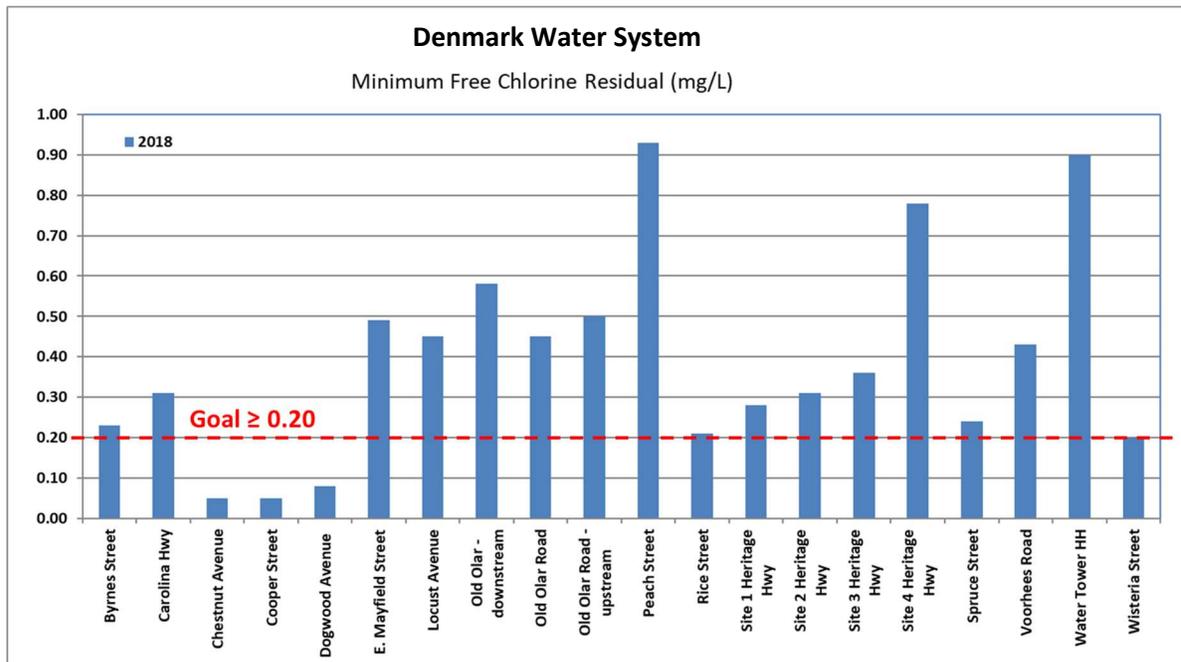
Further analysis of the chlorine residual results from the 2018 coliform monitoring is shown in Figure 14. This chart shows the lowest chlorine residual recorded at each sample site. Three sample sites (Cooper Street, Dogwood Ave., and Chestnut Ave.) had chlorine residual levels below the optimization goal.

**FIGURE 14. Lowest free chlorine residual at monitoring sites in 2018.**

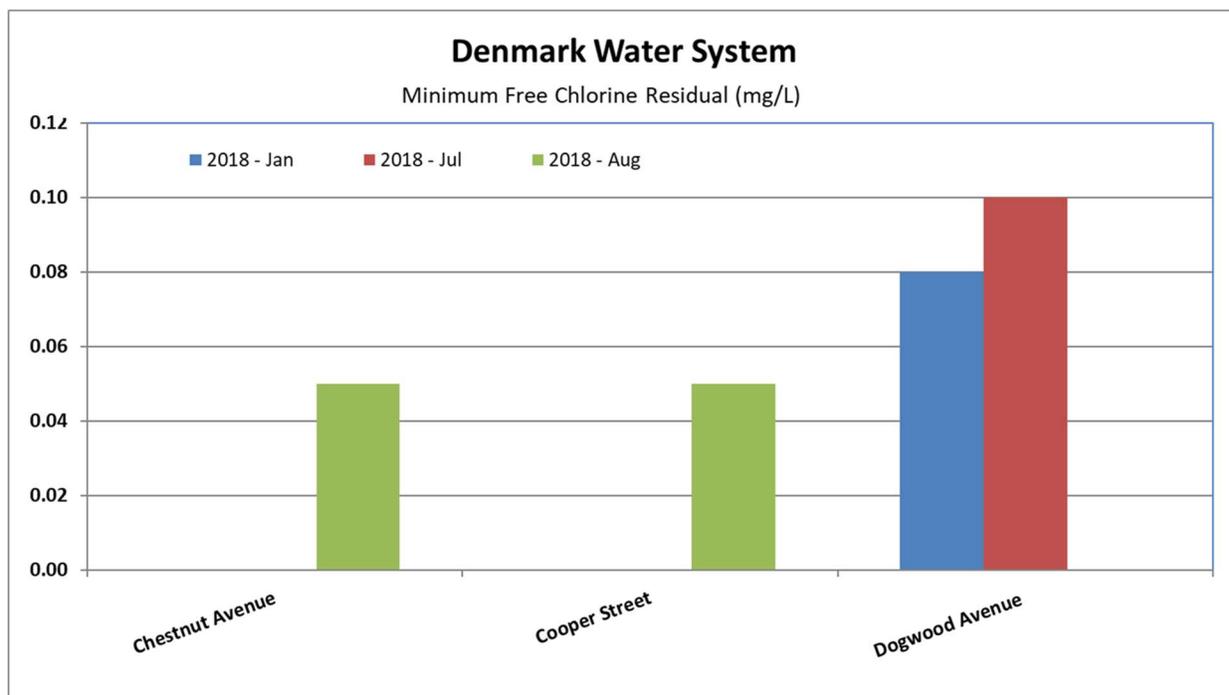
Figure 15 shows the months when these results occurred; three of the four events occurred during warm weather months of July and August. Water systems using ground water typically have relatively stable water temperature, but summer water temperature in the distribution system can be influenced by the water age in the piping and the elevated storage tanks. As water temperature increases, the chlorine residual decays more rapidly, resulting in low residuals like those experienced during the July and August sampling events. One low residual reading at the Dogwood Avenue site occurred in January, a colder weather month. This is somewhat unusual and may be related to other factors at the site that could impact chlorine residual (e.g., corrosion in older water mains).

**FIGURE 15. Sampling events when free chlorine residual was < 0.20 mg/L at monitoring sites in 2018.**

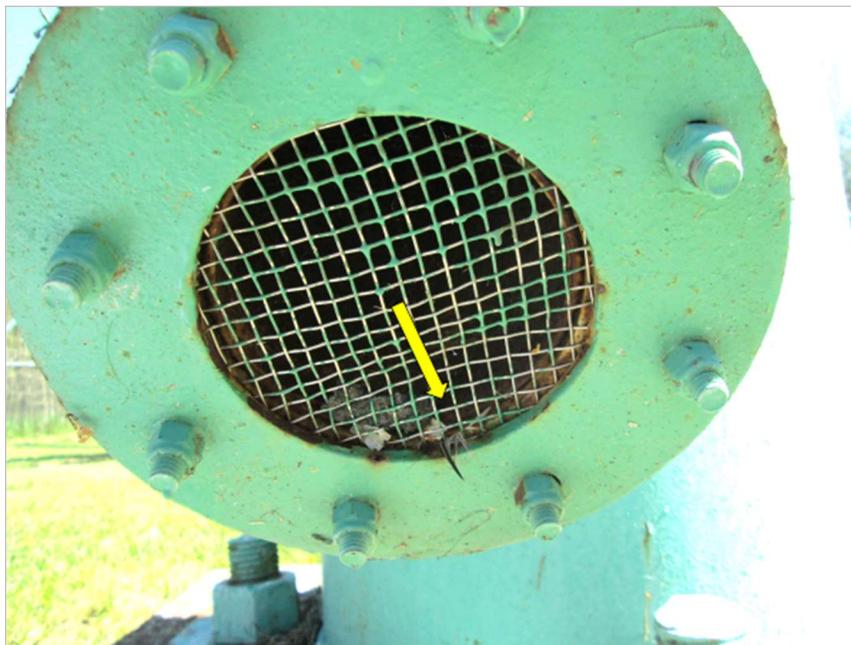
waterborne disease outbreaks in water systems in other locations around the country in the past and indicates a potential pathway for contamination in the Denmark system. The bird feathers in the overflow line are shown in Figure 18.

**FIGURE 18. East Voorhees storage tank overflow showing trapped bird feathers.**

- A tank inspection revealed that two storage tanks had unscreened or inadequately screened vents and a separation in the overflow line in April 2018, resulting in an opportunity for contamination (e.g., birds/insects) to enter the tank. The city had not addressed these issues at the time of this evaluation.
- The storage tank deficiencies were mentioned in a recent sanitary survey, with a request for a response by March 4, 2019. At the time of this evaluation, the city had not yet developed a response.
