BAXLEY 501 POND DAM : D0513

Dams Preliminary Inspection Form

Start Date: 09/24/2018 Completed Date: 09/25/2018

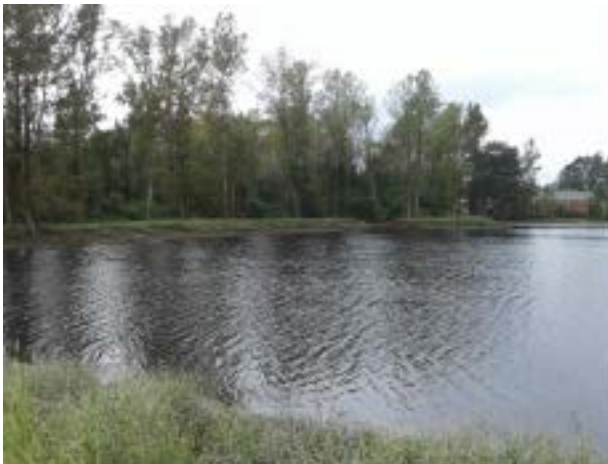
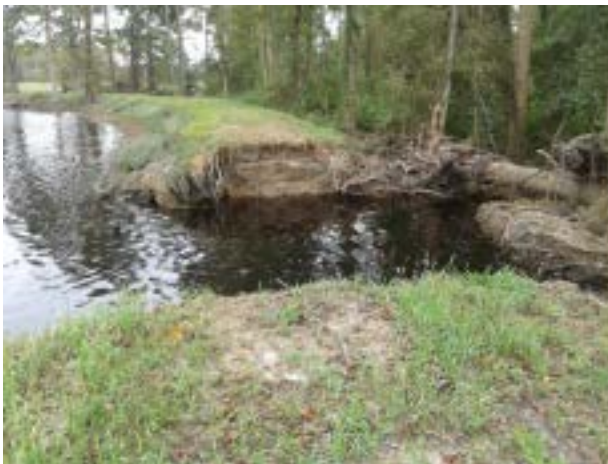
1. *Estimate the current level of the water in the reservoir:* Breached

Dam breached during recent Hurricane (Florence).

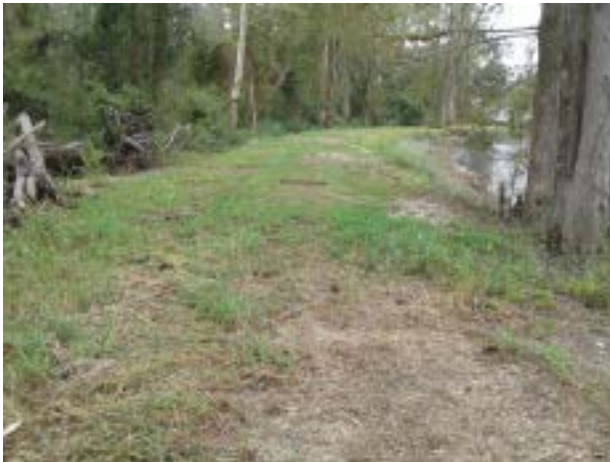
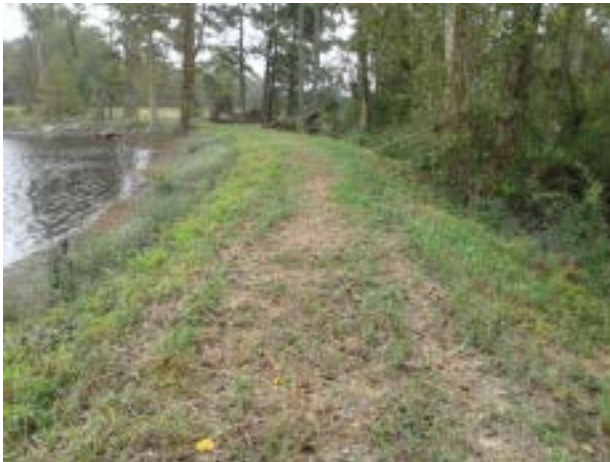
Some grass cover was observed along crest.

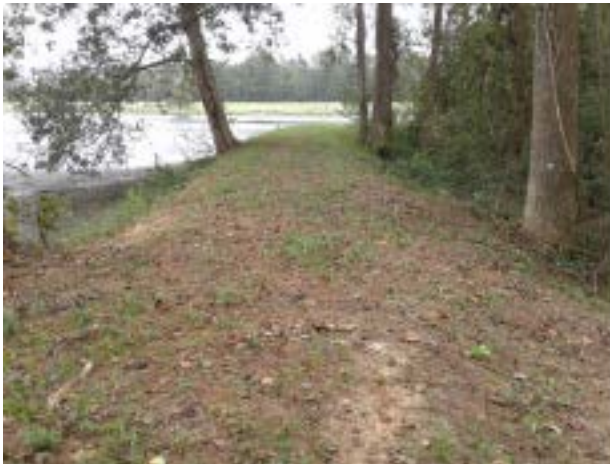
Large trees observed. See downstream and upstream slope sections.

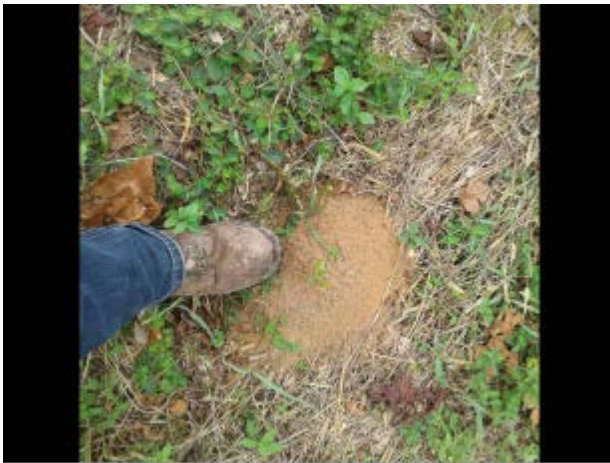
None observed. Some anthills observed.

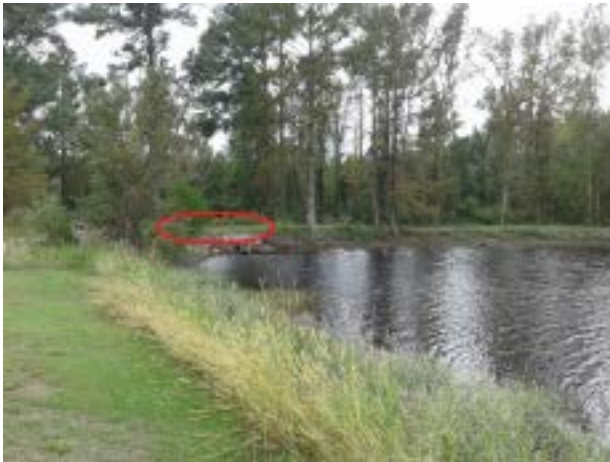
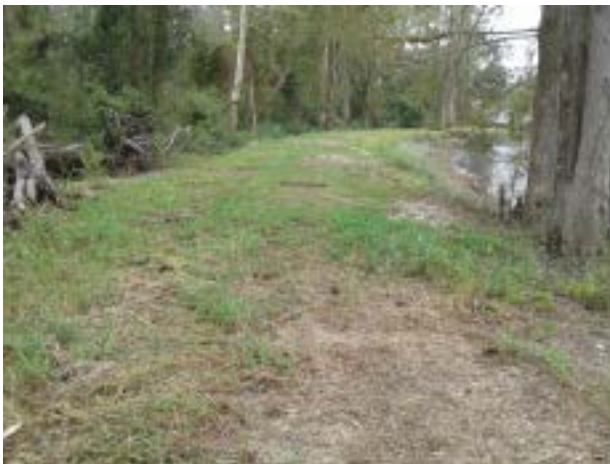
Some shallow depressions were observed near the primary spillway.

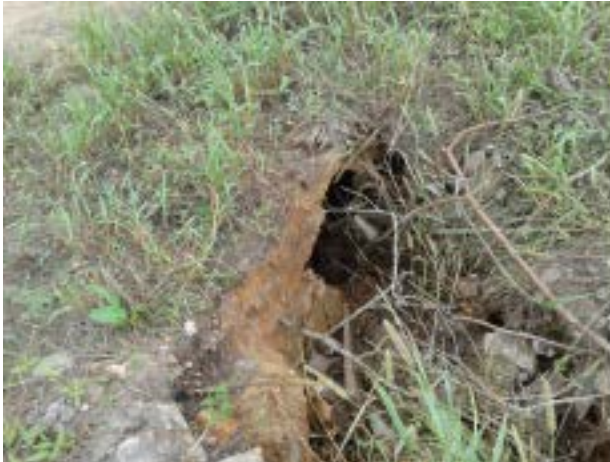
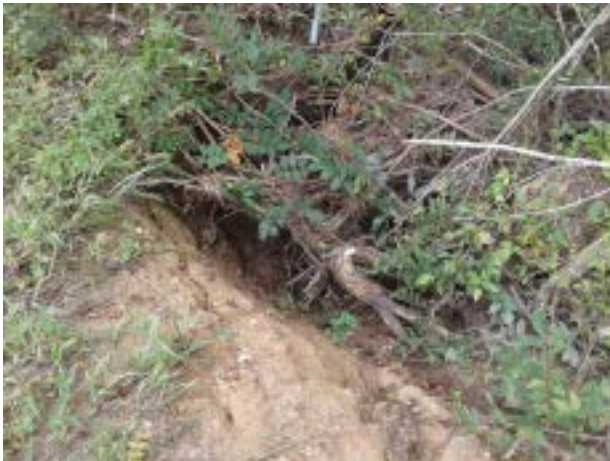
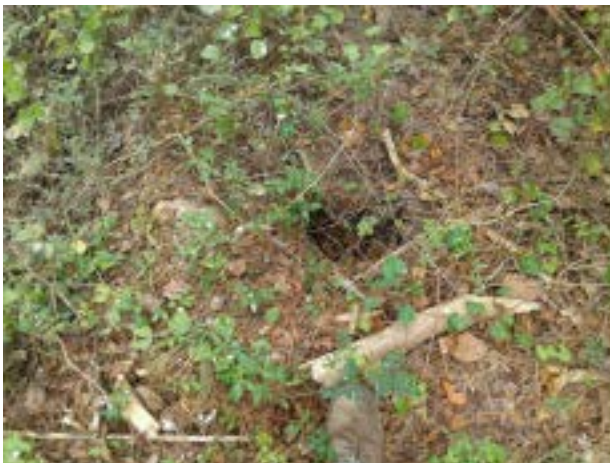
Both shallow, and deeper (12+ inches) erosion was observed. Many holes were observed, likely as a result of damaged and decaying trees.

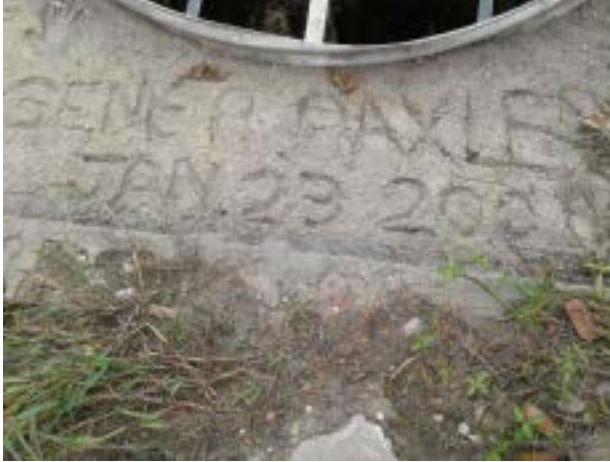
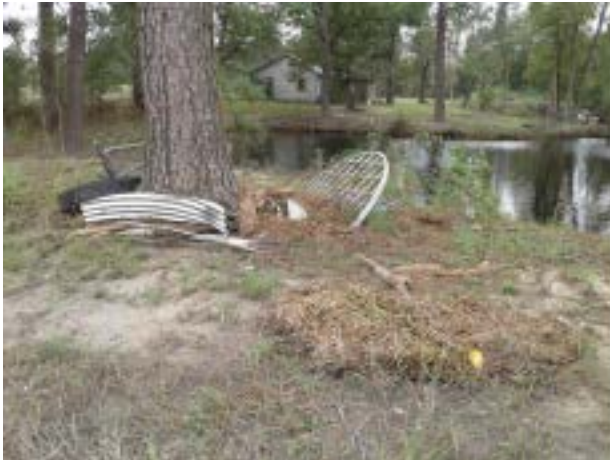
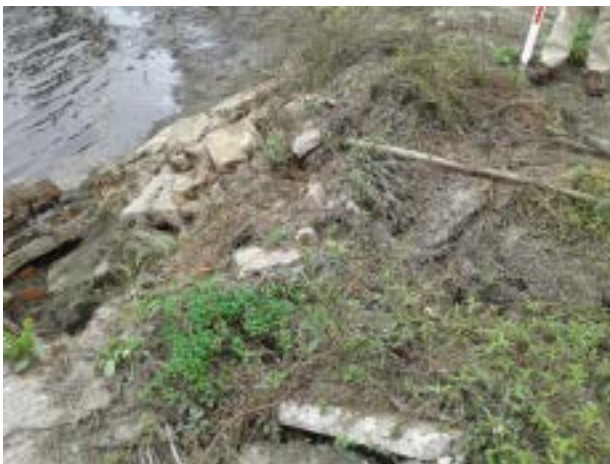
Modifications to the spillway were observed.

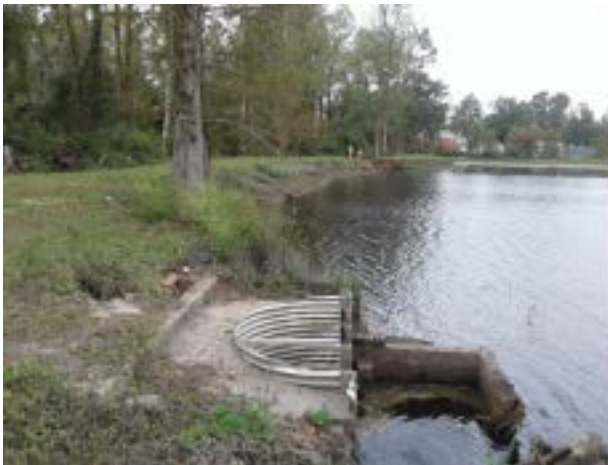
Little grass cover was observed.

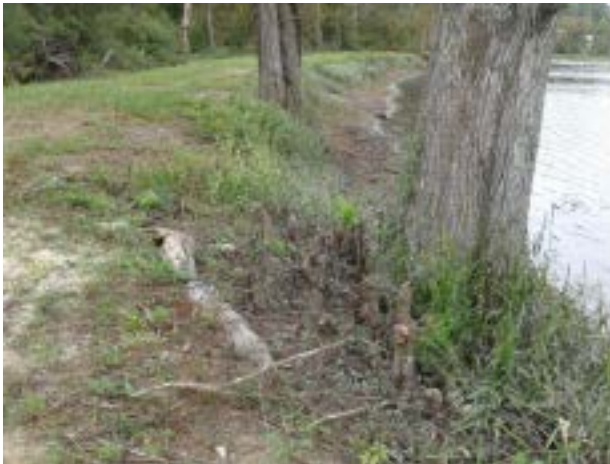
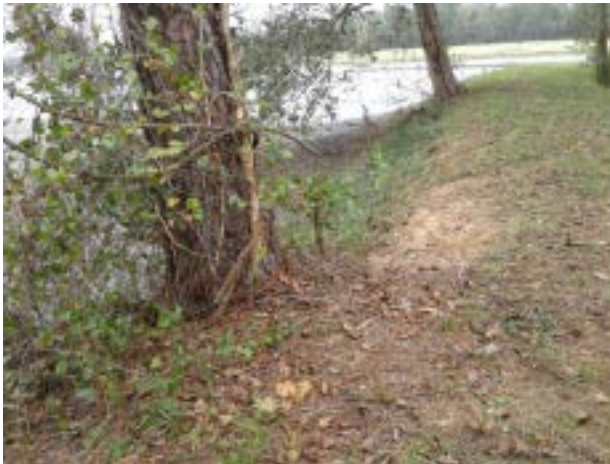
Several large trees were observed along the upstream slope.

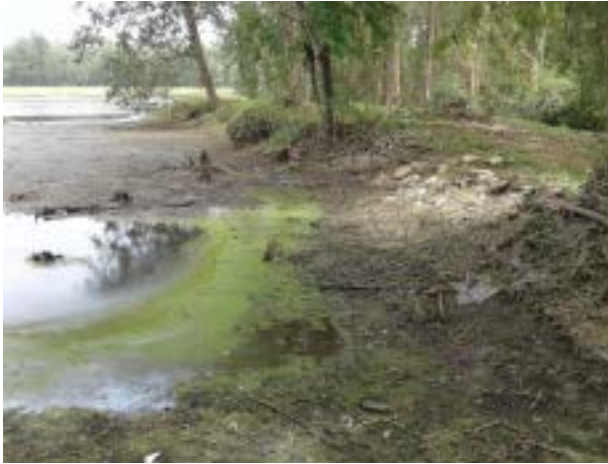
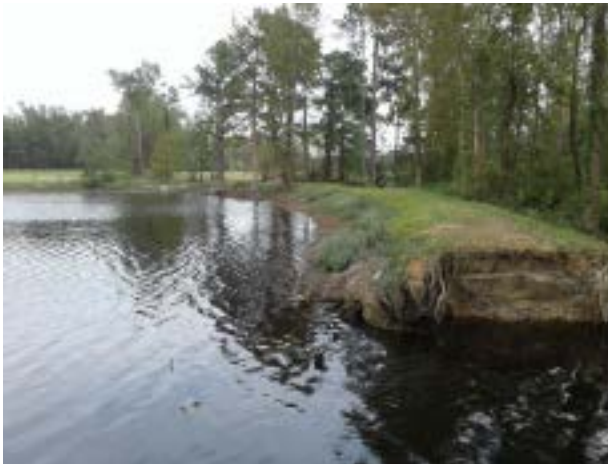
Large sections of the upstream slope were nearly vertical due to the scarping and wave action along slope.

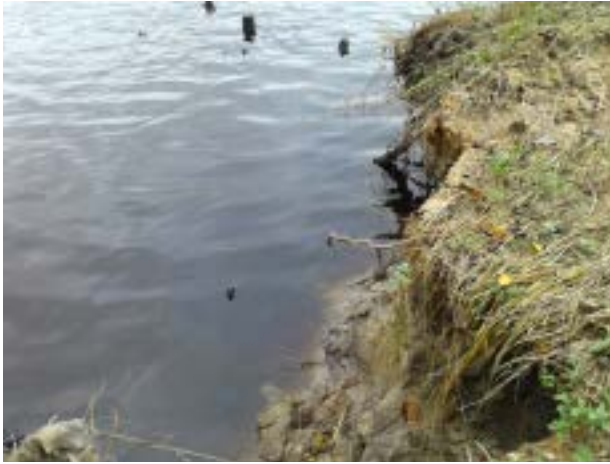
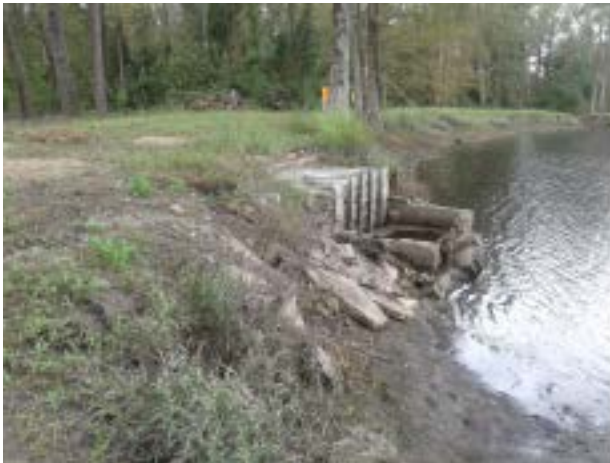
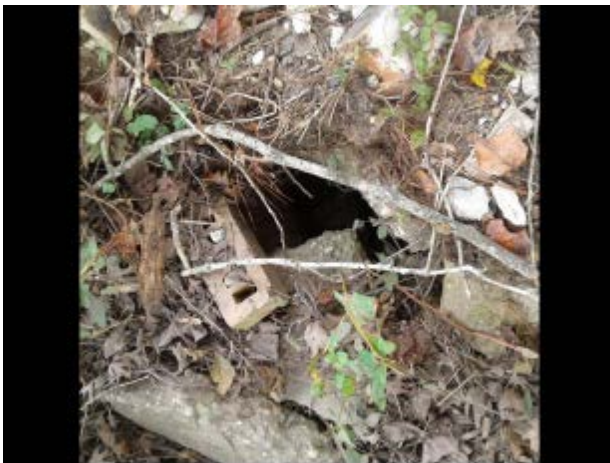
Large eroded holes were observed along slope, within breach, and near spillway. See also "Spillways: Inlet".

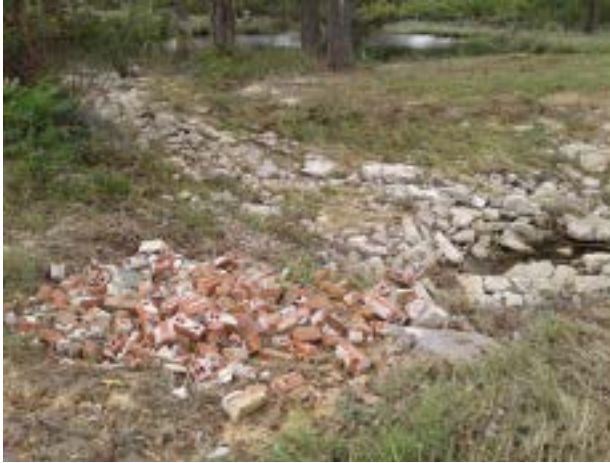
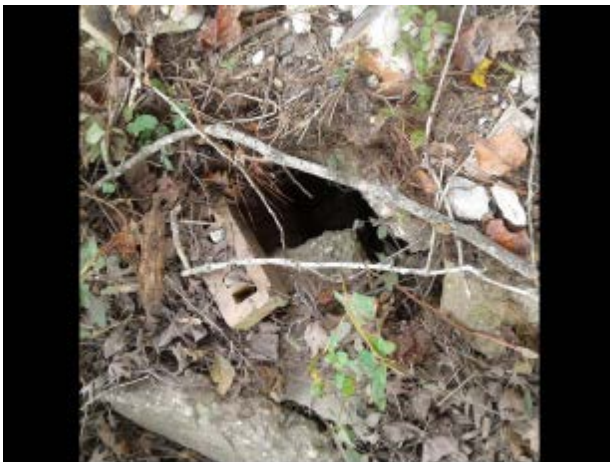
Brick and concrete rubble was used in an attempt to repair erosion.

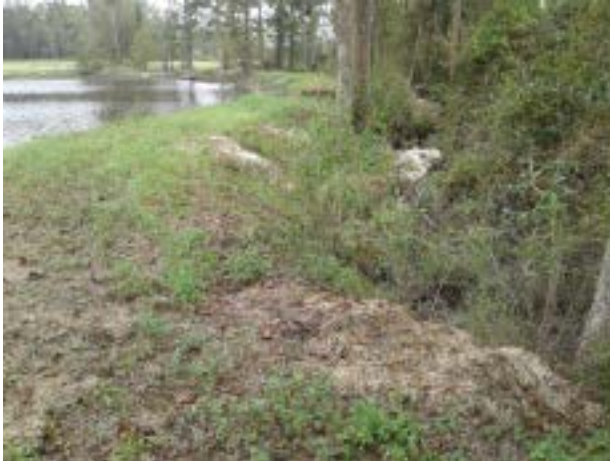
Tall brush and grasses observed on slope.

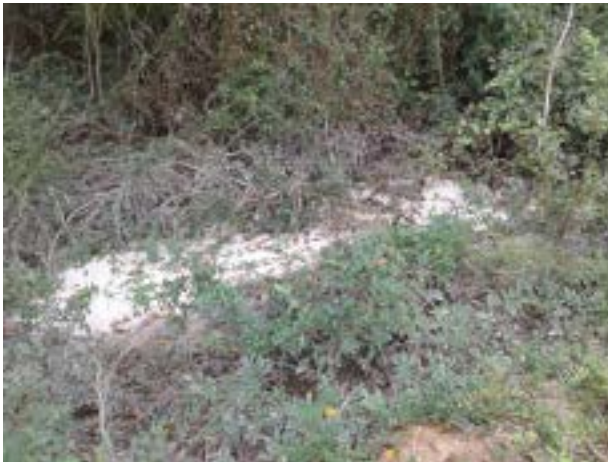
Dense brush observed along much of downstream slope.

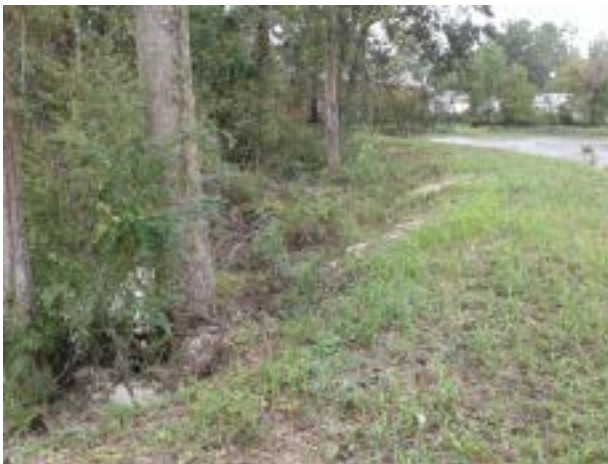
Sediment from overtopping and breaching of the embankment is shown.

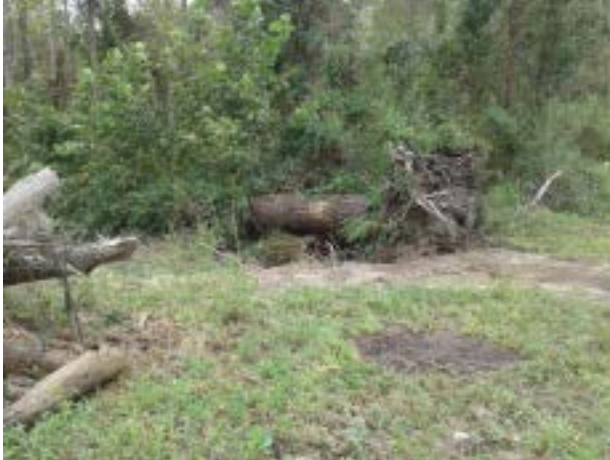
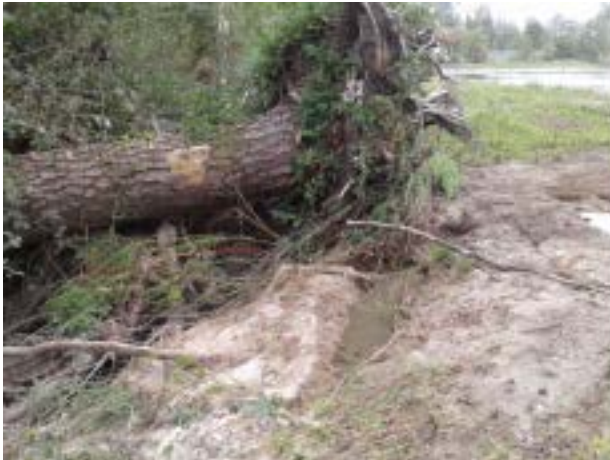
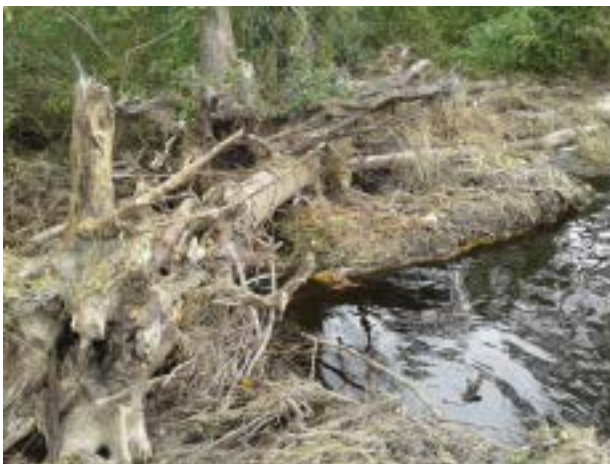
Large damaged and fallen trees observed in many places on downstream slope.

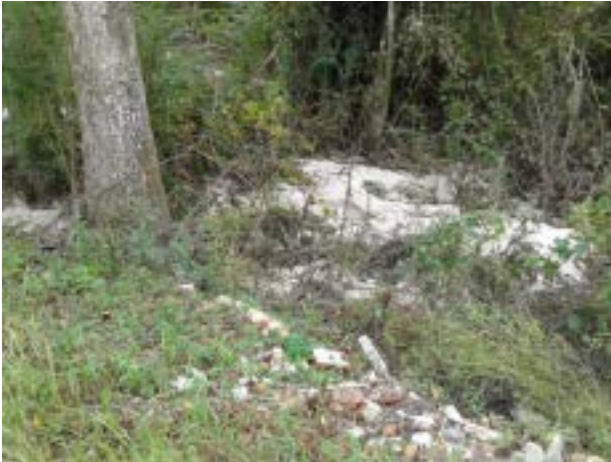
Embankment: Downstream Slope	
4. Animal Activity	Monitor
None observed.	
5. Surface Cracking	No Deficiency
6. Subsidence, Sinkhole	Investigate
Many areas of steep erosion and holes observed on the downstream slope.

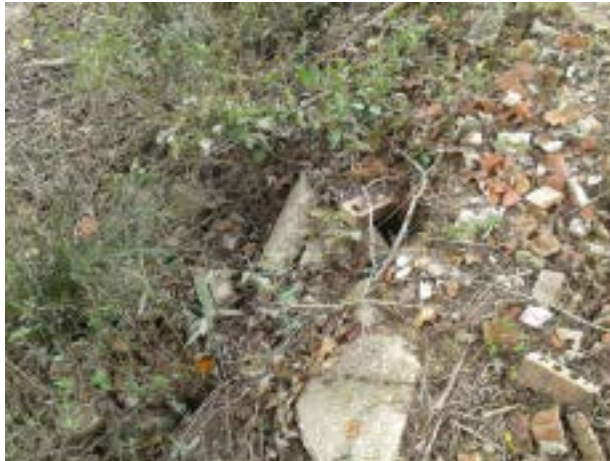
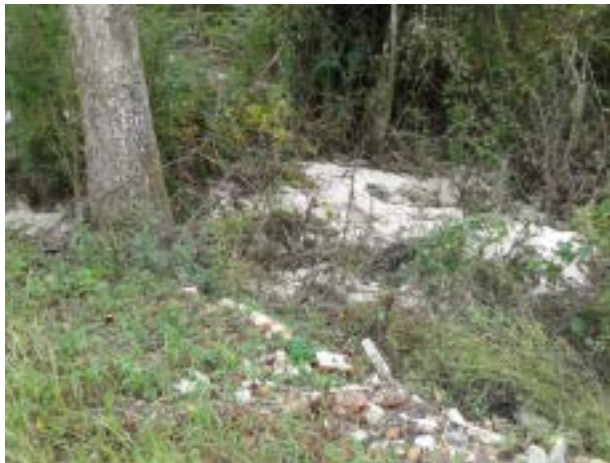
Brick and concrete rubble was observed in some areas along slope.

Armoring did not appear to be preventative, but rather as a result of erosion.

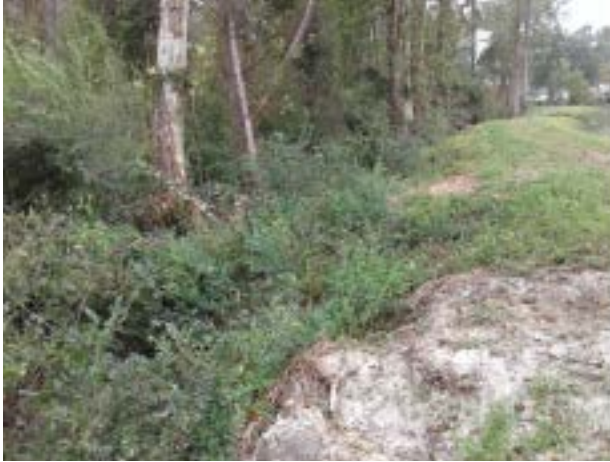
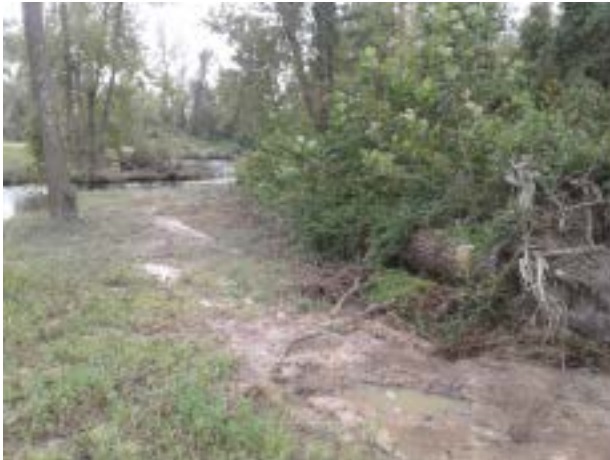
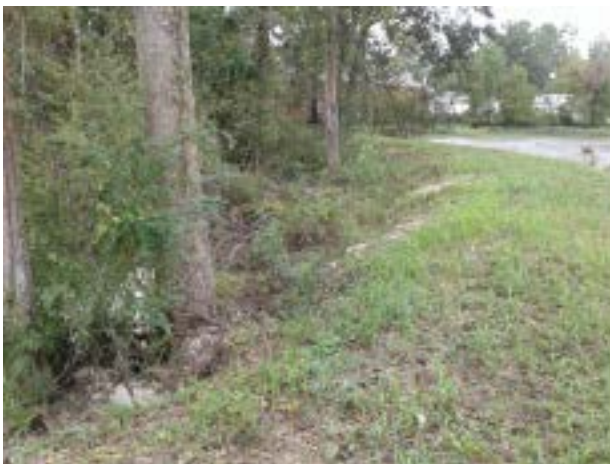
Large trees observed at and near the toe of the dam. Several trees were damaged and overturned.

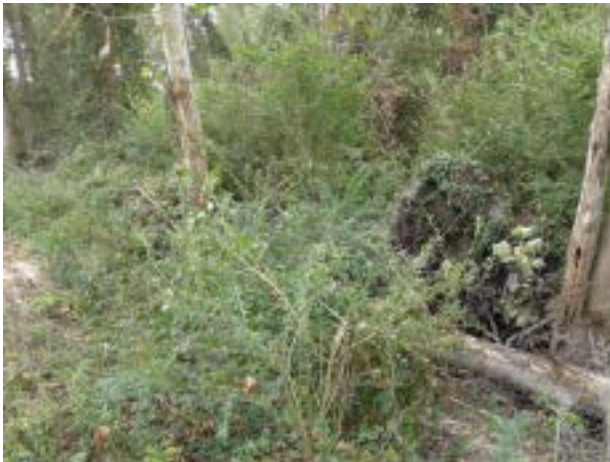
Dense brush observed in downstream area. See downstream slope photographs.

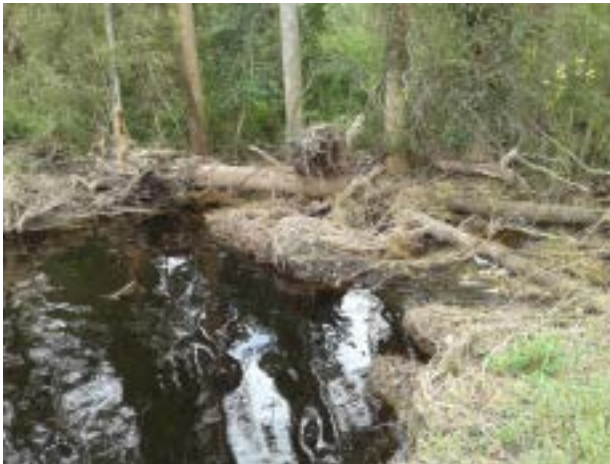
Large discarded tree pile was observed immediately downstream of breach.

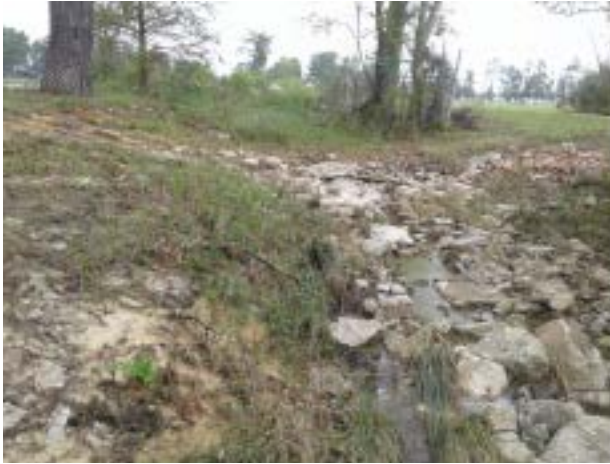
Left abutment.

Two erodible channels (earthen runarounds) were observed, one at the right abutment and one at the left abutment.

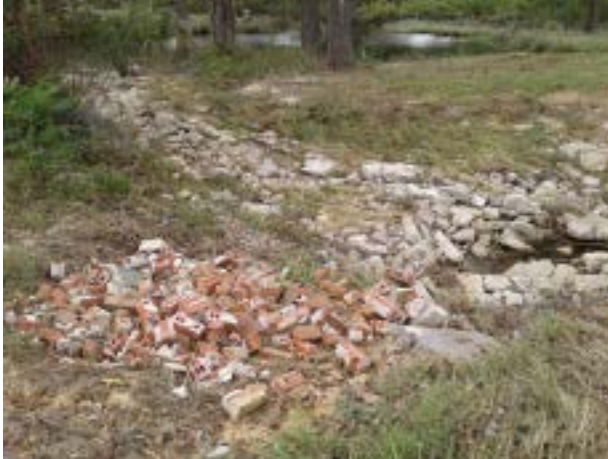
Left (downstream portion)

The left channel was grassy near the dam, but contained concrete rubble and brick to serve as erosion protection along the remainder of the length. The right channel was grassy but bare spots were observed.

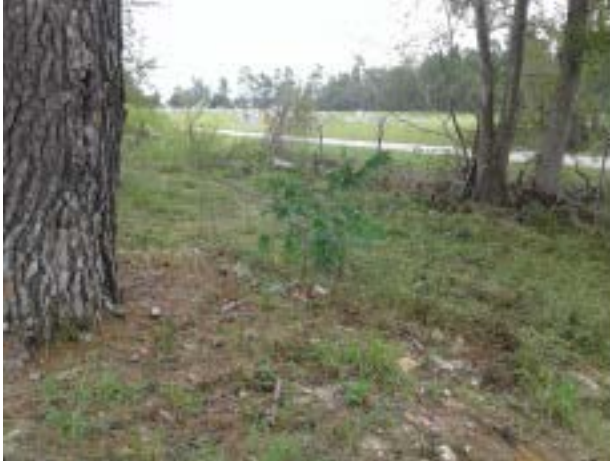
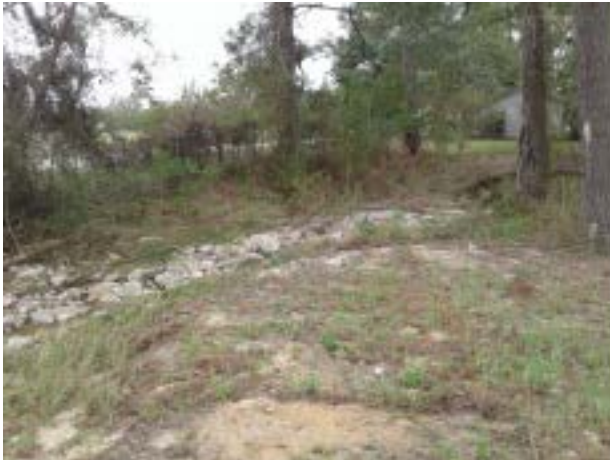
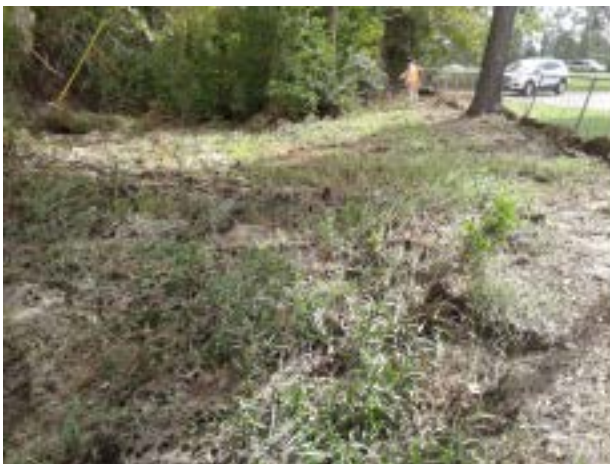
Large trees observed in both channels.

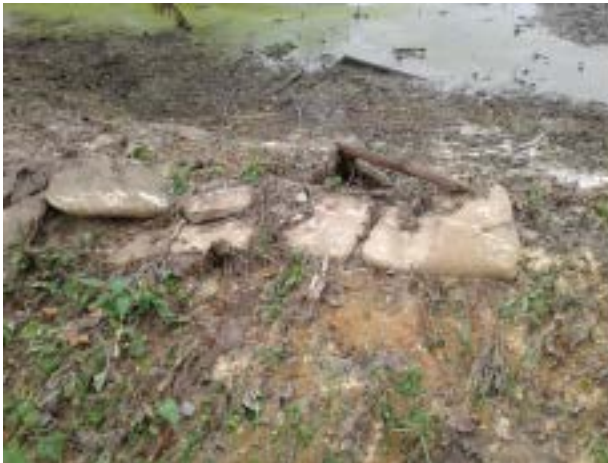
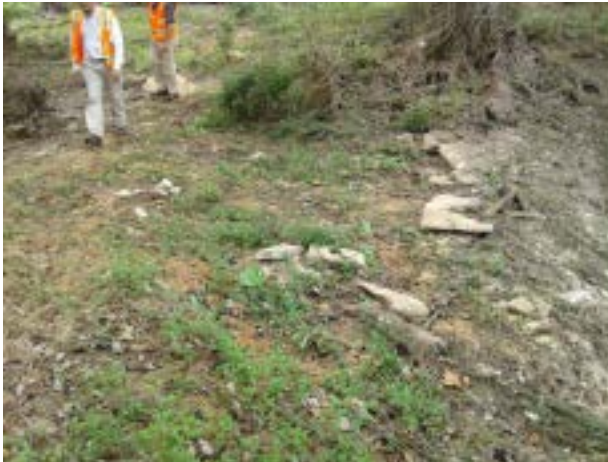
Shallow erosion was observed in the right channel.

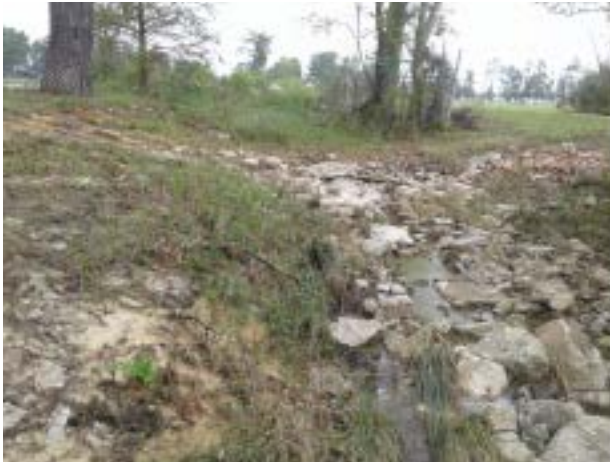
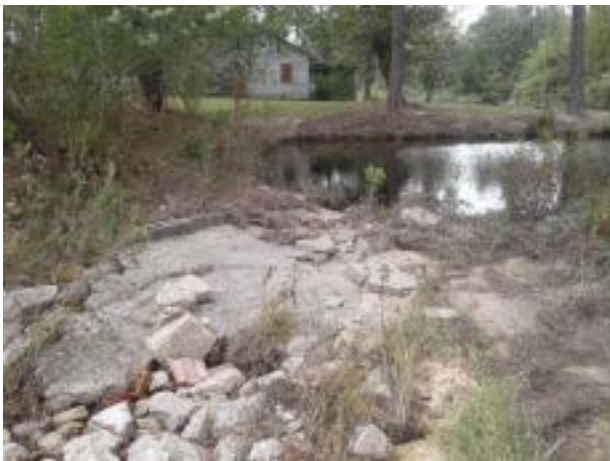
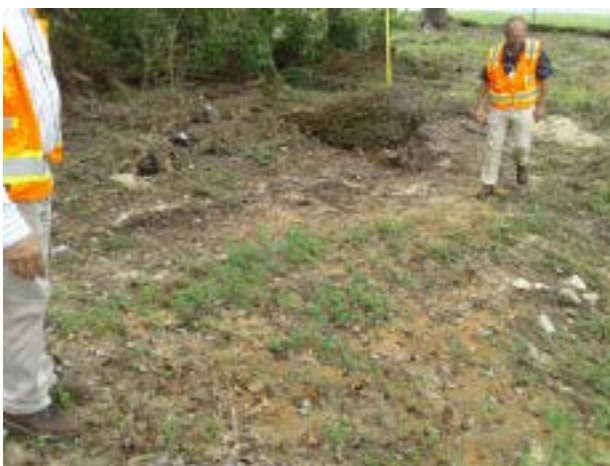
The left abutment contained standing water, but was not flowing. Right abutment was dry.

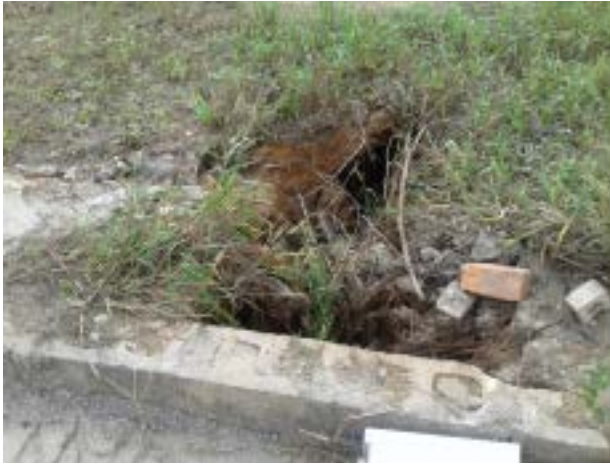
Large, deep hole was observed behind the concrete structure. Hole extended at least 7 feet into embankment, along spillway pipe the downstream.

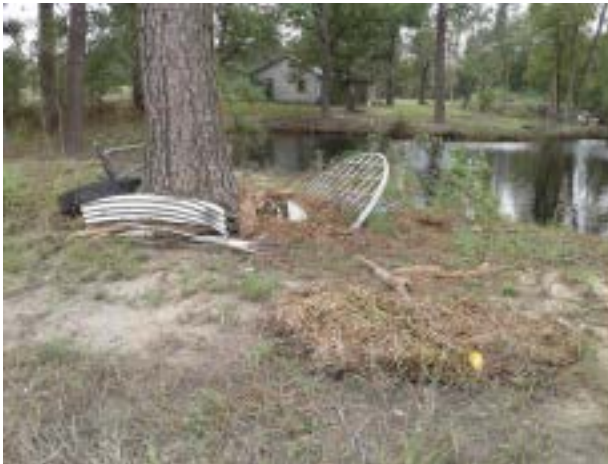
Trashrack was removed at the time of observation.

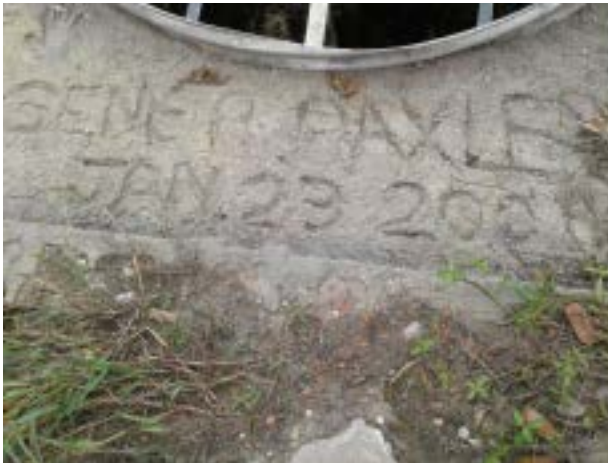
Repairs were made January 23, 2008, according to note on concrete.

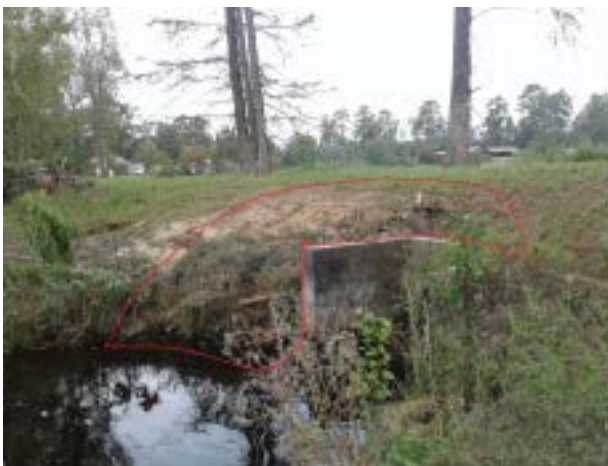
Erosion observed to the left of outlet pipe.
