Subject: Remedial Investigation Report Addendum
Former Bramlette Manufactured Gas Plant
400 East Bramlette Road, Greenville SC
VCC 16-5857-RP

REMEDIAL INVESTIGATION REPORT ADDENDUM

FORMER BRAMLETTE MGP SITE

JULY 30, 2021

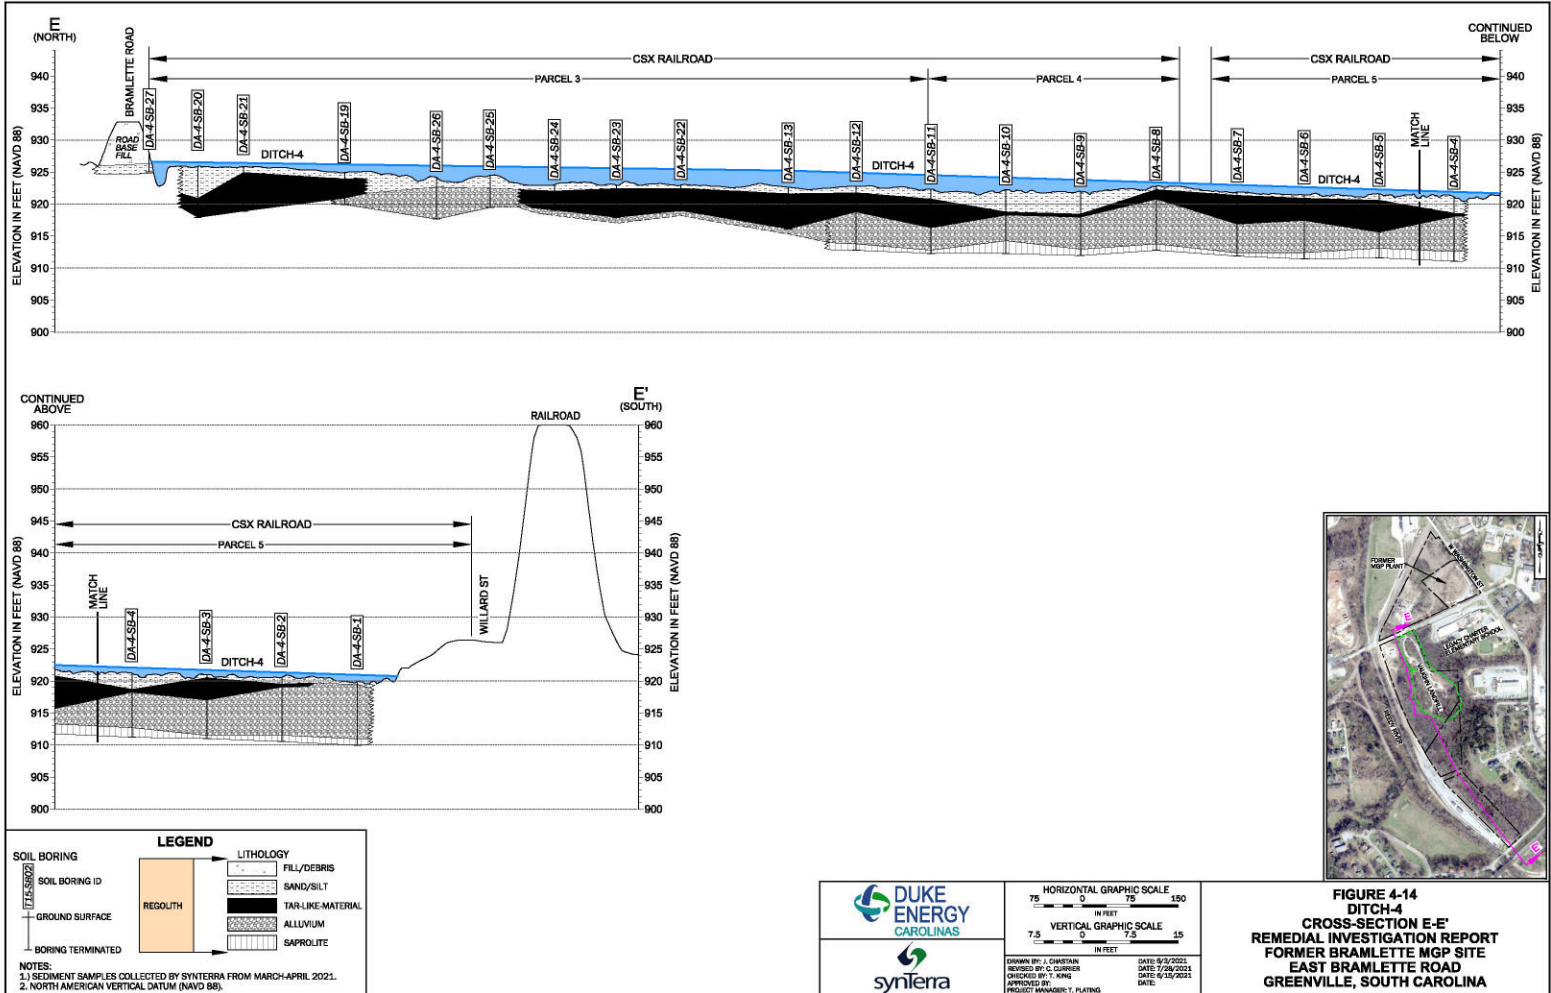
**FIGURE 4-14
DITCH-4
CROSS-SECTION E-E'
REMEDIAL INVESTIGATION REPORT
FORMER BRAMLETTE MGP SITE
EAST BRAMLETTE ROAD
GREENVILLE, SOUTH CAROLINA**

Total PAH concentrations of six samples analyzed from the southern end of Ditch 4 ranged from 7 mg/kg to 152 mg/kg. The PAH concentrations observed in Ditch 4 were the highest of all of the samples analyzed. PAHs in Ditch 4 are indicative of both weathered coal carbonization tar and urban PAHs.
