Phase I Environmental Site Assessment (ESA)

Clemson Complex

*500 West Cherry Road
Clemson, South Carolina*

March 2005

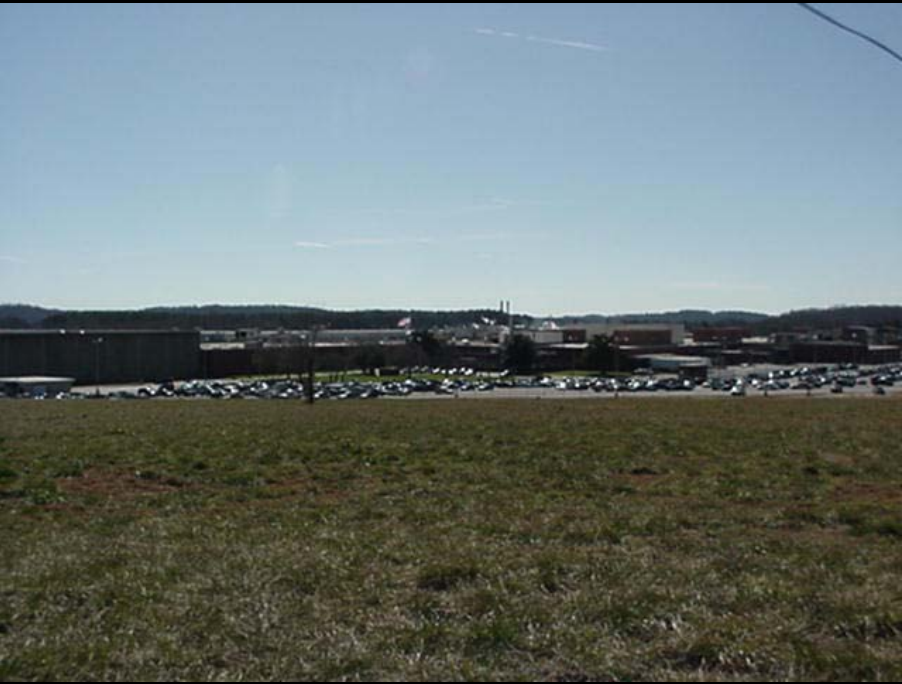
Client Name: WestPoint Stevens		Site Location: Clemson Plant	Project No.: 70583.86
Photo No. 1	Date 02/17/05

Description Overview of the Clemson Complex

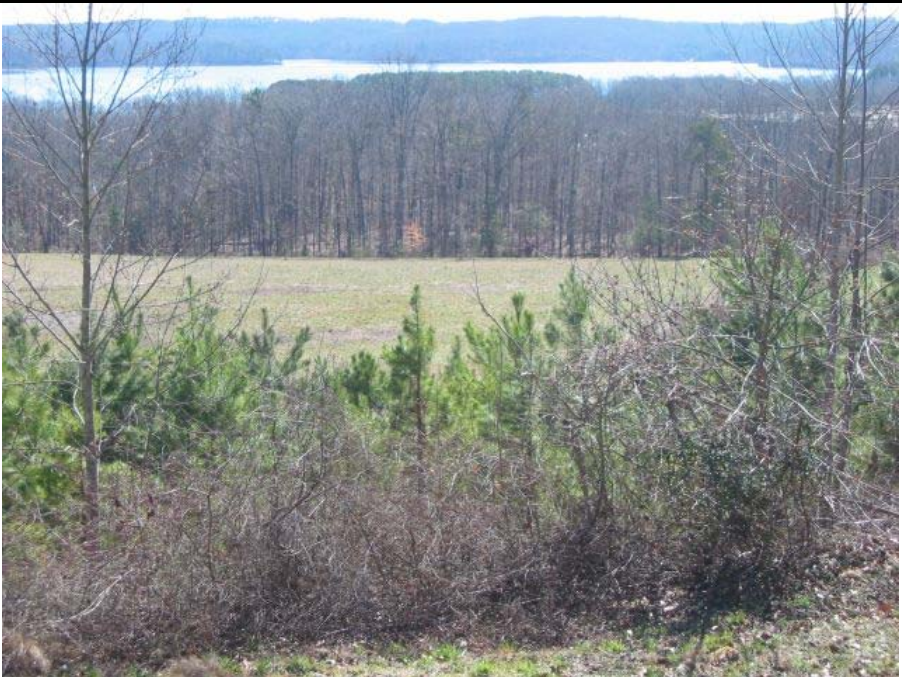
Photo No. 2	Date 02/18/05

Description Closed Fly Ash Landfill (Landfill No. 1).

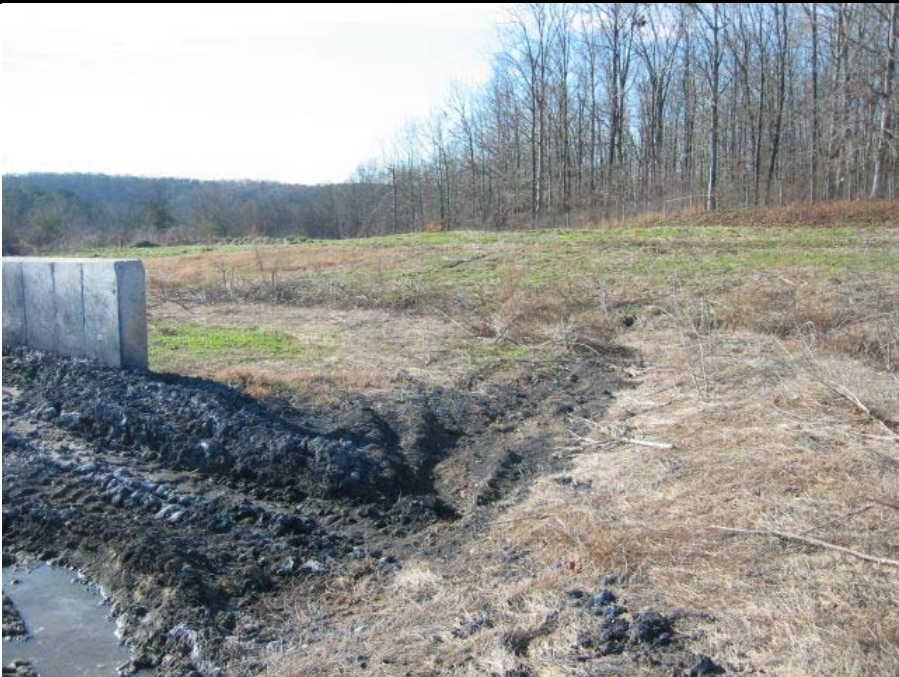
Client Name: WestPoint Stevens		Site Location: Clemson Plant	Project No.: 70583.86
Photo No. 5	Date 02/18/05

Description Wastewater solids runoff at sludge Landfill No. 3.			
Photo No. 6	Date 02/18/05

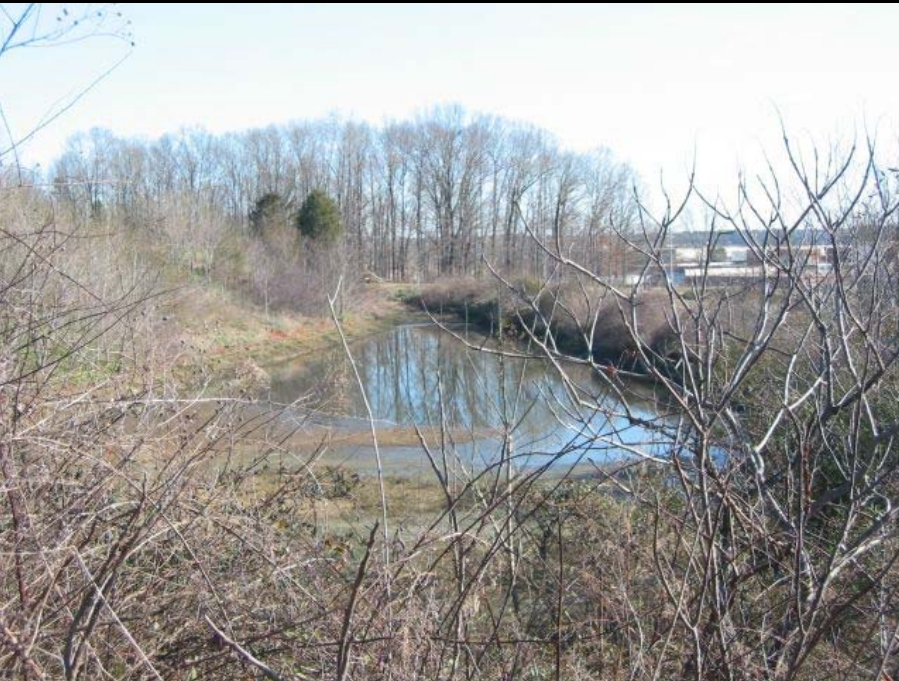
Description Surface water runoff basin at sludge Landfill No. 3. Water is pumped to WWTP.

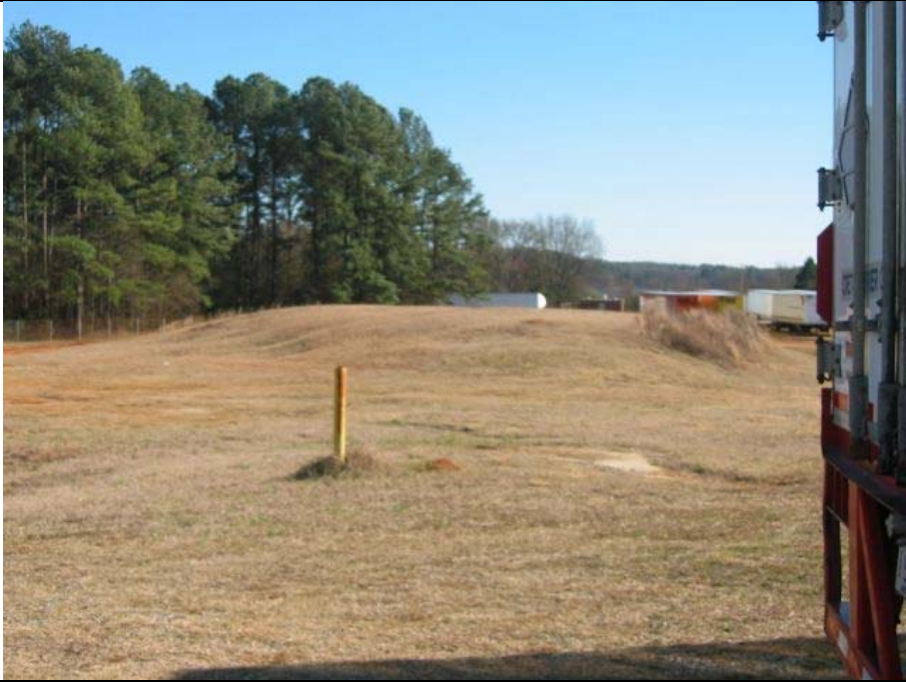
Client Name: WestPoint Stevens		Site Location: Clemson Plant	Project No.: 70583.86
Photo No. 7	Date 02/17/05

- ***Evidence of Recognized Environmental Condition:*** Landfill No. 4 is described in the South Carolina Department of Health and Environmental Control (SC DHEC) Screening Site Investigation (SSI) report as an area of about 1.5 acres that was used for trash disposal for

Description Unpermitted Landfill No. 4 area.

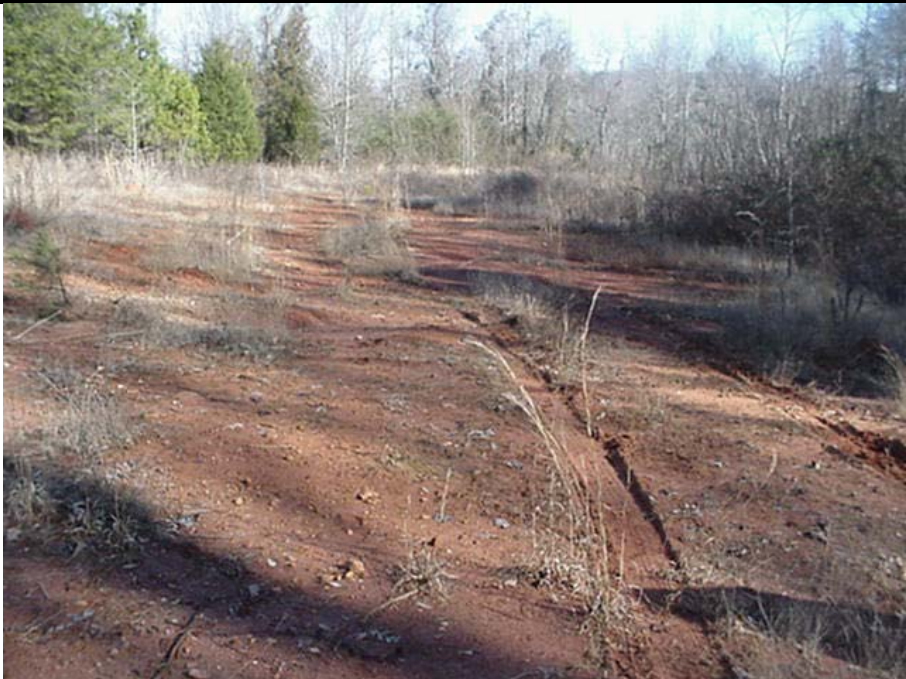
Photo No. 8	Date 02/18/05

- **Evidence of Recognized Environmental Condition:** Landfill No. 5 is described in the 1991 SC DHEC SSI report as an area of approximately 3 acres. Construction debris was observed on the ground surface during the SSI field reconnaissance. The area may have been used to dispose of debris generated during a 1967 explosion in the facility. Soil samples were not collected in this area during the SSI. However, the Law report states that eight soil samples were collected in 1981 and analyzed for polychlorinated biphenyls (PCBs) with no detections.

Description Abandoned landfill area north of sludge Landfill No. 3. Unpermitted Landfill No. 5 area.

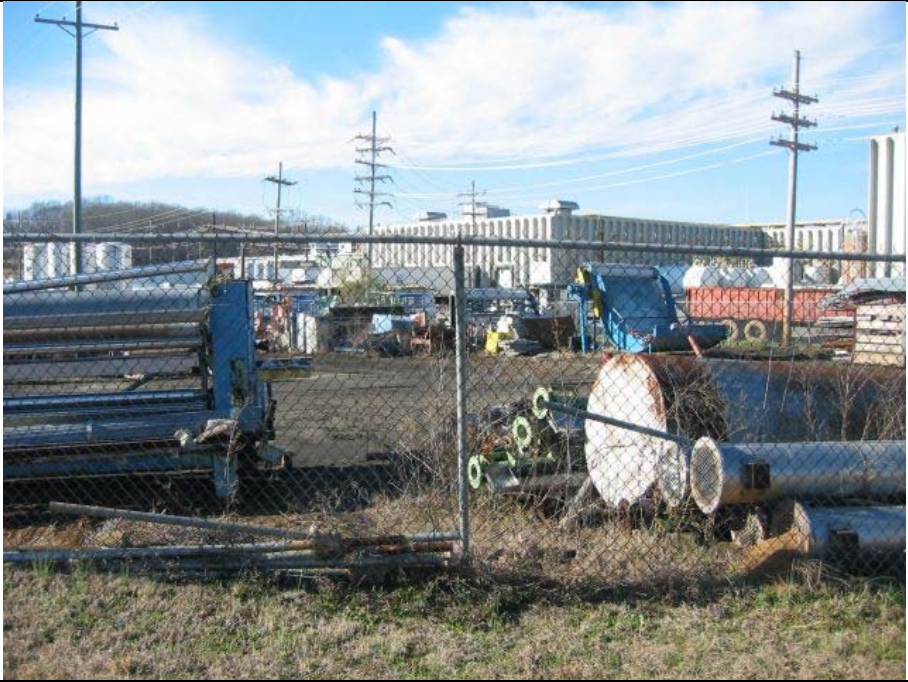
Client Name: WestPoint Stevens		Site Location: Clemson Plant	Project No.: 70583.86
Photo No. 9	Date 02/17/05

- ***de minimis* issue:** The boneyard, or equipment laydown area, west of the main manufacturing facility, was observed during the ESA site visit to contain a wide variety of mechanical equipment and tanks. There is no specific information documenting a release or observation of releases in this area. No obvious visual evidence of surface staining was observed in the boneyard.

Description Boneyard area west of main plain building.

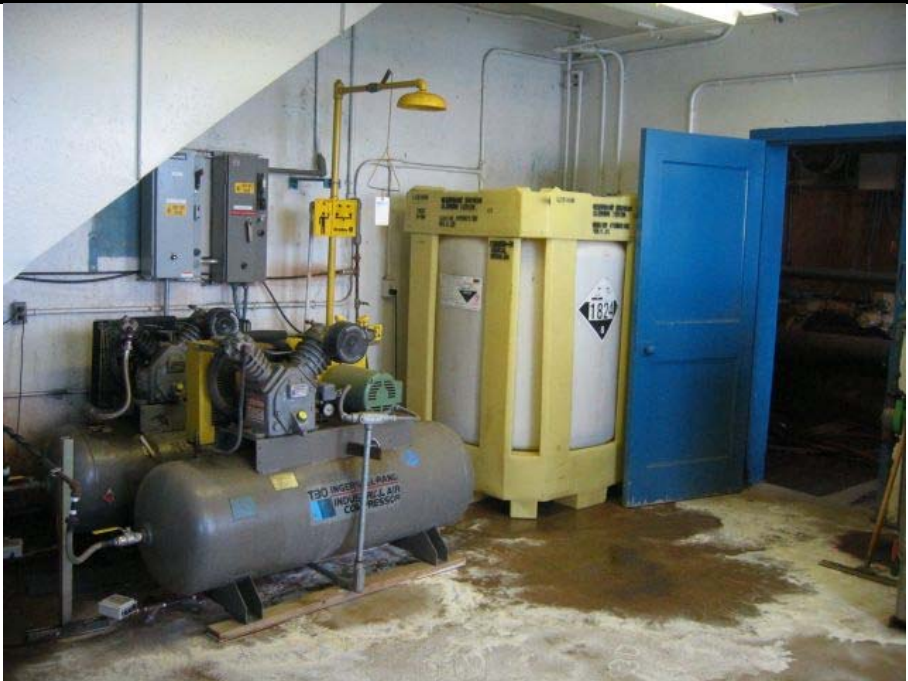
Photo No. 10	Date 02/17/05

Description Inside water treatment building.

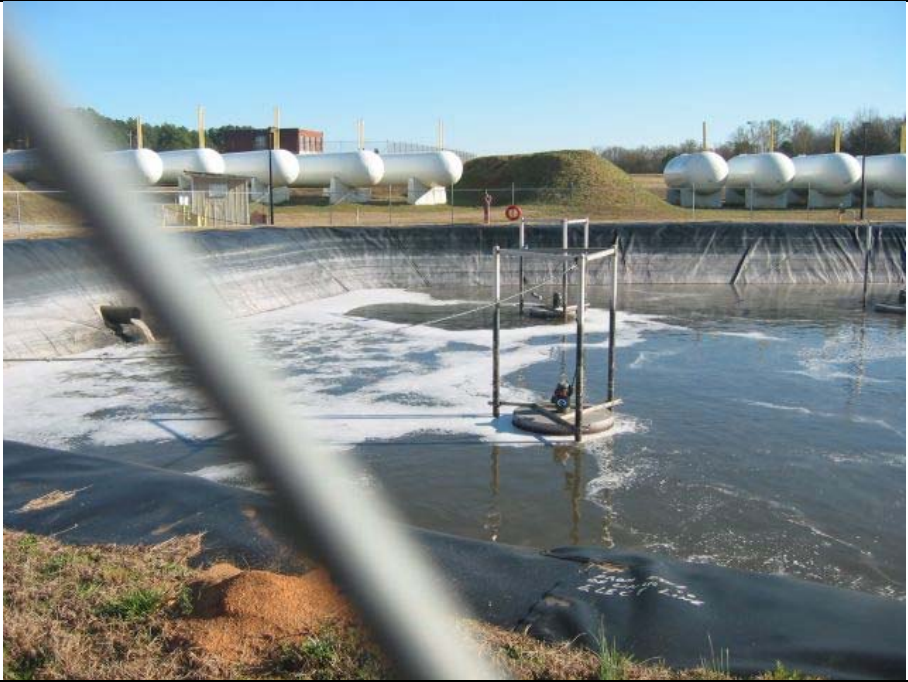
Client Name: WestPoint Stevens		Site Location: Clemson Plant	Project No.: 70583.86
Photo No. 11	Date 02/17/05

Description Industrial equalization basin			
Photo No. 12	Date 02/18/05

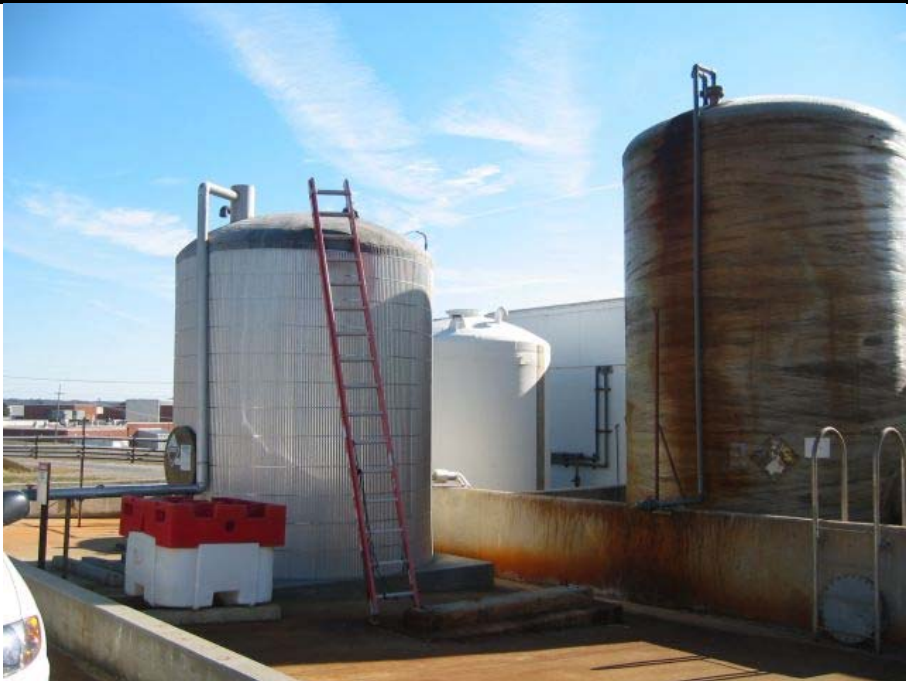
Description Tank storage at WWTP.

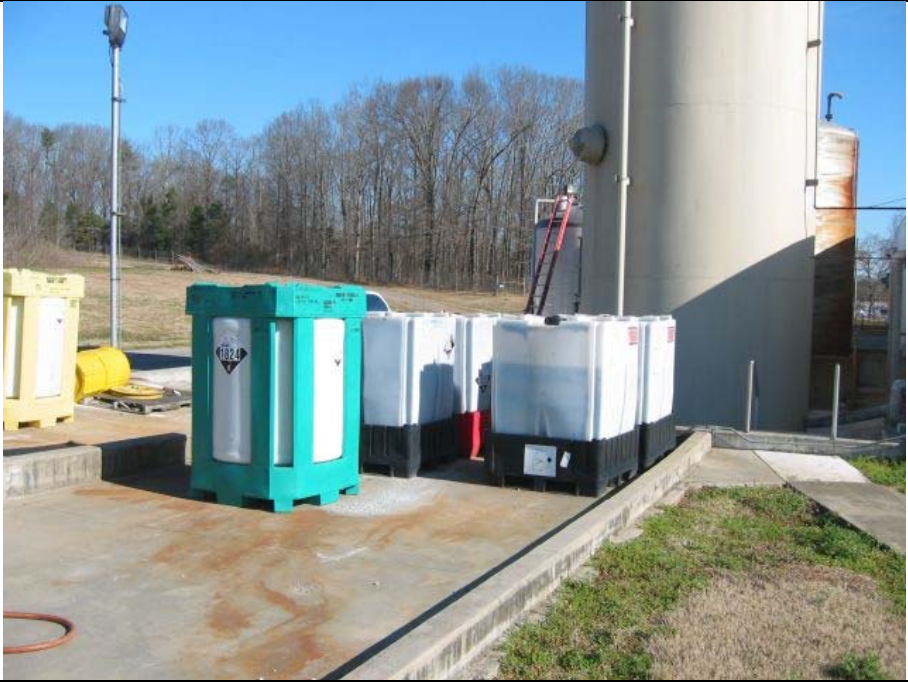
Client Name: WestPoint Stevens		Site Location: Clemson Plant	Project No.: 70583.86
Photo No. 13	Date 02/18/05

Description Tote storage at WWTP.

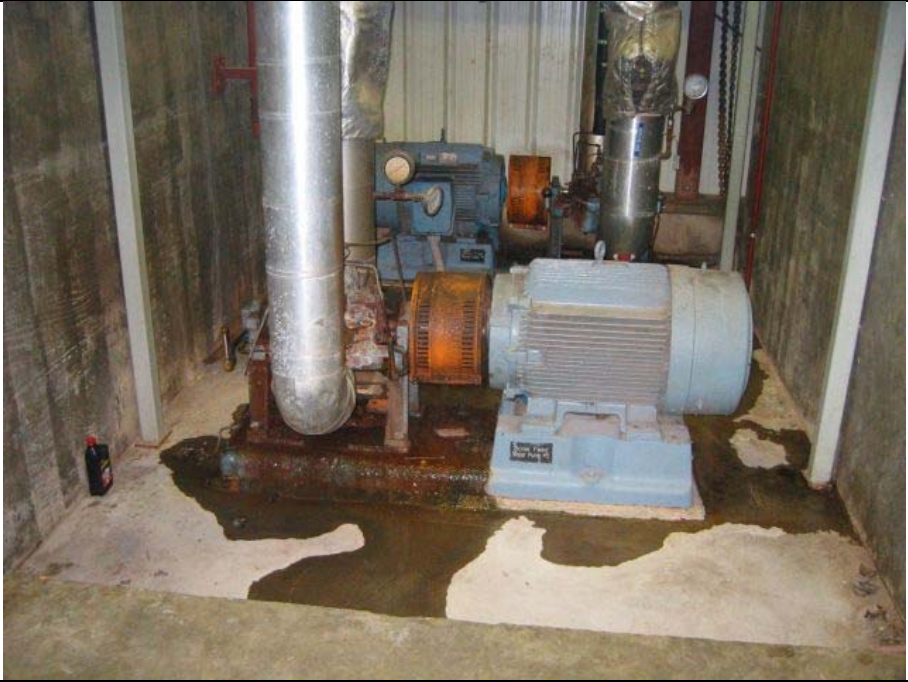
Client Name: WestPoint Stevens		Site Location: Clemson Plant	Project No.: 70583.86
Photo No. 15	Date 02/17/05

Description Pump leaking oil.

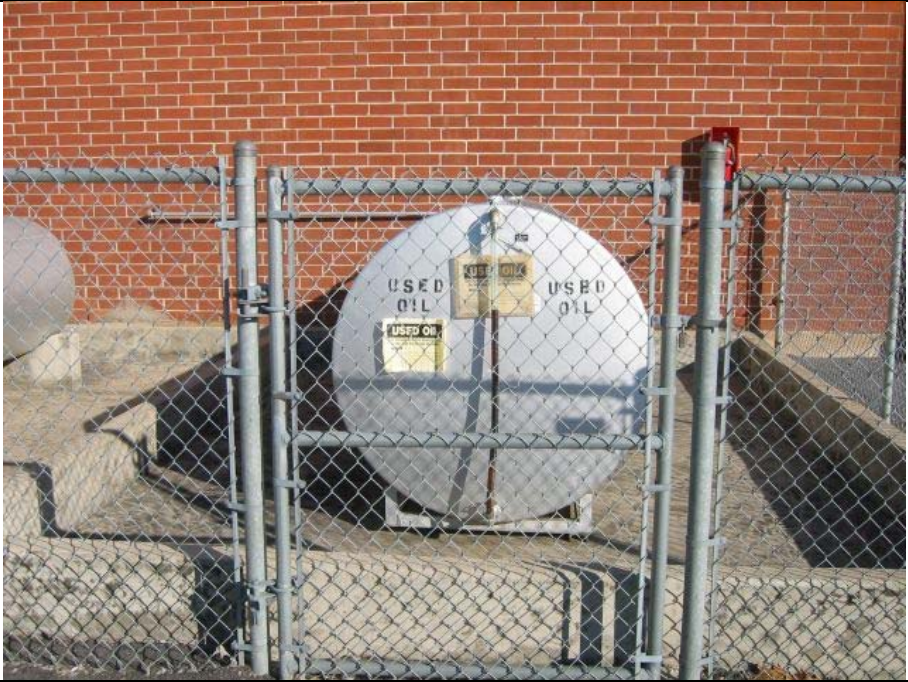
Client Name: WestPoint Stevens		Site Location: Clemson Plant	Project No.: 70583.86
Photo No. 17	Date 02/17/05

Description Used oil accumulation area east of main building.

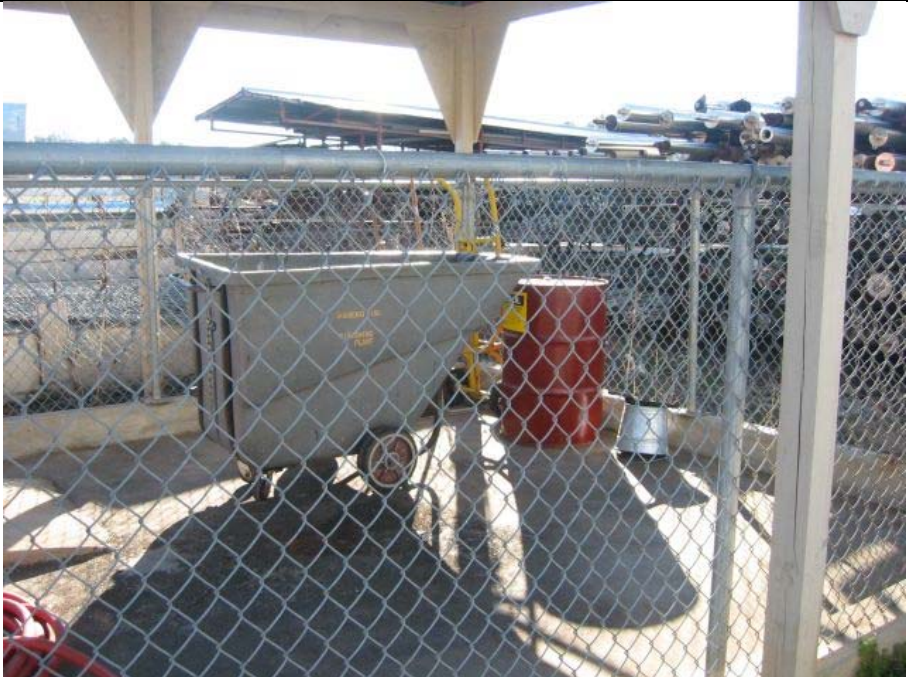
Photo No. 18	Date 02/17/05

Description Used oil accumulation area west of main building.

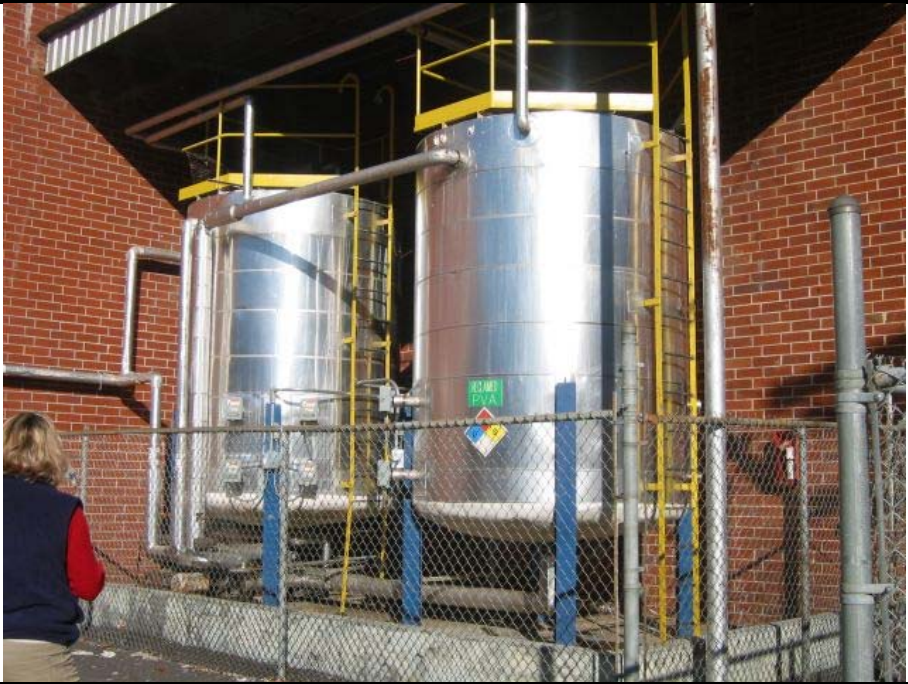
Client Name: WestPoint Stevens		Site Location: Clemson Plant	Project No.: 70583.86
Photo No. 19	Date 02/19/05

Description PVA tanks.

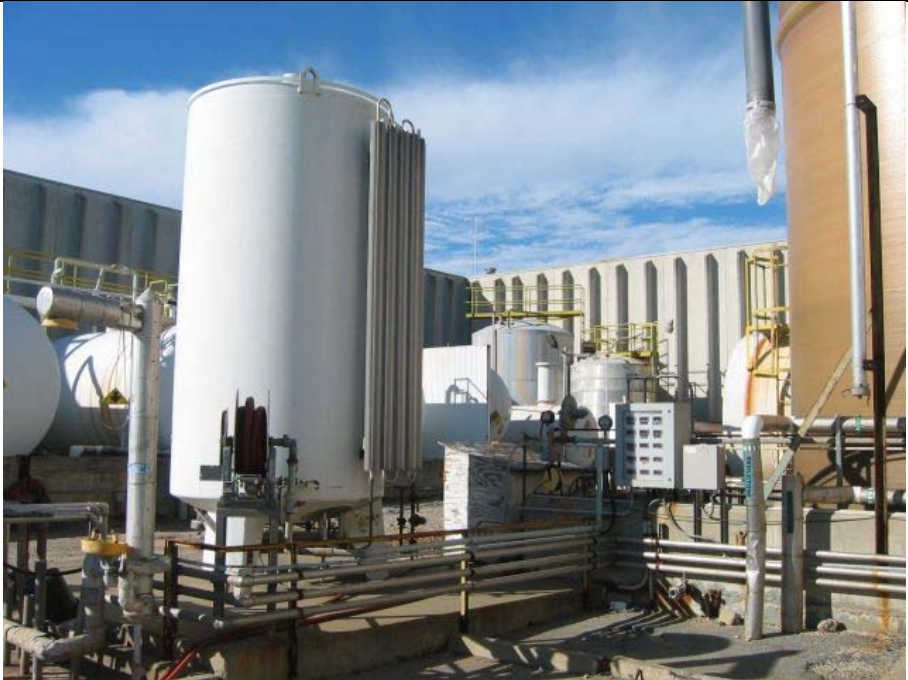
Client Name: WestPoint Stevens		Site Location: Clemson Plant	Project No.: 70583.86
Photo No. 21	Date 02/17/05

Description Tank farm area.

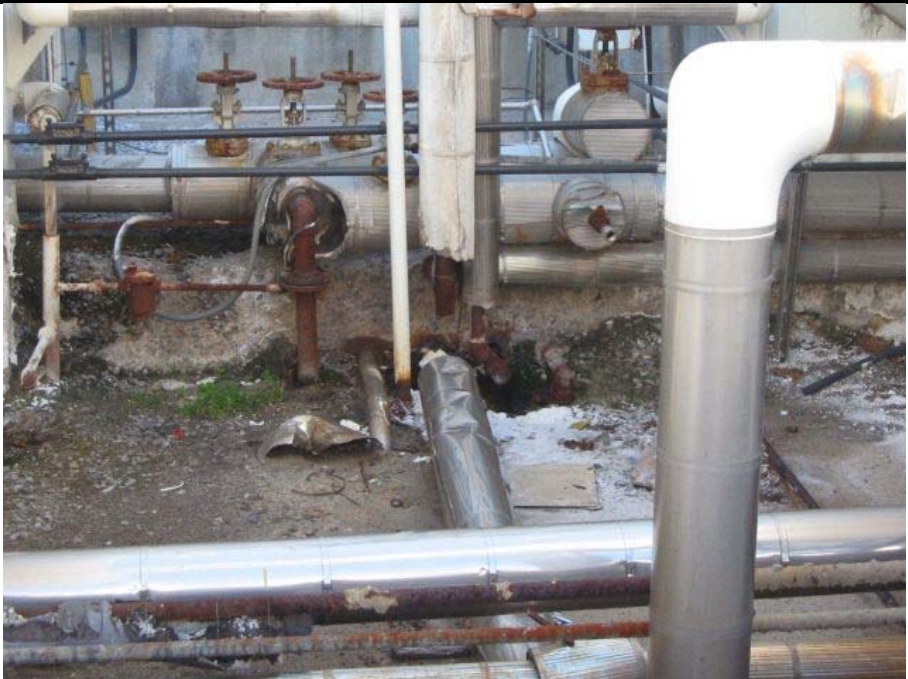
Photo No. 22	Date 02/17/05

Description Piping at tank farm area.

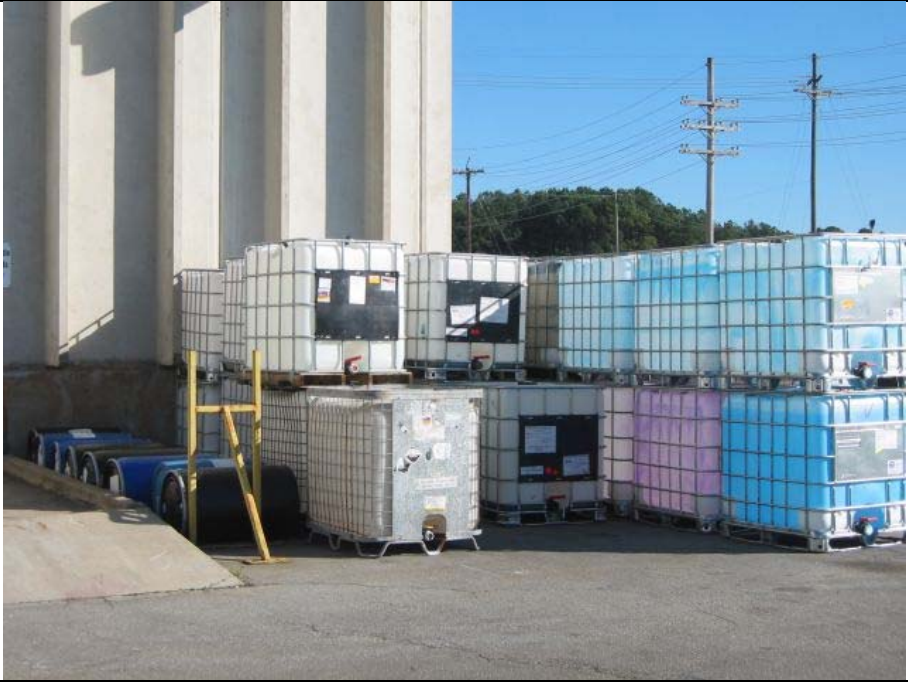
Client Name: WestPoint Stevens		Site Location: Clemson Plant	Project No.: 70583.86
Photo No. 23	Date 02/17/05

Description Tote storage area.

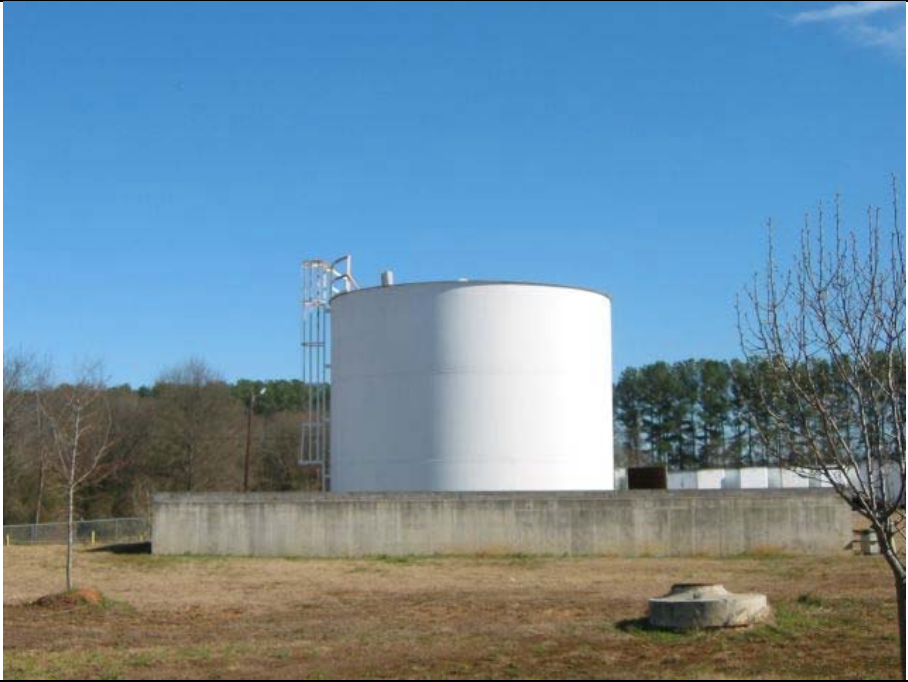
Client Name: WestPoint Stevens		Site Location: Clemson Plant	Project No.: 70583.86
Photo No. 25	Date 02/17/05

Description Standby fuel oil for boiler.

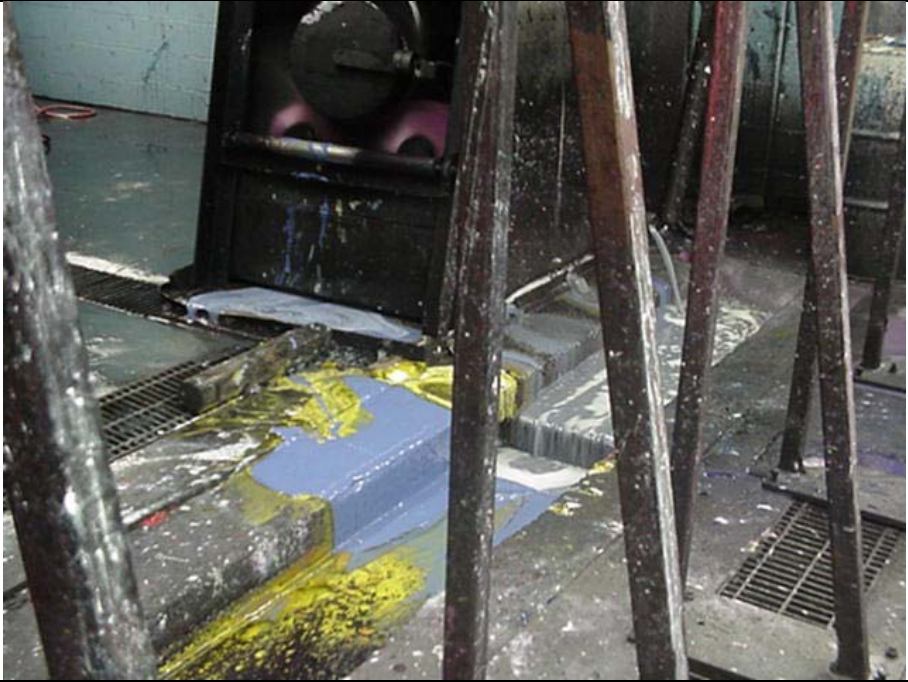
Client Name: WestPoint Stevens		Site Location: Clemson Plant	Project No.: 70583.86
Photo No. 27	Date 02/17/05

- ***de minimis* issue:** The floor of the print department had large areas wet with water and dyes. This portion of the plant is constructed on a concrete slab. The condition of the slab and of the floor drains could not be determined during the site visit.

Opinion of Impact: Floor drains inside the plant drain to the on-site WWTP, and there was no evidence of staining or stressed vegetation indicating releases to the environment outside the buildings. Therefore, significant environmental impairment to the subject property from this potential source is not expected.

Description Wastewater in printing area.			
Photo No. 28	Date 02/17/05

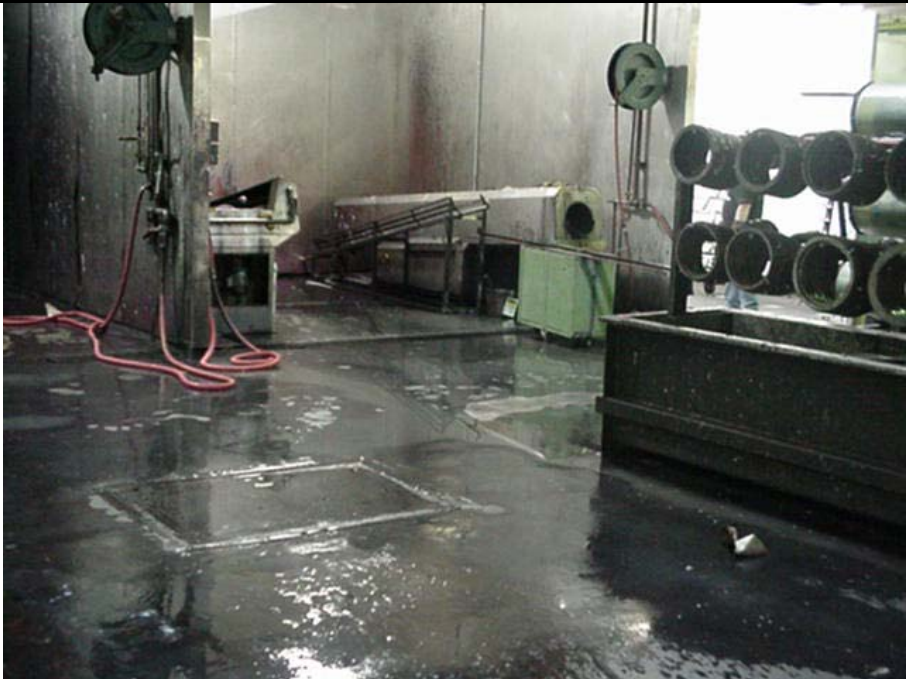
Description Screen cleaning area.

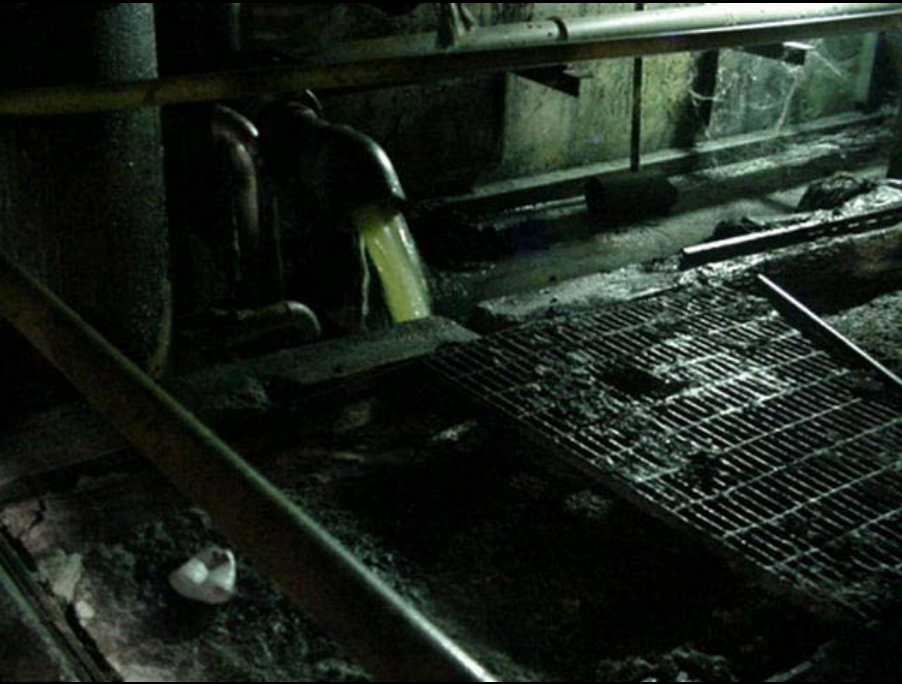
Client Name: WestPoint Stevens		Site Location: Clemson Plant	Project No.: 70583.86
Photo No. 29	Date 02/17/05

- **Evidence of Recognized Environmental Condition:** Wastewater from the facility is directed through pipes and floor drains to the basement from which it is then directed to the facility's WWTP. While the wastewater was contained in pipes and trenches, splashing was observed, and the floor was wet (to some extent from condensation). The condition of the trenches and floor drains could not be readily observed.

Opinion of Impact: Based on the long history of pipes, trenches, and floor drains in this basement in containing wastewater from the facility, there is a potential for leakage, which may have resulted in impact to soil and groundwater on the subject property.

Description Waste draining to the basement

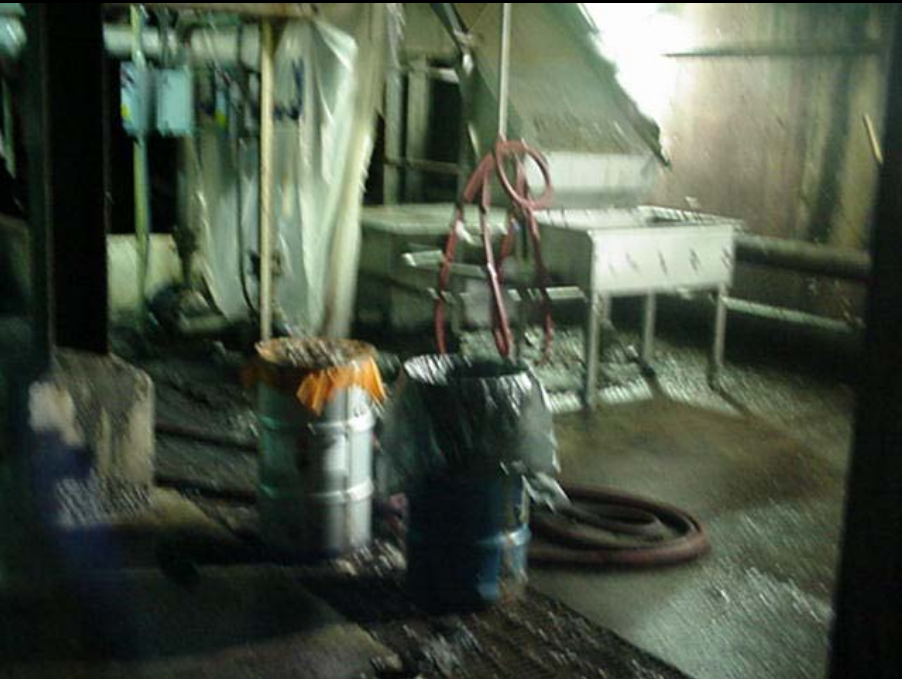
Photo No. 30	Date 02/17/05

Description Basement area.

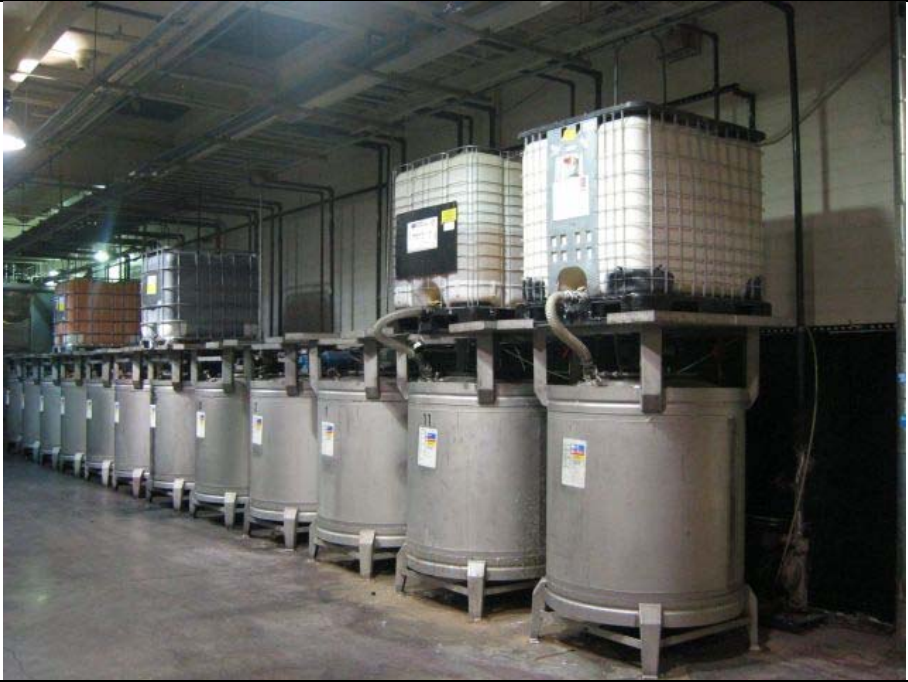
Client Name: WestPoint Stevens		Site Location: Clemson Plant	Project No.: 70583.86
Photo No. 31	Date 02/17/05

Description Chemical mixing in finishing plant.

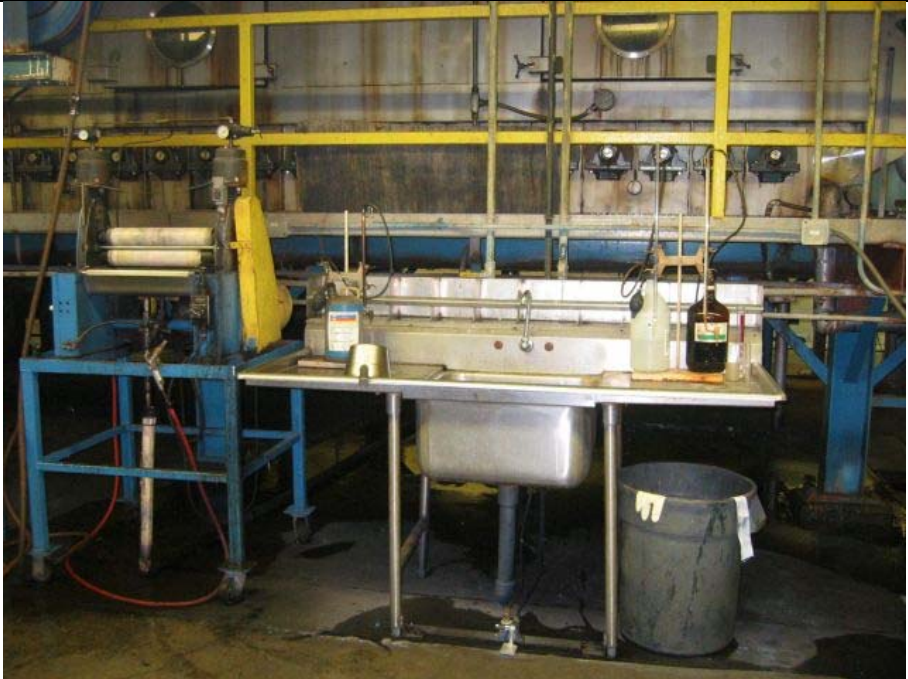
Photo No. 32	Date 02/17/05

Description Quality control titration area.

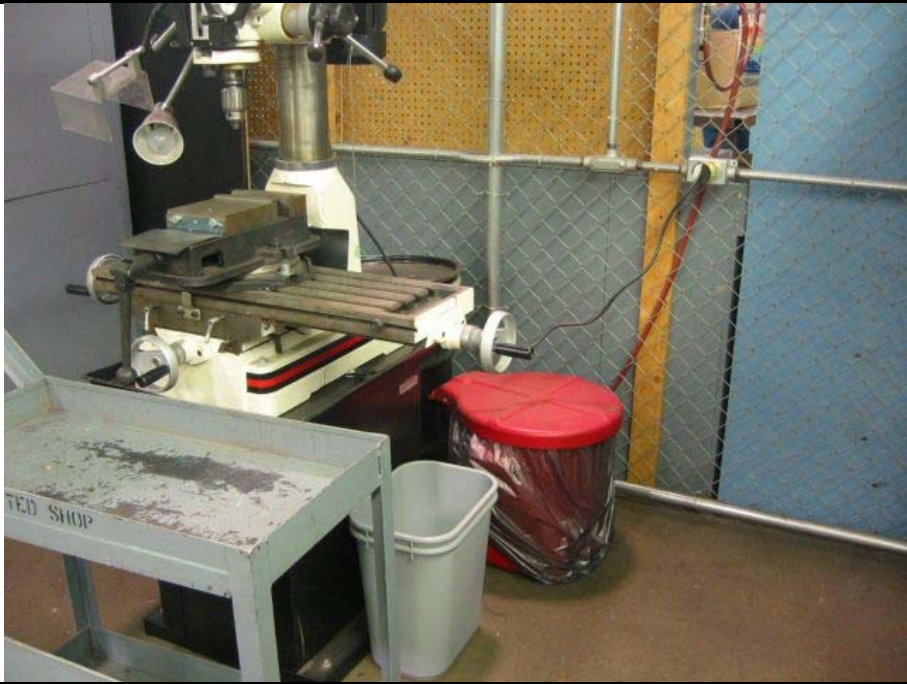
Client Name: WestPoint Stevens		Site Location: Clemson Plant	Project No.: 70583.86
Photo No. 33	Date 02/17/05

Description Machining area in finishing plant.

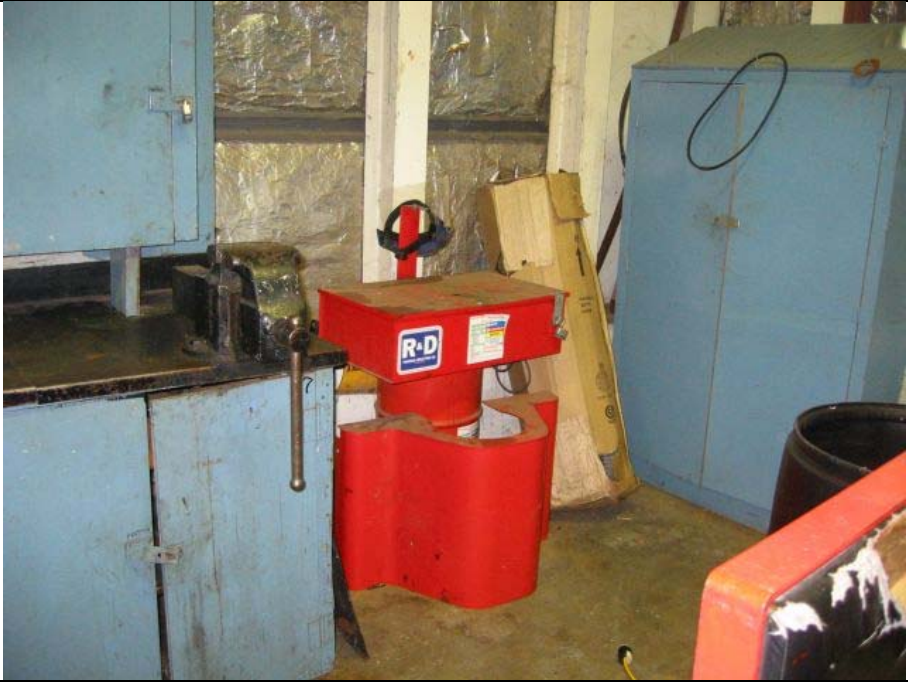
Client Name: WestPoint Stevens		Site Location: Clemson Plant	Project No.: 70583.86
Photo No. 35	Date 02/17/05

Description Typical parts cleaner.
