**BUREAU OF WATER**

## **Big Wateree Creek Study 2019**

Technical Report No. 006-2020

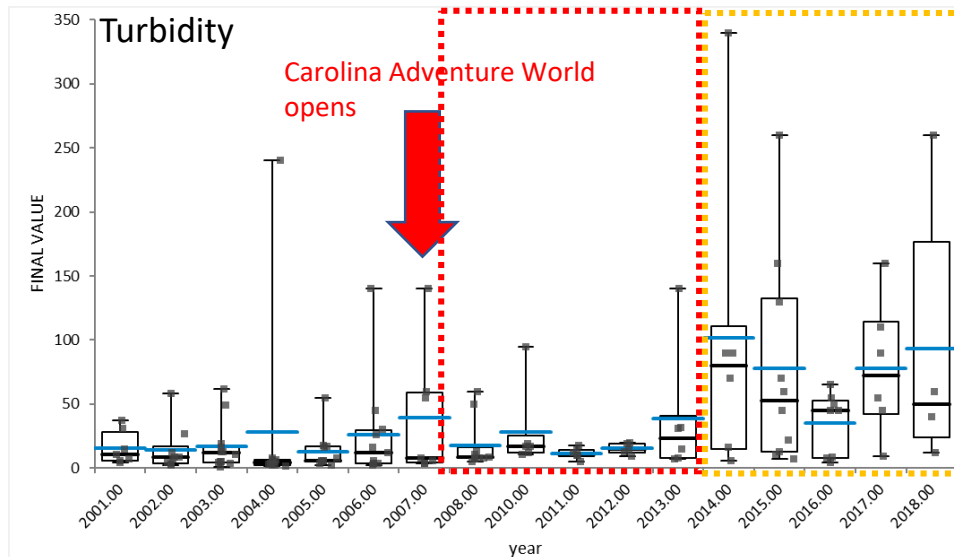
There is no long term TSS observed data available at station CW-072 in Big Wateree Creek; thus, turbidity was used as surrogate for TSS. Although colored organic matter could disrupt correlation between TSS and turbidity, there usually is reasonable relationship between the two parameters. The next few slides show the data from 2002 through 2019 of turbidity and related datasets. The plot below shows annual average turbidity (on the left) from STORET and rainfall data retrieved from 4km by 4km PRISM data (on the right).

Carolina Adventure World (CAW) opened in 2007. However, the turbidity data indicate the constant lower value in the next five years after the facility opened. Then, turbidity increased drastically from 2014. Although Levene test on turbidity indicates equal variance between the data of 2008-2013 and 2014-2018, T-test shows the mean is not equal between the two groups based on p-value of 0.007. The annual precipitation between the year groups, both Levene and T-test indicated the variance and mean are equal. If the annual rainfall is almost the same, what is causing the turbidity jump?

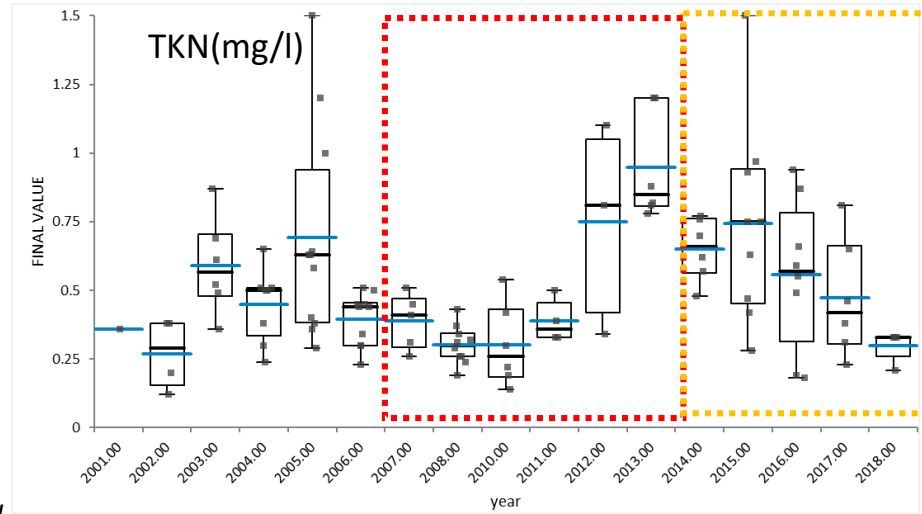
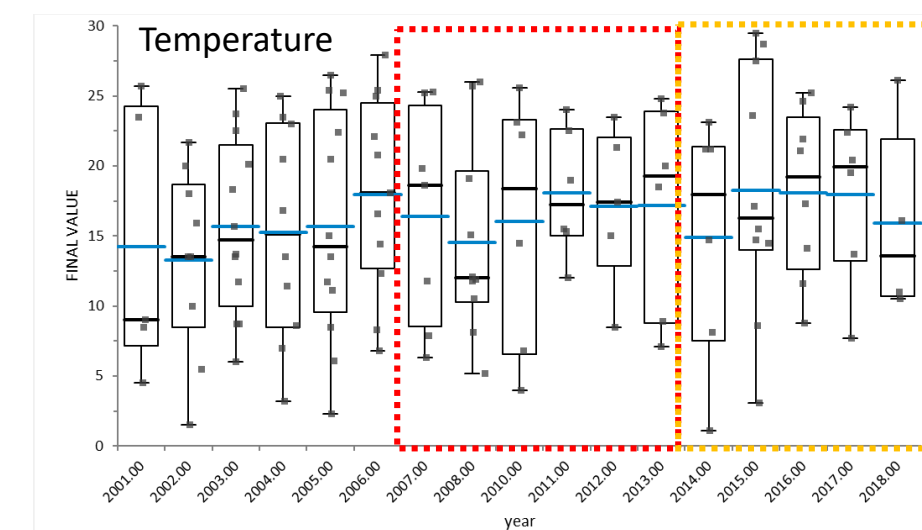
*As there is not enough Chl-a (only three observed data at CW-072), DO and pH were evaluated for potential biological production changes due to algal activity. DO and pH are related to photosynthesis and respiration. These two parameters were relatively constant, thus no clear indication of productivity changes to support any of the increased turbidity from 2014.*

Since organic matter and algal activity was evaluated to be not significant causes for the increase, the increase of turbidity from 2014 can be attributed to clay, silt increases, detritus from watersheds. If CAW and algal activity are not a cause of the turbidity jump and the annual rainfall patterns are the same, land-use changes can be a potential cause.

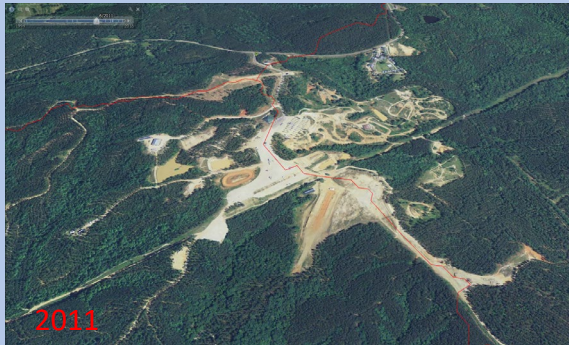
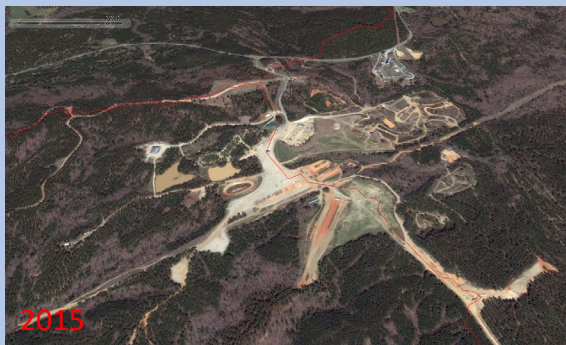
A comparison of CAW between 2011 and 2015 also show no significant change to CAW outer extent.

- Forest logging area was indicated as herbaceous land in NLCD category (see the herbaceous NLCD category and the logging area verification). Thus, this land use category was used to identify logging locations.
- The data indicated that there are intense logging activities at the northern upper watershed and lower watershed along the mainstem of Big Wateree Creek.

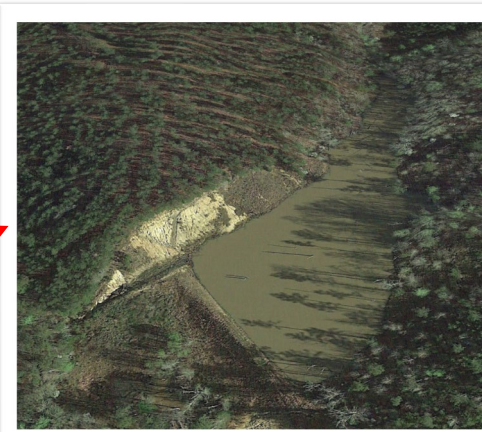
## Logging related sources potentially affecting BW-15

This aerial photo was dated in April 2017. The high observed TSS concentration was sampled in May of 2017. Thus, land surface conditions during the sample period were probably similar to what the picture shows here.

- A detention reservoir-possible overflow during wet weather.
- Logging site at the west face – possible erosion and sediment transfer to the stream during the wet weather.
- Logging site at the east face – possible erosion and sediment transfer to the stream during the wet weather.

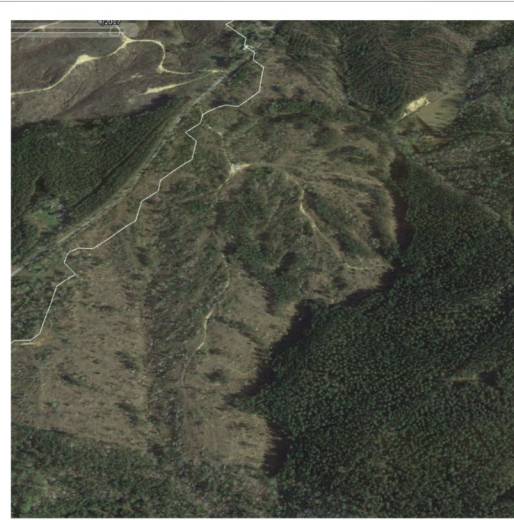
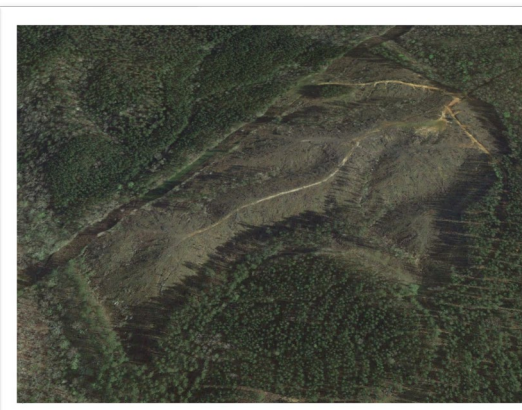
There appear to be three logging related sources. From the north to the south;

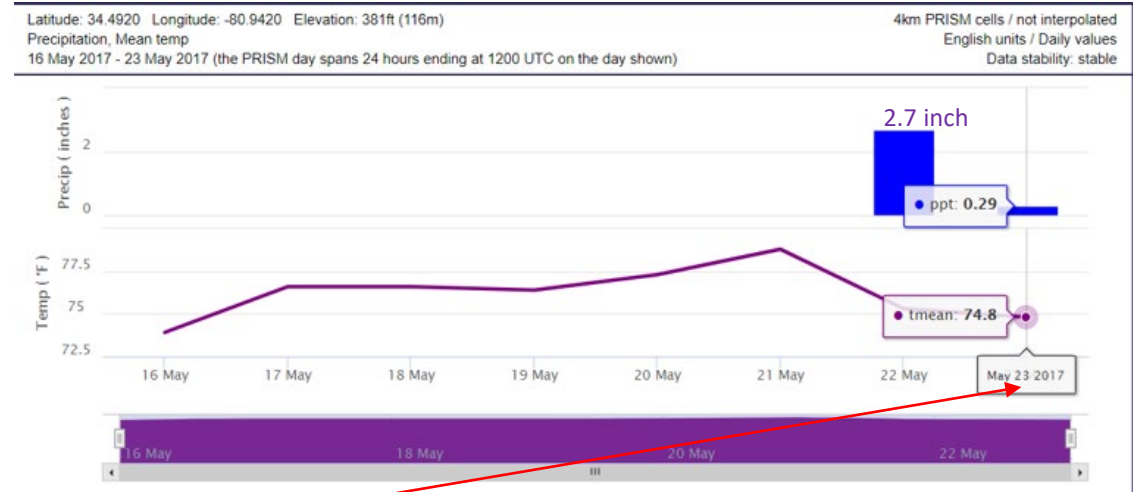
# Rainfall analysis during TSS measurement periods

Rainfall data indicated that 5/22-5/23/2017 had almost 3 inches of precipitation and 0.55 inches of rainfall on 6/15-6/16/2016 whereas 4/6 and 11/14 of 2016 had no rainfall. This analysis indicates wet weather causes the high TSS observed at BW-15. The high rainfall (3inches) transported large amounts of sediment to BW-15. However, without additional data, the sources can be identified as either CAW, logging, or combination of both.

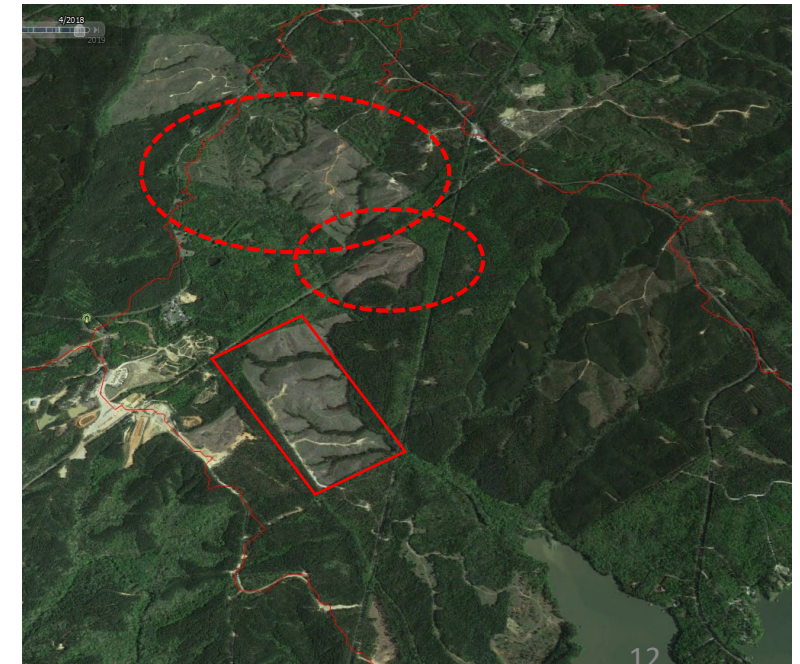
Generally, harvesting itself does not substantially increase soil erosion. However, skid trails, log decks, and roads commonly cover 2 to 10 percent of logged sites (Kochenderfer 1977) and represent the most significant threat to water quality from forest operations due to an increase in erosion potential resulting from bare soil exposure, compaction, and increased surface runoff .

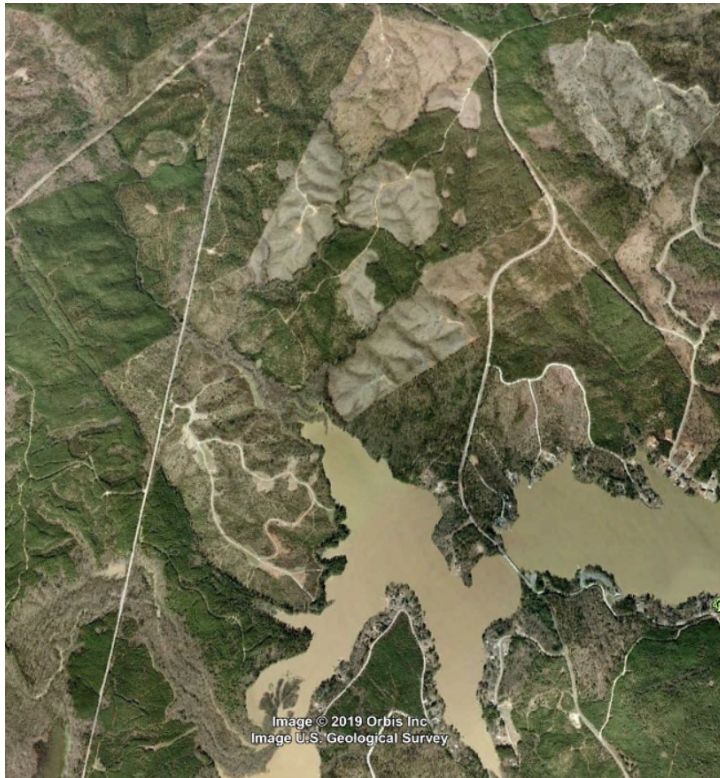
The picture on the left is from 2004. it shows an example of forest logging effect if the activity becomes severe.

CAW had not been built at that time. The picture shows concentrated logging activities throughout the Big Wateree Creek basin. The cove shows high turbidity indicating potential high TSS concentrations. Although the current conditions are not as severe as 2004 in terms of aerial photos, logging activity in the lower portion of the Lower Catawba basin appeared to still be very active.

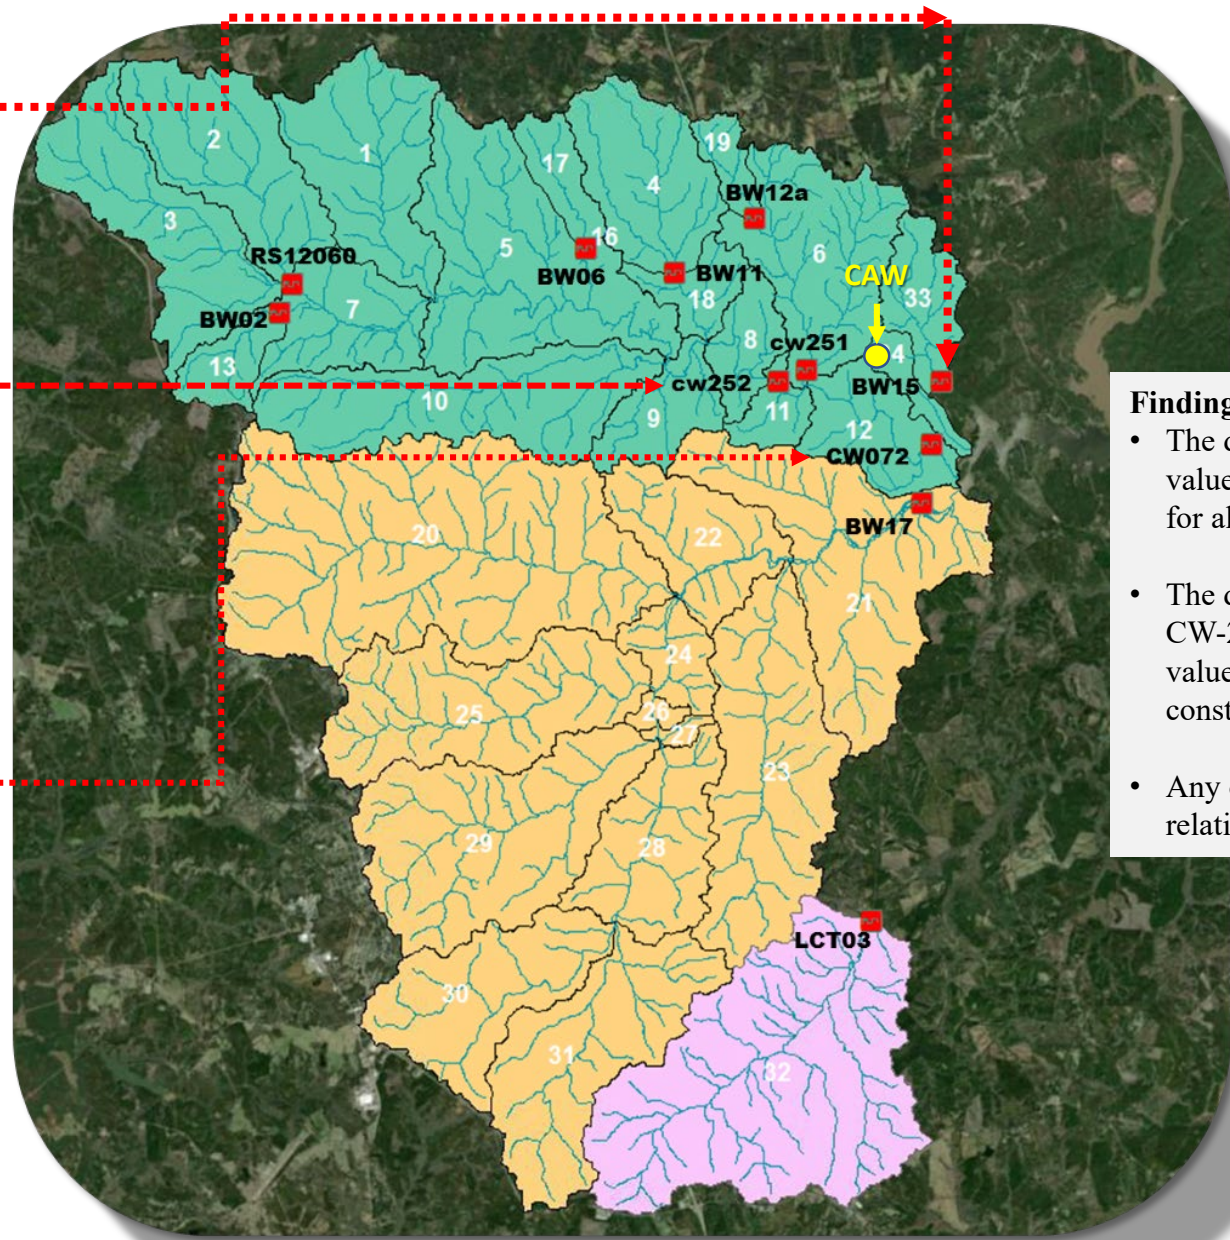
# A first look of the collected data set from 2019 data collection efforts

- Findings**
- The data at BW-15 shows high values (concentrations & NTU) for all turbidity, TDS and TSS.
  - The data at CW-072 and CW-252 indicate higher TSS values and lesser dissolved constituents in the data.
  - Any other data appears to be relatively constant and low.

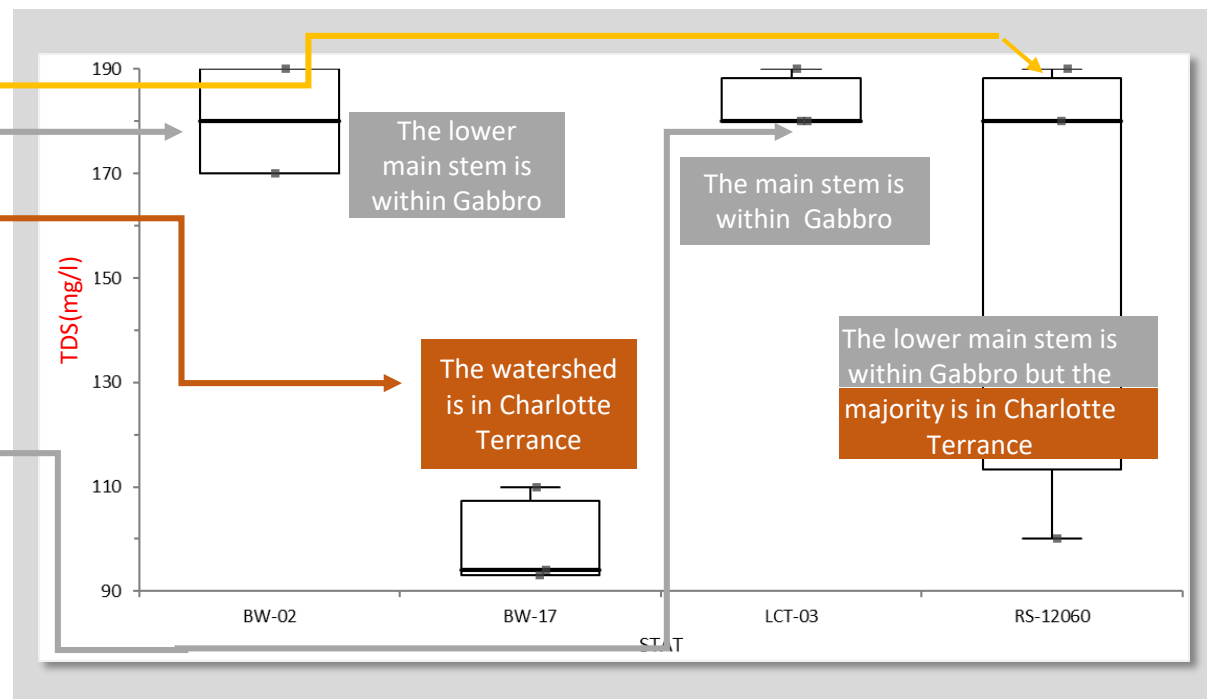
**Geology of the basin:** Gabbro: Coarse-grained, mafic igneous rock intruding the rocks of the Charlotte terrane. Charlotte Terrane: Infrastructural, mainly metaigneous taconites. However, the majority of the basin is charlotte terrance.

The data indicate that Gabbro based geology generate slightly higher TDS than the one observed from Charlotte Terrance. The data from RS-12060 contain both Gabbro and Charlotte terrance, and the TDS data range shows both ends.

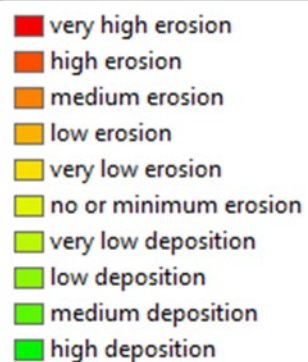
A comparison of the high erosion area and the aerial photo reveals that the higher erosion area mainly corresponds with forest clearcuttings and some loads from the residential setting area. The USPDE analysis was expanded to sws 29 to 31 where RUSLE identified sediment erosion (orange color). A similar story here that erosion coincident with clearcuttings and co-occurring with deposition (green color) area within short proximity to where the erosion occurs.

The left figure shows the K-factor (susceptibility of soil to erosion) of the Little Wateree Creek (the blue highlighted area). K-factor data reveals that the large portion of lower Little Wateree Creek's soil is categorized as minimum erosion potential soil. Additionally, K-factor shows erodible soil existing around the stream reach area (dark orange color). However, the aerial photo indicates that the area is covered by riparian vegetation, thus less likely that erosion occurs there, but more deposition. Hydrologic soil type at the outlet is also B, which is higher infiltration, thus less runoff and erosion. Therefore, no significant erosion mass is predicted to be added from the near outlet of the creek. All these data support BW-17 showing no significant TSS observed at the sampling location.

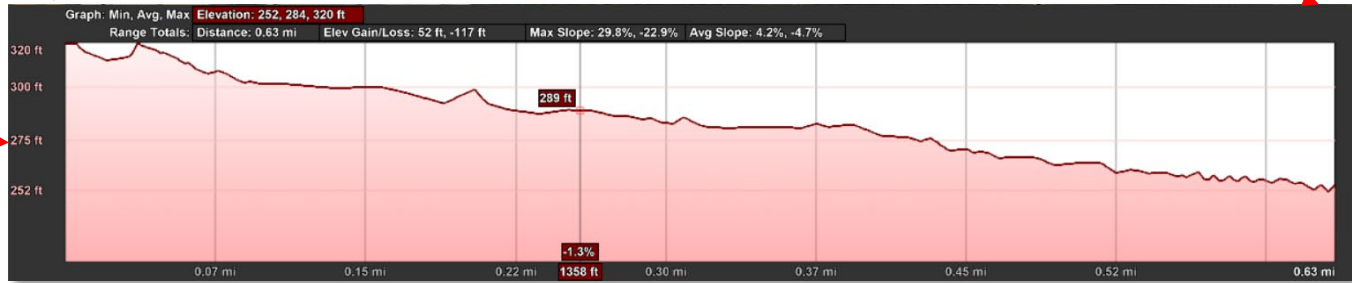
The figure on the left (figure 1) shows the slope condition of the CAW area and potential flow directions based on the slope.

Two things to notice from this plot:

1. The slope map indicates three general slopping directions from CAW: toward sws 6, sws 12 and sws 34. However, according to CW-251 data, the sediment flow toward sws 6 is probably minor (refer to slide 22 though 25).
2. Flow directions of CAW east side is a direction toward to sws 33. The map and the slope condition plot above (figure 3) show the possible flow path into sws33 from sws34. TWI map (see the lower left , figure 2) also indicates the moisten soil/shallow subsurface water as runoff/flow paths into sws33 from CWA area (the blue arrows indicate the flow directions).

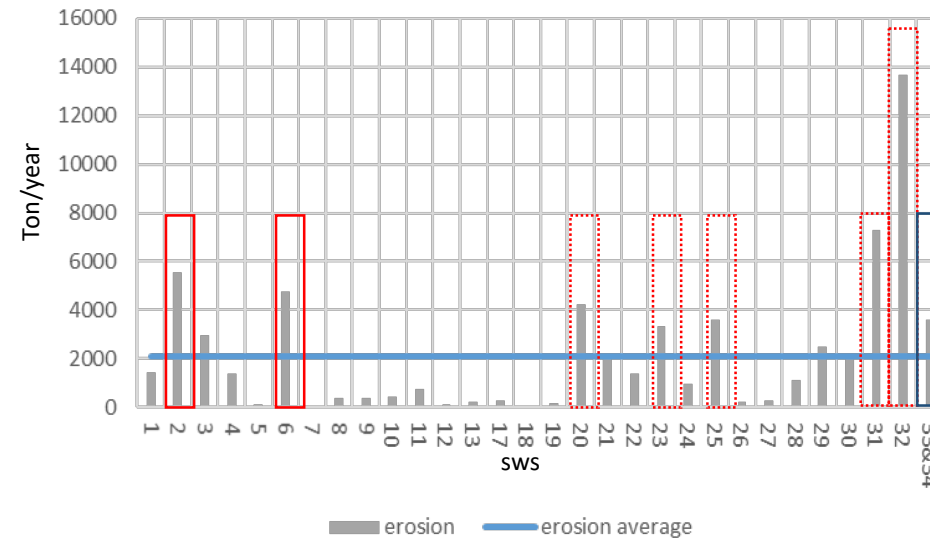
## Additional RUSLE model was run and erosion loading results of the clearcuttings in sws 33 and sws 34

After the missing clearcutting area was incorporated, an additional RUSLE model run was conducted. The plot on the right below shows the total erosion from the clearcuttings throughout the basin. USDA's sediment delivery ratio (SDR) method was assigned to account for deposition along the path from the erosion source to the watershed outlet. The watershed map is also shown here as a spatial reference purpose.

- Compared with the averaged clearcutting erosion of the whole basin (the blue line), sws 2, 6, 20, 23, 25, 31 and 32 exhibit higher total erosion from the clearcutting area. The erosion conditions in Dutchmans Creek (sws2) and Little Wateree Creek (sws 20, 23, 25 and 31) were already discussed in the previous slides 37 through 39. Although it shows higher erosion from the clearcuttings, they tend to deposit and incorporate into soils over the extent of the watershed.
