Cane Creek and Little Cane Creek Watershed Management Plan to Address E. Coli Impairment, Oconee County, SC

September 2018 (Rev. January 2020)

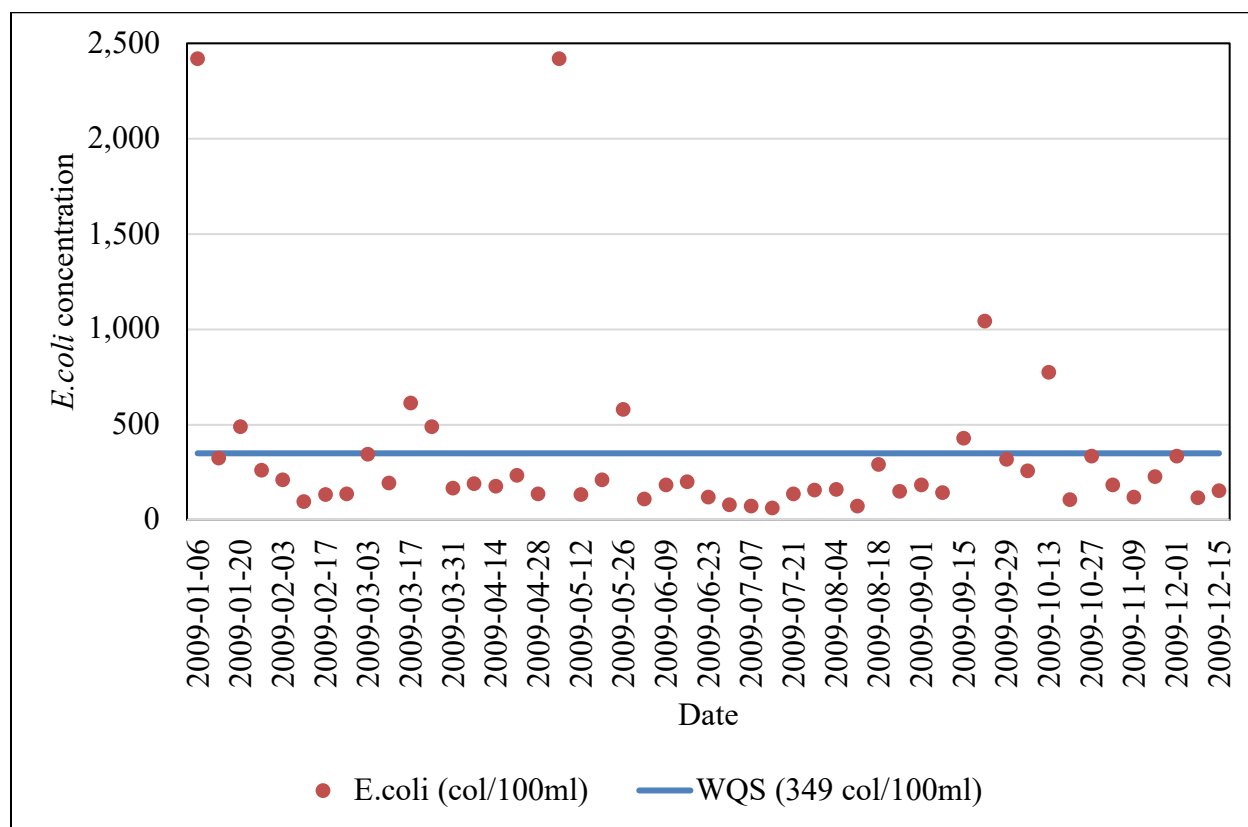
Fig. 4. *E. coli* results at SV-342 on Cane Creek in 2009, plotted against *E. coli* water quality standard for single grab samples (349 col/100mL).

The stations of significance to this watershed plan are those used in the development of the fecal coliform TMDL. SV-342 is on Cane Creek; SV-343 is on Little Cane Creek (Figs. 4 and 5). Both have been monitored since 1999 for a full suite of water quality parameters. 2009 is the only year each were monitored for *E. coli* and the last year of data collection at these two stations. In 2009, 49 results are available for *E. coli* at both monitoring locations.

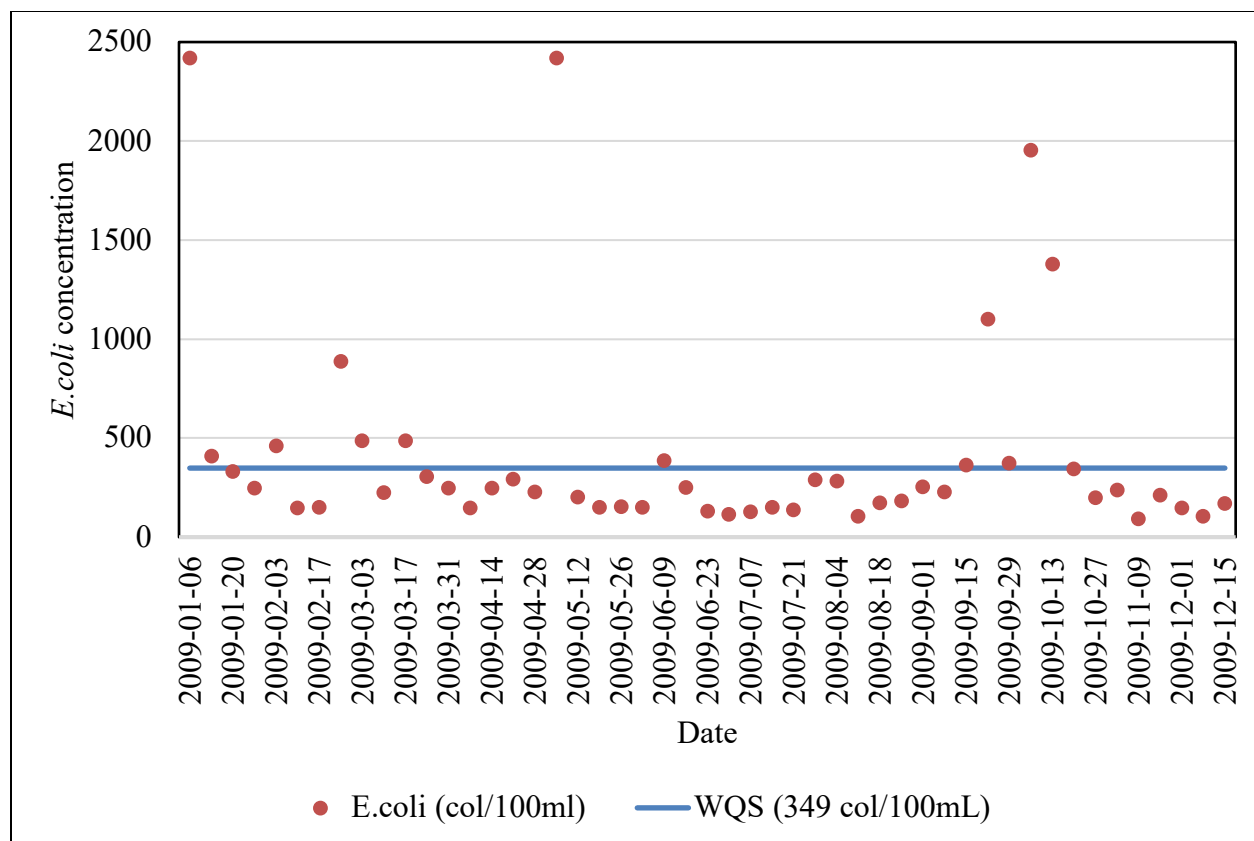
Fig. 5. *E. coli* results at SV-342 on Cane Creek in 2009, plotted against *E. coli* water quality standard for single grab samples (349 col/100mL).

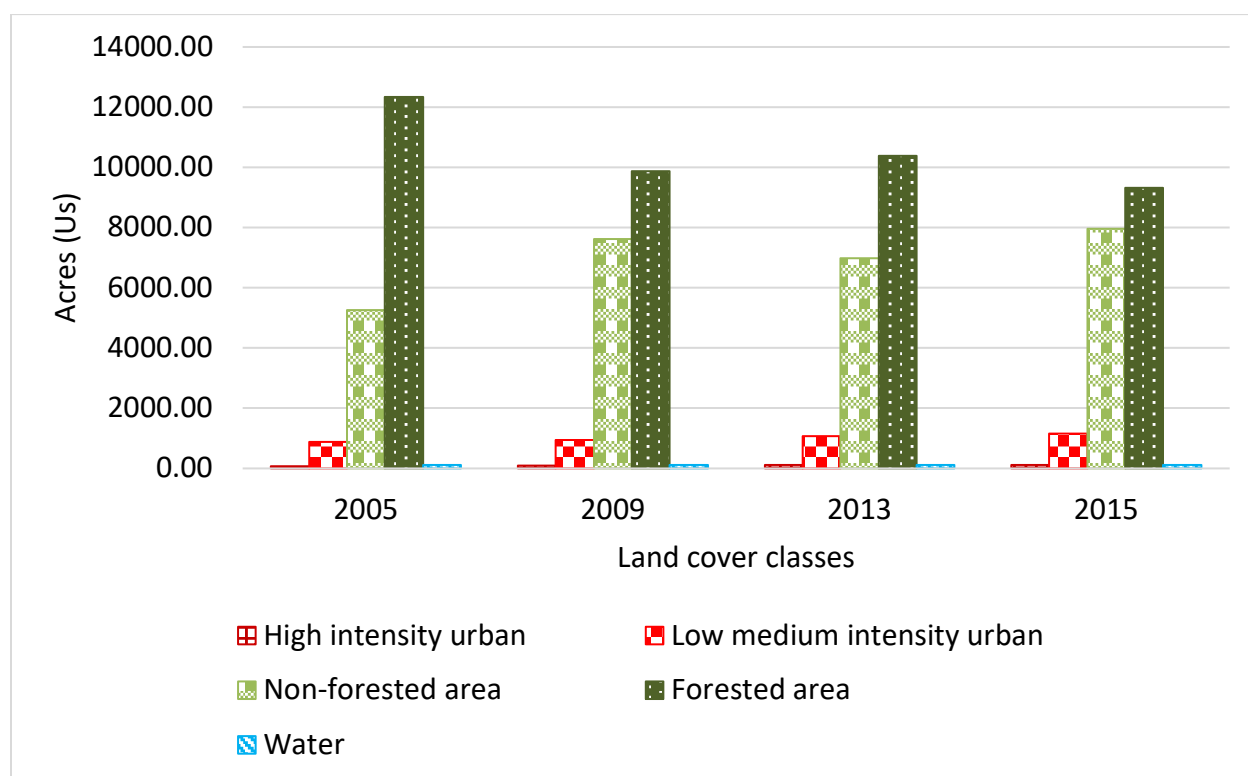
Fig. 10. Land use change depicted in the watershed.

Classification results for the four-year intervals and 2015 is summarized in Table 6 and Figure 10. Results indicate that the impervious surface areas (low-medium intensity urban; high intensity urban) continuously increased over time, dominated more so by low-medium intensity urban. Forested areas of the watershed declined overall. The construction boom's halt during the 2009 recession may be the cause for increase in forested areas between 2009 and 2013; when the economy recovered, forest loss then continued from 2013 to 2015.

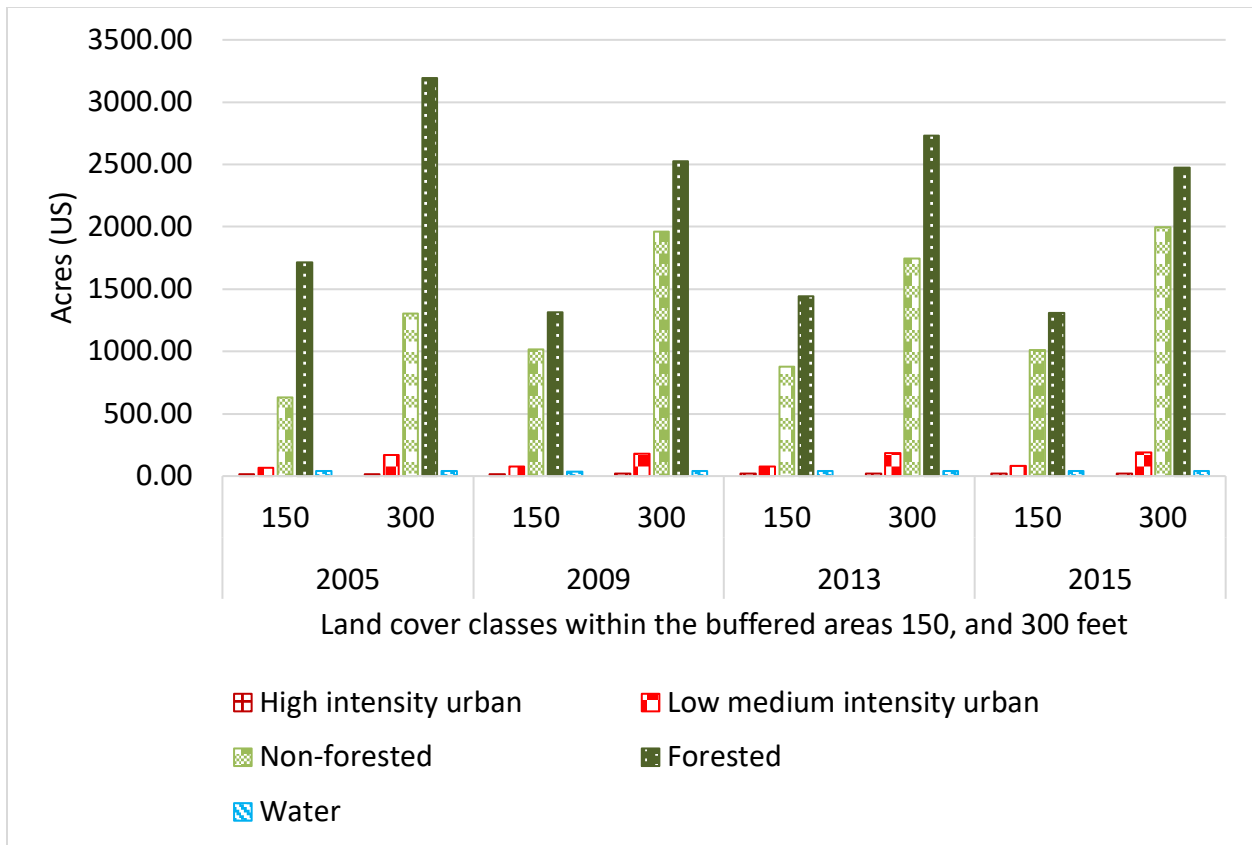
Fig. 12. Land cover classes and change within the buffered areas of 150 and 300 feet.

Land use change is an especially important consideration when it is occurring adjacent to waterbodies, as water quality mimics its neighboring land use due to runoff and quality can be characterized by the conditions of use. Following the work of the Coastal Riparian Buffers Analysis conducted for the EPA in Connecticut (University of Connecticut NEMO 2007) the analysis of land use change in the riparian corridor was completed at two buffer widths - 150 feet, and 300 feet on each side of open water - over the selected time intervals (Fig. 12 and Fig. 13).

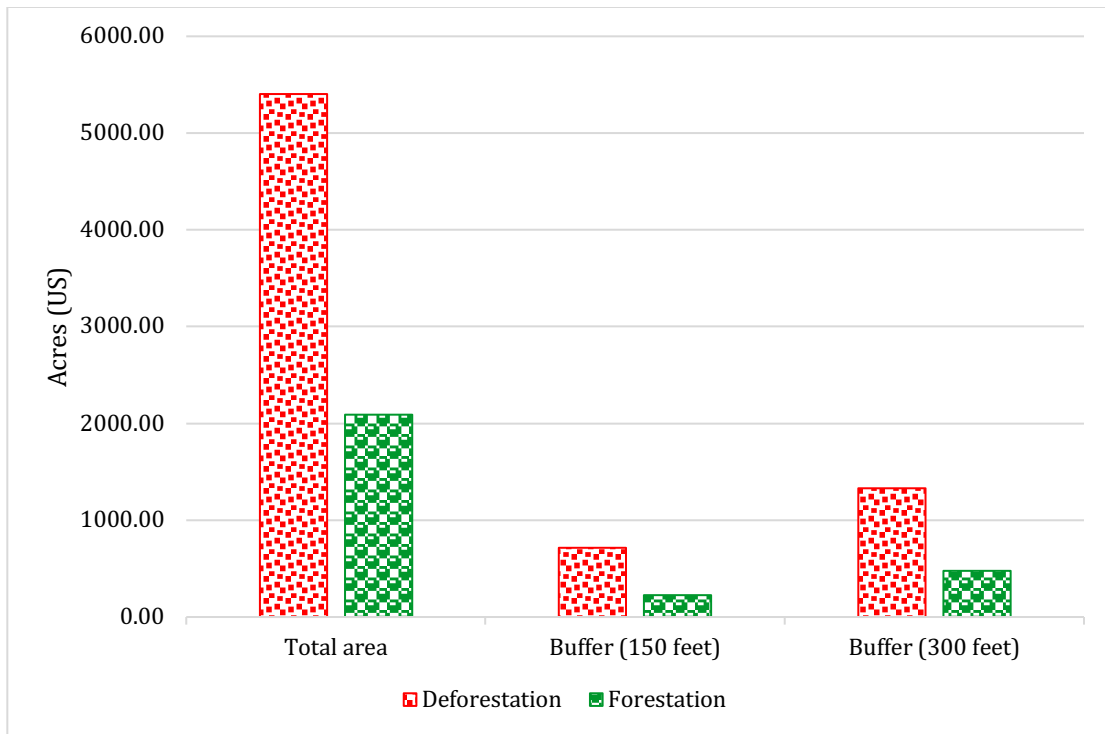
Fig. 15. Total area of deforestation in the watershed and selected buffer widths from 2005 to 2015.

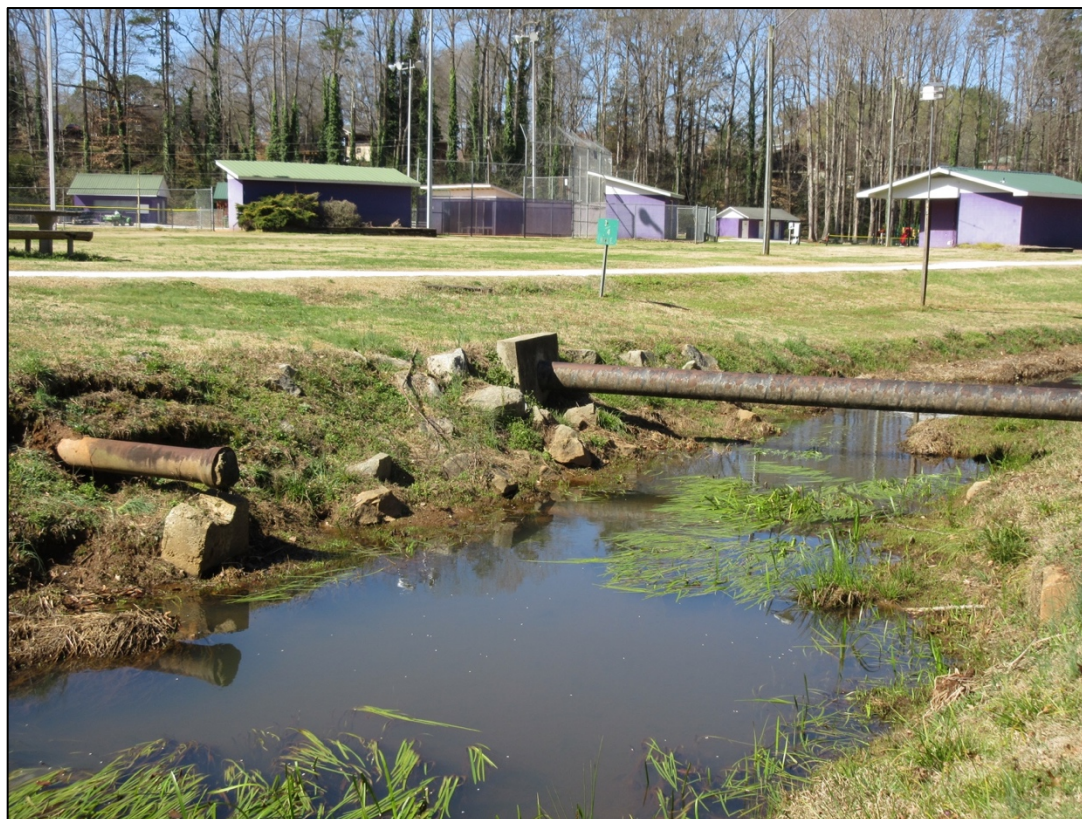
Fig.18. Previously sealed and replacement sewer lines hover just a few feet over unnamed tributary leading to Cane Creek, which runs through Sertoma Field, Walhalla, SC.

documented as a source of overflows to Cane Creek. These occurrences have been noted in the most frequently used public park in the area, Sertoma Field. This public park includes the main sewer line, which parallels and then crosses a tributary to Cane Creek and concrete cinder cones house risers and manholes from the sewer line. Sertoma Field is the most popular and most frequented park in the area, where baseball games, track, disc golf, and other recreational amenities are available to the public, as well as several community festivals such as Walhalla's annual Oktoberfest.

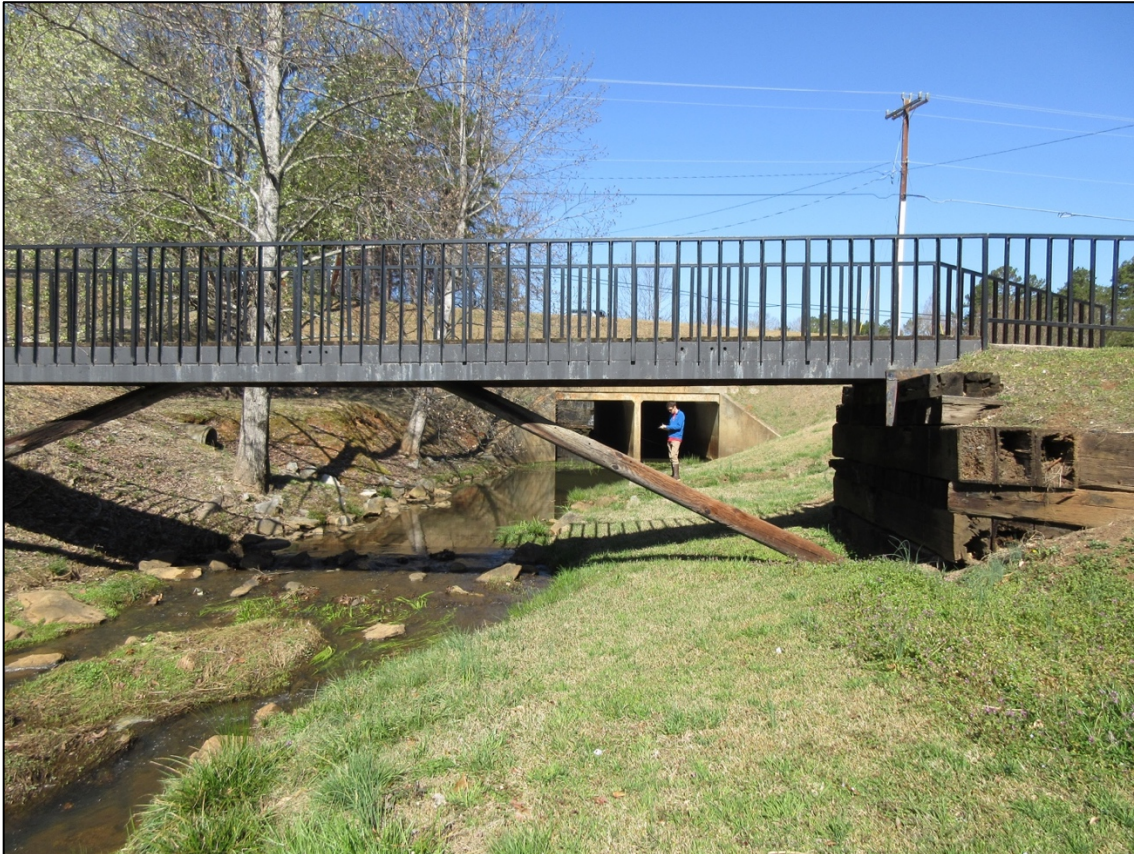
Fig. 19. Tributary to Cane Creek from neighborhood pond, after it passes under Highway 183 and enters into Sertoma Field.

length and for the majority of the year. The tributary is shaded by a few large trees, but predominantly has turf extending to the edge of the low bank (Fig. 19). Though not observed during the development of this watershed plan, stakeholders have stated that this park and adjacent parking lot floods several times per year. The adjacent parking lot is not curbed and is at a distance between 15 and 30 feet from the tributary for its full length. The opposing side includes utilities, walking path, and turf to the edge of the waterway (Fig. 20).

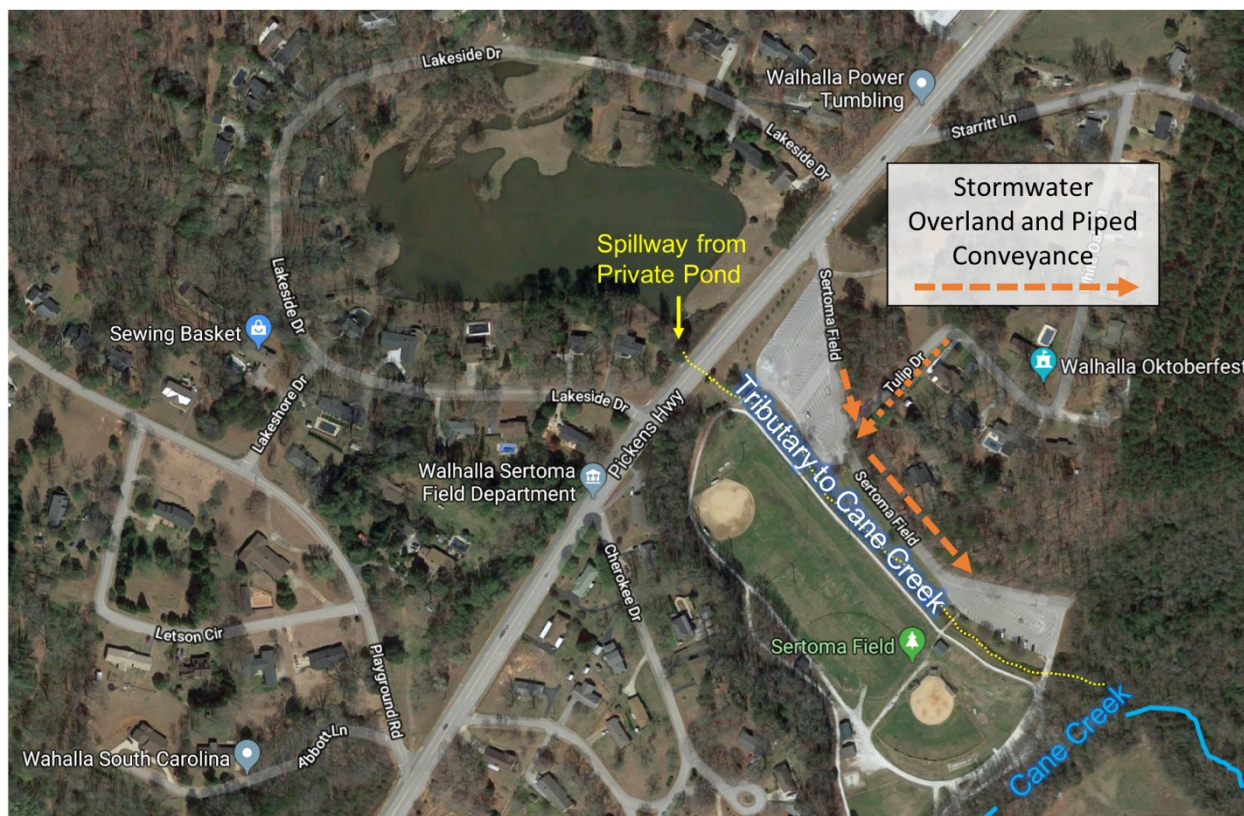
Fig. 21. Sertoma Field and conveyances of runoff and pond input to Cane Creek.

Across the parking lot, a relatively small neighborhood lies uphill, with an access road perpendicular to the park road (Fig. 21). Stormwater infrastructure has been observed as buried under sediment and covered with debris. There is little evidence of maintenance, and stormwater likely bypasses the pipe to flow over land and asphalt to the unnamed tributary and Cane Creek, which flows along the outer perimeter of the park. Residential stormwater can transport fecal bacteria from domestic and feral animals, trash containers, ruminants, wildlife, and septic system leachate.

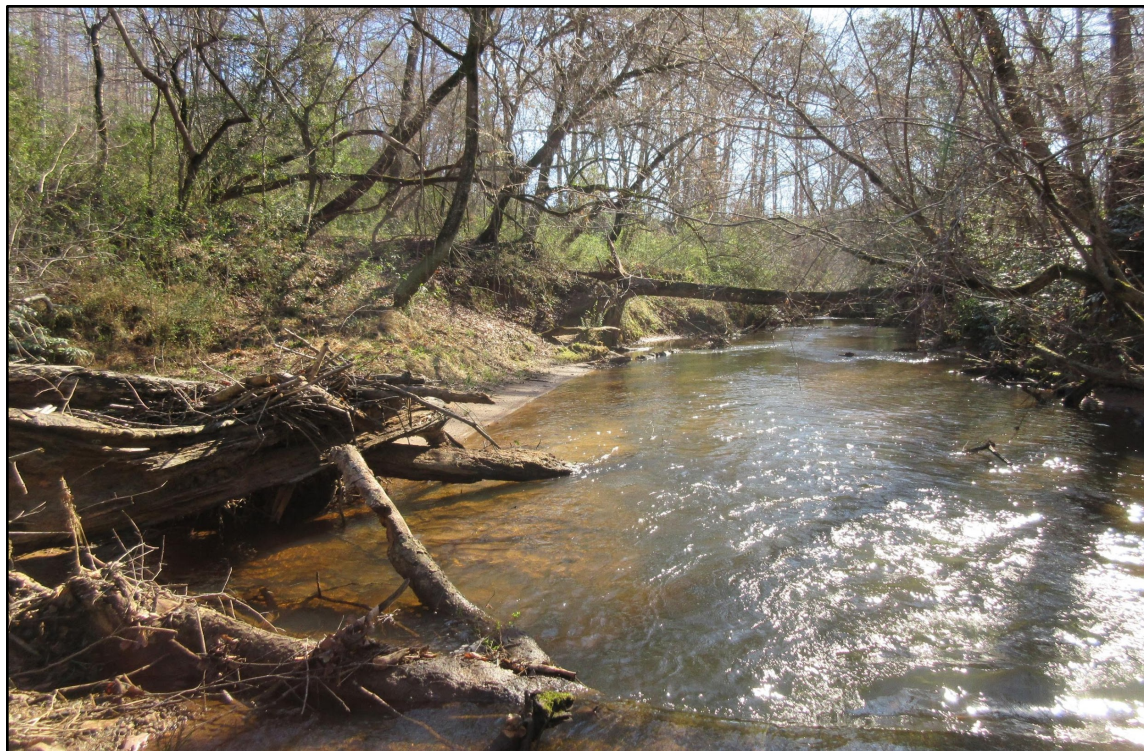
Fig. 22. A corridor of leaning and downed trees in the lower reaches of Cane Creek.

Field observations showed widespread loss of large trees in the riparian corridors of Cane and Little Cane Creeks (see Fig. 22). This was further documented in the land use change analysis that revealed 28% loss of trees within 300' of stream between 2005 and 2015. With loss of large trees, comes streambank failure and streambank sediment deposition into the stream. Furthermore, the large downed trees slow stream flow and remove the natural flushing mechanism that occurs naturally during large storm events.

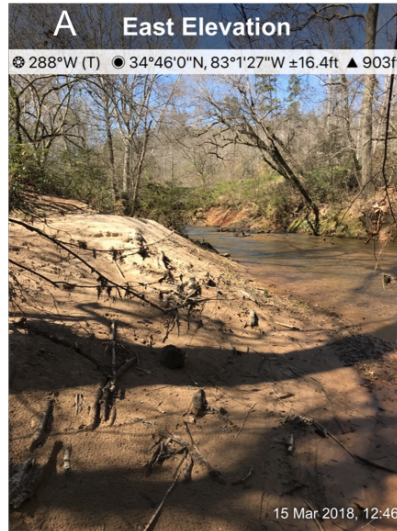
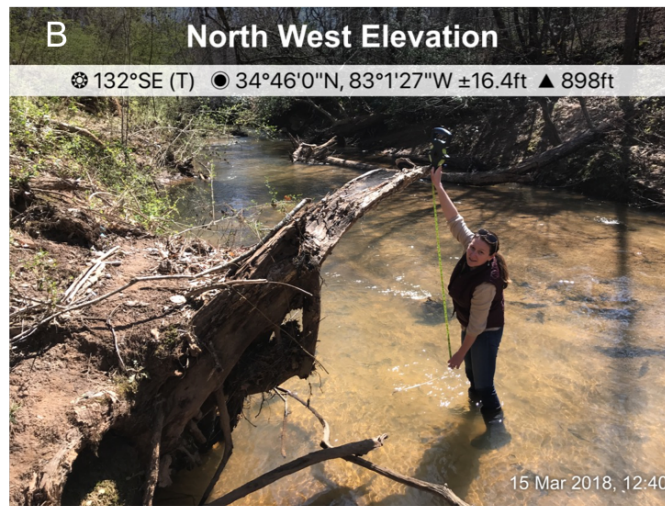
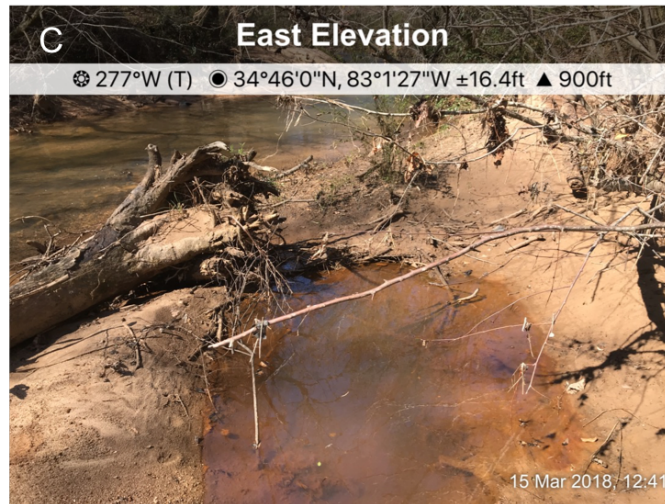
Reach of Cane Creek showing A) Sediment deposition along channel bend; B) Downed tree; C) Space left by downed tree and sediment available for stream bed deposition

Fig. 23. Pictures of lower Cane Creek displaying the repeated cycle of trees on the cusp of collapsing into the stream, sediment accumulation, trees already have fallen into the stream, and vulnerable sediment for deposition.

Given the characteristic failing of large trees in the stream corridor, the incurred deposition of sediment due to bank loss, and the accumulation of sediments in the stream bottom, it is believed that this series of events, paired with a regular input of fecal polluted runoff or leachate is a significant cause of the observed bacteria impairment frequency in the surface waters of Cane and Little Cane Creek near their DHEC monitoring stations (see Fig. 23).

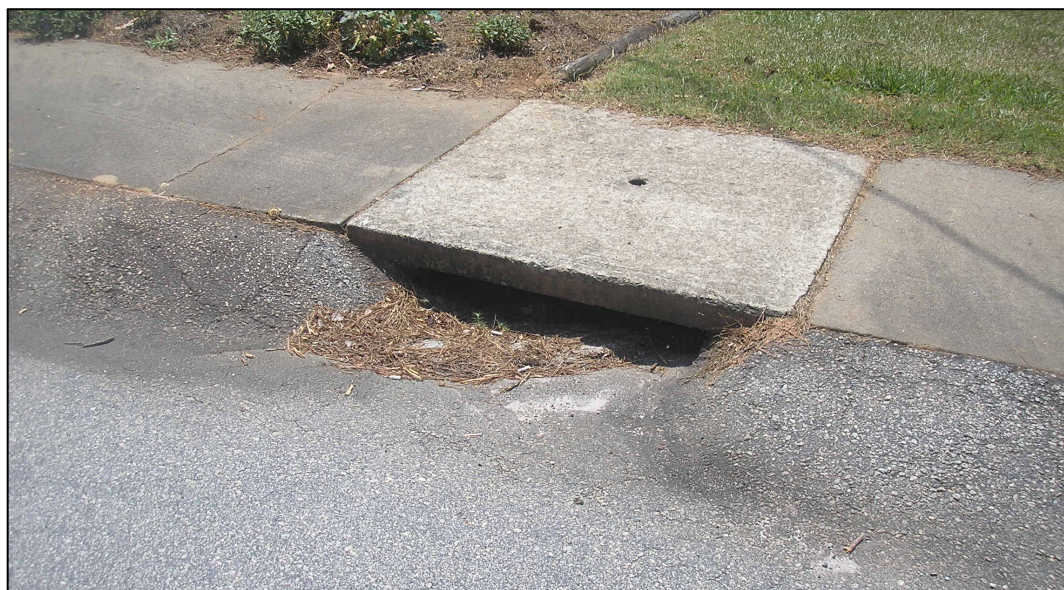
Fig. 25. Catch basin with landscape and natural debris in the basin.

The catch basins within the Cane Creek Watershed are predominantly in Walhalla and all are owned by the SC Department of Transportation (SC DOT). The city currently does not have capacity to vacuum or maintain the interior of these chambers, nor the ownership to do so. It would be an improvement to the quality of receiving waters for annual maintenance to occur, or a schedule developed suitable for the needs of downtown.

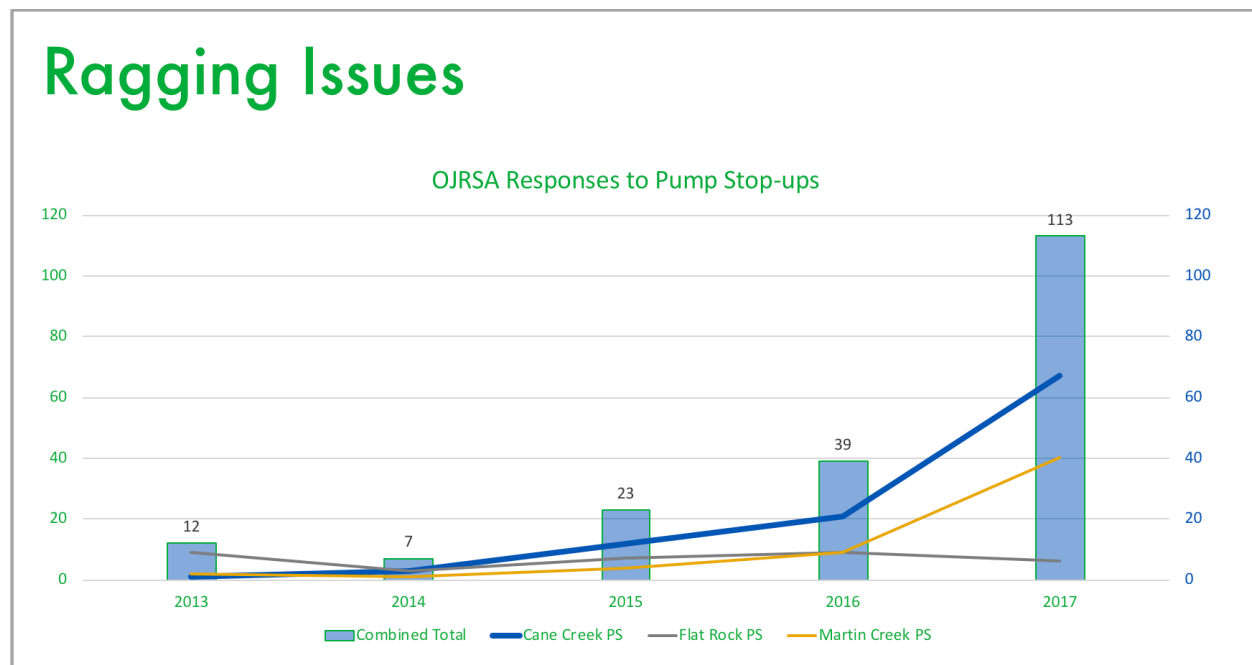
Fig.26. Increasing number of responses to “ragging issues” related to flushable wipes, with Cane Creek (shown in thick blue line) having the greatest number of failures each year recorded.

FOGs and flushable wipes have been documented as causing significant issues in the sewer system of the Oconee Joint Regional Sewer Authority, within Cane Creek. Responses to failures relating to flushable wipes increased from 20 to nearly 70 in just one year (Fig. 26). The results of these failures have included back-ups into residences and buildings, overflowing manholes, and sewer spills. These occurrences are a source of fecal pollution to the watershed.

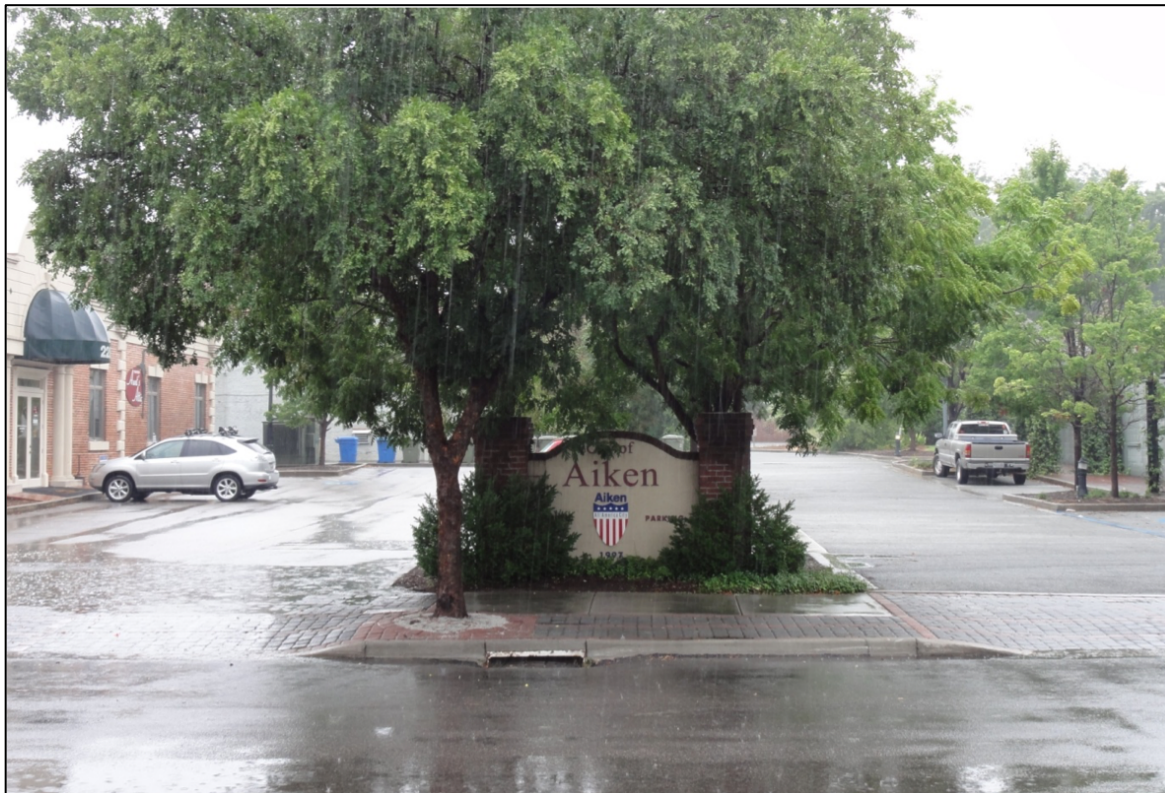
Fig. 28. This image from Aiken, SC demonstrates the ability of a porous asphalt road (right) to quickly infiltrate rain water, in comparison to standard asphalt (left) showing puddles (Source: Calvin Sawyer, Ph.D., Clemson University).

While the porous asphalt is being installed, stormwater infrastructure should be eliminated along the parking lot and collected from Tulip Drive, which is perpendicular to the park road. With the porous asphalt in place, this stormwater will be more effectively treated than traditional pipe collection (Fig. 28).
