SITE ASSESSMENT,
REMEDIAL ACTION &
REVITALIZATION

**Subject: VCC Progress Report #2
Auriga, Spartanburg Facility
BoW Site ID# 00225, VCC 13-5841-RP
AECOM Project No. 60280417**

Auriga Spartanburg Voluntary Cleanup Contract 13-5841-RP Progress Report September 2013

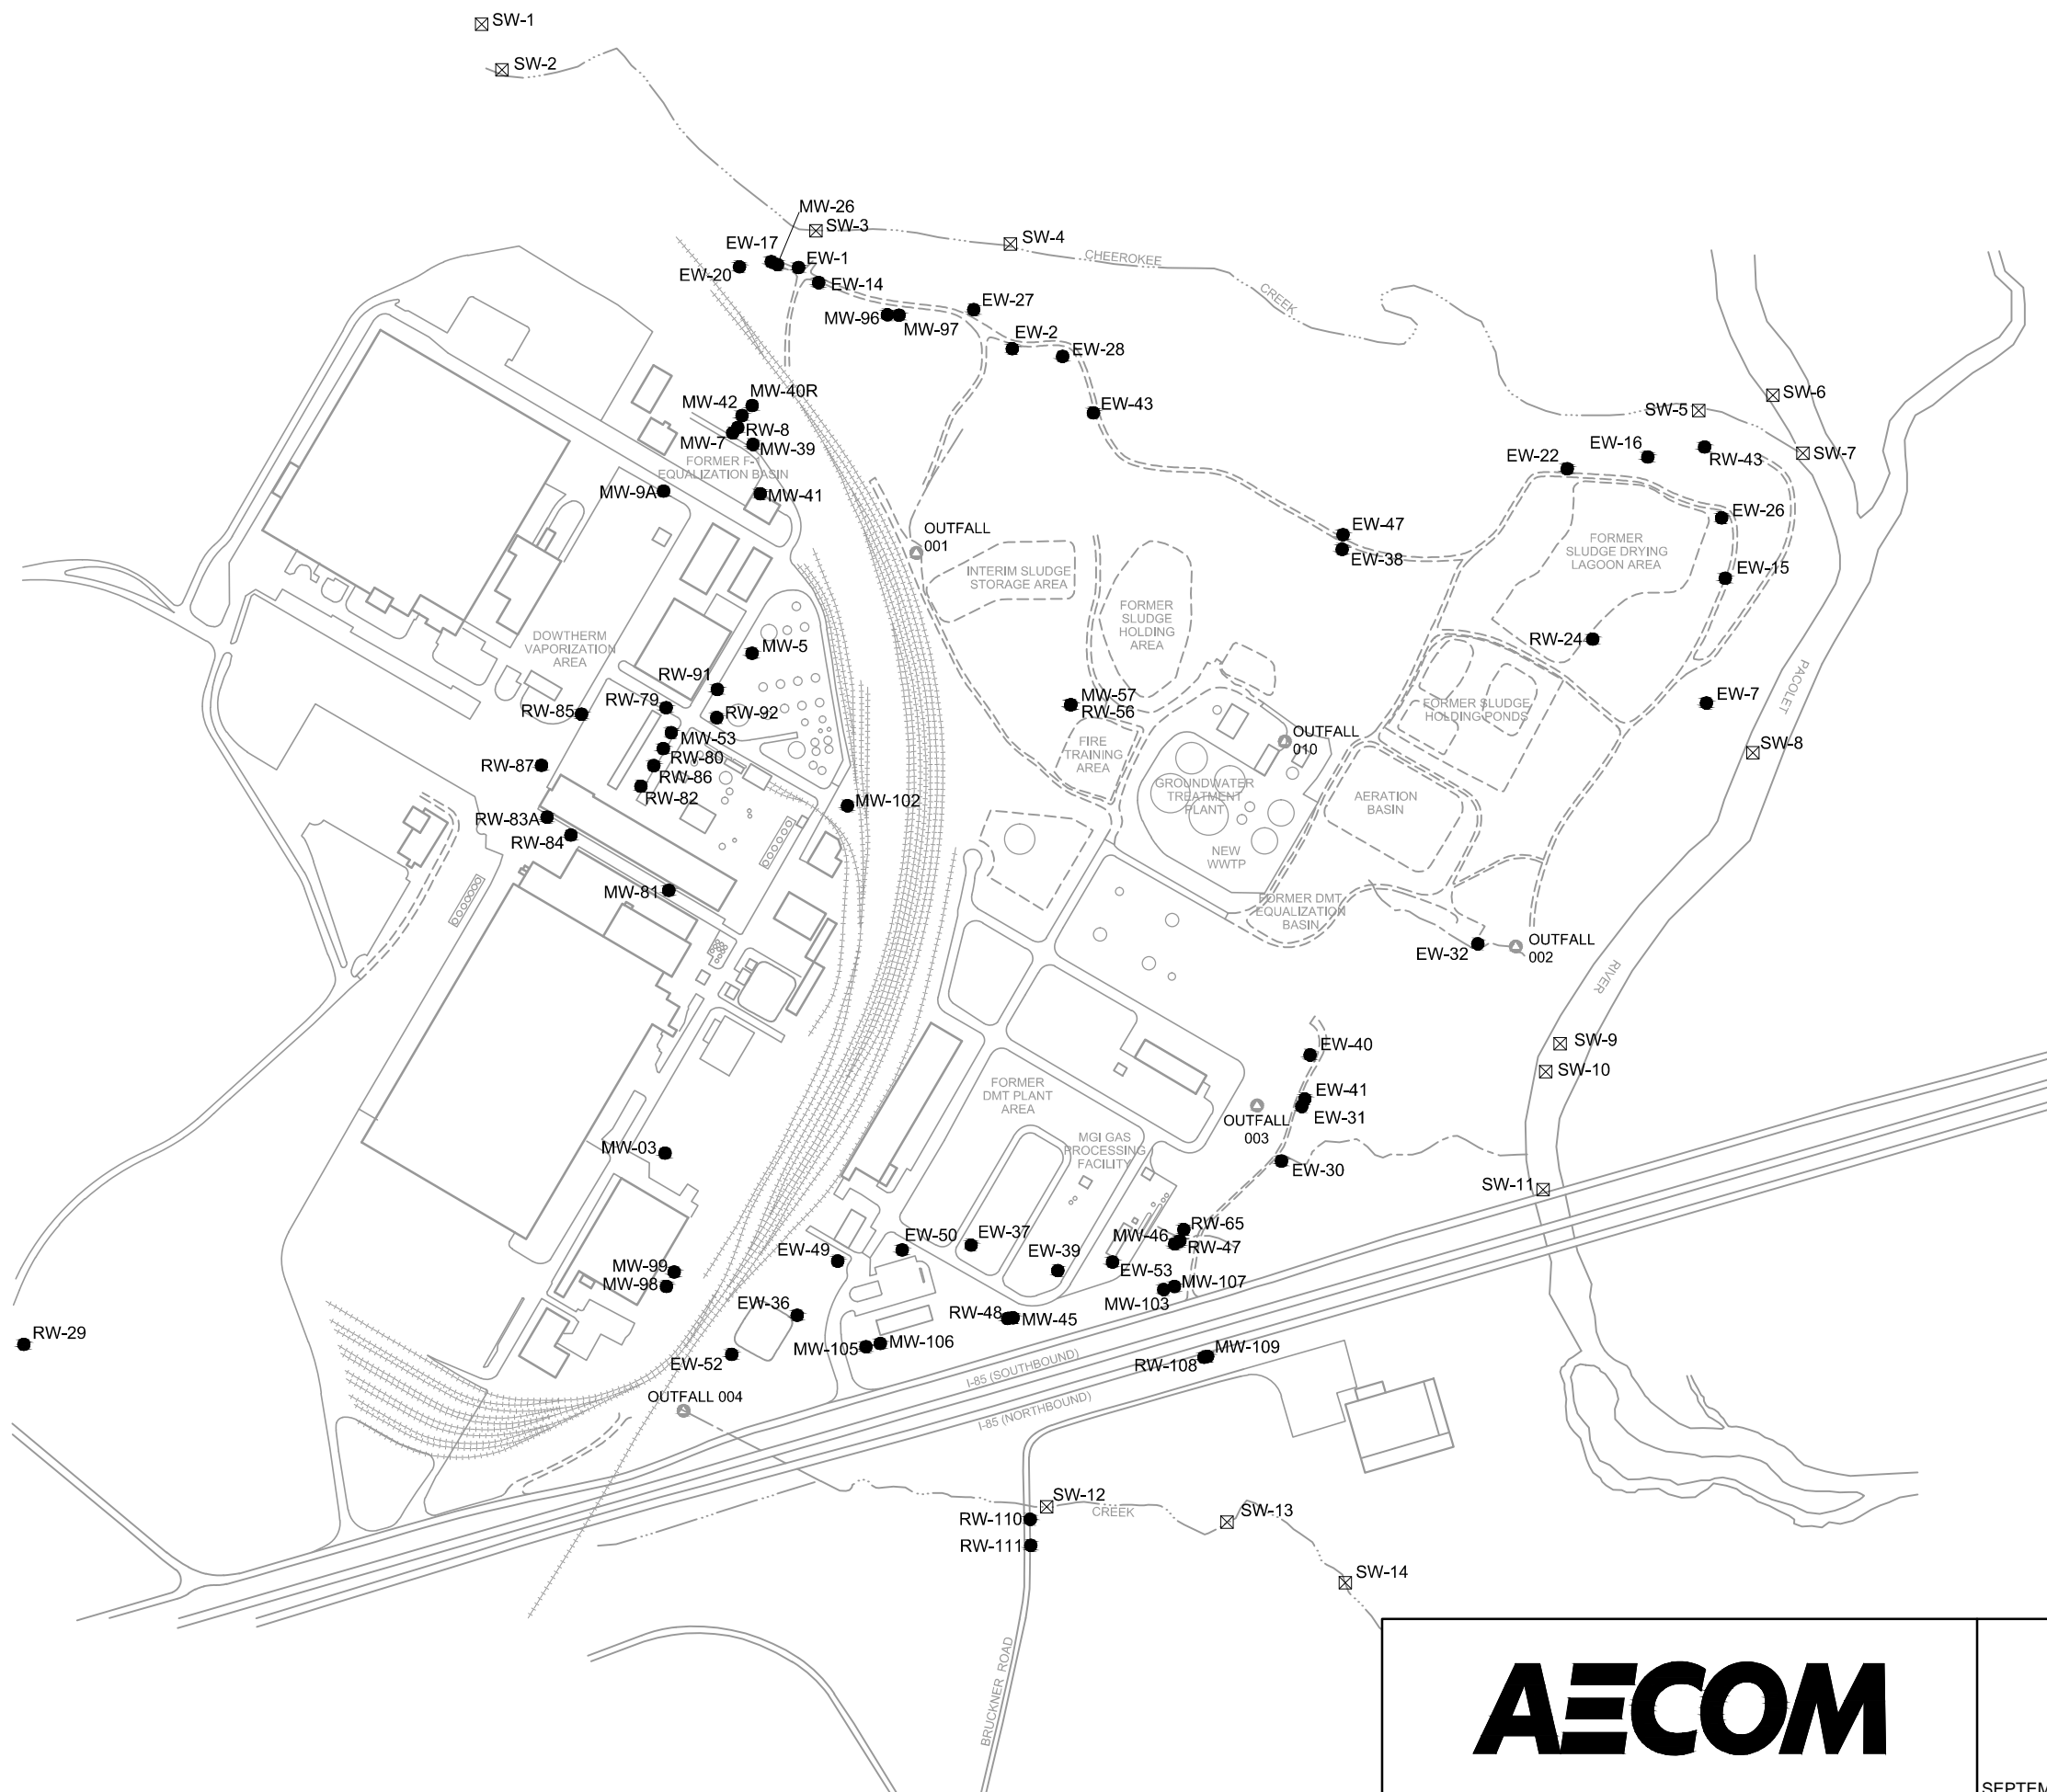
FIGURE 2
SAMPLE LOCATION MAP
JUNE 2013

The annual sampling event was completed between June 17 and June 20, 2013. The sampling event was completed as described in the VCC work plan. This plan was approved verbally during a telephone conversation between Addie Walker and Bryon Dahlgren on May 28, 2013. The June 2013 sampling plan is presented in Table 1. The June 2013 sampling locations are shown on Figure 2.

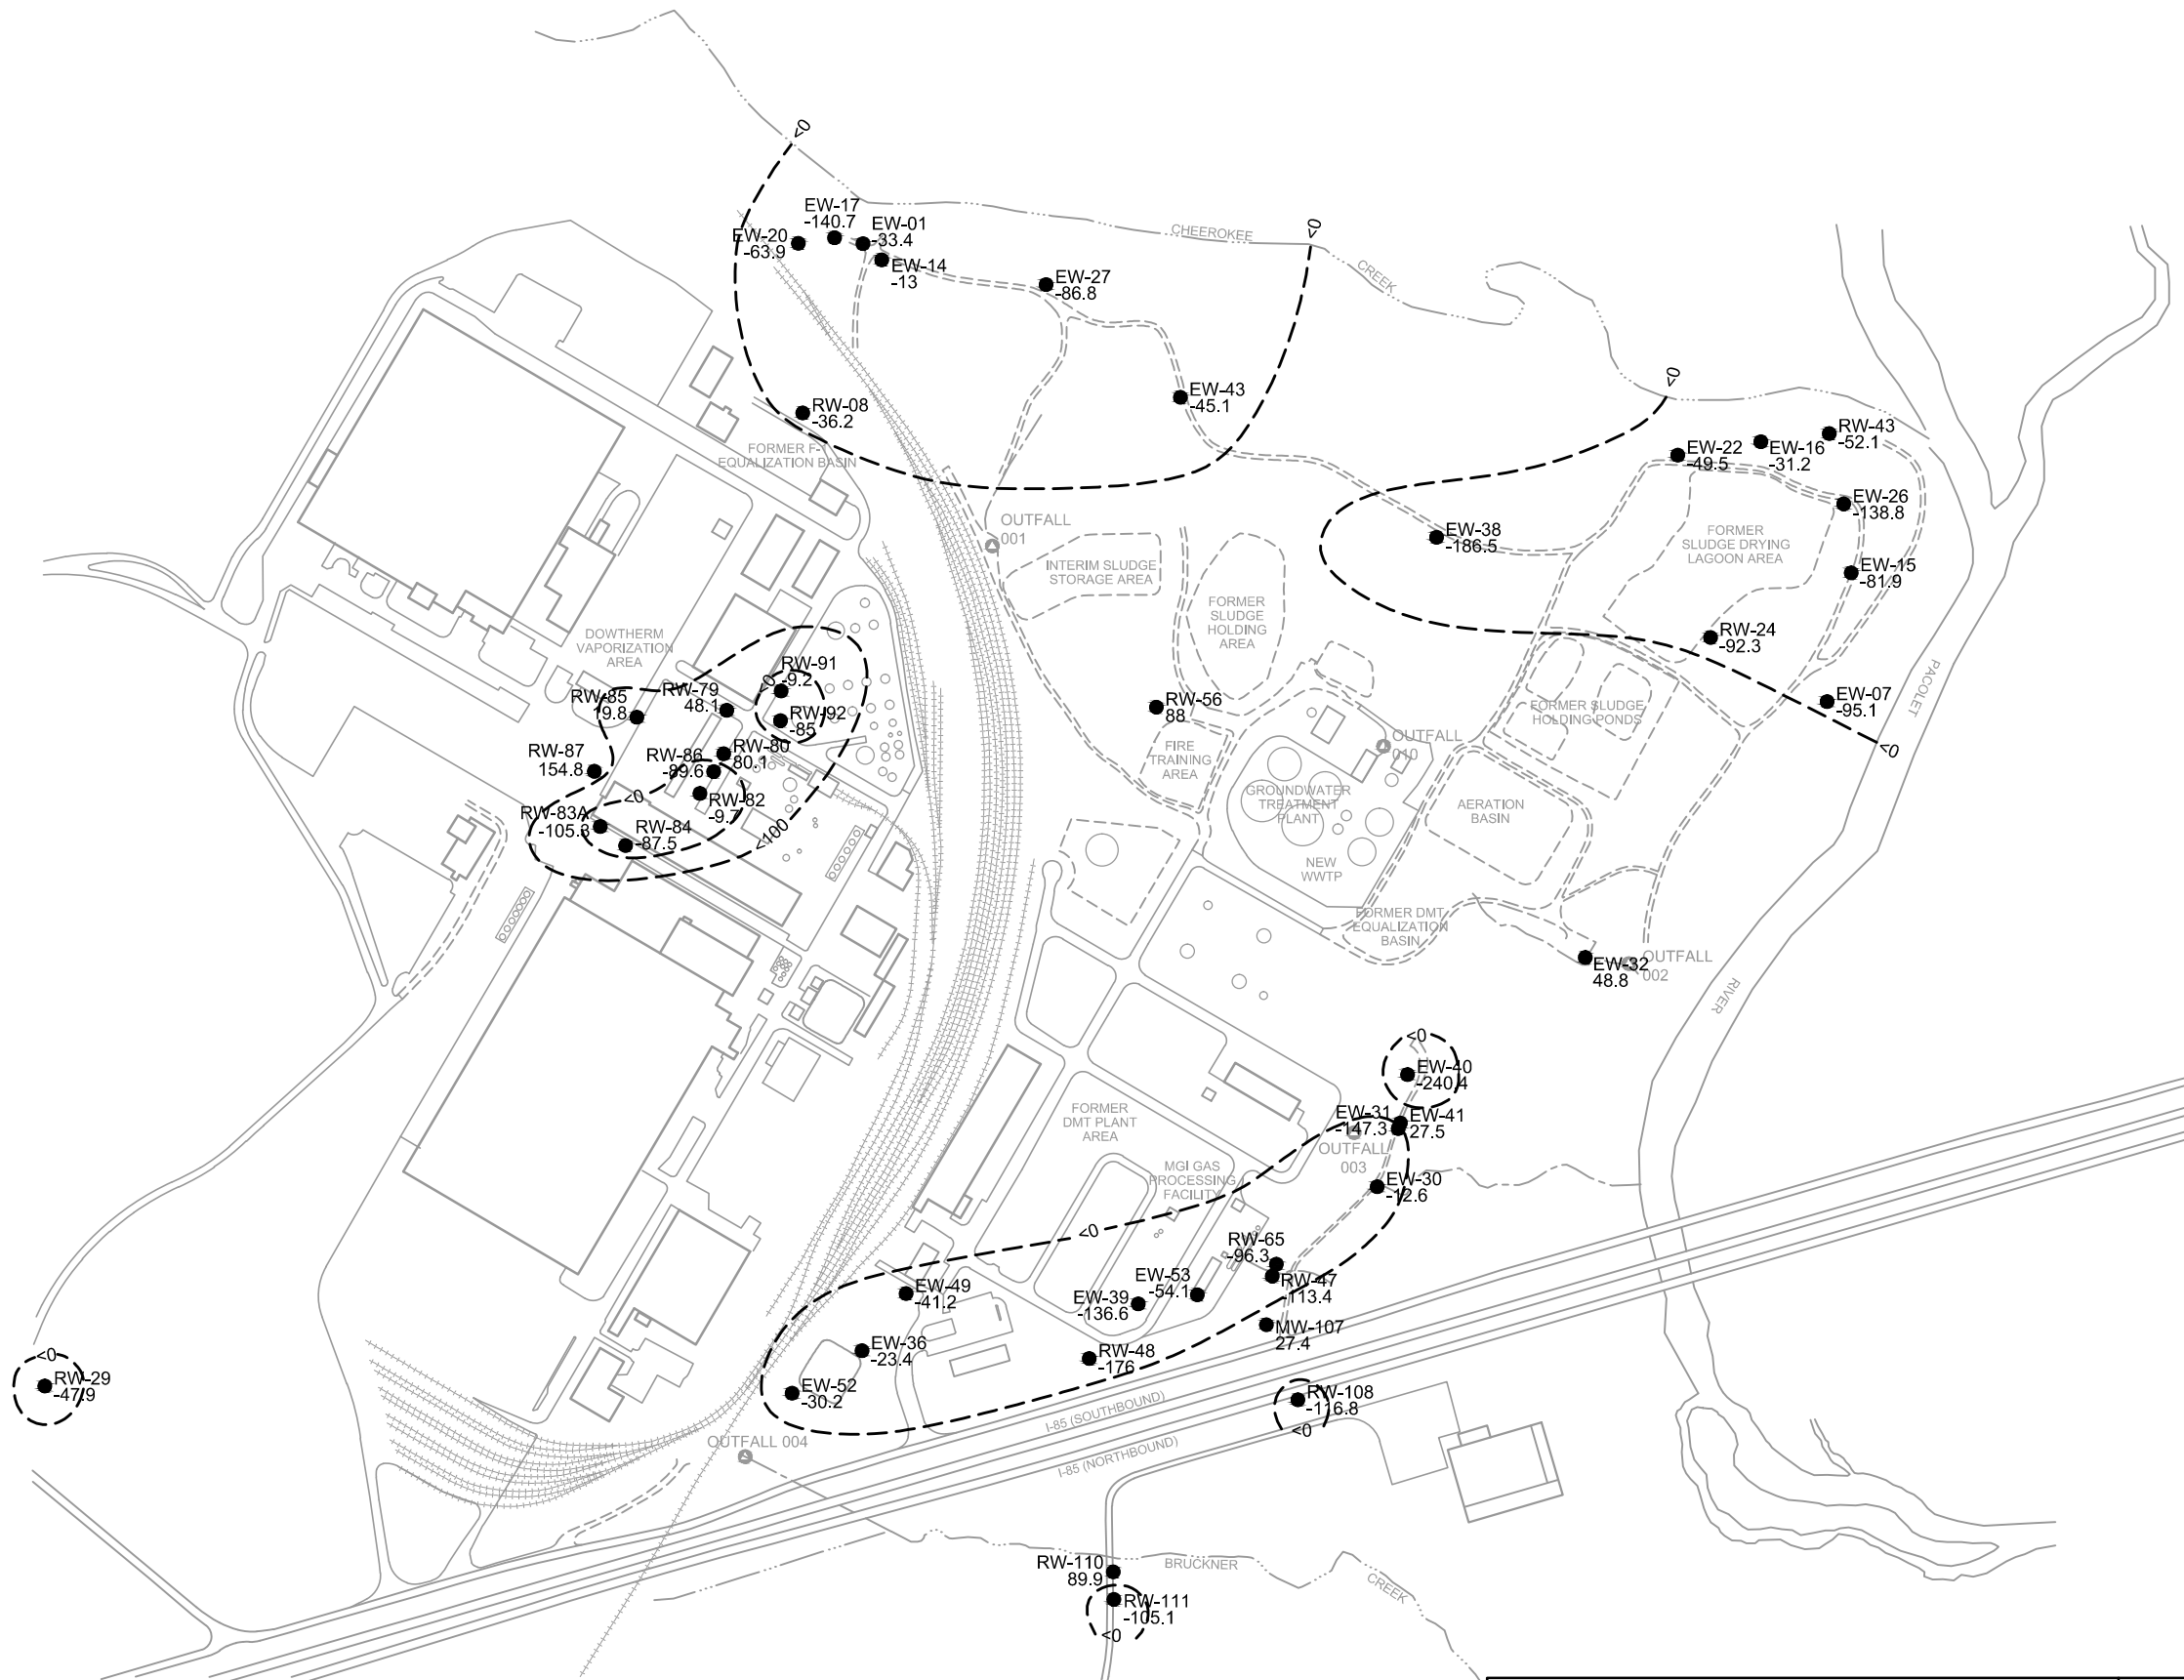
Dissolved oxygen data are presented on Figures 17 and 18. ORP data are presented on Figures 19 and 20. These figures present similar results with reducing conditions and low dissolved oxygen concentrations in the same locations, as expected. The low oxygen areas are consistent with either

- MONITORING WELL LOCATION
- 0.00514 ORP CONCENTRATION
- - - >0 - - - ORP ISOCONCENTRATION CONTOUR
