PHASE I CULTURAL RESOURCES SURVEY

OF THE LUCK SALUDA SITE

Saluda County,
South Carolina

August 7, 2023 • Revised **Draft Report**
New South Associates Technical Report 4500

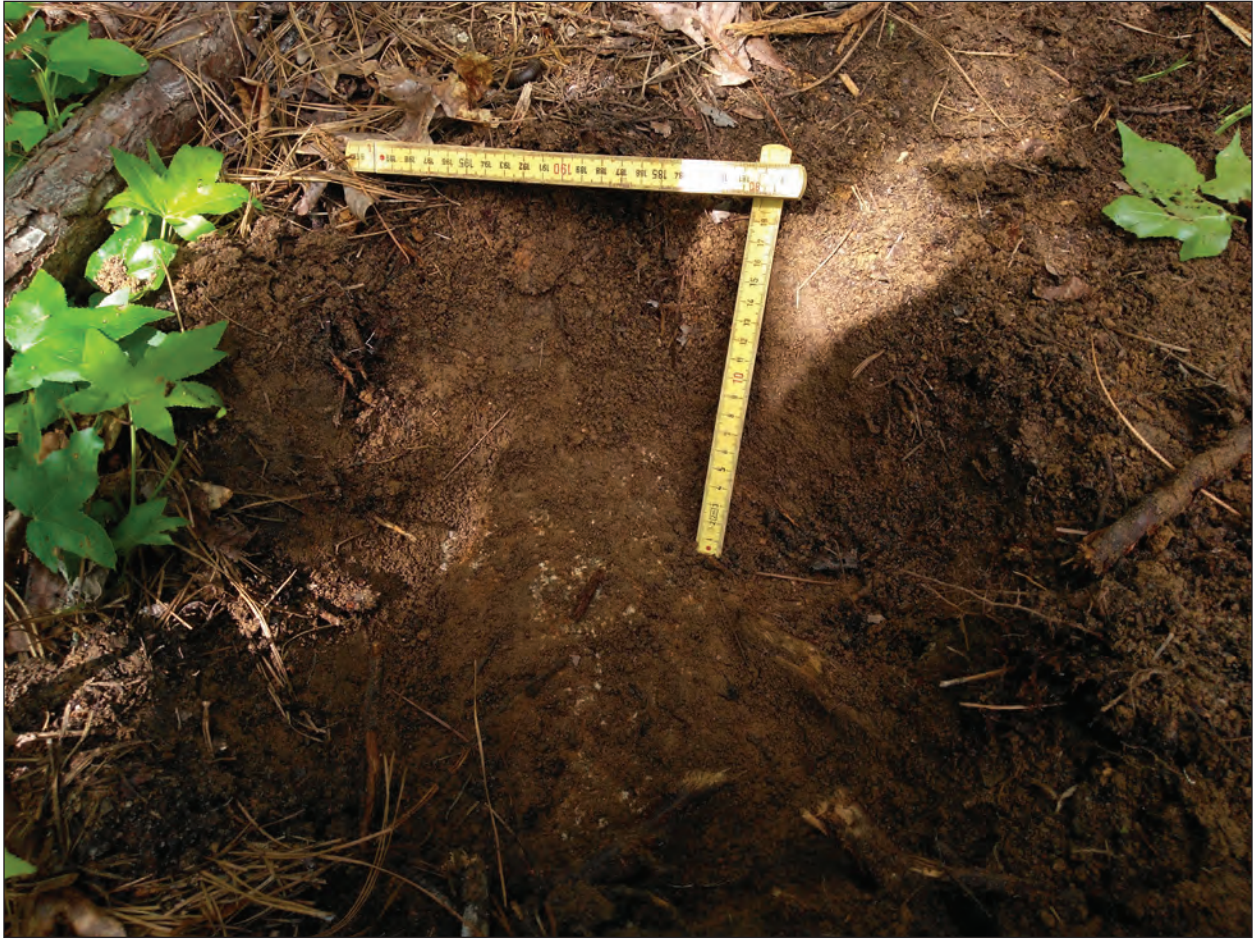
Figure 11.
Typical Shovel Test in the Project Area

Soil profiles varied across the project area, although one general soil profile was noted. A typical soil profile consisted of approximately 18 centimeters of yellowish brown (10YR 5/4) sandy loam E horizon overlying a yellowish red (5YR 5/8) sandy clay subsoil. An Ap horizon consisting of approximately 10 centimeters of grayish brown (10YR 5/2) sandy loam was noted in some shovel tests (Figure 11). Eroded and compact soils were identified across the project area.

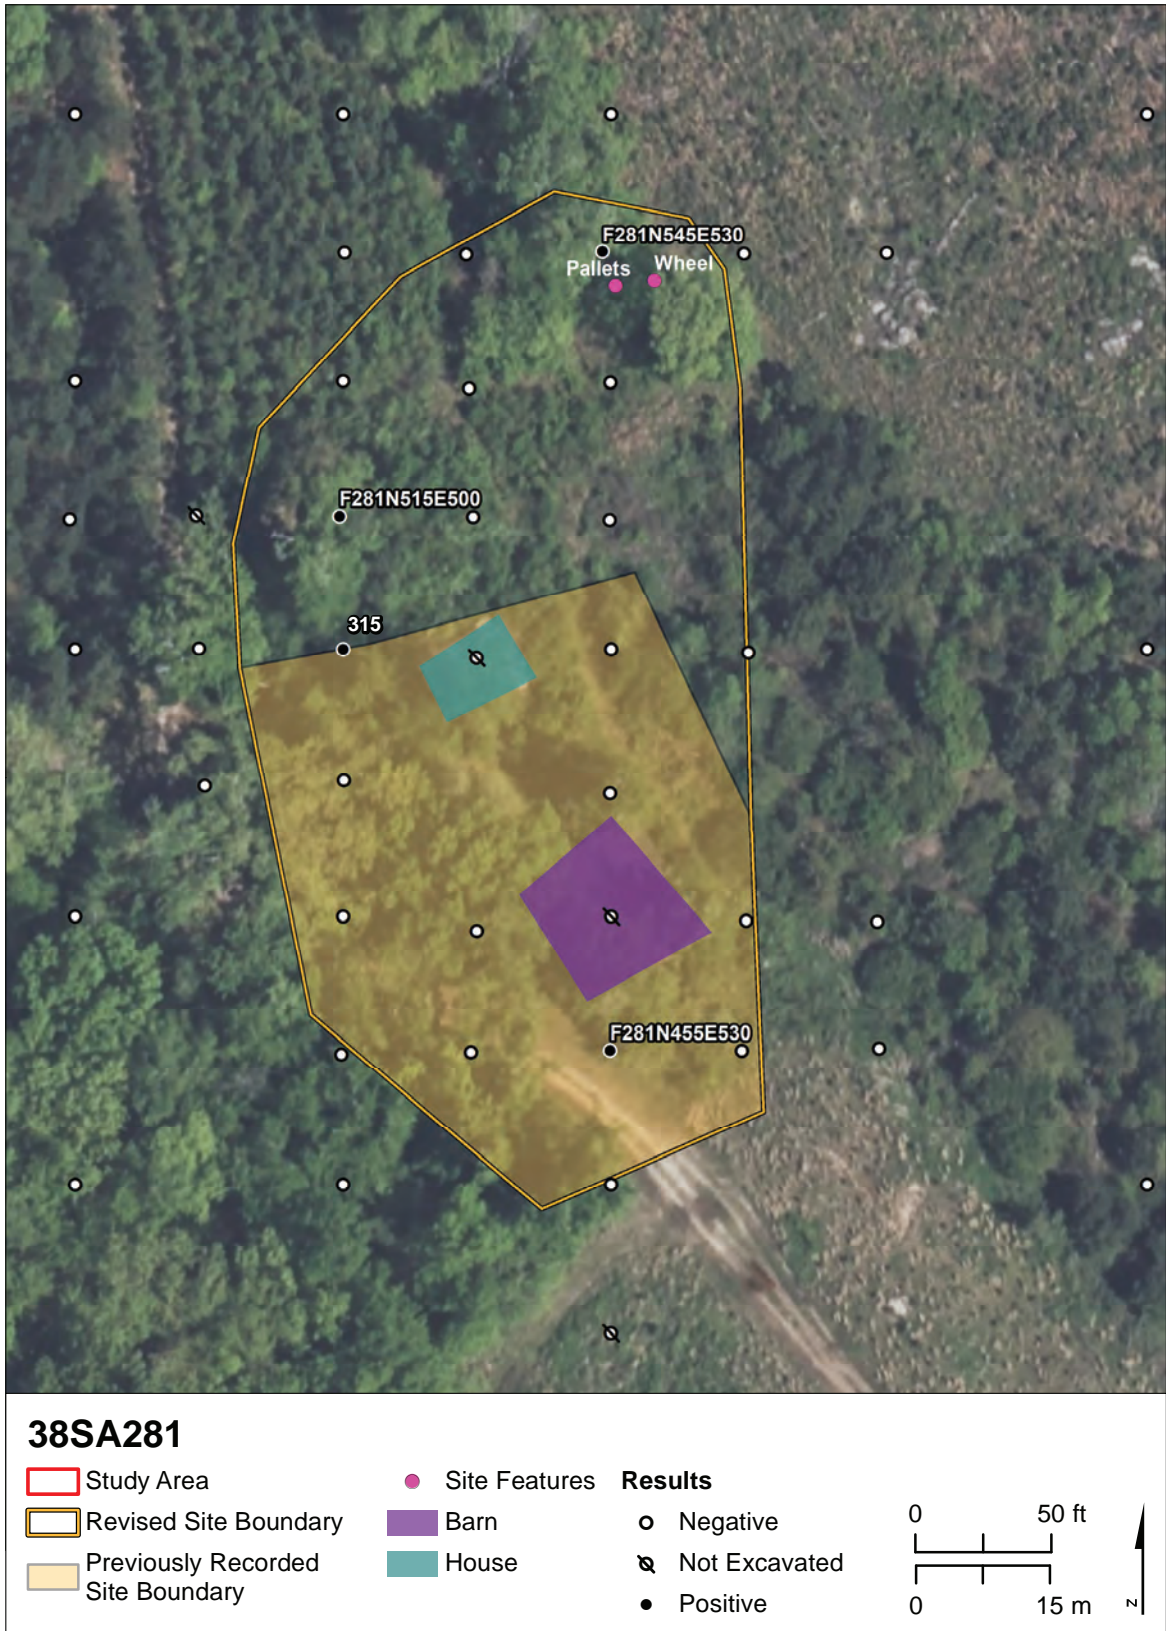
Figure 13.
Map of Site 38SA281

NSA investigated 36 shovel test locations across 38SA281, three of which were positive for cultural material. The site was delineated by close- interval shovel testing on a 15-meter grid, with two delineation tests not excavated due to the house and barn (see Figure 13). No surface scatter

Site 38SA281 is a mid-twentieth century farmstead located in the eastern portion of the project area, and consisting of a frame house, barn, and artifact scatter. The frame house and barn are depicted on the 1964 USGS topographic map as being unoccupied. The site has low artifact density, has been impacted by erosion, and features such as a privy or well were not identified. It is unlikely any features have survived beneath the shallow plow zone. Because the site cannot be associated with any known events or people, it does not contain elements that merit evaluation under NRHP Criteria A and B. Although the site is associated with historic buildings, the frame house is in ruins, and the barn is a common type. Site 38SA281 does not merit evaluation under Criterion C. Additionally, the site is unlikely to provide any significant contributions to the history of Saluda County and is recommended not eligible under Criterion D. Therefore, no additional work is needed for this project.

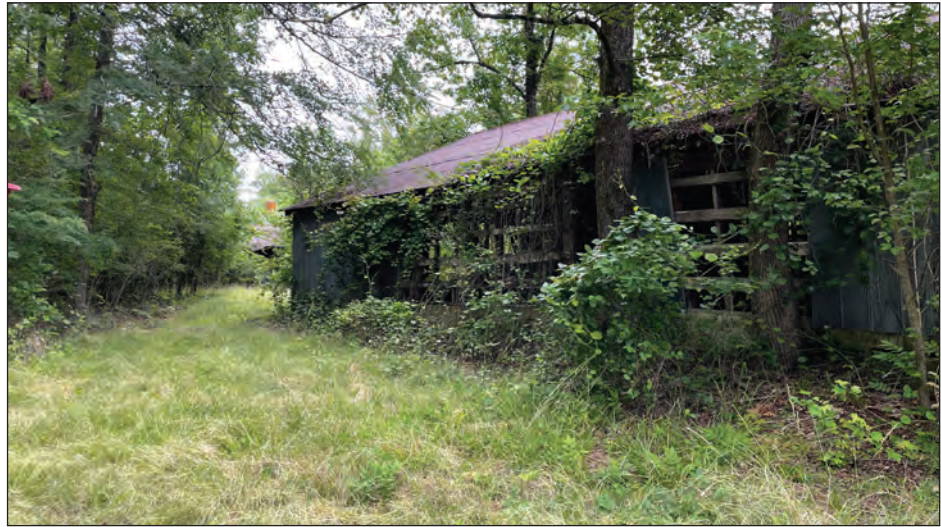
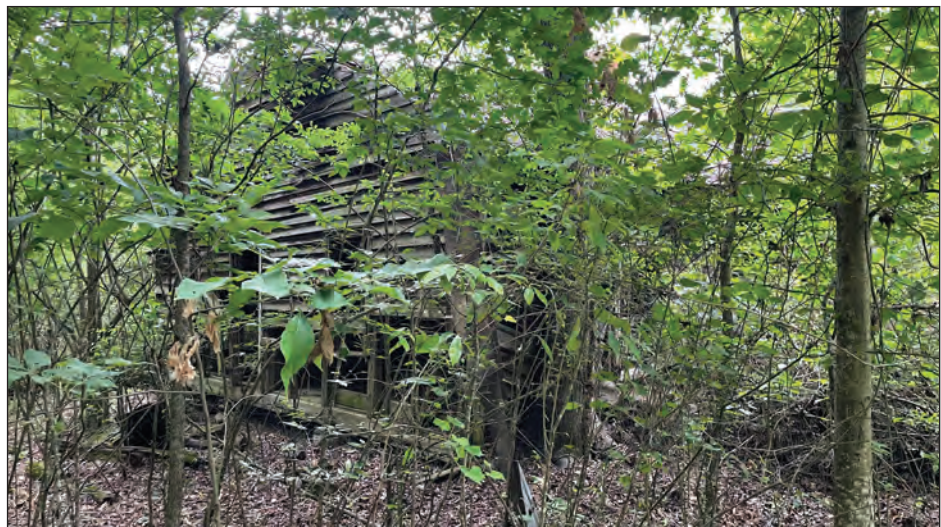
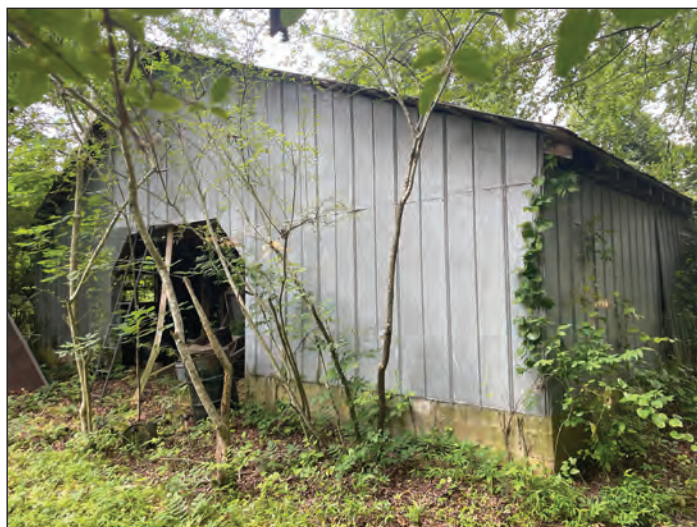
Figure 14.
Photographs of Site 38SA281

Site 38SA281 consists of a small twentieth-century farmhouse and barn located approximately 270 meters west of Double Bridges Road recorded during the March 2023 reconnaissance survey. The site is located at a fork in a dirt road that leads into the property. Based on surface indications and shovel testing, the site is approximately 75 meters north/south by 60 meters east/west (Figure 13). The wood-framed house is in ruins with fieldstone piers and has a modern brick interior chimney. The barn is made of corrugated metal with a cinderblock foundation and contains an old car, firewood, and deer stand materials (Figure 14). The 1939 County Highway Map (Figure 6b; SC Highway and FWA PRA 1939) shows no buildings in this location, indicating that they were constructed after that time. A 1964 USGS map (see Figure 1) shows the buildings as open squares, suggesting that they were vacant at that time. Vegetation at the site consists of young hardwoods and brambles, and disturbances include erosion and access roads construction.

A. Site 38SA281
Overview, Facing
North

B. Frame House,
Southeast, Facing
Southeast

C. Barn, Facing Northeast

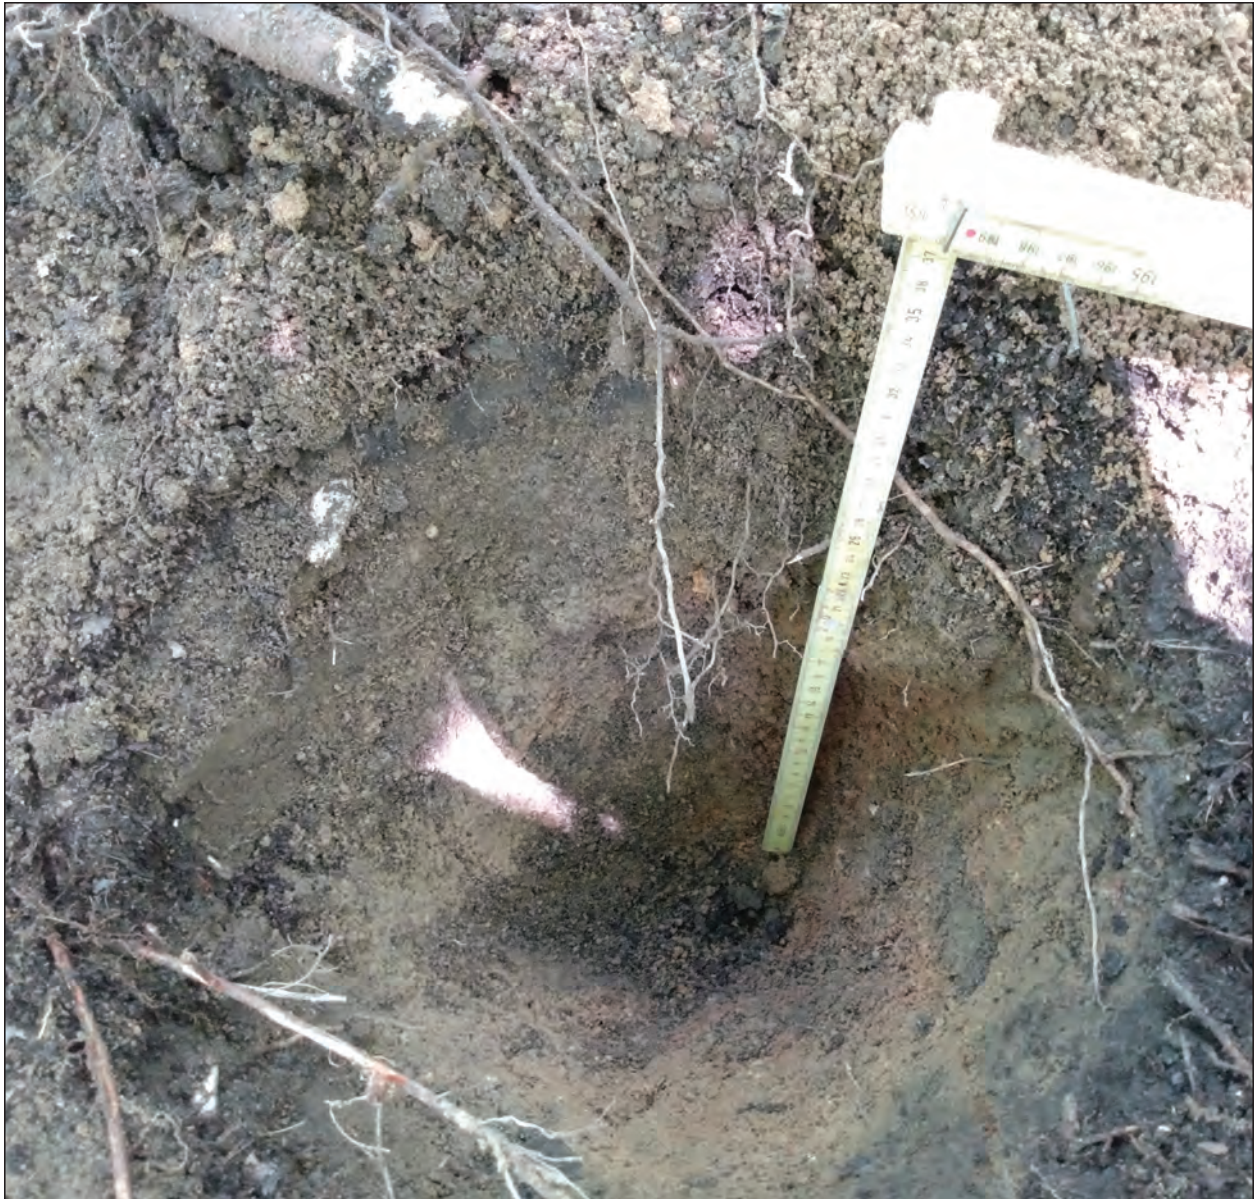
Figure 15.
Shovel Test Profile

was noted. The soils in this location are classified as moderately well drained Helena sandy loam, 2–6 percent slope. Typically, these soils have an Ap horizon of grayish brown (10YR 5/2) sandy loam 4–10 inches thick over light yellowish brown (10YR 6/4) sandy loam, 0–10 inches thick. Subsoil is brownish yellow (10YR 6/6) sandy clay loam. Excavated shovel tests consist of approximately 25 centimeters of grayish brown (10YR 5/2) sandy loam Ap horizon overlying a yellowish brown (10YR 5/4) sandy clay loam to sandy clay. Some shovel tests contained a third horizon consisting of a strong brown (7.5YR 4/6) sandy clay subsoil (Figure 15).

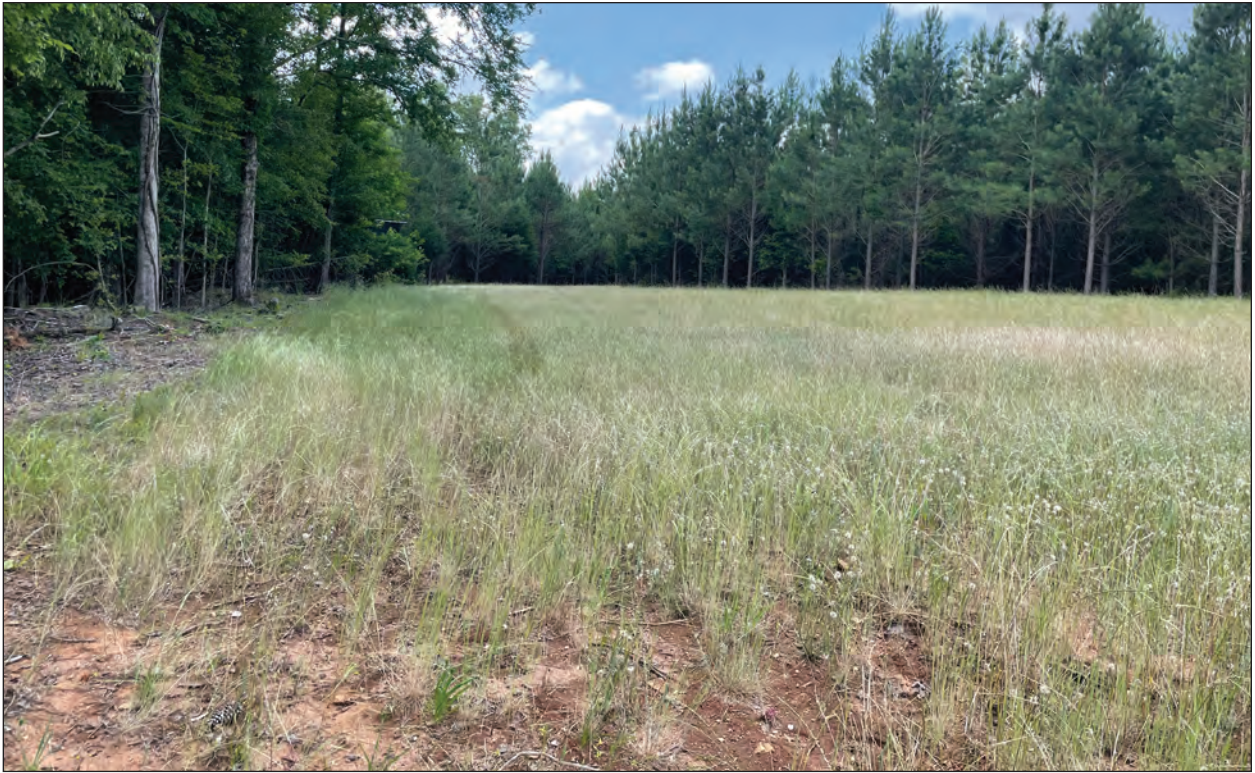
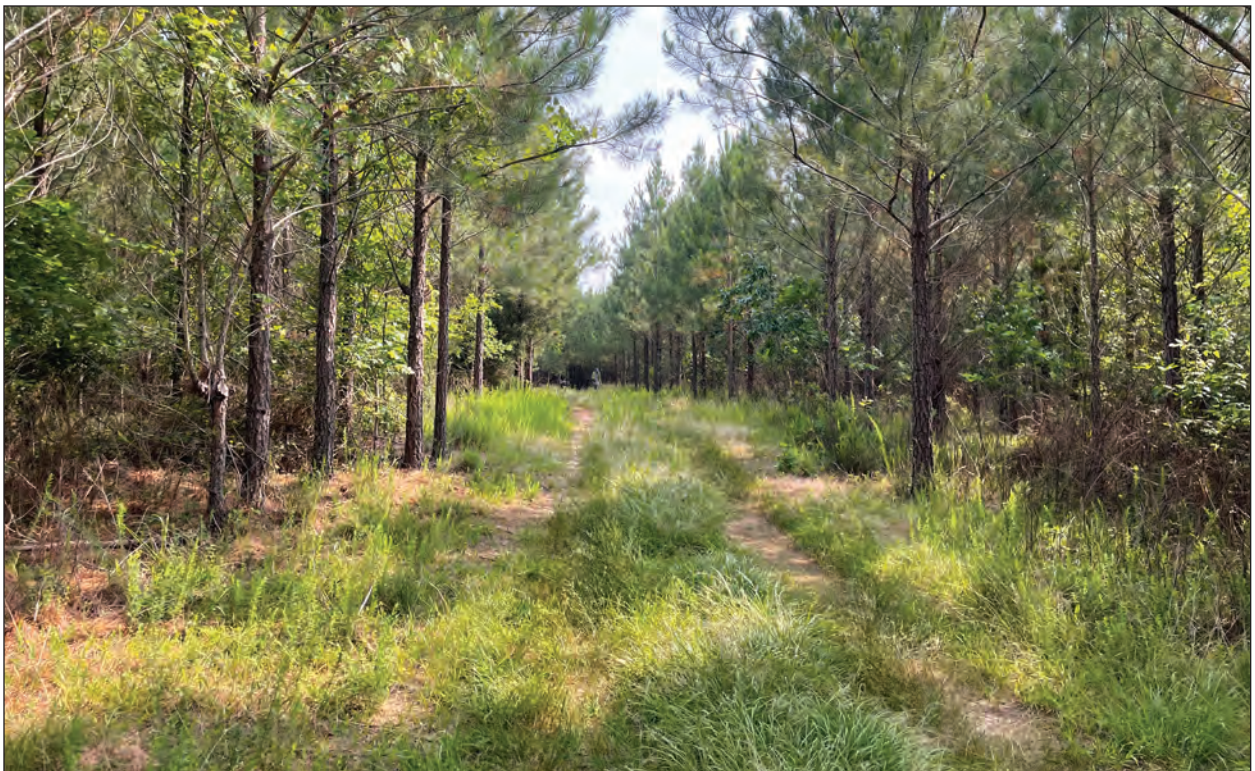
Figure 16.
Photographs of Site 38SA282

Site 38SA282 consists of a large sparse Early Archaic–period quartz lithic scatter identified during the March 2023 reconnaissance. It is located in a ridge saddle on the western side of Flat Rock Branch along a dirt road and in a large food plot where surface visibility was very good (Figure 16). Vegetation at the site consists of short grasses and planted pines, with disturbances including erosion and access road construction.

A. Site from Feed Plot, Facing South

B. Site along Access Road, Facing North

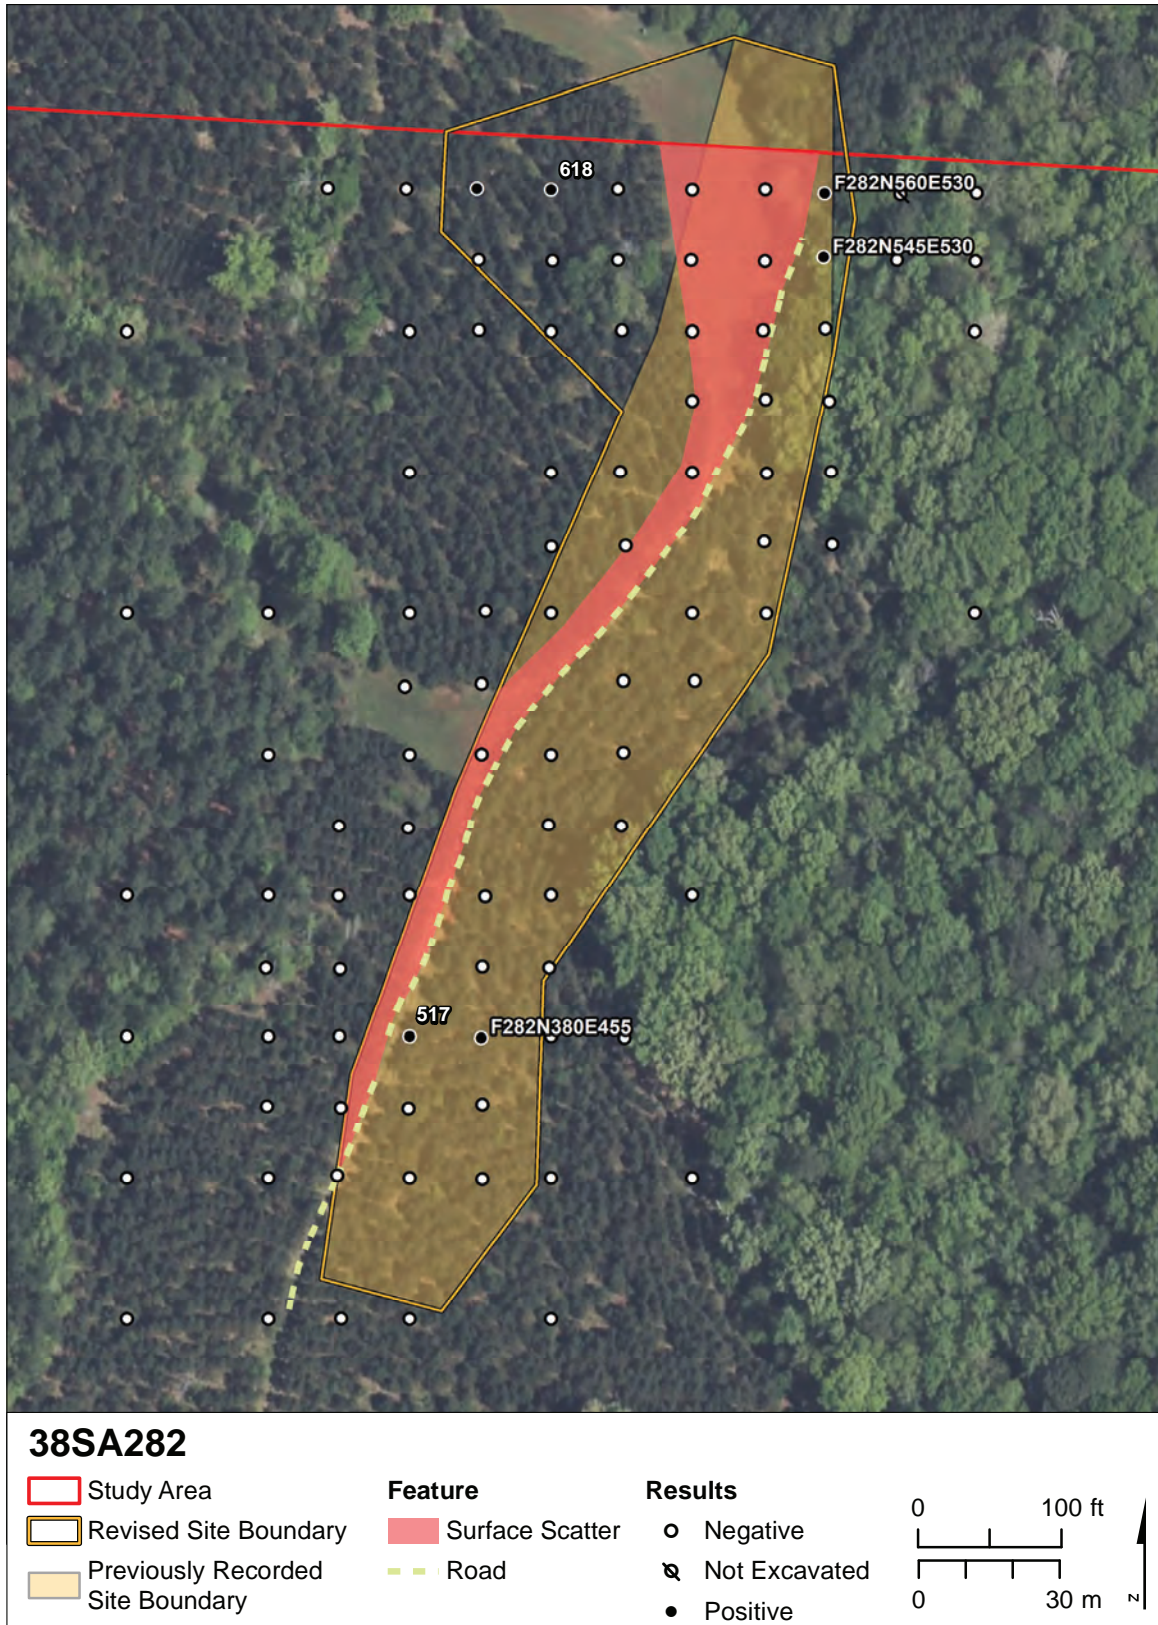
Figure 17.
Map of Site 38SA282

NSA investigated 79 shovel test locations across the site, six of which were positive for cultural material. The access road and feed plot were investigated as a pedestrian survey and a surface scatter was noted. The site was delineated by close-interval shovel testing on a 15-meter grid. Based on surface indications, shovel tests, and landform, the site is approximately 210 meters

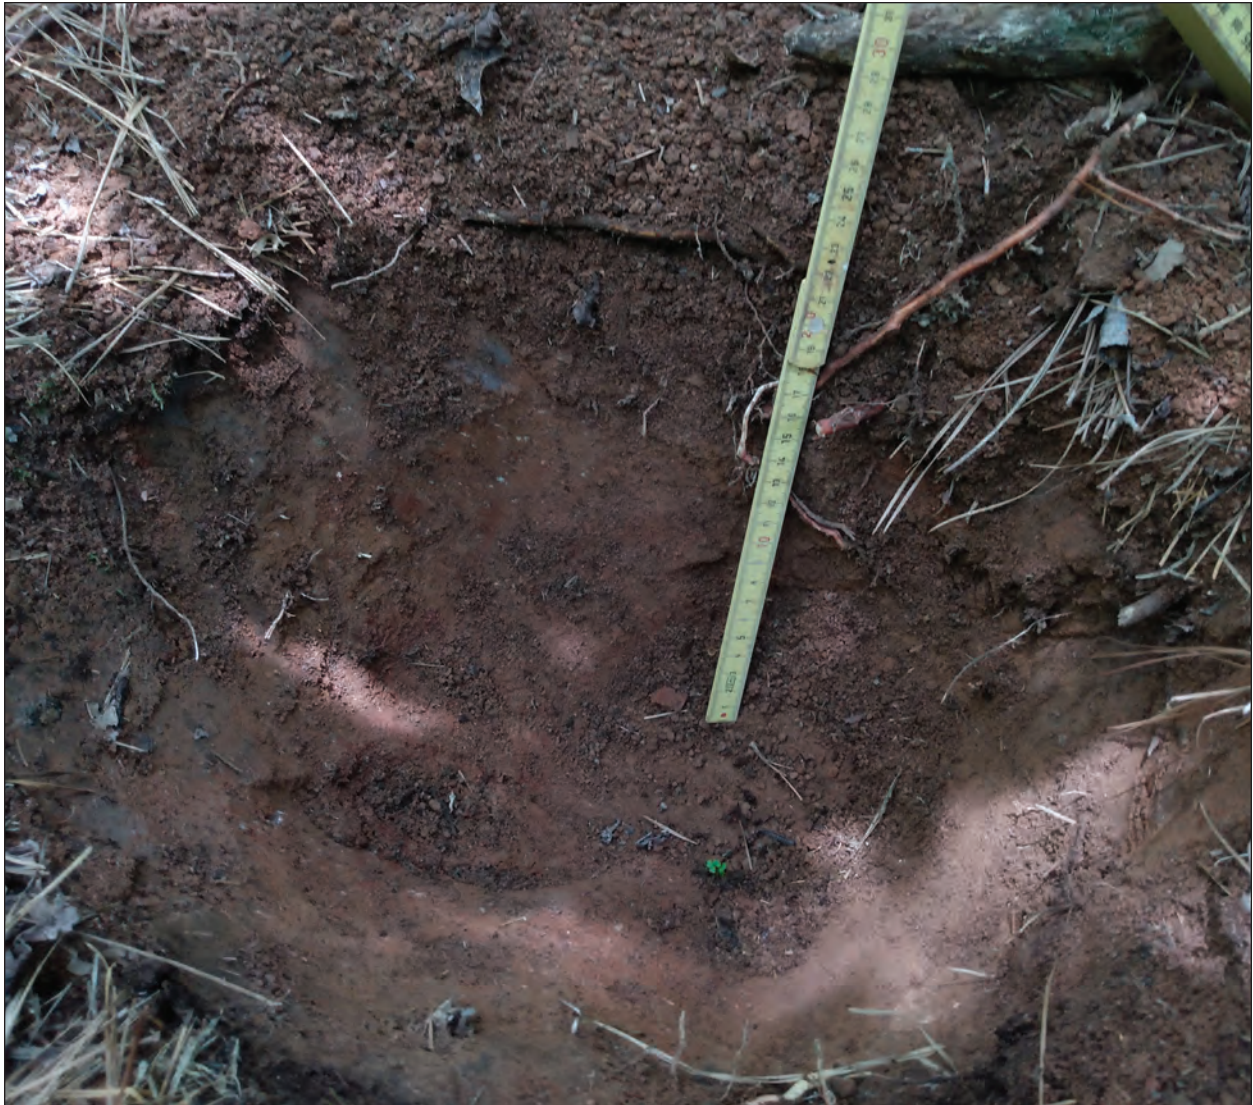
Figure 18.
Shovel Test Profile

north/south by 120 meters east/west (Figure 17). Soils in this location are classified as Cecil clay loam, 2–6 percent slopes, severely eroded. The NRCS lists this soil type as having a clay loam A horizon from 0–13 cm and a clay Bt horizon from 13–136 cm. A typical soil profile consists of approximately 15 centimeters of brown (7.5YR 4/3) sandy loam Ap horizon overlying a yellowish red (5YR 4/6) sandy clay subsoil (Figure 18).

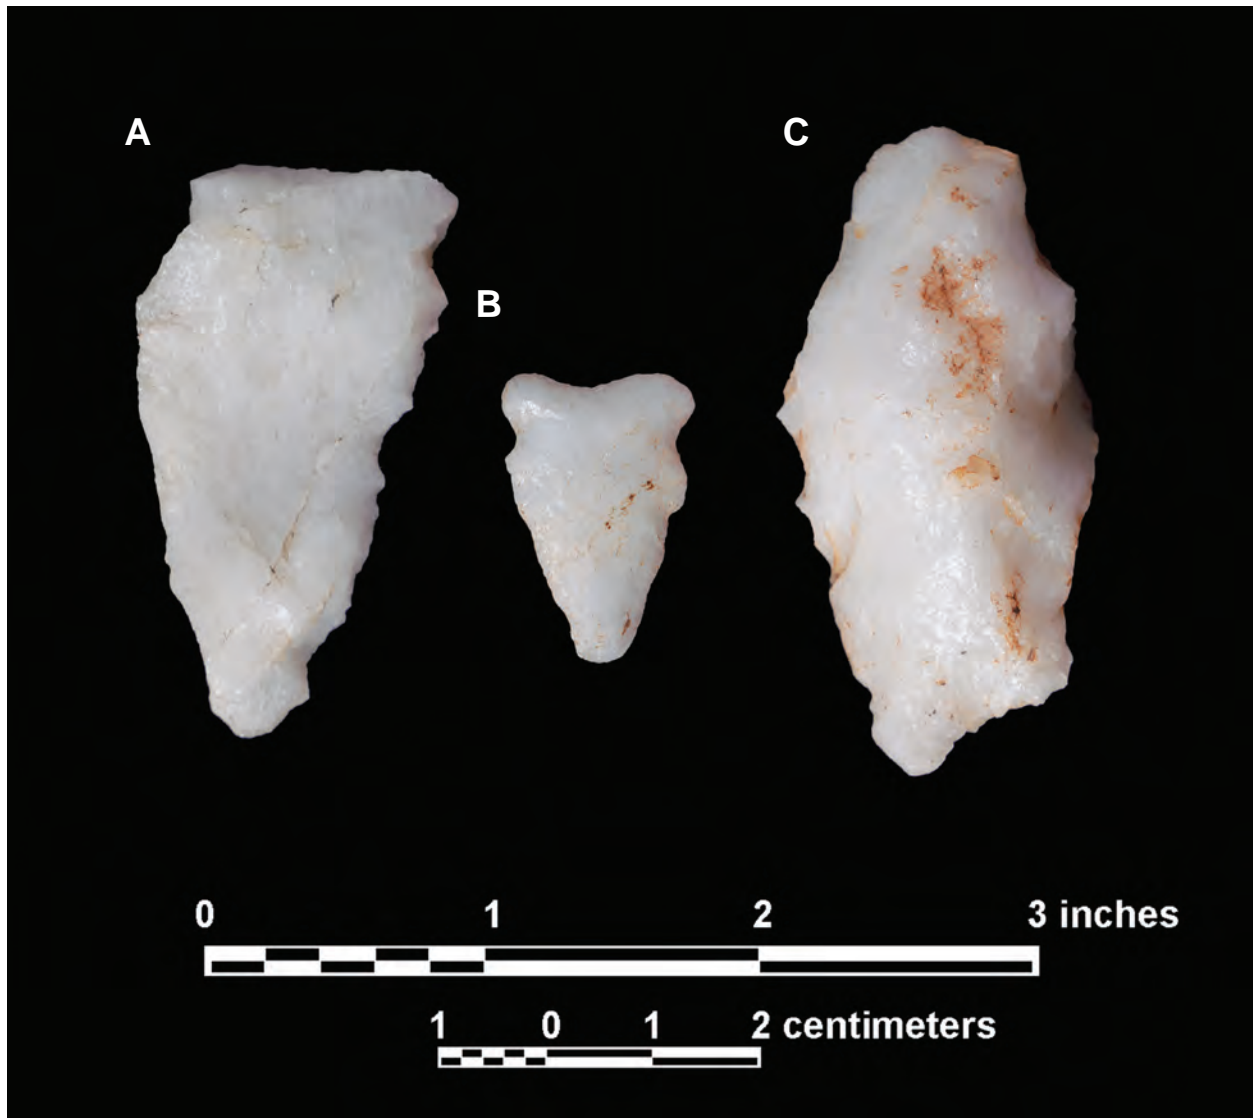
Figure 19.
Quartz Palmer PPK and Bifaces Recovered from Site 38SA282

A. Quartz Biface; B. Quartz Palmer PPK; C. Quartz Biface

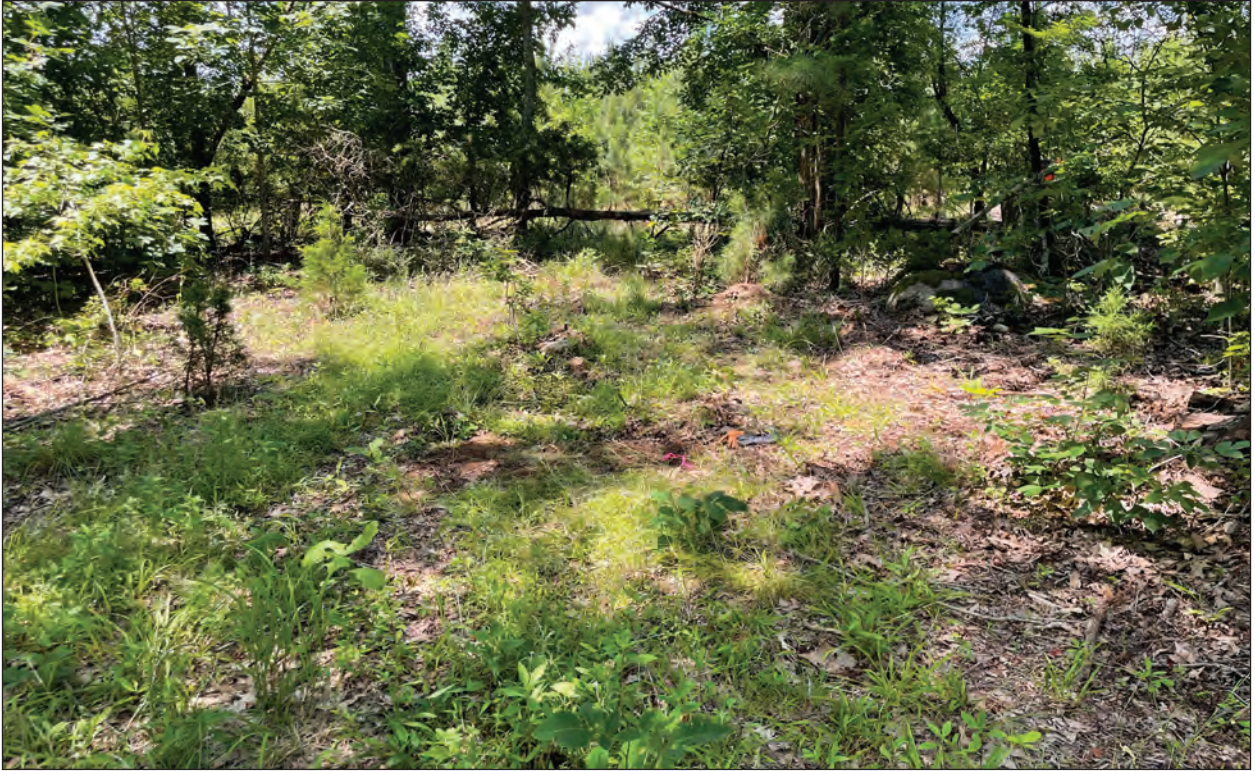
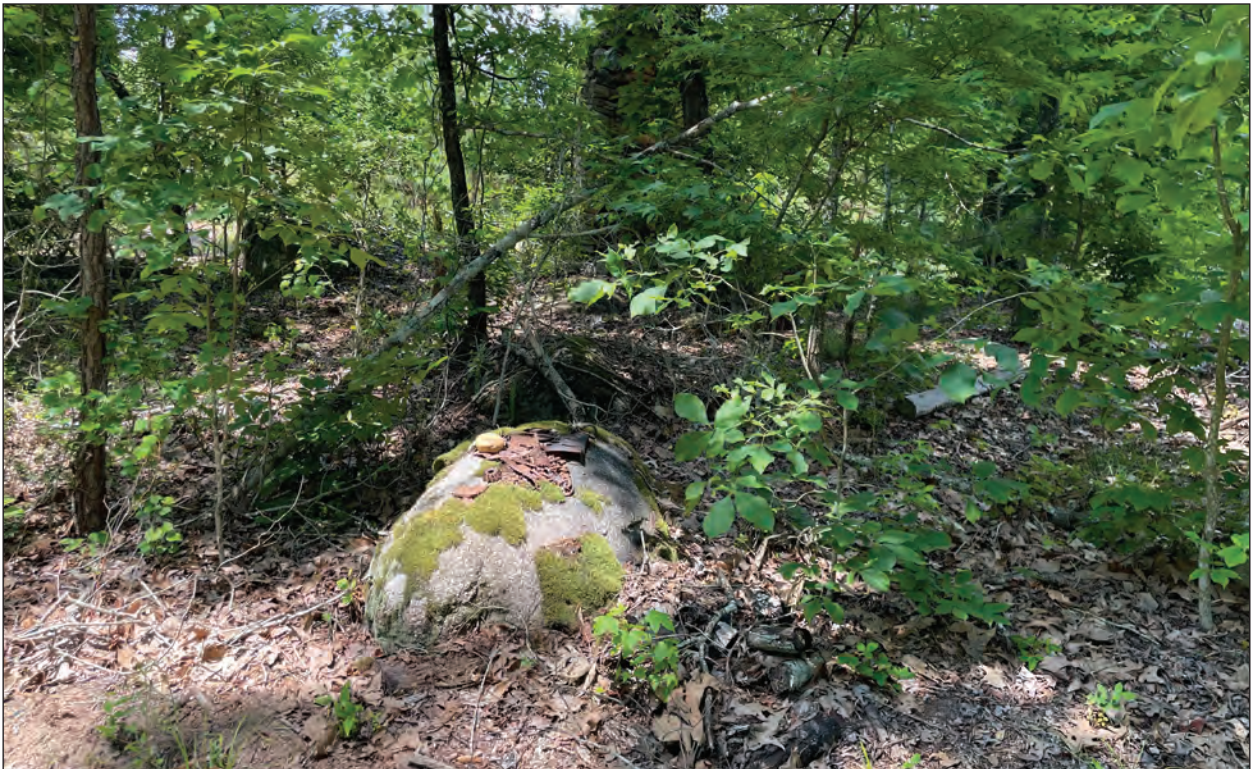
Figure 20.
Conditions at Site 38SA283

A. Facing West

B. Facing North

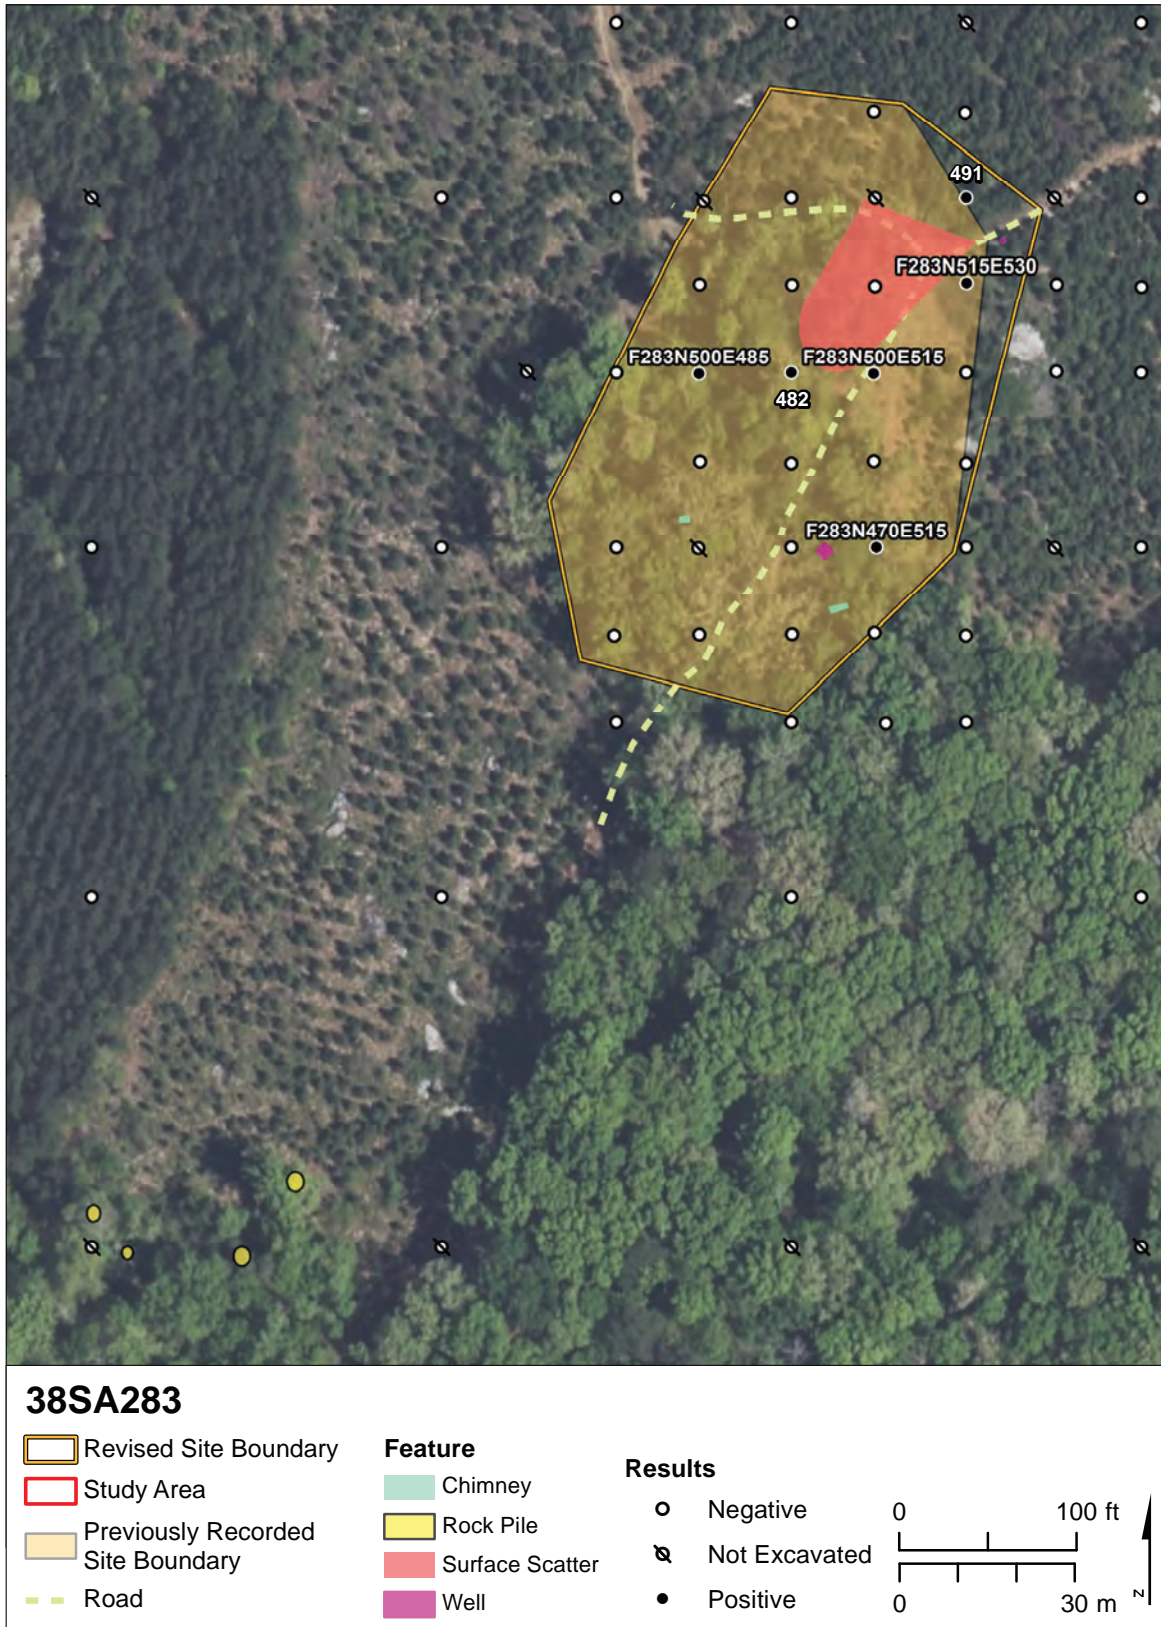
Figure 21.
Map of Site 38SA283 and Adjacent Rock Piles

Site 38SA283 consists of a historic farm settlement, probably dating from the late nineteenth to early twentieth century and was recorded during the March 2023 reconnaissance survey. It is located on a knoll near the center of the tract at the intersection of two access roads. The site was initially identified when a fieldstone chimney was found. Additional surface inspection revealed a second chimney, the base of what may be a third chimney, a fieldstone well, and a sparse surface scatter. Furthermore, it was clear that someone had been metal detecting the site, as there were two piles of iron objects lying adjacent to or on top of above-ground features. The Phase I survey identified a second fieldstone well. This site does not appear on any of the historic maps reviewed. However, given the types of artifacts found, it probably postdates the 1871 Boles Map (Figure 19b), and it was absent by 1939 (Figure 19b; SC Highway and FWA PRA 1939). Vegetation at the site is primarily older growth hardwoods and the site has been impacted by erosion and access road construction (Figure 20). Based on surface indications and shovel testing, the site is approximately 85 meters north/south by 70 meters east/west (Figure 21).

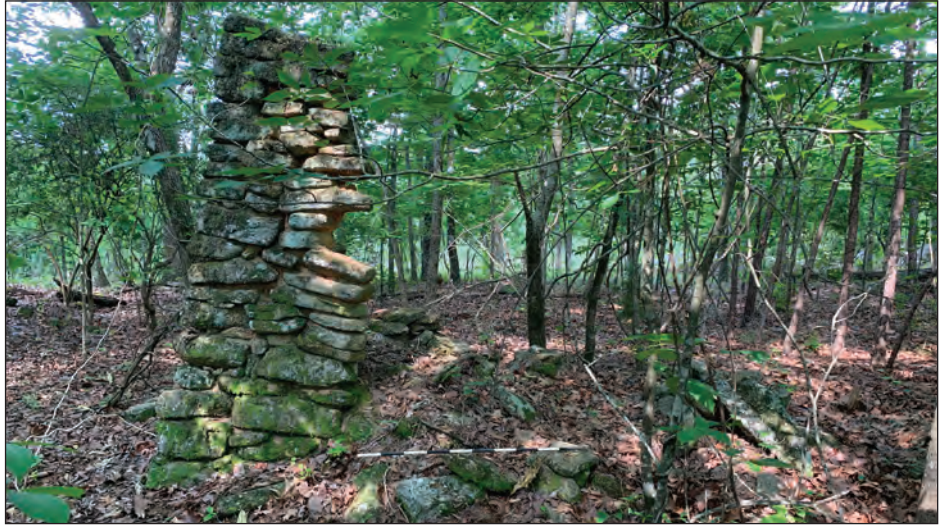
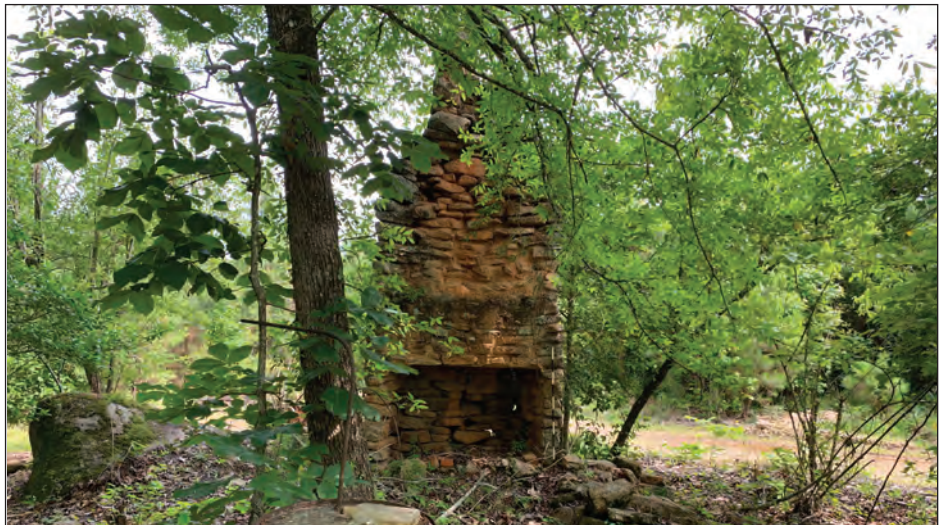
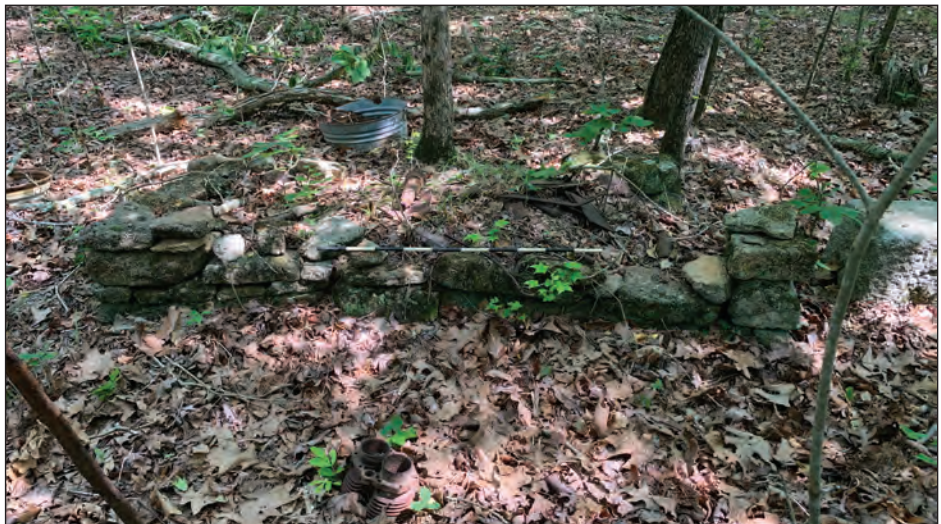
Figure 22.
Features Identified at Site 38SA283, 1 of 2

Chimney 1 is approximately 15 meters west of the access road and located between STPs 450 and 451. It measures 1.7 meters north/south by 1.5 meters east/west, with rubble extending an additional five meters by 2.8 meters. The chimney is constructed of fieldstone and its remaining height is roughly two meters. Chimney 2 is located approximately 55 meters to the north, at the intersection of two access roads. The base of this fieldstone feature measures 80 centimeters north/south by three meters east/west, and it extends roughly 3.5 meters high. A rubble field extends an additional 1.5 meters south of the chimney base. The possible chimney base is located in the southern portion of the site, approximately five meters east of the access road. It is constructed of fieldstone and is rectangular in shape, measuring 1.10 meters north/south by 2.5 meters east/west and is 30 cm high. A granite block with six drill holes is located immediately to the west, and scrap metal surrounds the feature (Figure 22).

A. Chimney 1,
Facing West

B. Chimney 2,
Facing North

C. Possible
Chimney, Facing
North

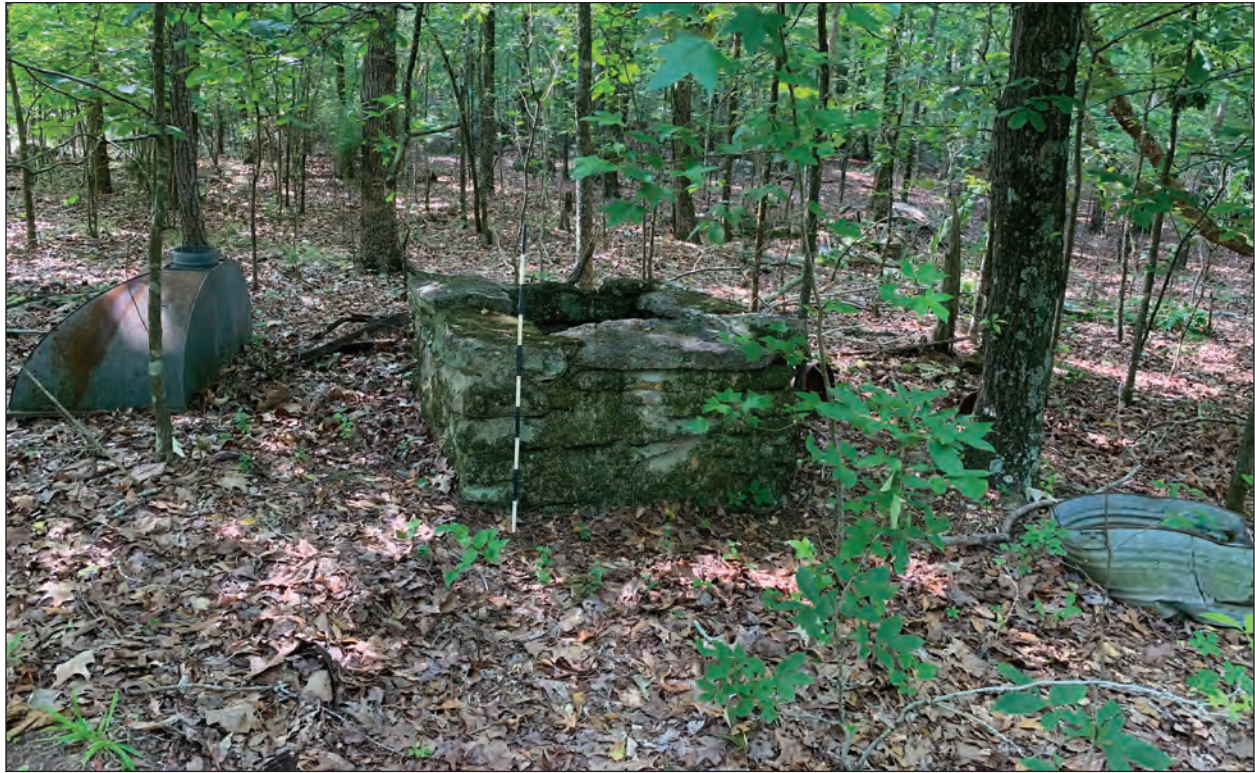
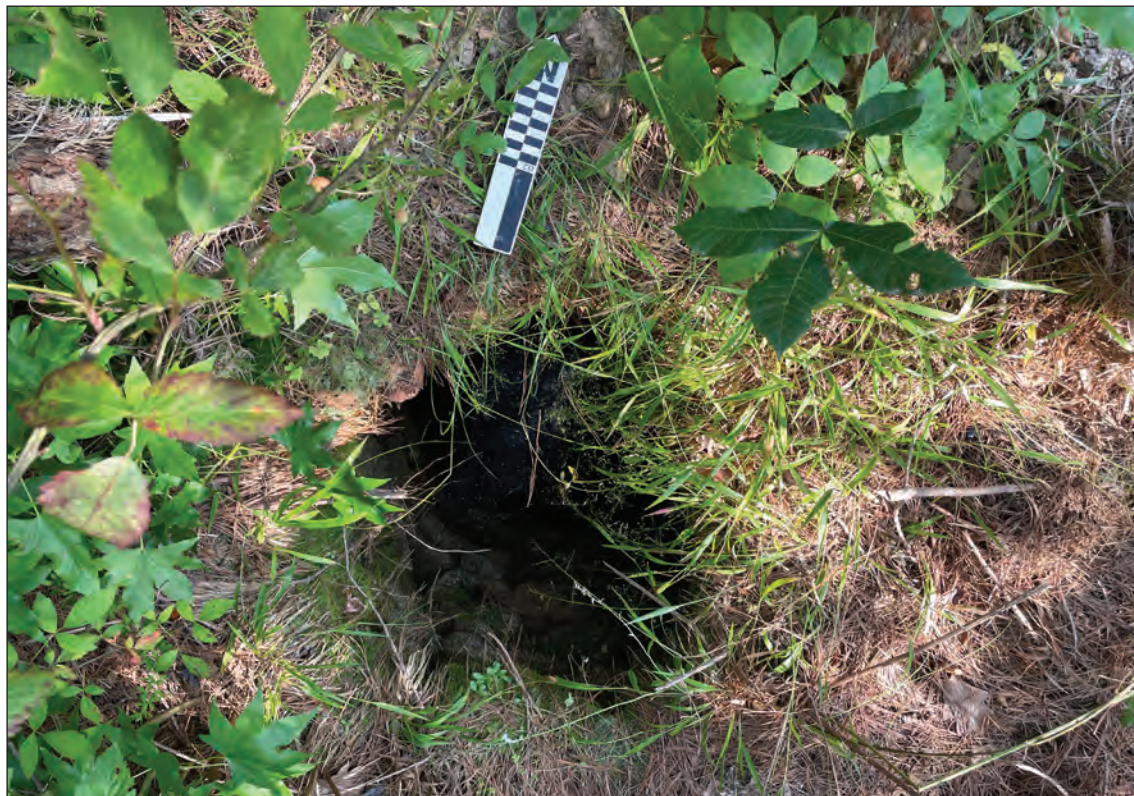
Figure 23.
Features Identified at Site 38SA283, 2 of 2

A. Well 1, Facing East

B. Well 2, Facing East
