PHASE I CULTURAL RESOURCES SURVEY

OF THE LUCK SALUDA SITE

Saluda County,
South Carolina

August 7, 2023 • Revised **Draft Report**
New South Associates Technical Report 4500

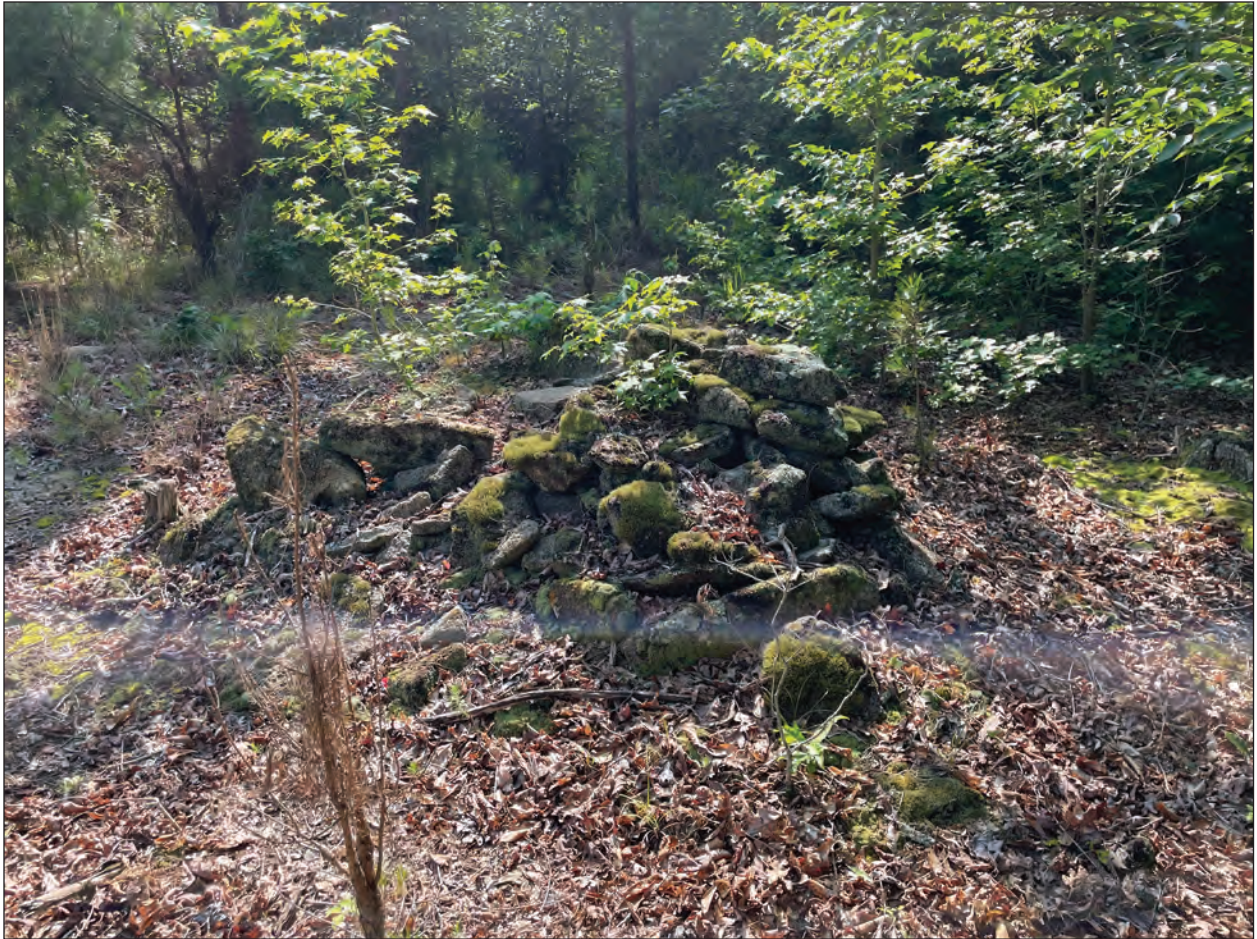
Figure 24.
Rock Pile Southwest of Site 38SA283, Facing East

Although not recorded as part of this site or as its own site, a cluster of three stone piles is located downslope, approximately 110 meters southwest of the site. An example of one of these piles is shown in Figure 24. They overlook a small flowing spring. While the property is covered with uncountable rock outcrops, these appeared to have been made by people. Their location here makes sense in relation to Site 38SA283, as it could be that when the settlement was first constructed, an attempt was made to rid the immediate area of movable stone so that the houses could be built. Given this complex of buildings and features, the site is likely a tenant farming settlement.

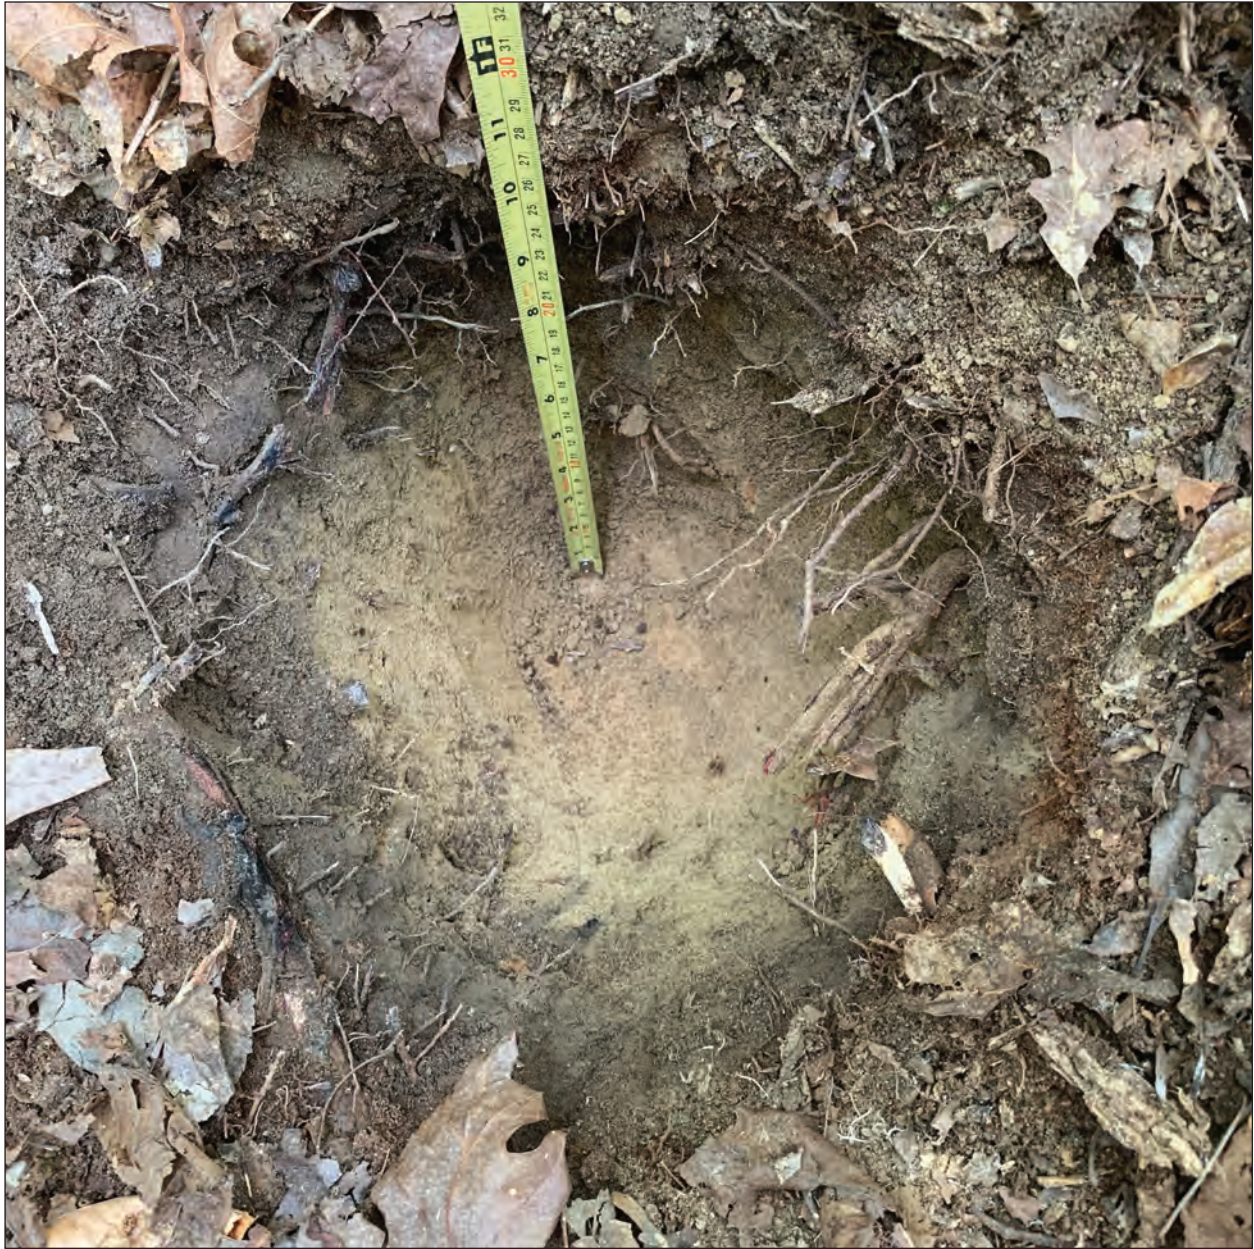
Figure 25.
Shovel Test Profile

NSA investigated 35 shovel test locations across the site, of which five were positive for cultural material. An additional four judgmental shovel tests were excavated approximately three meters downslope from the rock piles mentioned above; the four shovel tests were all negative for cultural material. The site was delineated by close-interval shovel tests on a 15-meter grid, with five shovel tests not excavated due to slope greater than 15 degrees, access roads, or aboveground features. Soils in this location are classified as Appling sandy loam, 6–10 percent slopes, eroded. The NRCS describes this soil series as having a sandy loam Ap horizon from 0–13 cm, a clay Bt horizon from 13–81 cm, and a BC horizon from 81–122 cmbs. A typical soil profile at the site consists of approximately 20 centimeters of yellowish brown (10YR 5/6) Ap horizon overlying a reddish brown (2.5YR 4/3) sandy clay subsoil (Figure 25).

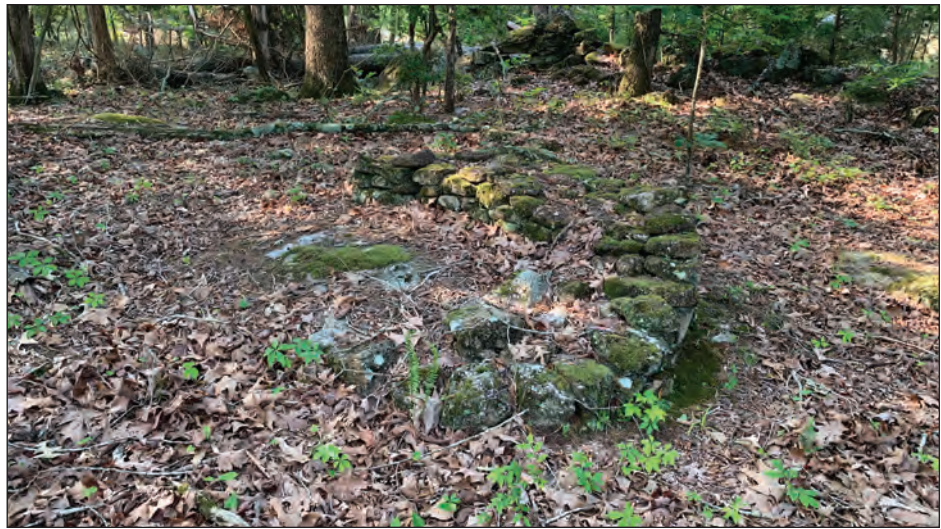
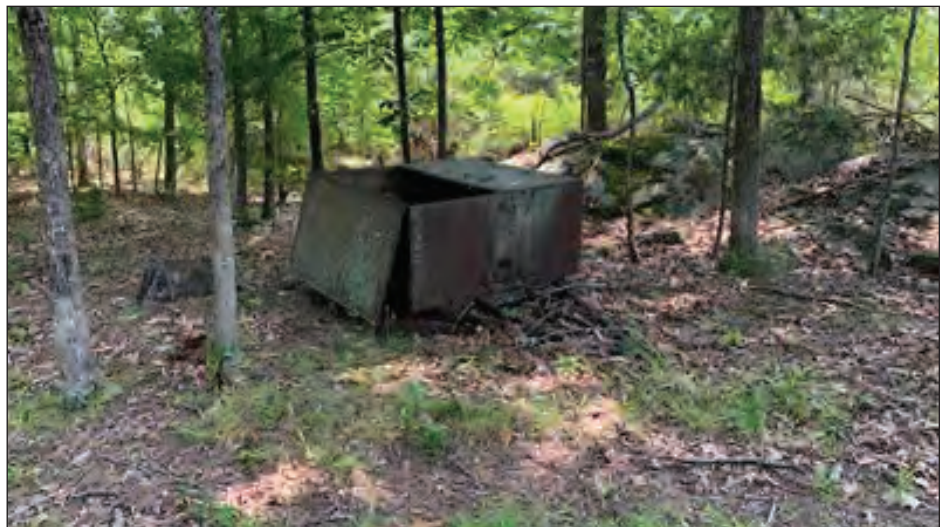
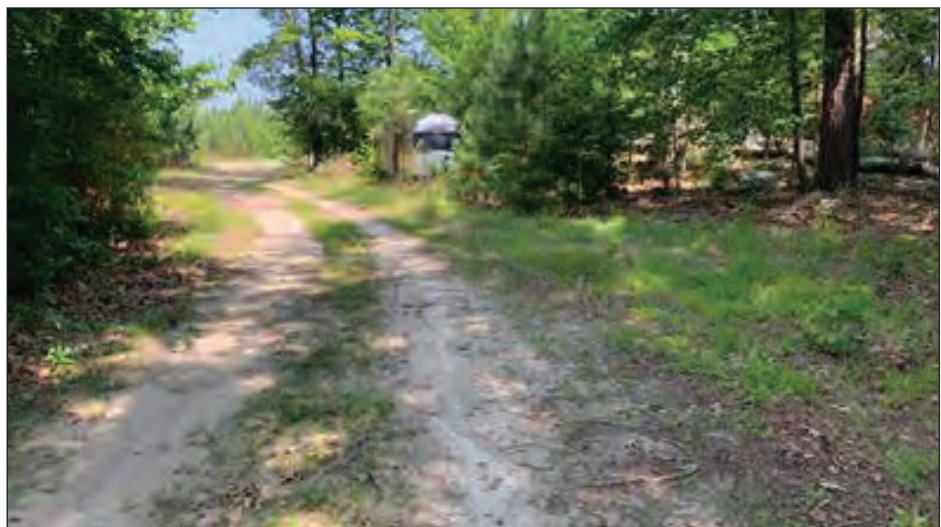
Figure 27.
Conditions and Features at Site 38SA284

Site 38SA284 was initially identified due to the presence of a possible fire pit feature near STP 590 in the northeastern portion of the project area. The fieldstone feature, measuring approximately 1.5 m in length by 30 cm wide by 60 cm high, is located on a rock outcrop along an access road, and a surface scatter extends approximately 20 meters along this road (Figure 26). Metal debris and a metal box on a bumper trailer were noted to the east of the rock outcrop and feature. Vegetation consists of hardwood trees and grass, and surface visibility along the access road was 100 percent. Disturbances to the site include erosion and access road construction (Figure 27).

A. Possible Fire Pit,
Facing Southeast

B. Metal Box and
Trailer, Facing North

C. Surface Scatter
and Conditions,
Facing Northwest

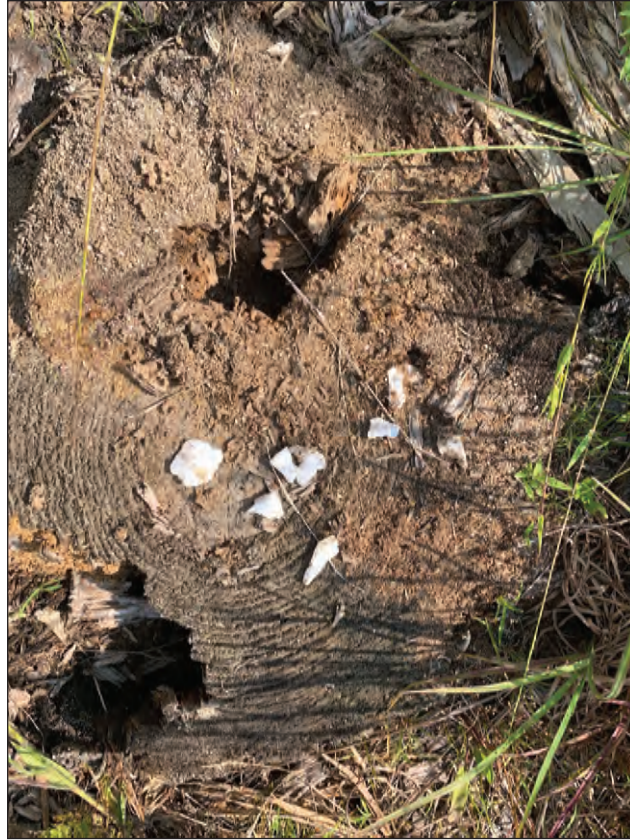
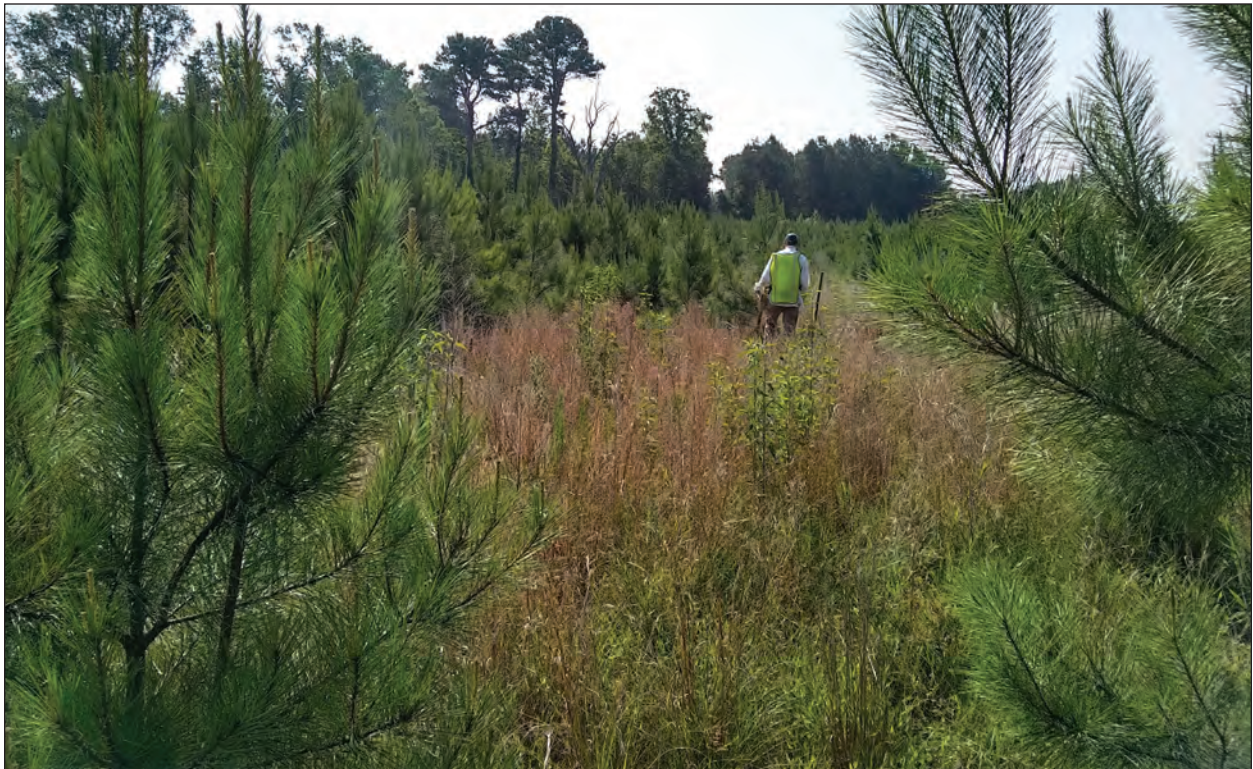
Figure 29.
Conditions at Site 38SA285

A. Flakes on
Tree Stump

B. Old Access Road and Vegetation, Facing Southeast

Site 38SA285 is a Precontact lithic scatter of undetermined age. All artifacts were recovered from the surface of the site, and it has been impacted by looters. Shovel tests exhibited eroded soils and it is unlikely intact subsurface features are present. Absence of temporally diagnostic artifacts, a small artifact assemblage, and no subsurface artifacts limit the site's research value. NSA recommends Site 38SA285 not eligible for the NRHP, and no further work is needed.

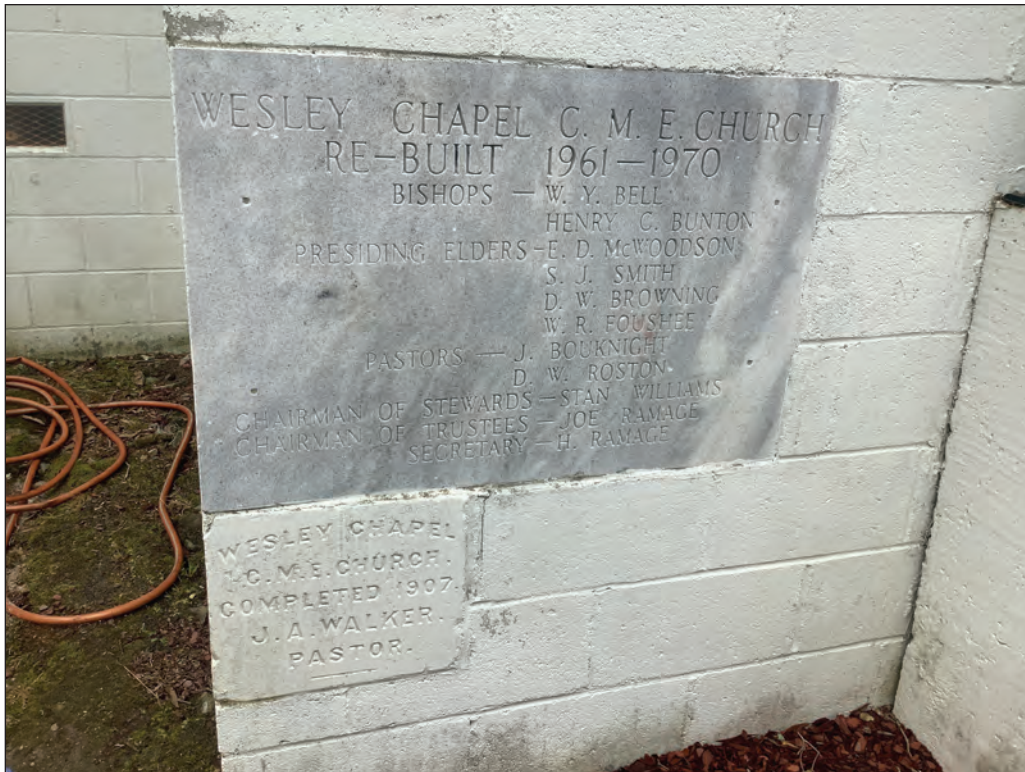
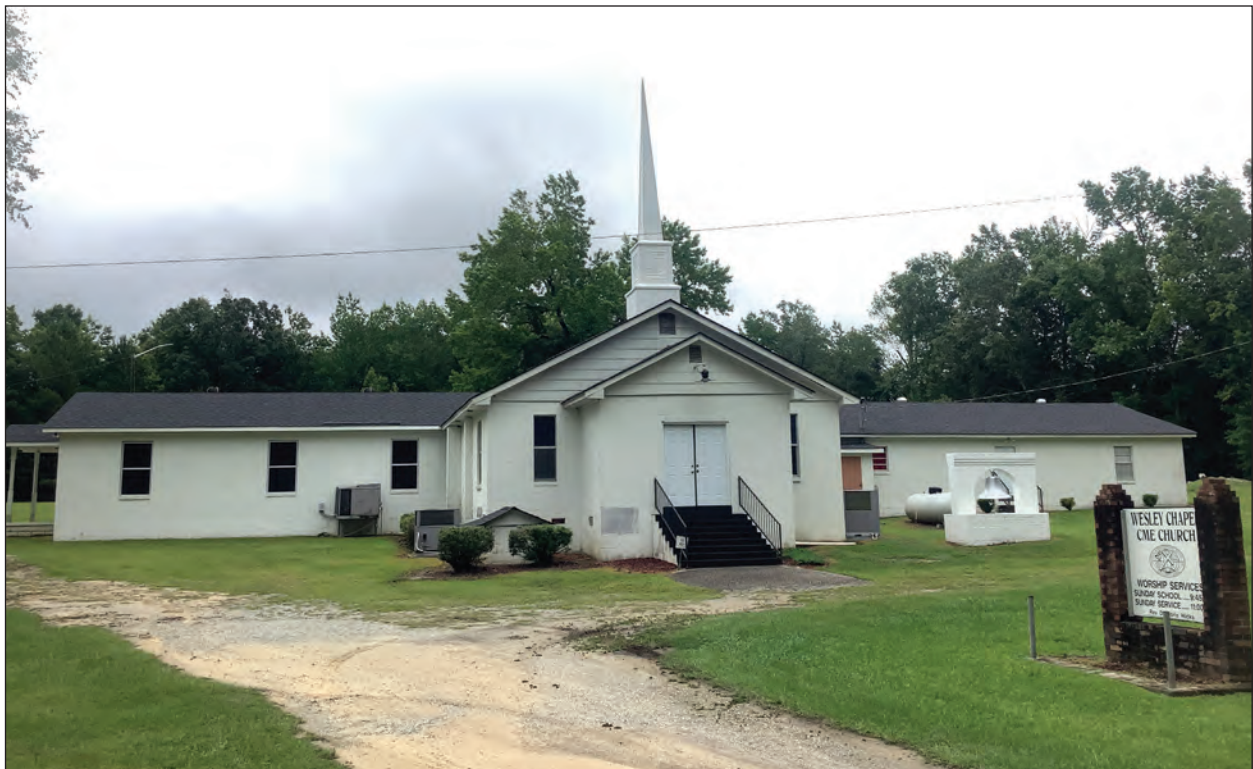
Figure 32.
Resource 0053: Wesley Chapel C.M.E Church

Steps lead to a gabled, double door entry. A steeple sits on the front gable roof. South of the front entrance is a brick bell stand. On the north elevation of the church, there is a gabled portico supported by turned wood posts and rests on a raised concrete block foundation. A well house is approximately 10 feet north of the front steps. It also has a front gabled roof and is of concrete block construction (see Figure 32B). Between the historic core and the south wing, there is a small, shed roof projection with a solid metal door. In the middle of the south wing, there is a secondary entrance (Figure 33).

A. Church Corner Stone

B. Wesley Chapel C.M.E Church, Facing East

Resource 0053 is located approximately 95 feet east of Double Bridges Road and east of the proposed site. The resource is on a tract of flat land. Resource 0053.01 shares this parcel. This church is not a distinctive or noteworthy example of this church type which is common in South Carolina. Alterations to the church, including two additions and the replacement of some two-over-two metal sash windows, have diminished its integrity of design, materials, and workmanship. Additionally, it does not embody distinctive characteristics of a type, period, or method of construction, nor does it represent the work of a master or possess high artistic value. It is not known to be associated with events or persons significant in the past. Therefore, the resource is recommended as not individually eligible for the NRHP under Criteria A, B, or C.

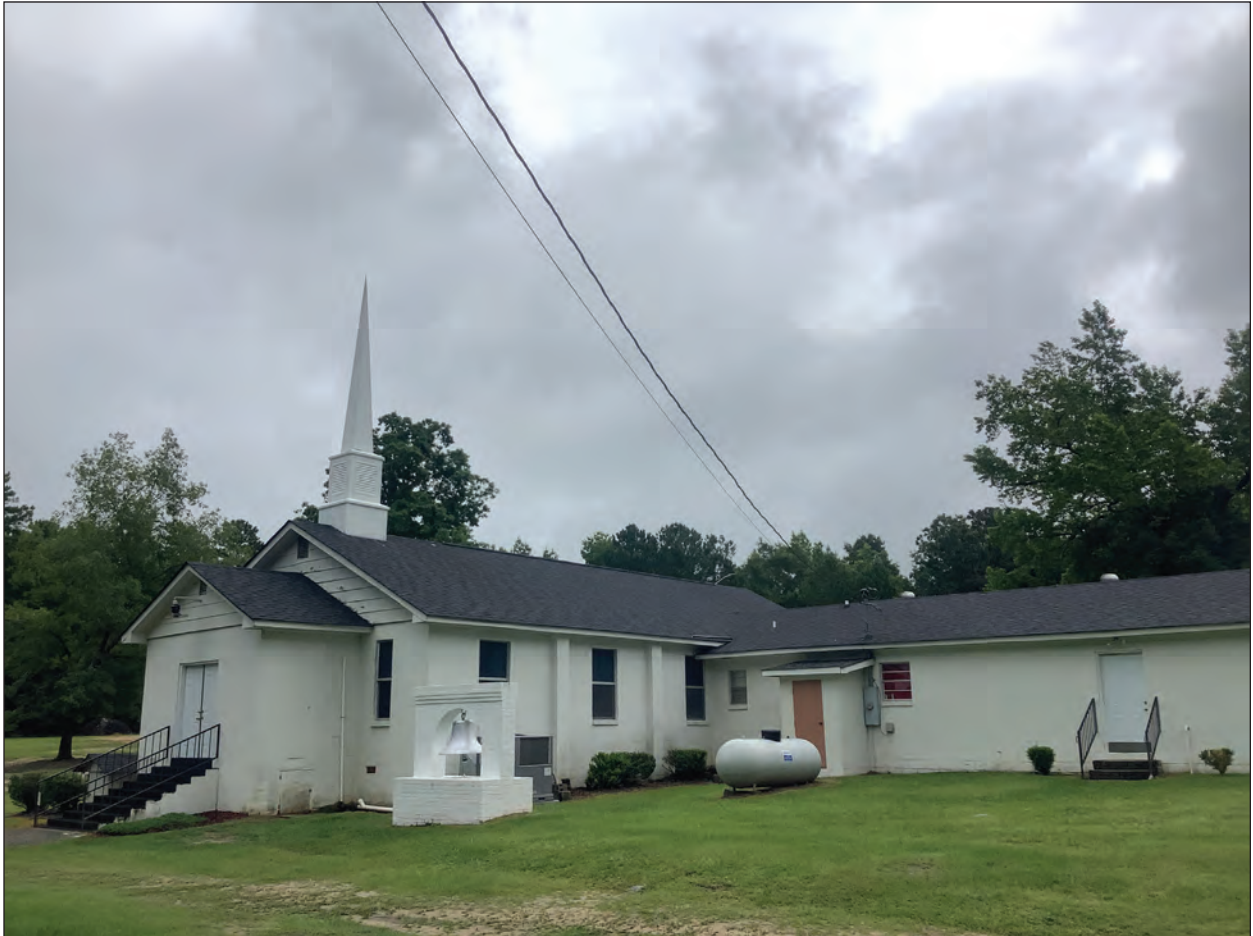
Figure 33.
Resource 0053: Historic Core and South Wing of Church, Facing Northeast

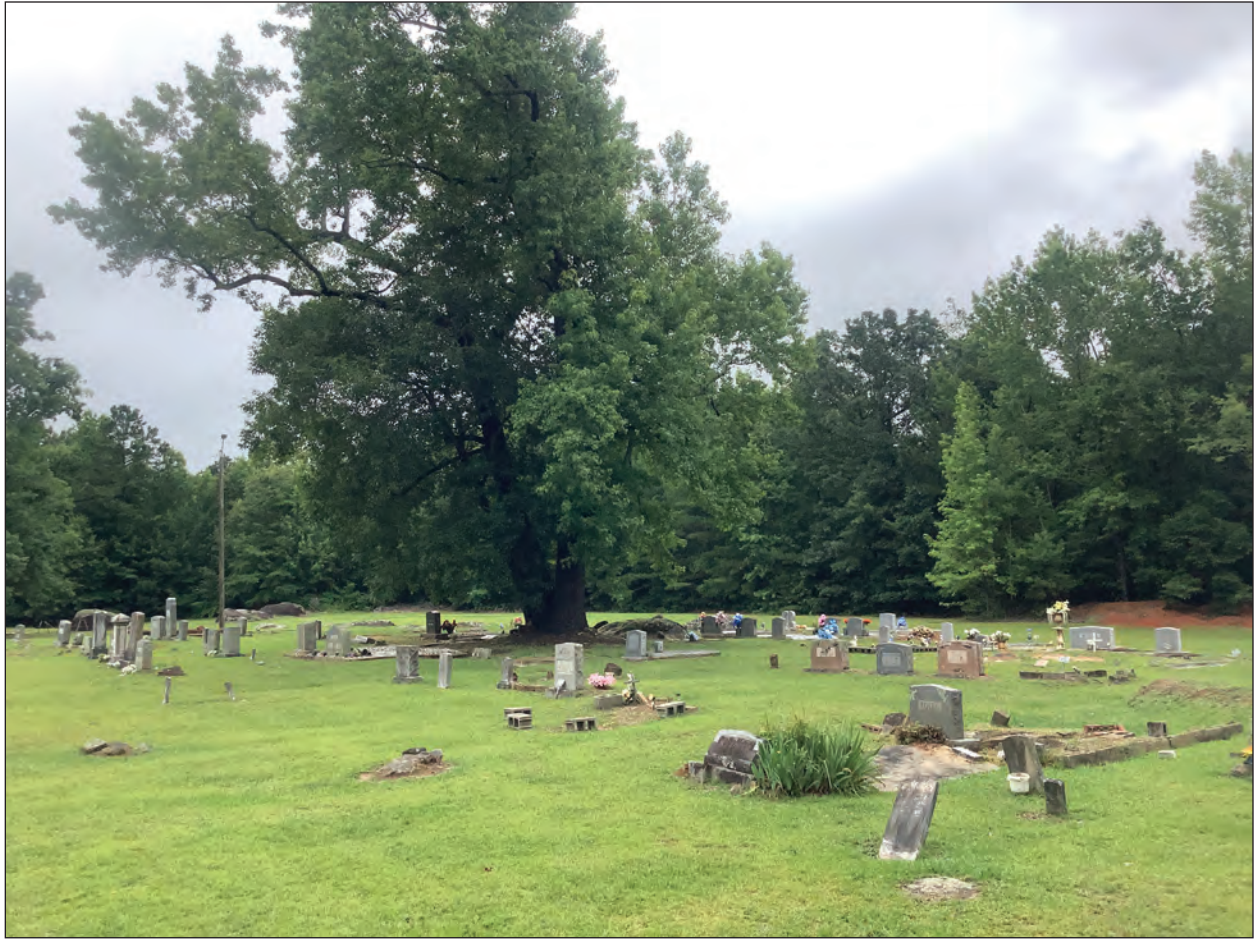
Figure 34.
Resource 0053.01: Wesley Chapel Church Cemetery

Resource 0053.01 is located approximately 120 feet east of Double Bridges Road and approximately 20 feet east of Resource 0053, Wesley Chapel C.M.E. Church. The resource is on a tract of flat land. Resource 0053.01 is not a noteworthy or distinctive example of a nineteenth-century church cemetery and does not represent the work of a master or possess high artistic value. It is not affiliated with persons of historical importance and does not contain the graves of any significant person. It is not known to be associated with a significant historic event. Therefore, the resource is recommended as not eligible for inclusion on the NRHP under Criterion A, B, or C.

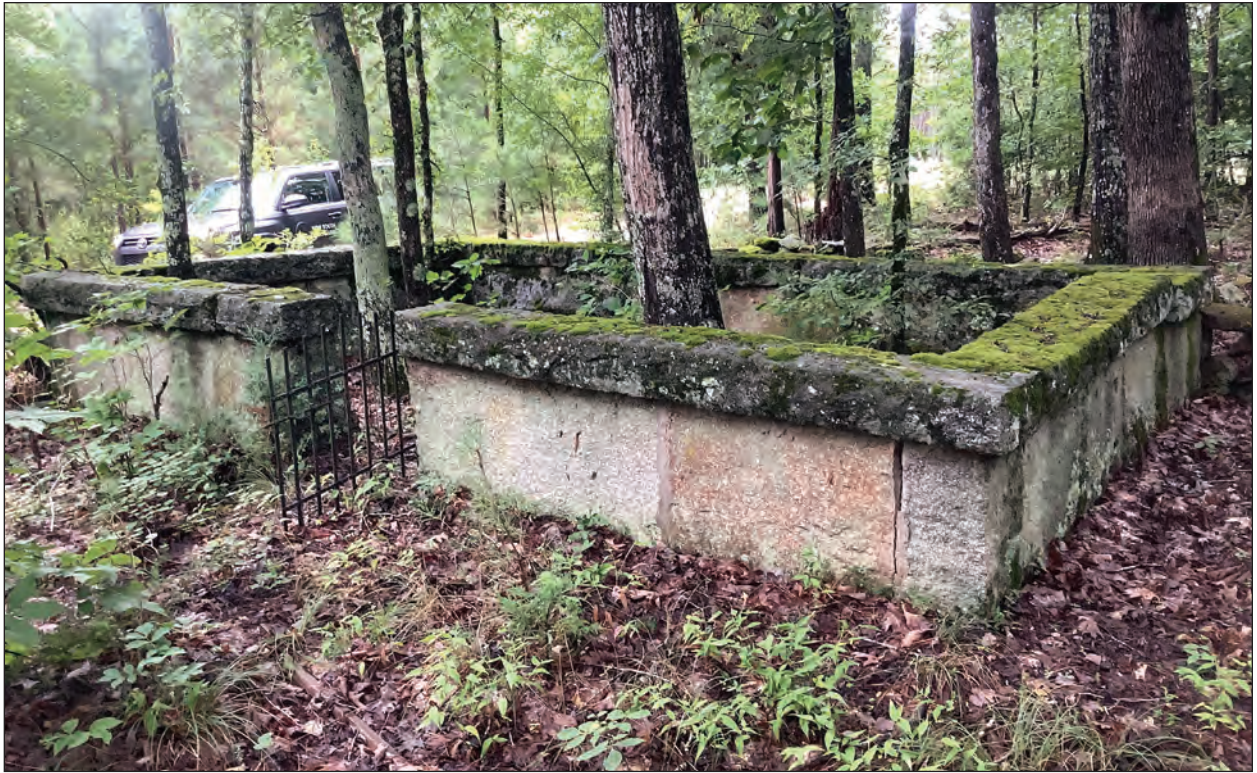
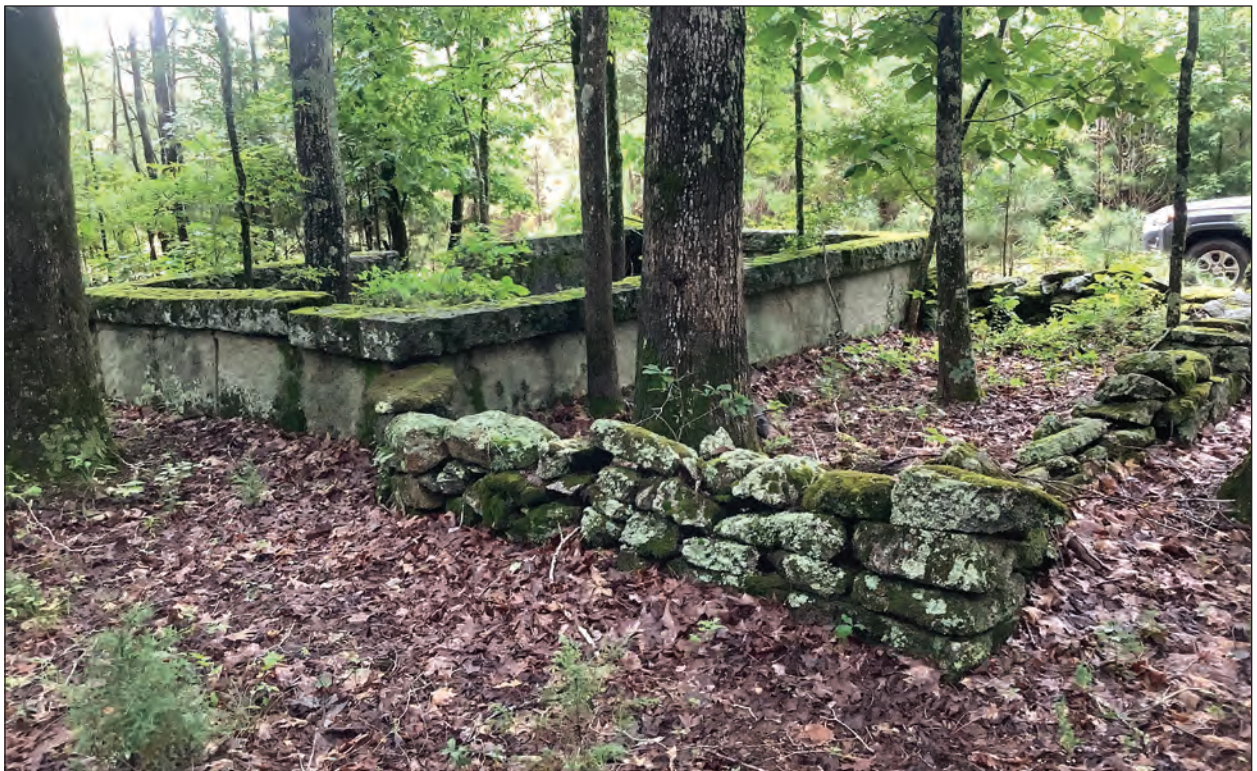
Figure 35.
Resource 0054: Prater Cemetery

Resource 0054 is the Prater Cemetery, located about 0.5 miles west of Double Bridges Road. The date of origin is unknown, but it first appears in a 1962 aerial photograph. This burial site is comprised of two enclosures. The main enclosure is made of cut stone walls with a cut stone trim. It has an iron gate leading into the enclosure. Only one fieldstone is visible within the main enclosure along with two depressions (Figure 34A). The secondary enclosure is made of stacked fieldstone walls and is north of the main enclosure (Figure 34B). No depressions were observed in this enclosure.

A. Main Enclosure, Facing Northeast

B. Both Enclosures, Facing Southwest

Resource 0054 is located along a dirt road on an adjacent parcel north of the proposed project area. It is relatively overgrown with trees growing in the enclosures. Resource 0054 is an intact example of a late nineteenth-century family burial ground with its planned plots; however, it does not possess high artistic value. Additionally, it is not affiliated with persons of historical importance and does not contain the graves of any significant person that we know of. It is not known to be associated with a significant historic event. Therefore, the resource is recommended as not eligible for inclusion on the NRHP under Criteria A, B, or C.

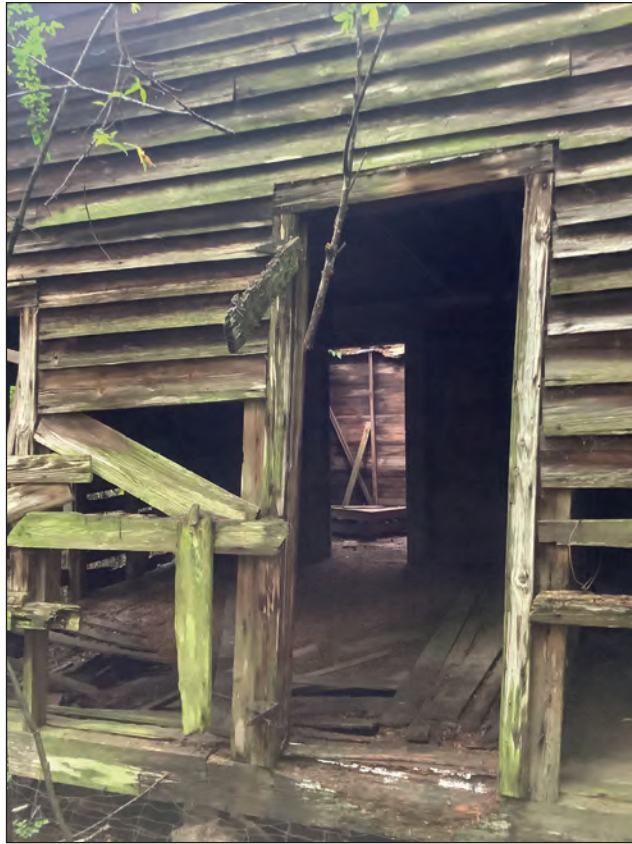
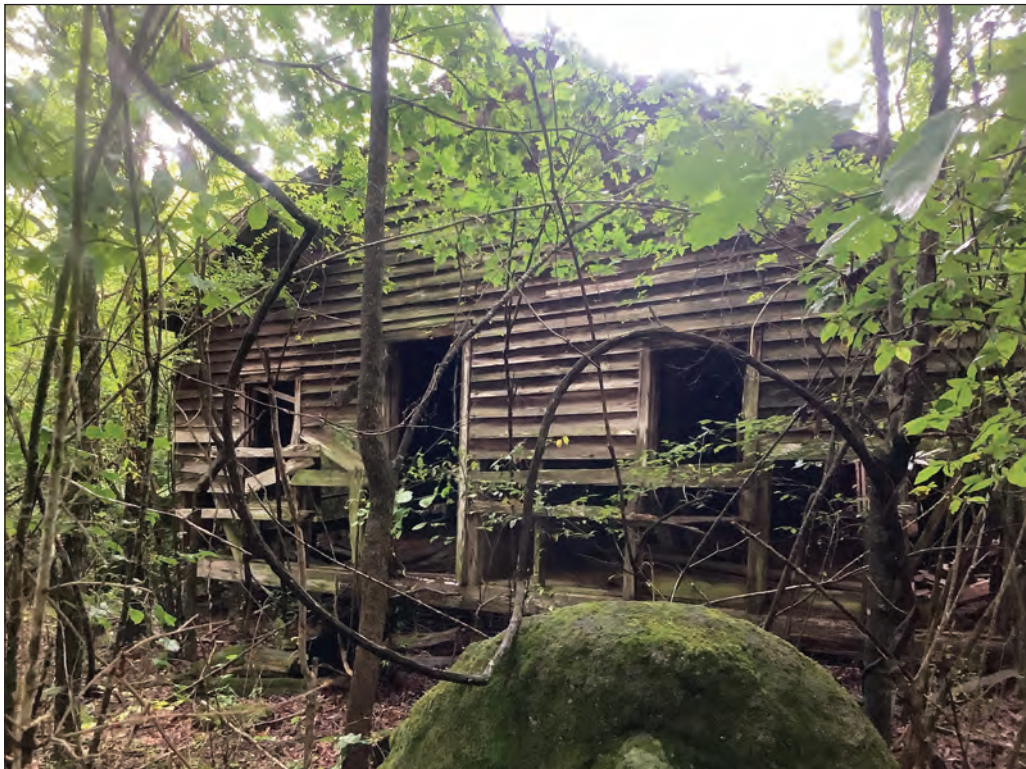
Figure 36.
Resource 0055: Residence, West of Double Bridges Road

Resource 0055 is a gabled house west of Double Bridges Road in parcel 174-00-00-006. The date of construction for the residence is unknown; however, it is first depicted in a 1962 aerial photograph. Rectangular in plan, this front gabled residence is protected by corrugated metal on the roof. It rests on a stone pier foundation and is clad in weatherboard. Currently, there are no windows or doors (Figure 35A). The house has been abandoned for some time and is now falling into ruin (Figure 35B).

A. Interior of
Residence

B. Exterior of Residence

Resource 0055 has a winding dirt driveway on the west side of Double Bridges Road. The house is in a wooded area approximately 0.3 miles northwest of Resource 0053. Resource 0055 is a front gable residence, but it is not a distinctive or noteworthy example of its type due to its current condition. It does not embody the distinctive characteristics of a type, period, or method of construction, nor does it represent the work of a master or possess high artistic value. It is not known to be associated with events or persons significant in the past. Therefore, the resource is recommended as not individually eligible for the NRHP under Criteria A, B, or C.

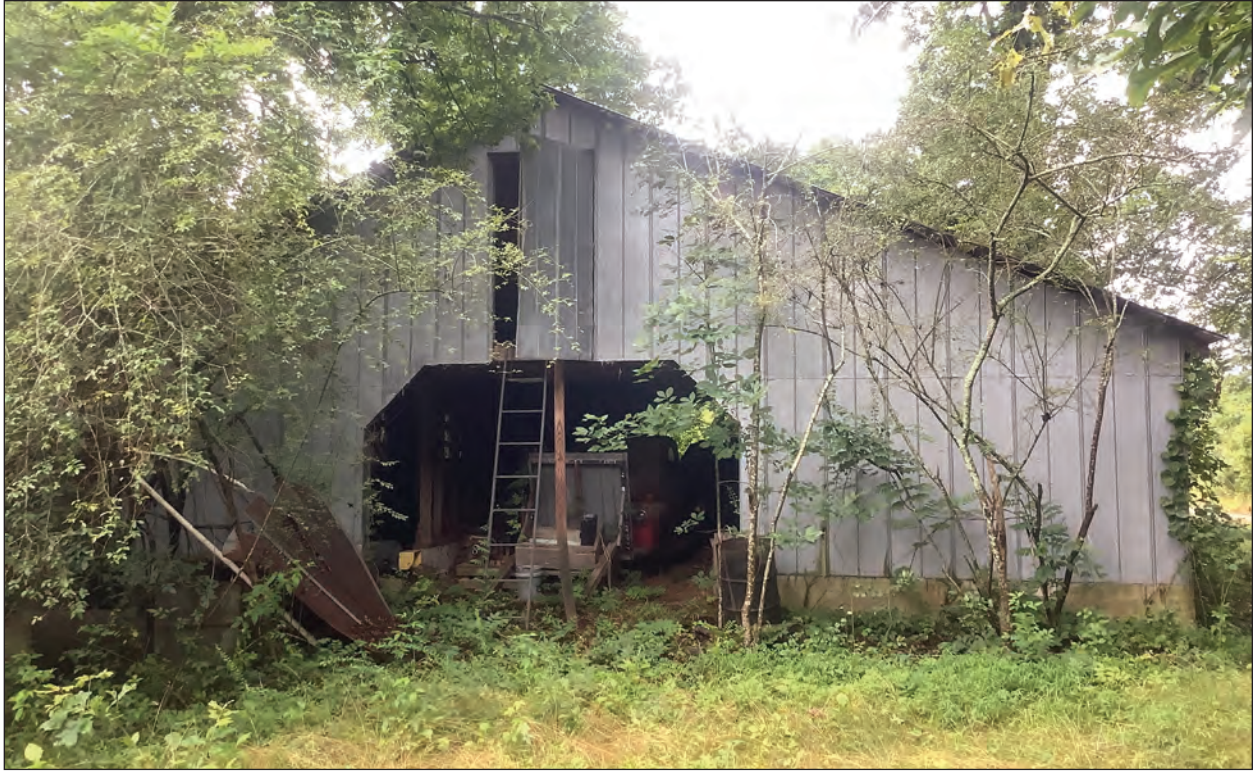
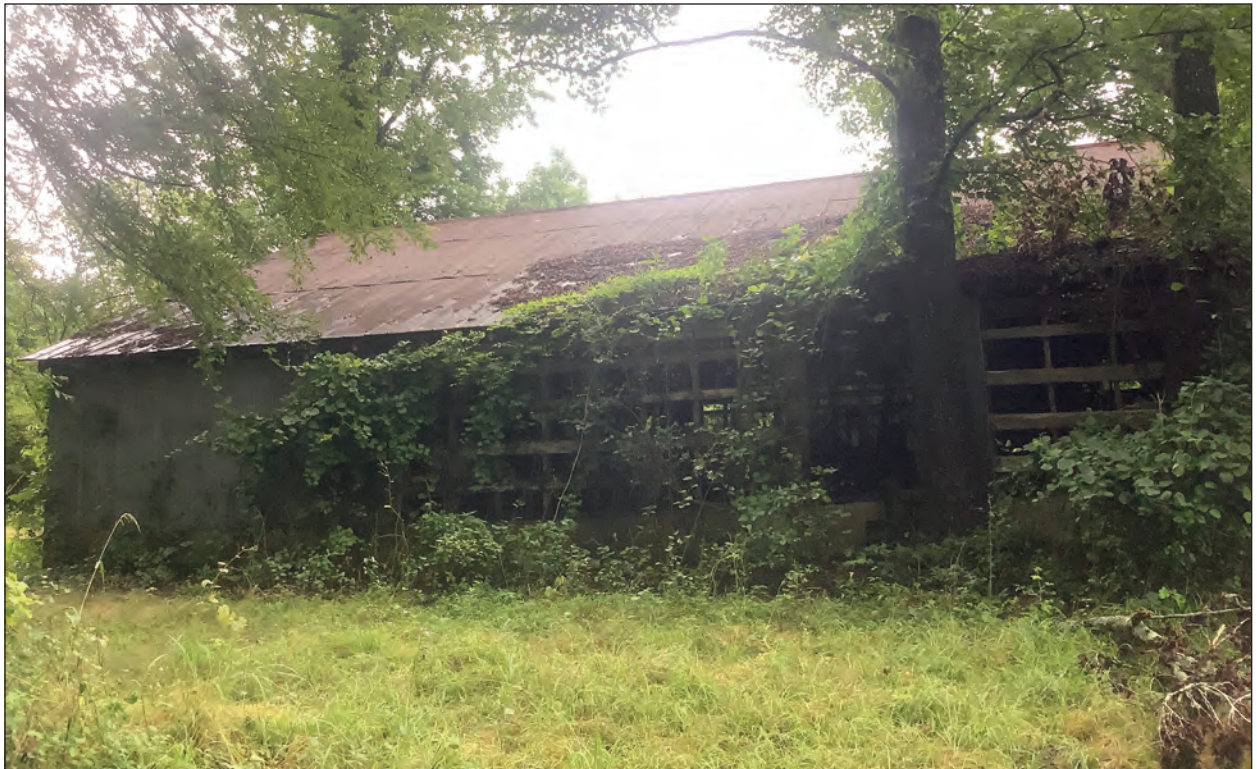
Figure 37.
Resource 0055.01: Barn, West of Double Bridges Road

Facing southwest from its site, Resource 0055.01 is a barn. It first appears in a 1962 aerial photograph. This one-and-a-half story double crib barn has a front gable roof covered in 5V crimp metal. It is of frame construction and is clad in corrugated metal. The foundation is obscured by vegetation. There are no windows (Figure 36A). On the southwest façade is a door leading to the loft and an opening with angled corners on the first floor. The metal siding has fallen off on the sides of the barn exposing its wooden frame (Figure 36B). Inside the barn the different spaces are defined and there is a concrete block wall with central beams (Figure 37).

A. Barn Façade, Facing East

B. Southeast Elevation of Barn, Facing Northwest

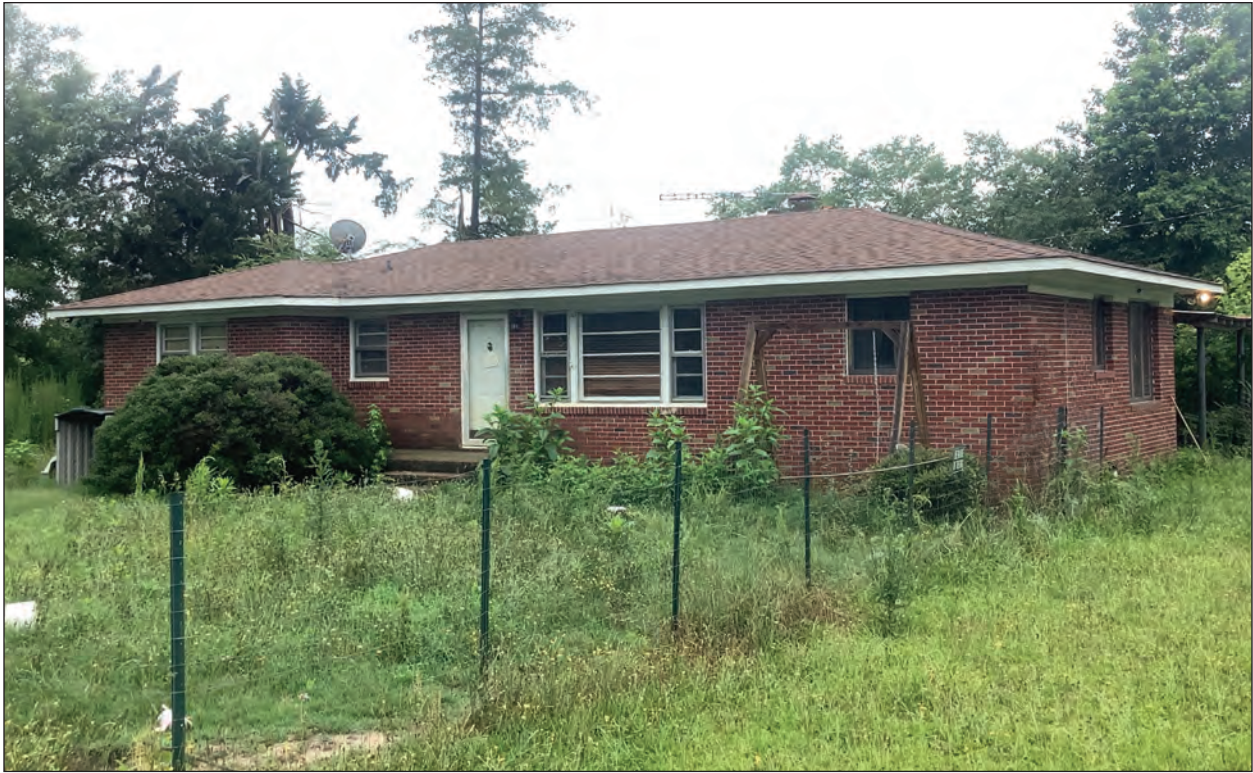
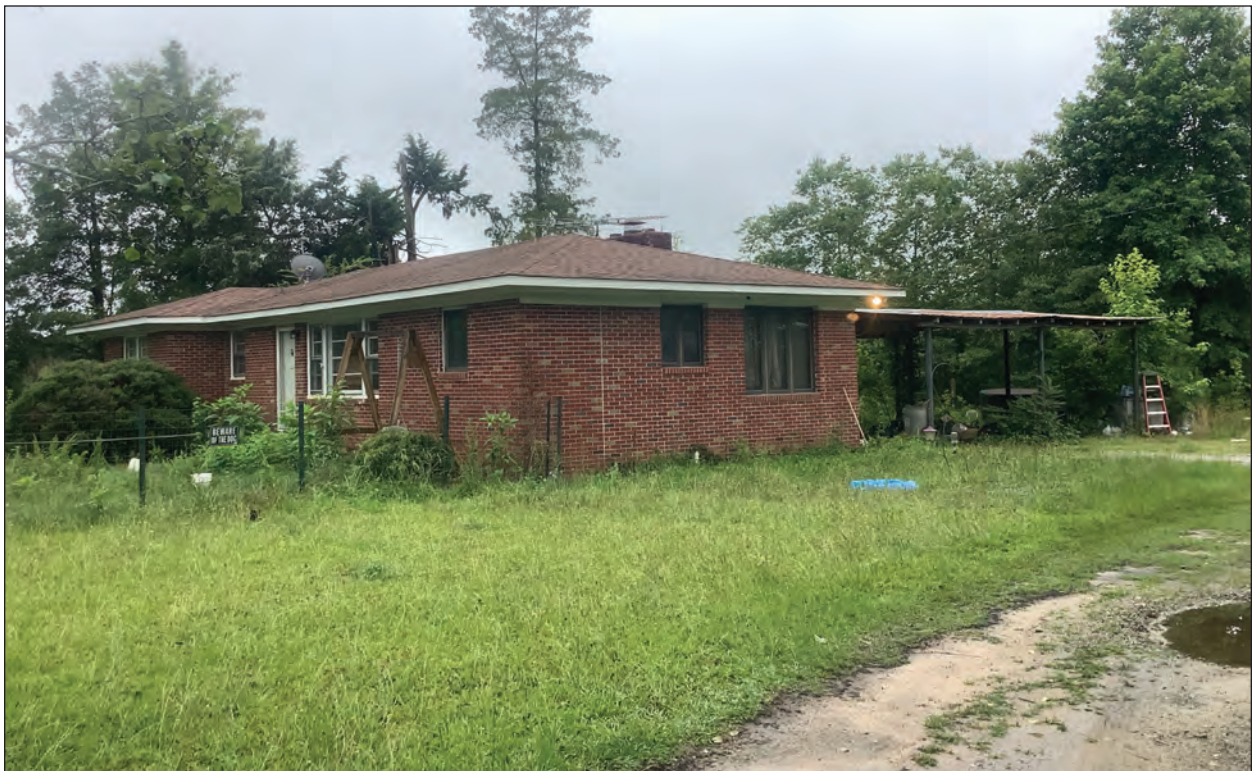
Figure 39.
Resource 0056: 4668 Double Bridges Road

Resource 0056 is a 1961 Linear Ranch House located at 4668 Double Bridges Road. The historic core is one-story with a rectangular plan and a hipped covered in composition shingle. It is of frame construction and is clad in brick veneer. The foundation is obscured by vegetation (Figure 39A). Windows are horizontal two-over-two, double hung sashes and casement windows. The porch gable is supported by wood posts. Along the façade are concrete steps that lead to a non-historic paneled front door behind an aluminum framed glass storm door. There is also an original tripartite window to the right of the front door. An interior brick chimney pierces the roof on the west end. A canopy/carport is on the northwest corner of the residence. It has a low-pitched front gable roof covered in 5V crimp metal and is supported by metal posts (Figure 39B).

A. Façade of the Residence, Facing West

B. Northeast Oblique of the Residence, Facing Southwest

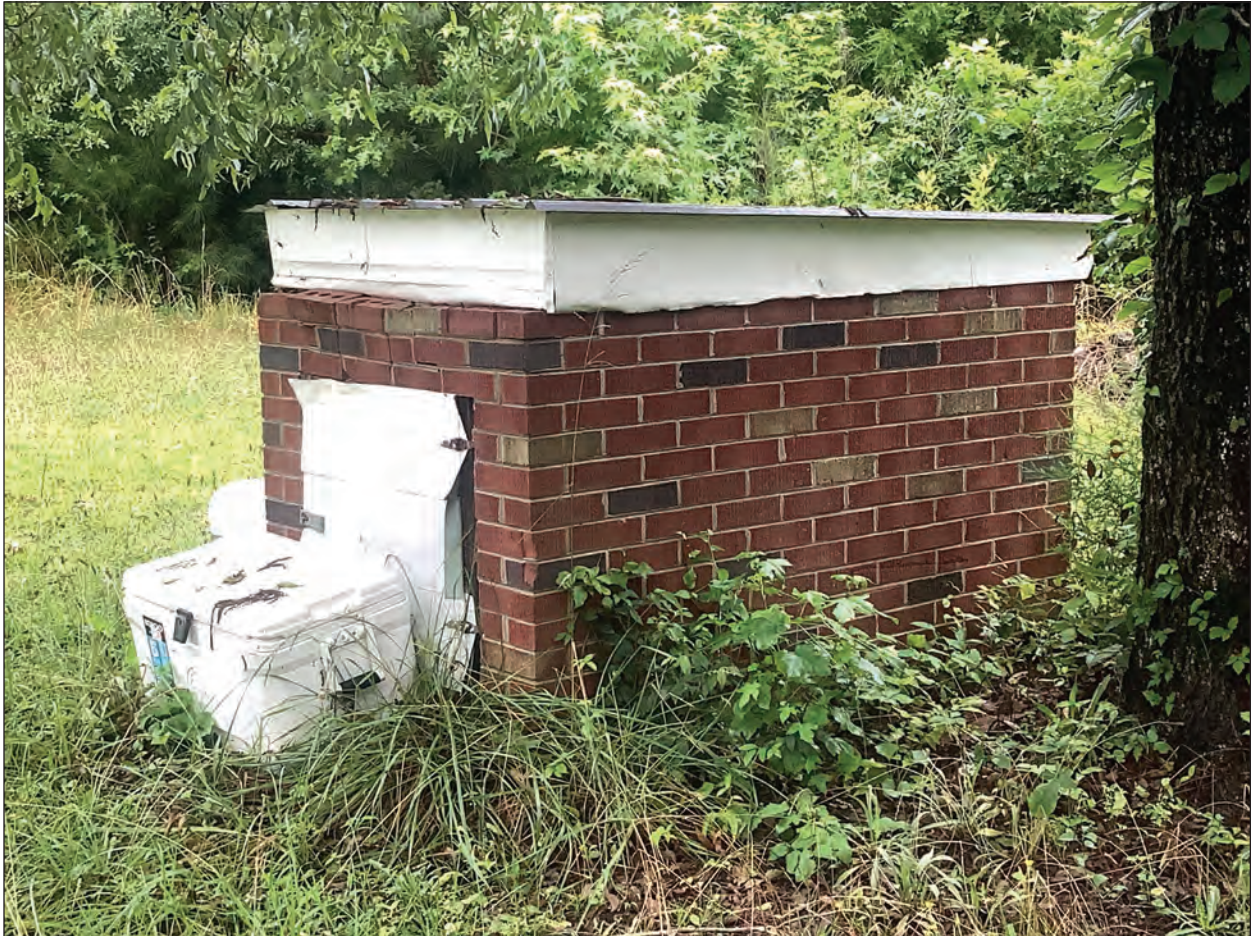
Figure 41.
Resource 0056.01 Well/Pump House

Resource 0056.01 sits approximately 70 feet northwest of Resource 0056 and about 15 feet southwest of a non-historic prefabricated trailer. It is shaded by a mature tree a few inches east. Although Resource 0056.01 is historic, it is not a distinctive or noteworthy example of this outbuilding type that is common in South Carolina. It does not embody the distinctive characteristics of a type, period, or method of construction nor does it represent the work of a master or possess high artistic value. It is not known to be associated with events or persons significant in the past. Therefore, the resource is recommended as not individually eligible for the NRHP under Criteria A, B, or C.
