PHASE I CULTURAL RESOURCES SURVEY

OF THE LUCK SALUDA SITE

Saluda County,
South Carolina

August 7, 2023 • Revised **Draft Report**
New South Associates Technical Report 4500

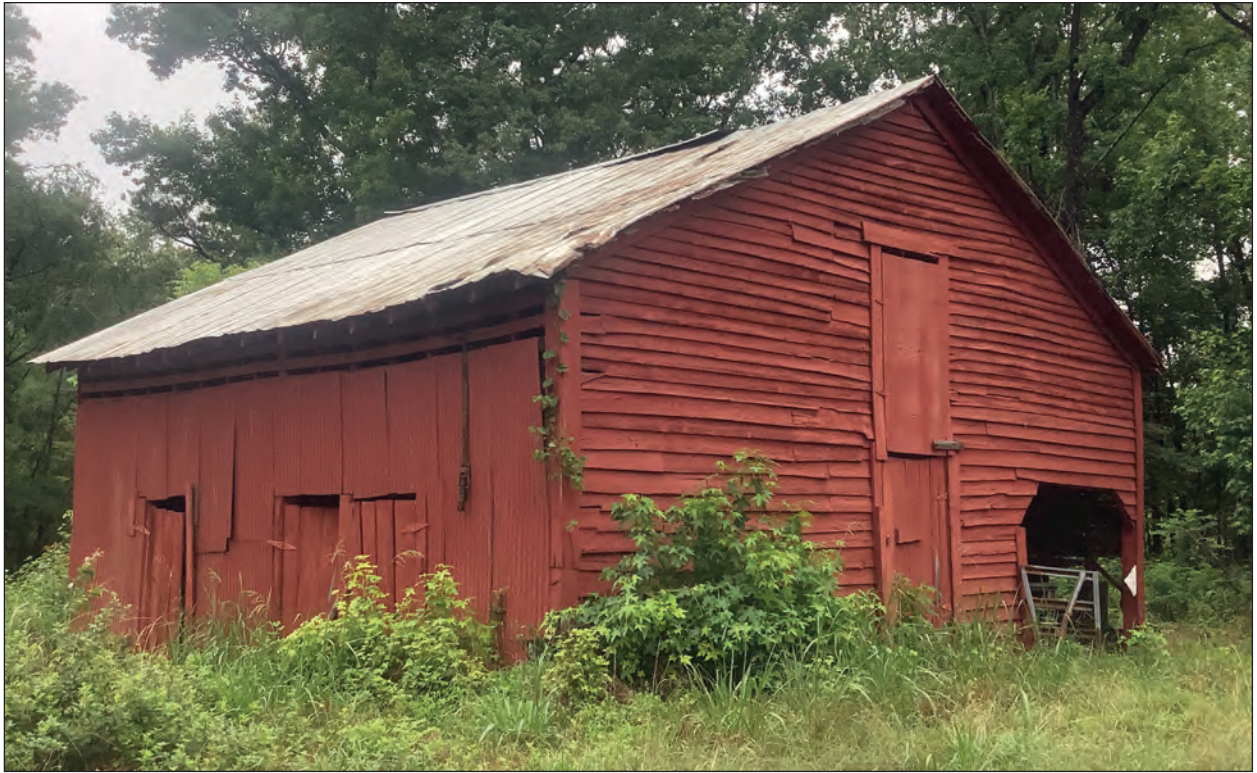
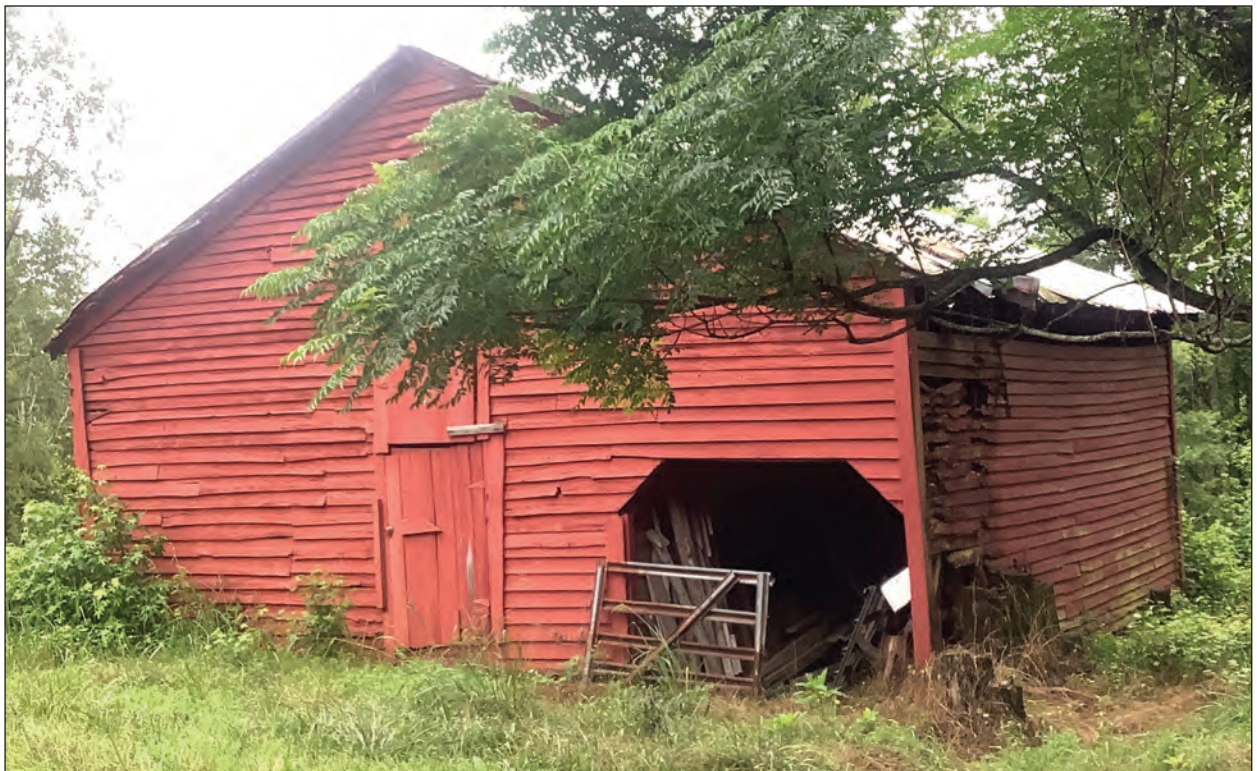
Figure 42.
Resource 0057: 4578 Double Bridges Road

Facing east from its site at 4578 Double Bridges Road, Resource 0057 is a barn. It first appears in a 1962 aerial photograph, although it appears to have been constructed circa the 1950s. This one-and-a-half story single crib barn has a front gable clad in 5V crimp metal. It is of frame construction and clad in weatherboard on three elevations and corrugated metal on the south elevation. The foundation is obscured by vegetation. There are no windows, just original wood doors (Figure 42A). On the east facing façade is an entrance door on the first floor and a door leading to the loft. An opening with angled corners on the north end of the façade leads to a storage area. Rot is setting in on the north elevation (Figure 42B).

A. Northwest Oblique of Barn, Facing Southwest

B. Southwest Oblique of Barn, Facing Northwest
