# An Investigation into the Potential Impacts of Coal Tar Contamination on the Invertebrate Community of the Congaree River near the City of Columbia, Richland County, SC

*By James B. Glover, Ph.D.*

*Bureau of Water  
Aquatic Biology Section  
07/07/2017*

*Technical Report Number 0804-17*

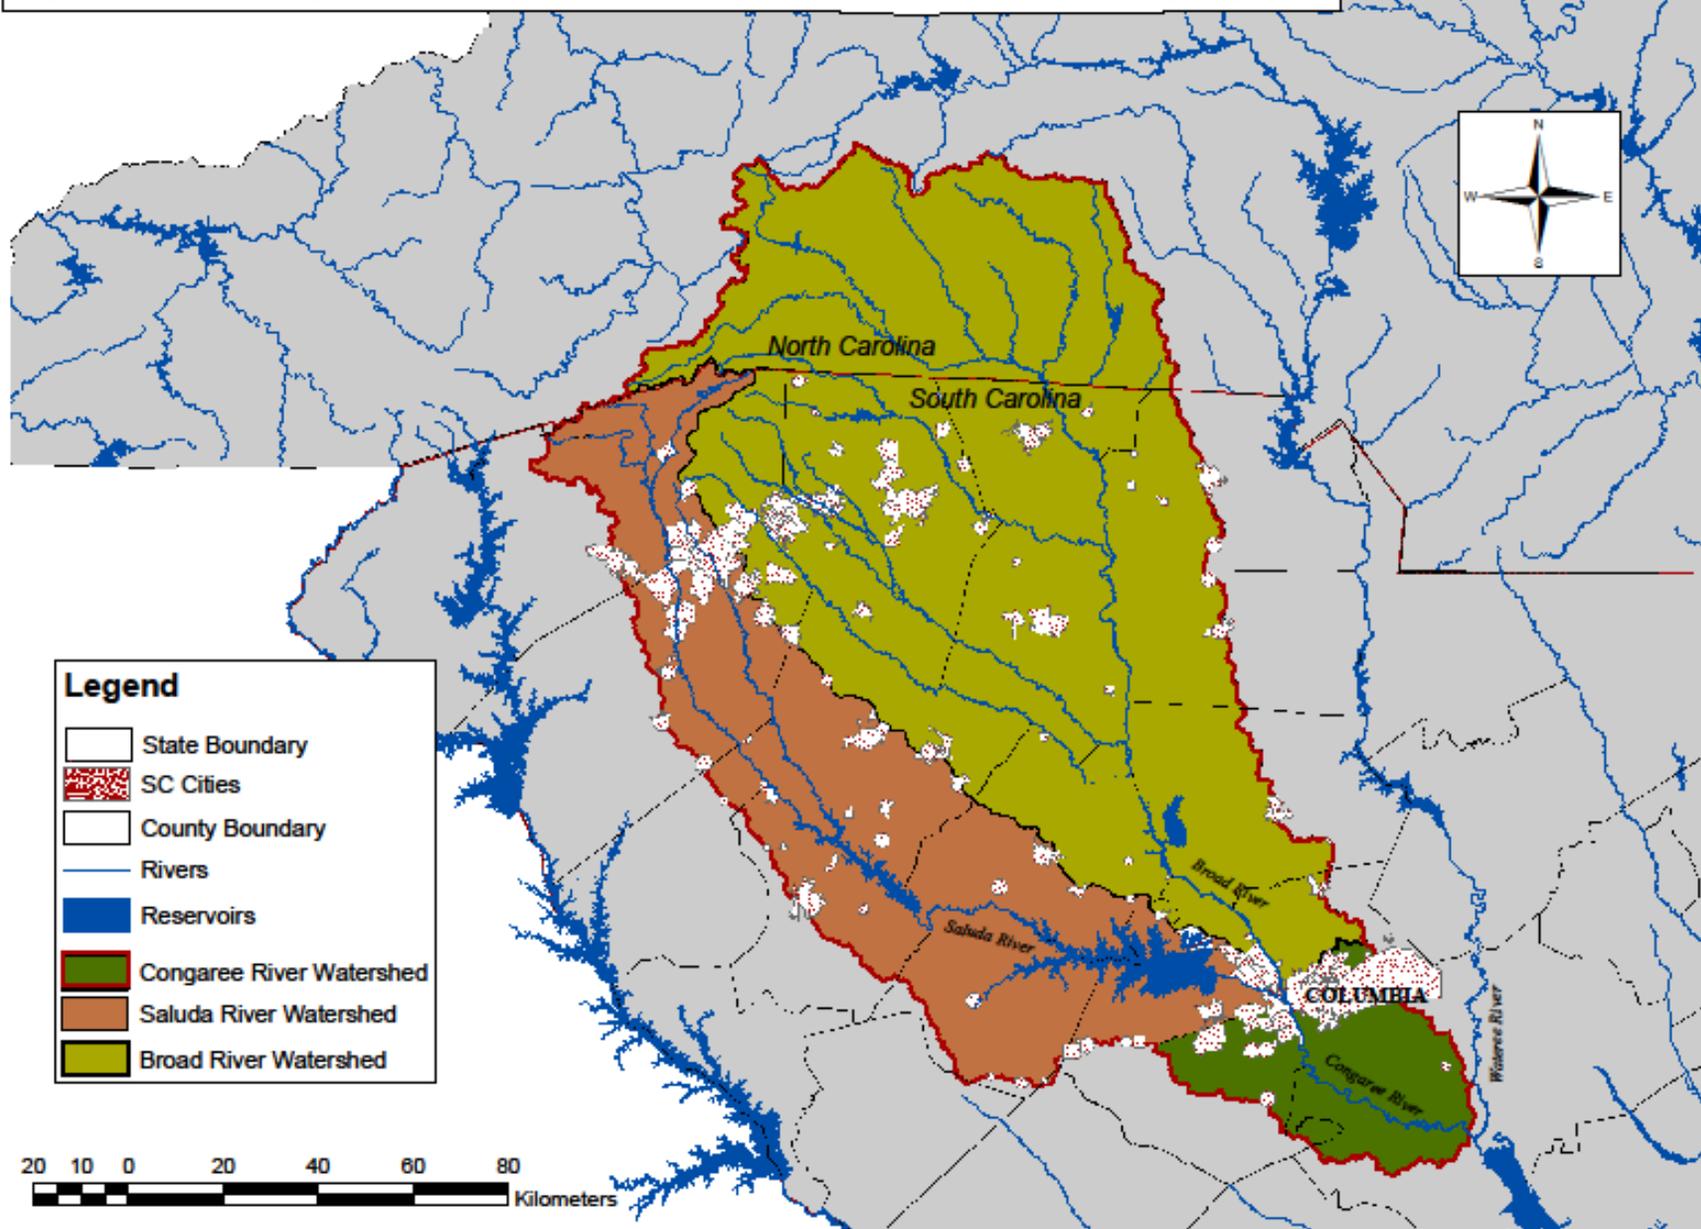
Figure 1. The Congaree River watershed with two component parts highlighted.

The Congaree River is a relatively short segment of waterway that is contained within the Santee Watershed, the headwaters of which are in the Blue Ridge Mountains (Figure 1). The Congaree begins near Columbia, SC after the Saluda River and the Broad River merge. After the Wateree River merges with the Congaree River, a name change occurs, with the union creating the Santee River. The headwaters

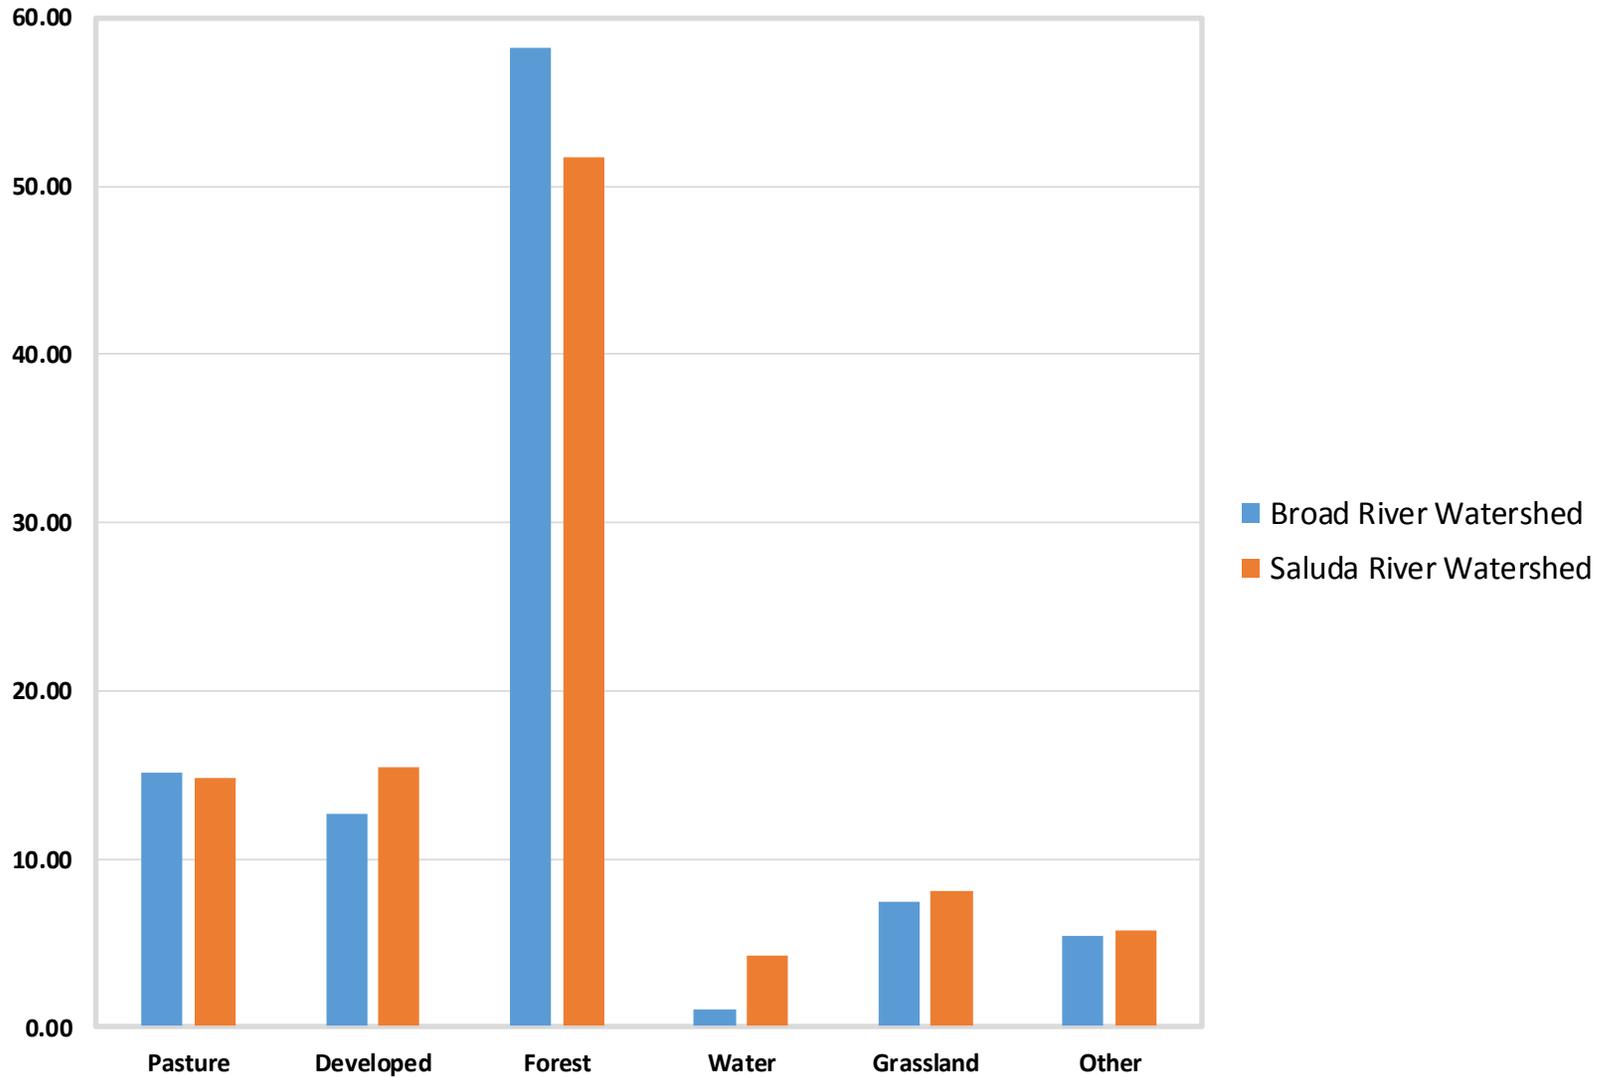
**Figure 2. Percent landuse within the Broad River and Saluda River Watersheds.**

Data compiled from the 2011 National Land Cover Database; some categories combined, see Glover et al. (2010)

of both the Broad River and the Saluda River are in the Blue Ridge Mountains, with some tributaries separated only by a mountain ridge. Their paths diverge as they carve their way through the piedmont. The waters of the Saluda are fully contained within SC, while some to the Broad Rivers headwaters are located in NC. The Broad River Watershed is about twice the size of the Saluda, at over 13,700 Km<sup>2</sup> versus 6500 Km<sup>2</sup>, respectively. The landuse is very similar for both the Saluda and the Broad River Watersheds (Figure 2), being mostly forested and rural. Both watersheds have similar proportions of developed area (15.7% Saluda, 12.5% Broad) with pasture/hay also being rather dominant (14.8% Saluda, 15.2% Broad). The waterways in both watersheds have numerous impoundments with Lake Murray near Columbia likely exerting the greatest influence on the chemical and biological differences seen between the lower portions of the two rivers. Once the two rivers merge, the entire watershed upstream of points on the Congaree River should, in theory, be an aggregate of the Broad River and Saluda River watersheds. In reality however the two rivers appear to remain unmixed for some distance, with samples collected from the Richland County side of the Congaree best thought of as the Broad River Watershed and those of the Lexington County side best considered the Saluda River watershed.

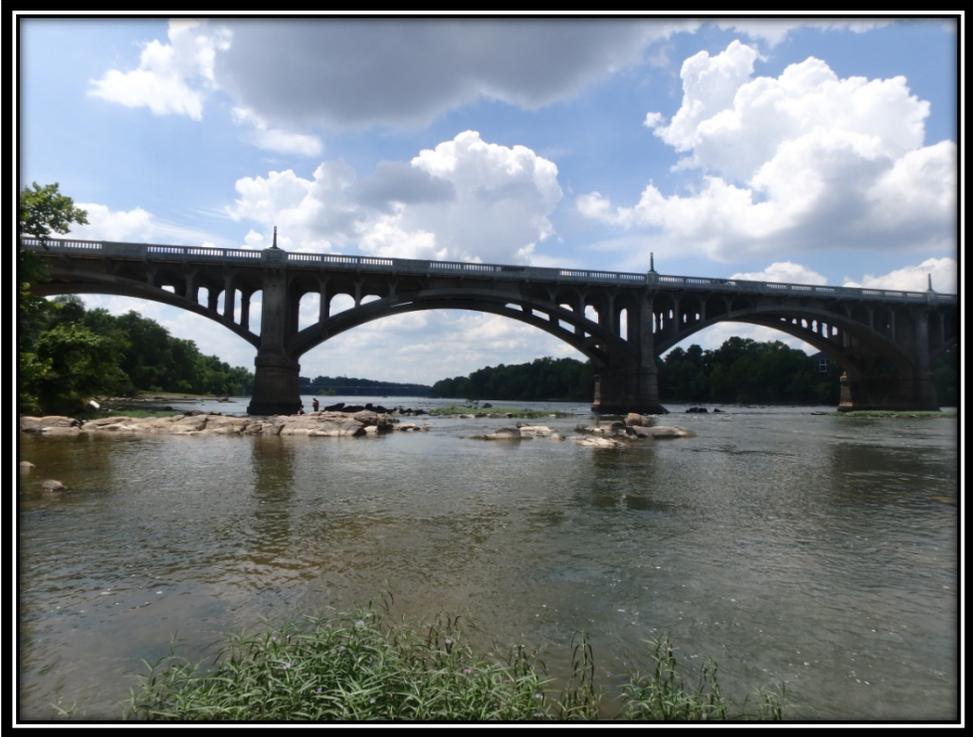
Figure 3. Congaree River looking downriver toward the Gervais Street Bridge.

The upstream control site, station S-1007, was established on the eastern side of the Congaree River just upstream of the Gervais Street Bridge (Figure 3). Sampling took place over a 180 meter reach with the bridge forming the downstream border. Habitat here consisted primarily of boulders, cobbles and exposed bedrock often covered with riverweed (*Podostemum ceratophyllum*). Logs and other woody habitat were also plentiful. Good riparian root habitats were difficult to find and processed leaf detritus was absent, which is not unusual in large rivers. Very little sedimentation was observed. Flow was strong but low water levels allowed easy access by wading. Three biologists sampled this site for a total of 4.5 person-hours.

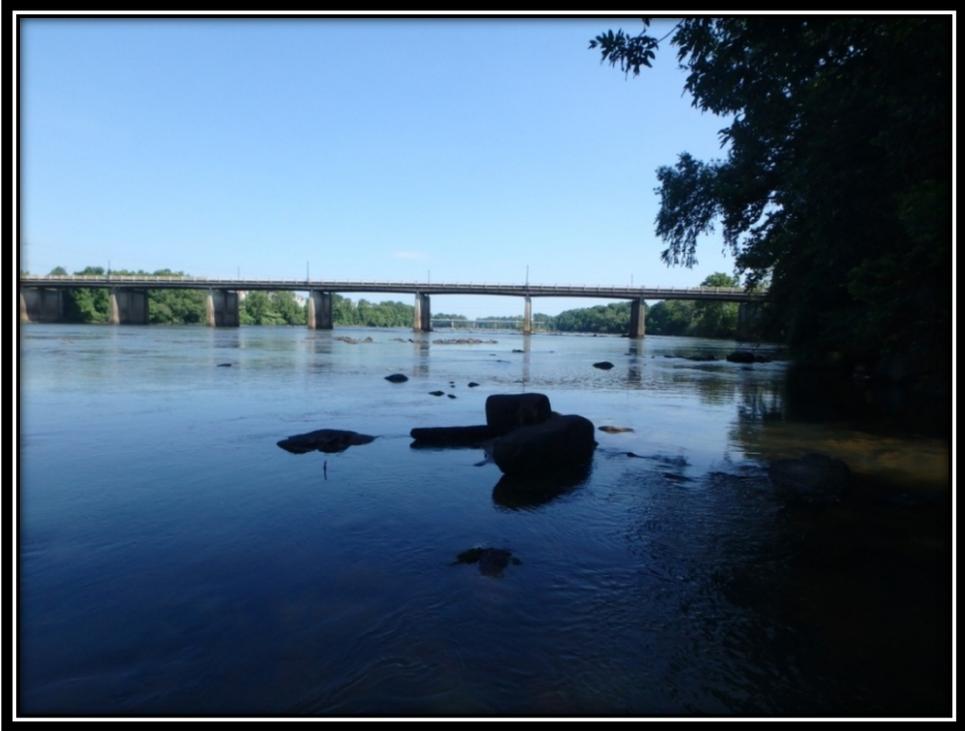
Figure 4. Congaree River looking upriver toward Blossom Street Bridge.

The downstream test site, station CSB-001R, was sampled from a point adjacent to the pump station at the end of Wheat Street and extended upstream from there for 150 m with the reach ending slightly downstream of the Blossom Street Bridge (Figure 4). Like the upstream site, boulders, cobbles and bedrock covered in riverweed, along with submerged logs and sticks, made up the most abundant habitats. Riparian subaquatic root habitat again was scarce. No detrital leaf packs were observed, which is consistent with predictions of the river continuum concept for large rivers (Vannote et al. 1980). There was a moderate amount of sedimentation here but in this regard, this site was much more similar to the upstream site, S-1007, than it was to the area between the two, which based on observations from several days prior, appeared buried in sediment. Flow was strong as it was upstream and the low water levels allowed easy access to the available habitats by wading. Three biologists sampled this site for a total of 4.5 person- hours.

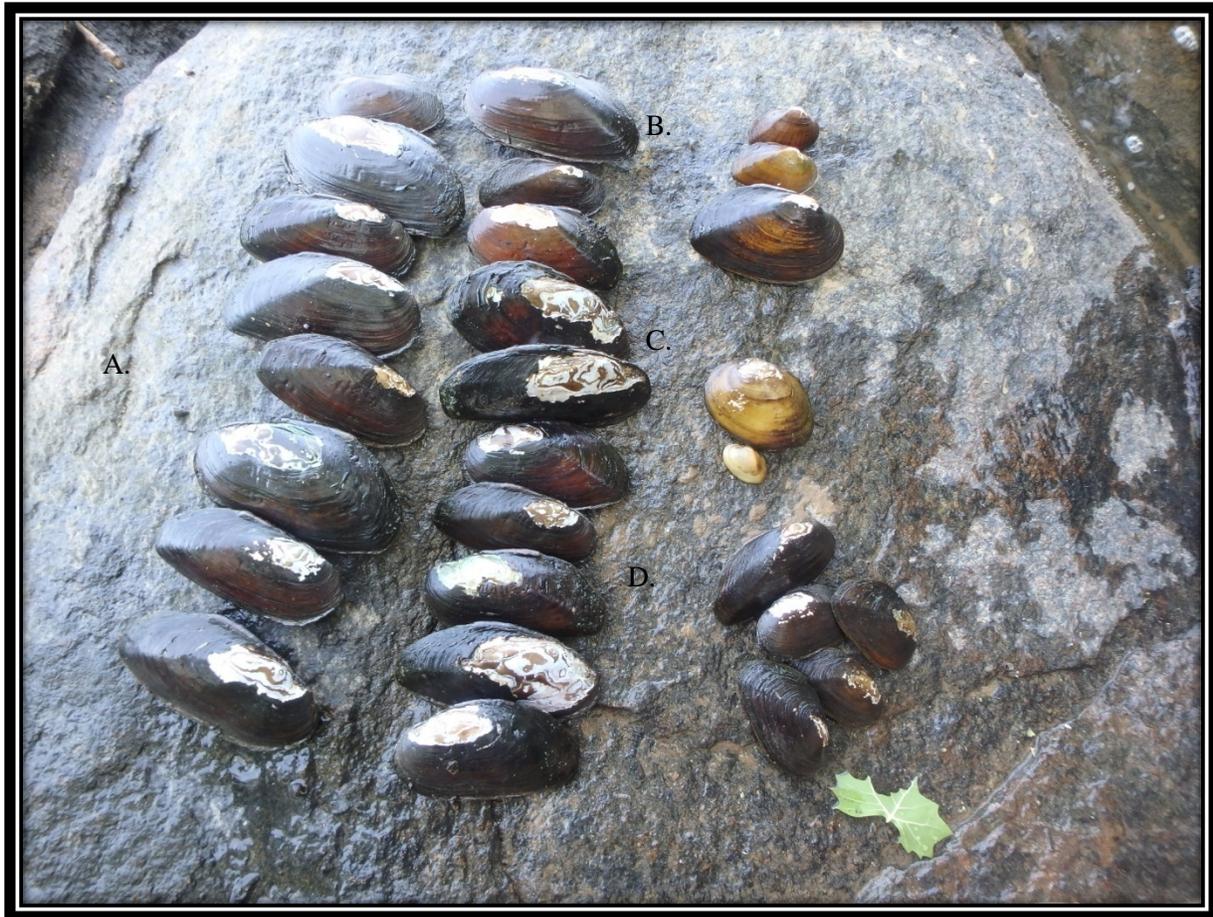
Figure 5. Freshwater mussels found in the Congaree River near Blossom Street Bridge; A. *Elliptio roanokensis* (Roanoke Slabshell), B. *Elliptio congarea* (Carolina Slabshell), C. *Lampsilis cariosa* (Yellow Lamp mussel), and D. *Elliptio complanata* (Eastern Eilliptio).

Street Bridge location (Figure 5). The unionid mussels that were documented at the Blossom Street site included *Elliptio roanokensis* (Roanoke Slabshell), *Elliptio congarea* (Carolina Slabshell), *Lampsilis cariosa* (Yellow Lamp mussel), and *Elliptio complanata* (Eastern Elio). Differences in species composition is likely due to natural variability rather than significant differences in water quality. The presence of the relatively immobile unionid mussels, some of which are up to 5 years of age, further suggests that the contaminated sediment has not impacted the native invertebrate fauna of the Congaree River at the Blossom Street Bridge. The presence of a very young Yellow Lamp mussel also demonstrates ongoing recruitment to this area.

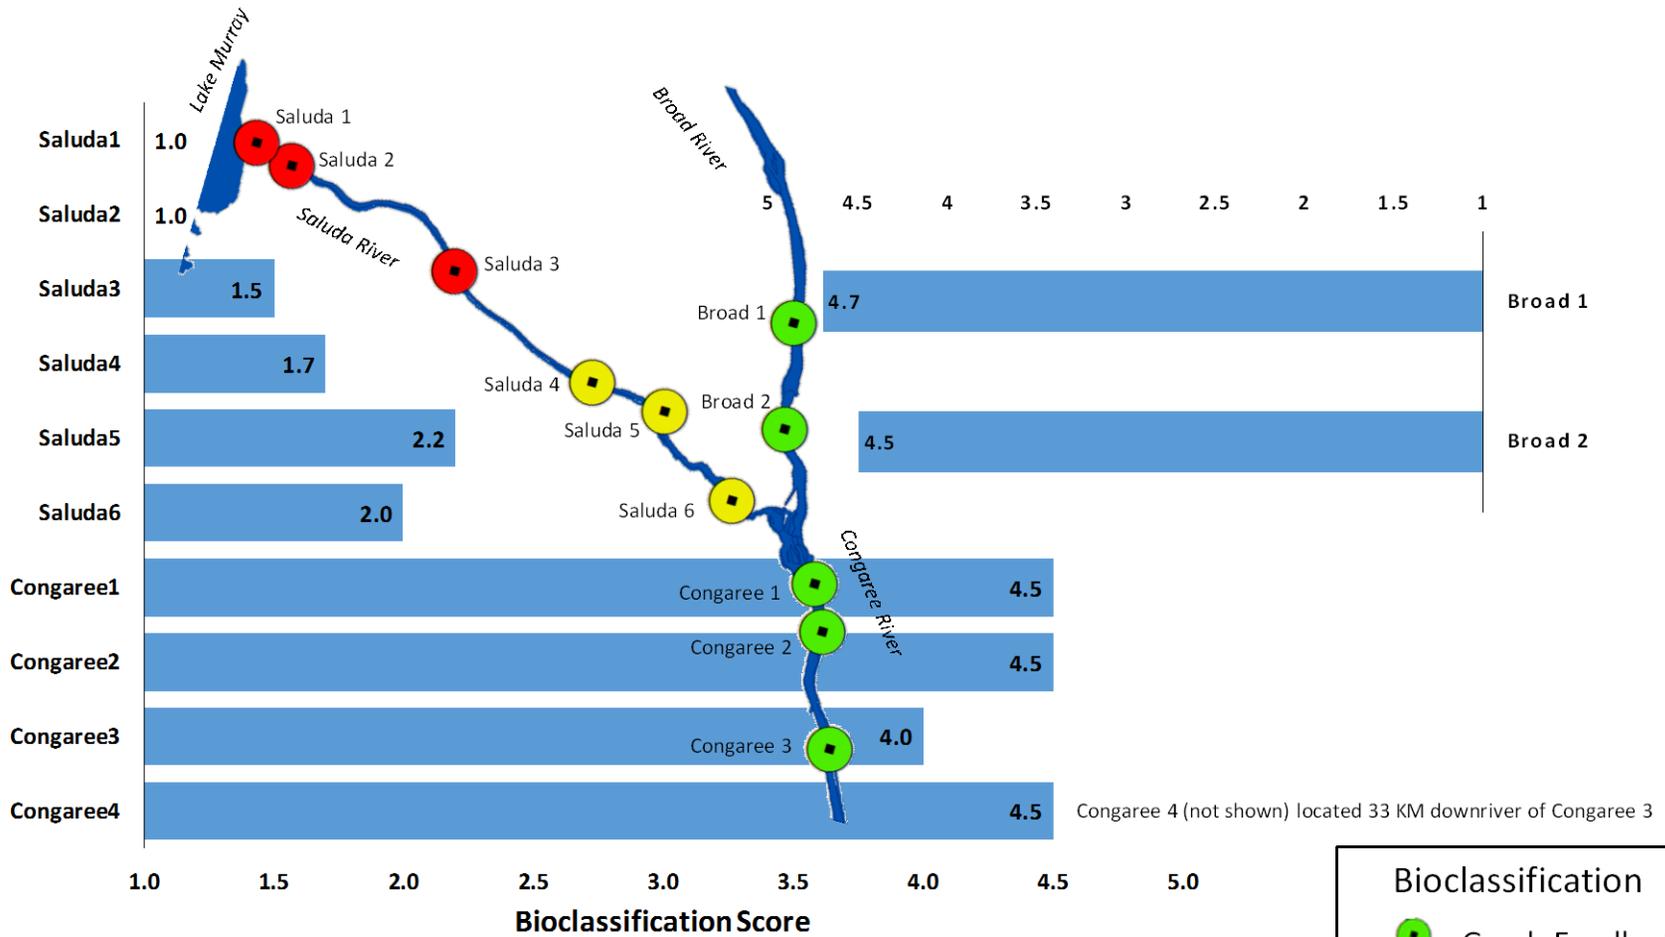
**Figure 6. Bioclassification Scores of the Saluda, Broad, and Congaree Rivers Near Columbia, SC**

*Congaree 1 (Control) upriver of Gervais Street Bridge, Congaree 2 located downriver of TLM near Blossom Street Bridge (collected 2017); Scores shown using coastal plain criteria .*

Bioassessment results for the Saluda, Broad, and Congaree Rivers conducted in previous years are reported here to add context and insight into the results of this investigation (Figure 6). Results from the Saluda River were gathered in 2006 by Carnagey Biological Services (2006), which was conducted during a FERC Relicensing process of the Lake Murray Dam. There were 6 sites collected by DHEC in 2014 as part of the ambient monitoring program: 2 on the lower Saluda River, 2 on the Lower Broad River, and 2 on the Congaree River. As shown in Figure 6, stations on the Lower Broad River and the Congaree River are comparable and indicate a Good to Excellent biocondition. By contrast, the invertebrate fauna on the Saluda River near the Lake Murray Dam resulted in a score of Poor (1.0 - 1.5) in 2006. Conditions progressively improved moving away from the dam with a biocondition of Fair (2.0 - 2.2) being measured in the Saluda River near the Zoo. The values shown in Figure 6 for the Saluda are all from the year 2006. Not shown are two additional sampling sites from 2014, evaluated by DHEC, that indicated a bioclassification of 2.5 (Fair to Good-Fair) at S-1002, which is fairly close to the dam and also a score of 2.5 at S-298, a station slightly upriver of the zoo location. This suggests that conditions may have improved somewhat since 2006, although season, natural variability, or difference in local conditions at the sampling site could account for the differences. Regardless, the biotic condition of the Saluda River is not as good as those in the Broad and Congaree, likely because of numerous variables associated with the reservoir. The effects of large dams on rivers have been studied and reviewed extensively (see Poff 1997) and changes in aquatic biota are thought related to numerous conditions such as flashy flows, water chemistry alterations, and alterations of energy flows within lotic waterways.
