Evaluating Living Shorelines To Inform Regulatory Decision- Making in South Carolina

Living Shorelines in South Carolina

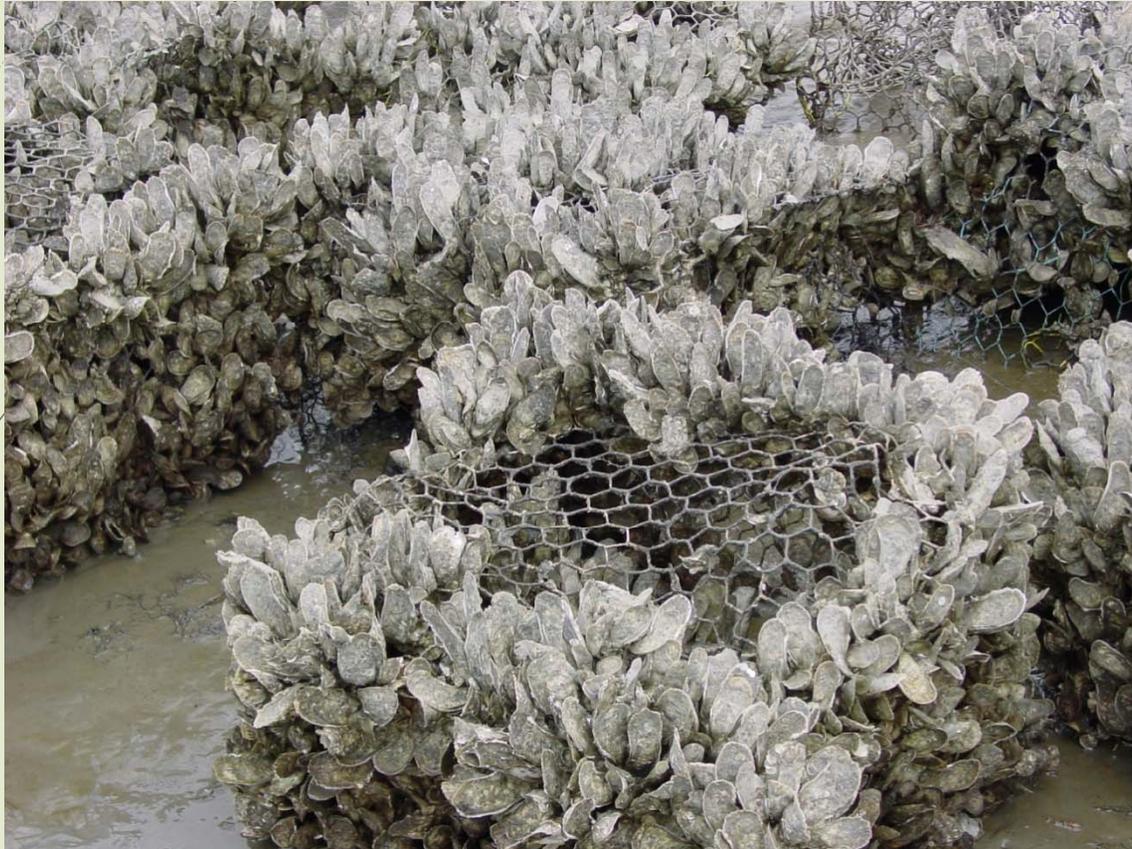
- **Creating reefs from salvaged crab traps**

**Bears Bluff National Fish Hatchery
Collaboration between SCDNR & USFWS
Reef installed on May 2nd, 2011
Photo taken on July 3rd, 2012 (Ben Stone, SCDNR)**

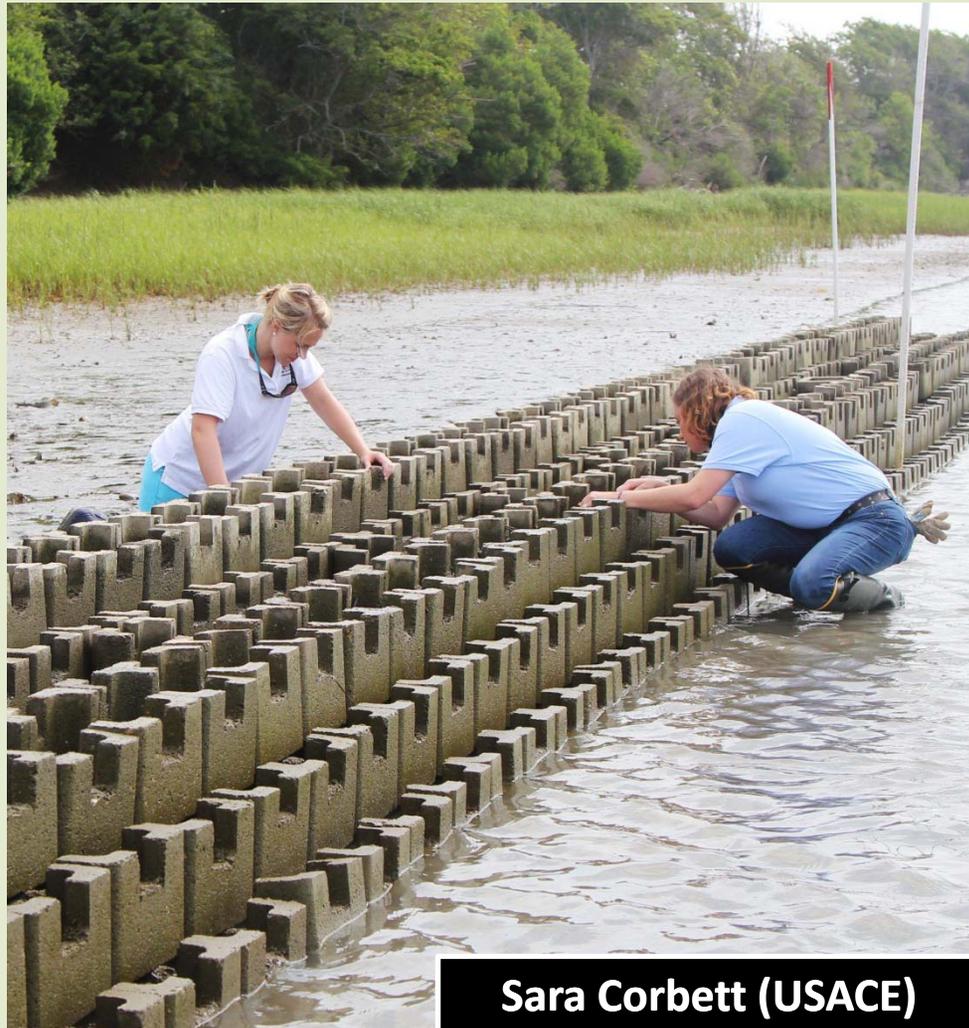
- **Oyster Castles: Interlocking blocks of concrete, limestone, crushed shell, and silica**

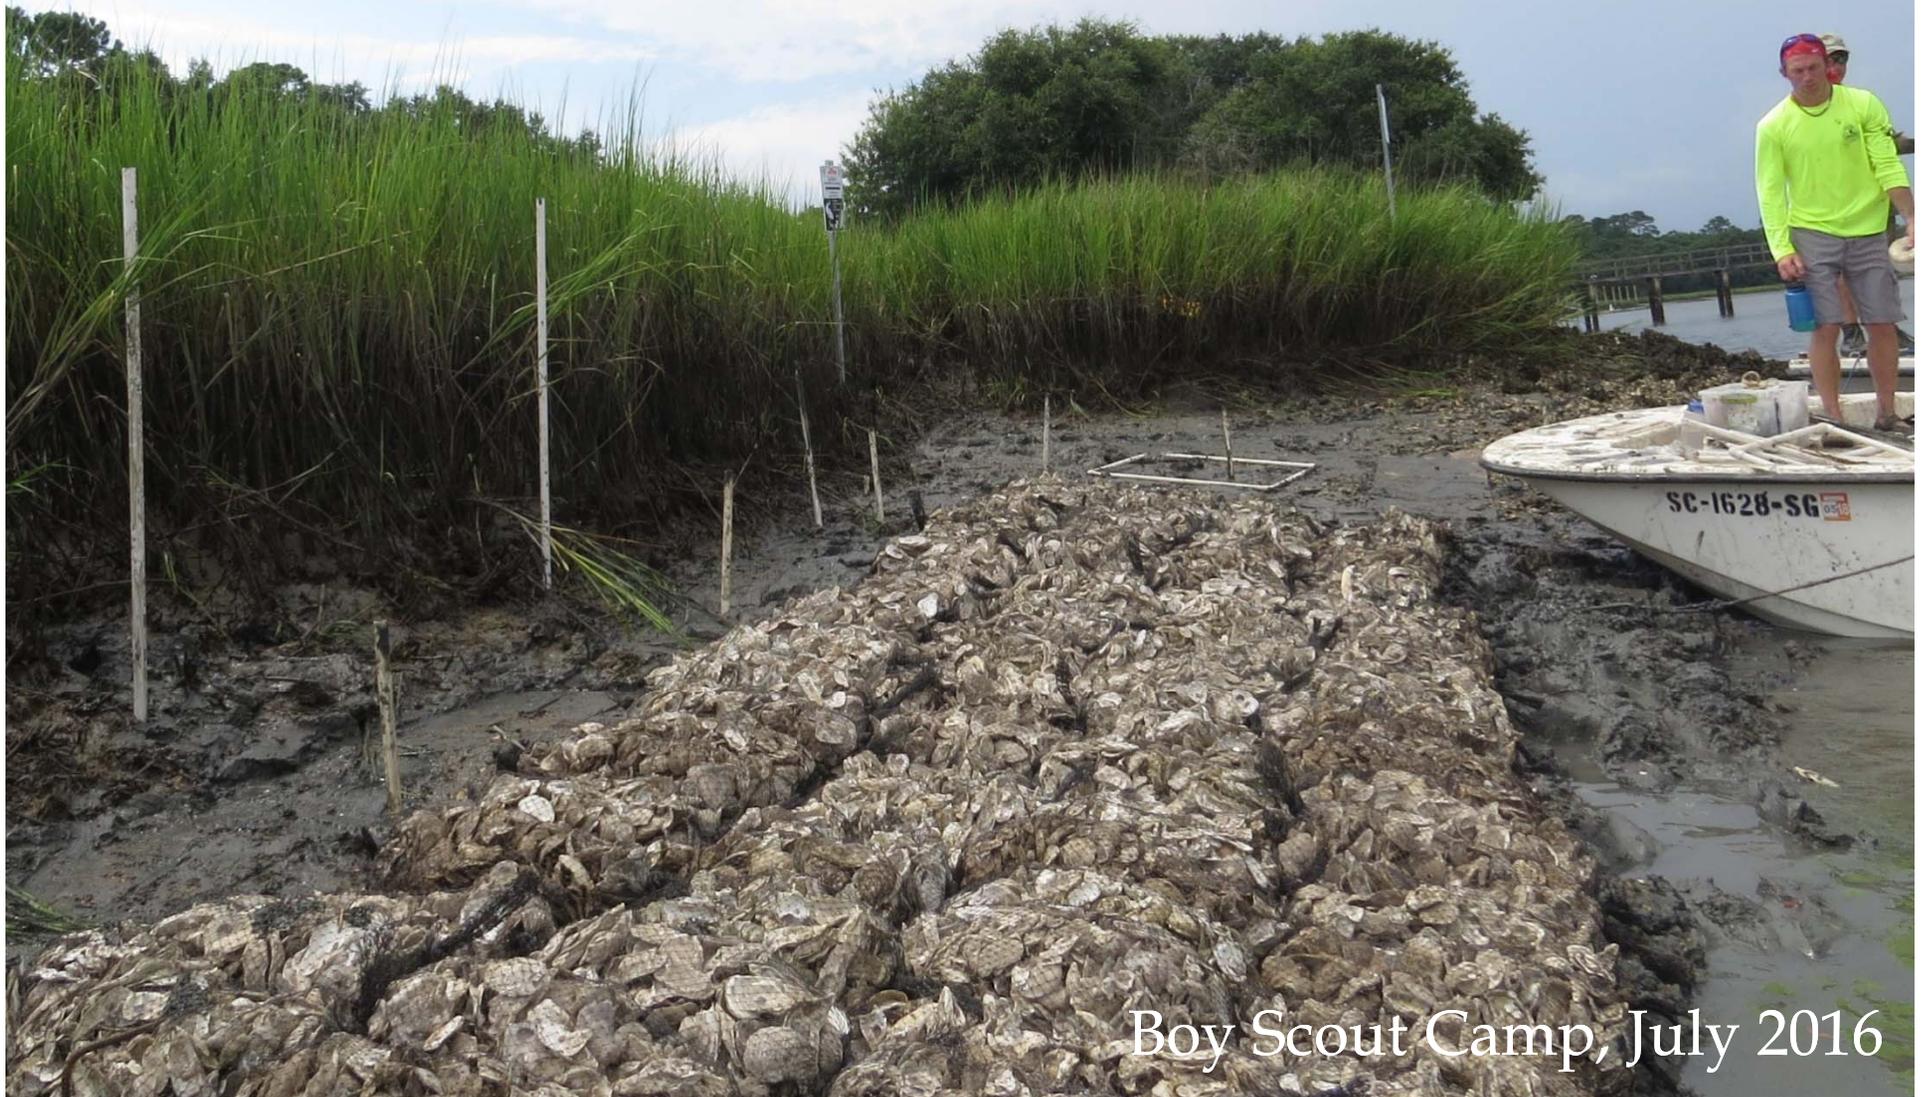
Boy Scout Camp, July 2016

Treatment: Bagged oyster shell (“bags”) (placed atop wood pallets at soft-sediment sites)

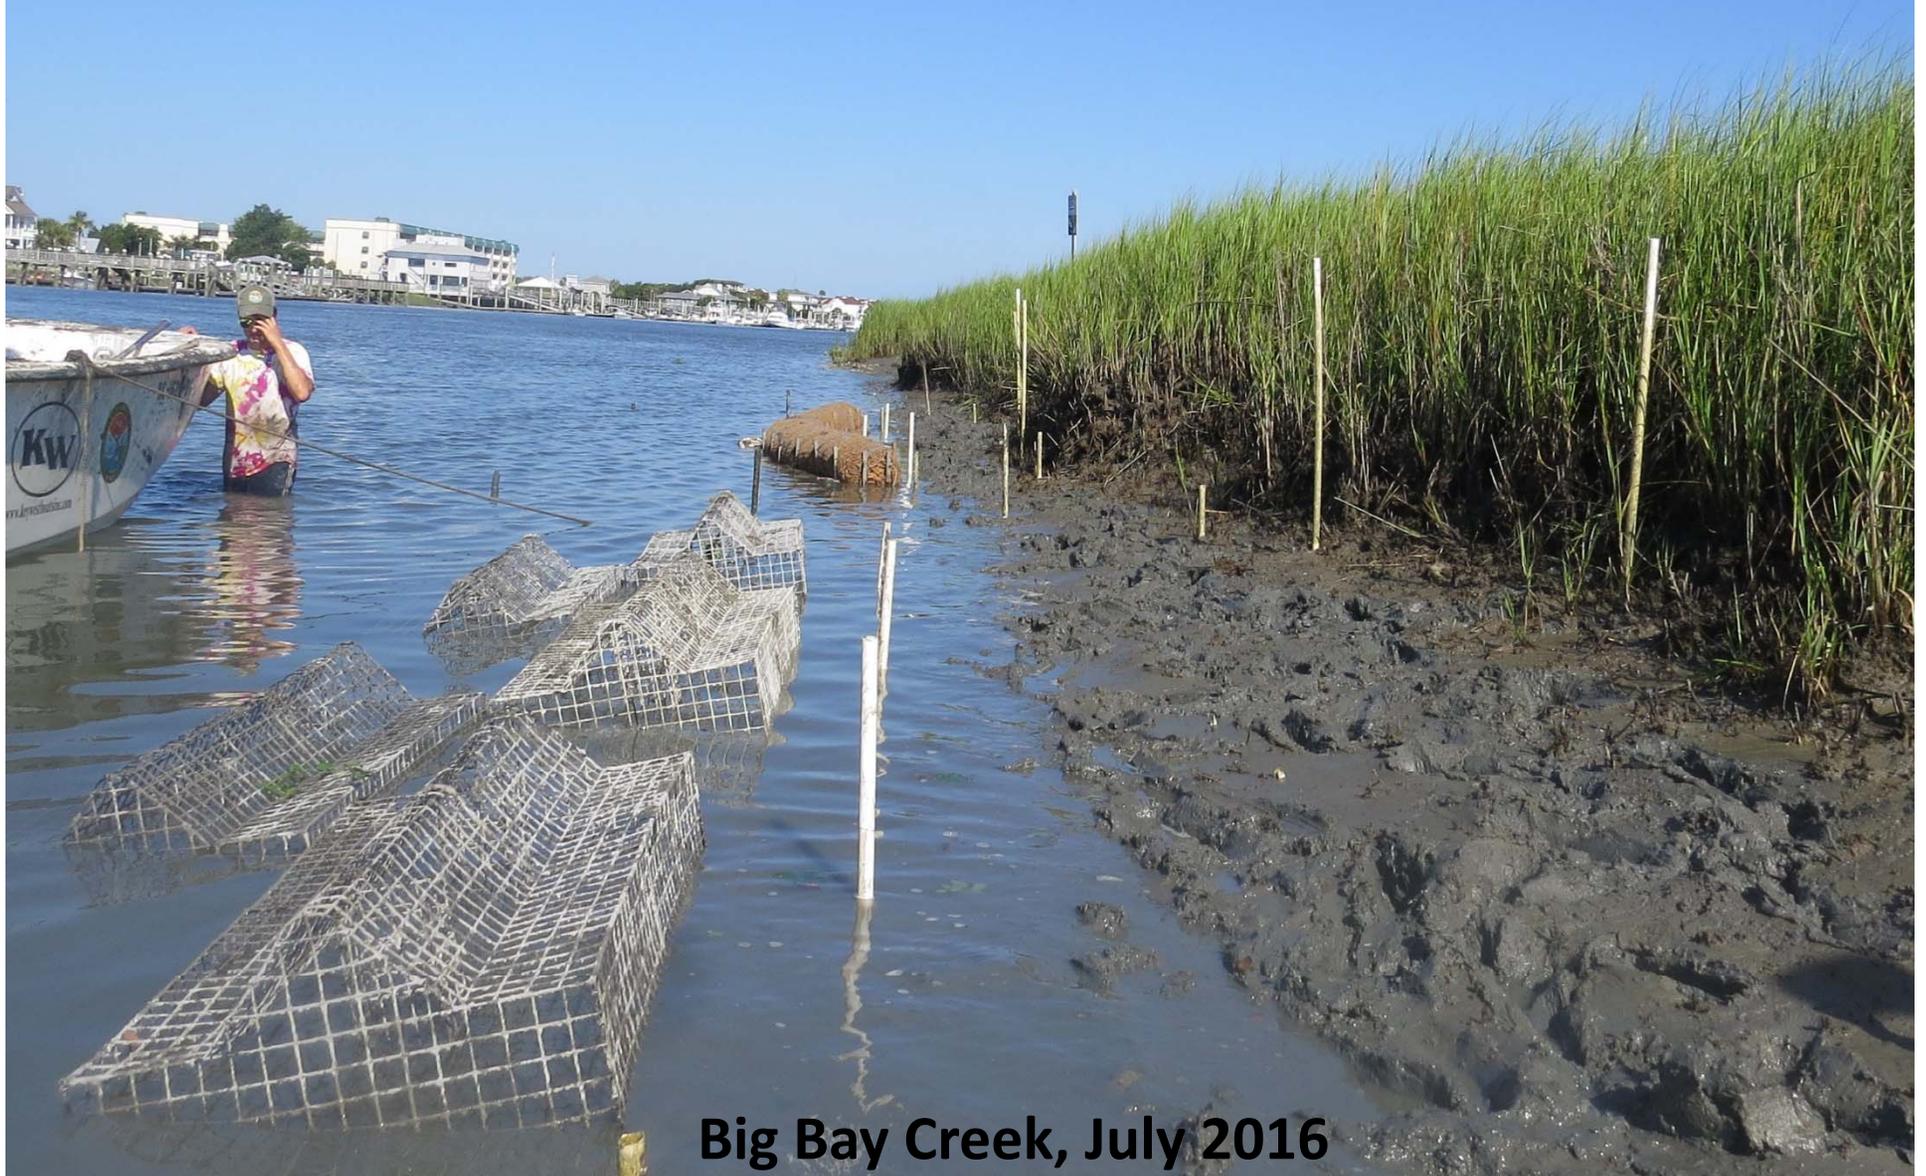
Big Bay Creek, July 2016

Treatment: Modified crab traps

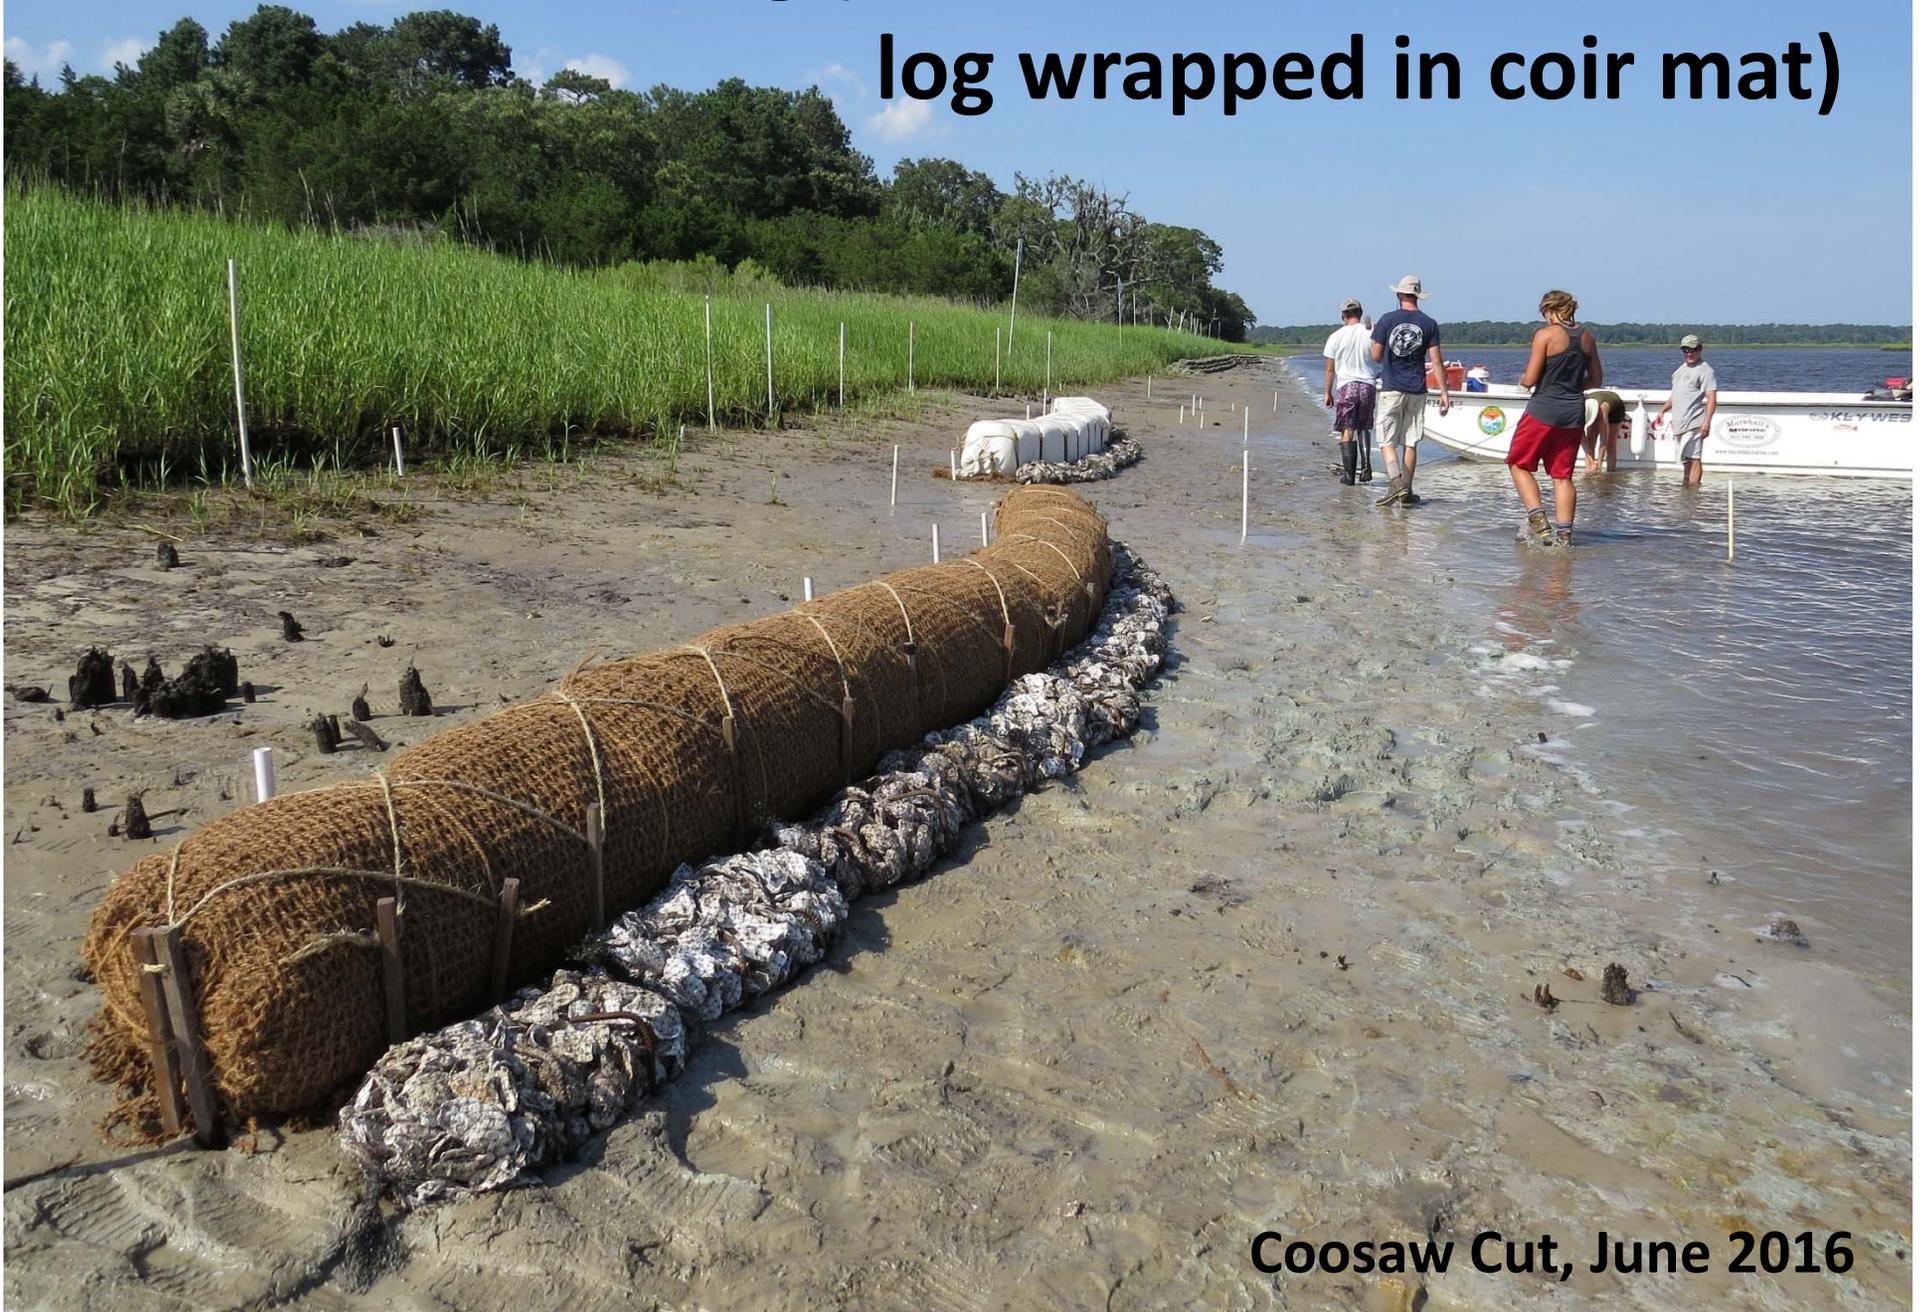
Coosaw Cut, June 2016

**Treatment: Coir log (coconut fiber;
log wrapped in coir mat)**

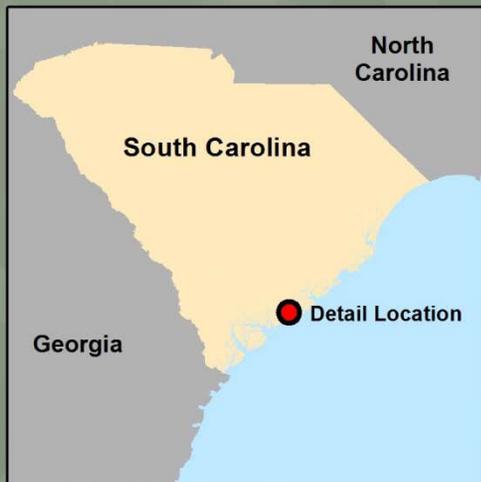
A-Site Detail: Boy Scout

Marsh

Control

Coir + shell

Curlex + shell

Bagged Shell

- Marsh edge
- Treatment corner
- Treatment elevation
- High edge
- Low edge

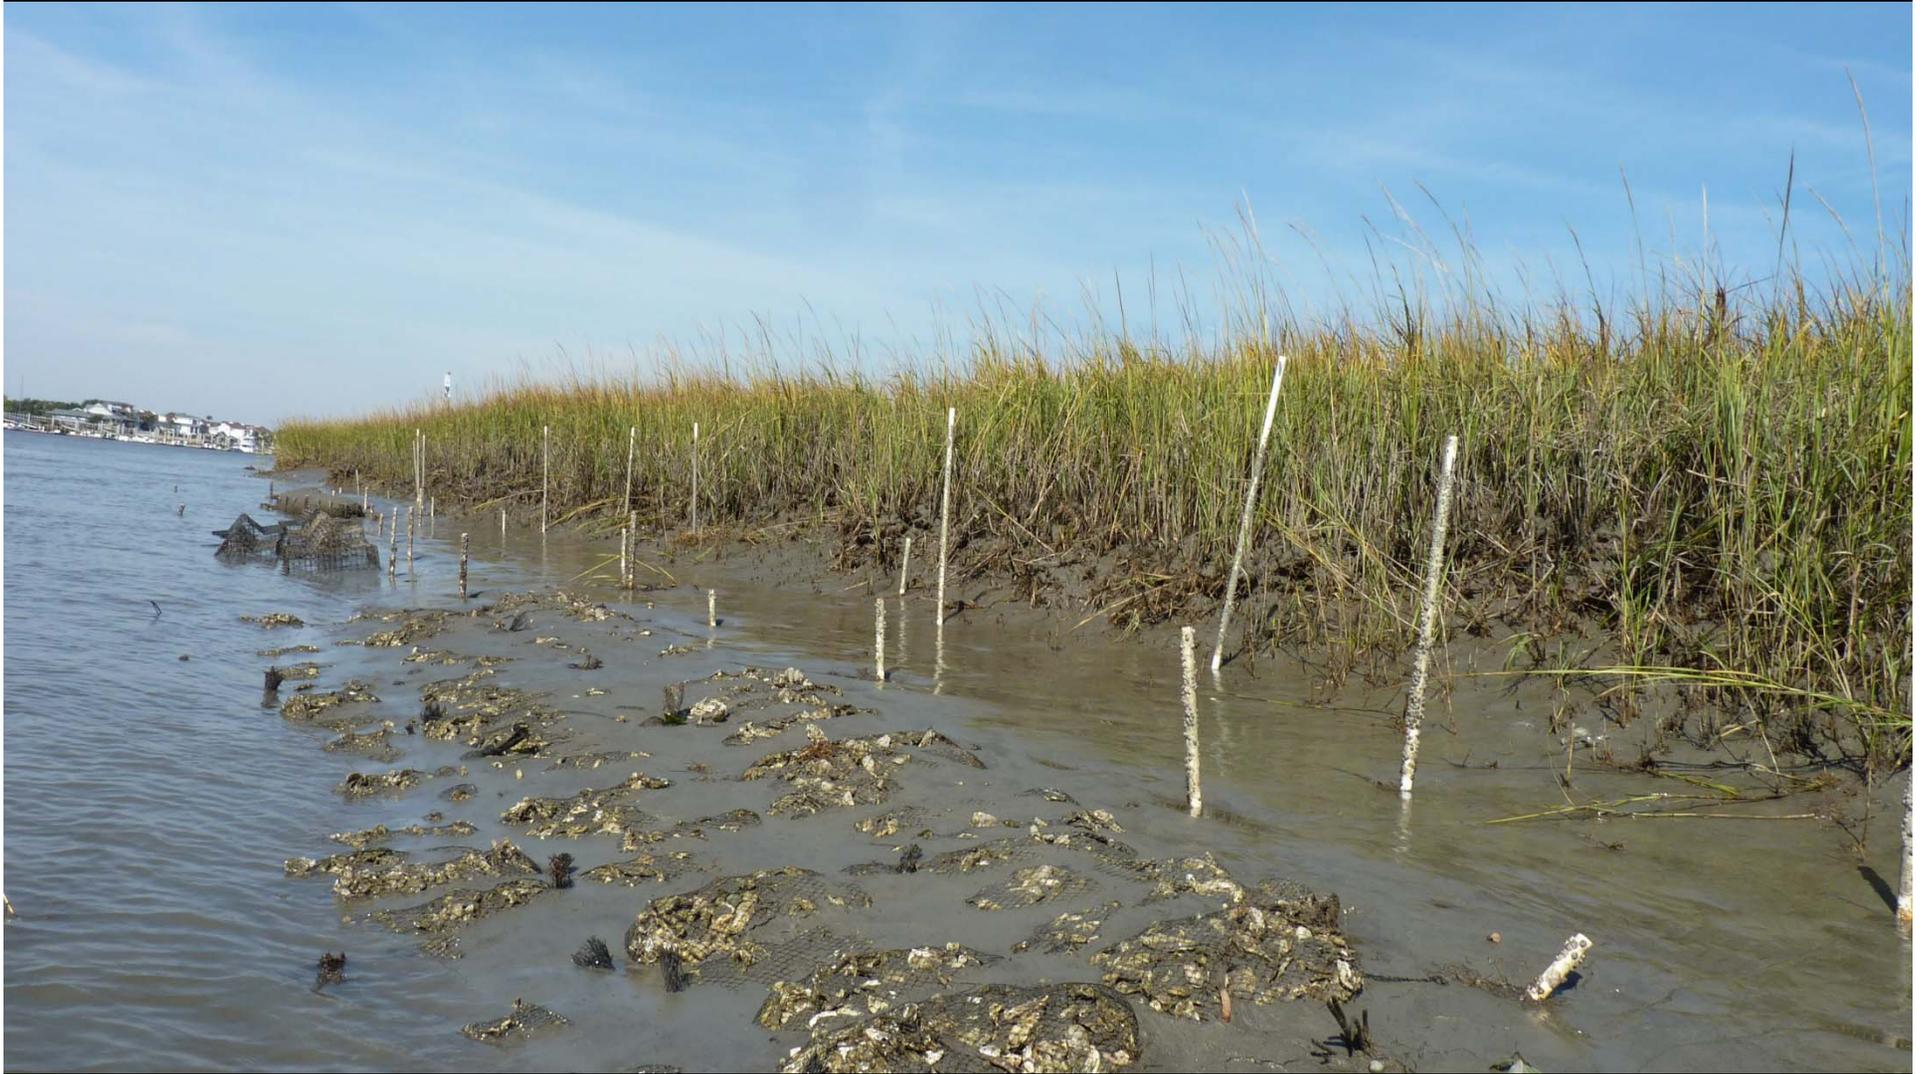
Big Bay Creek, Oct 14th 2016

... and less than 3 months later

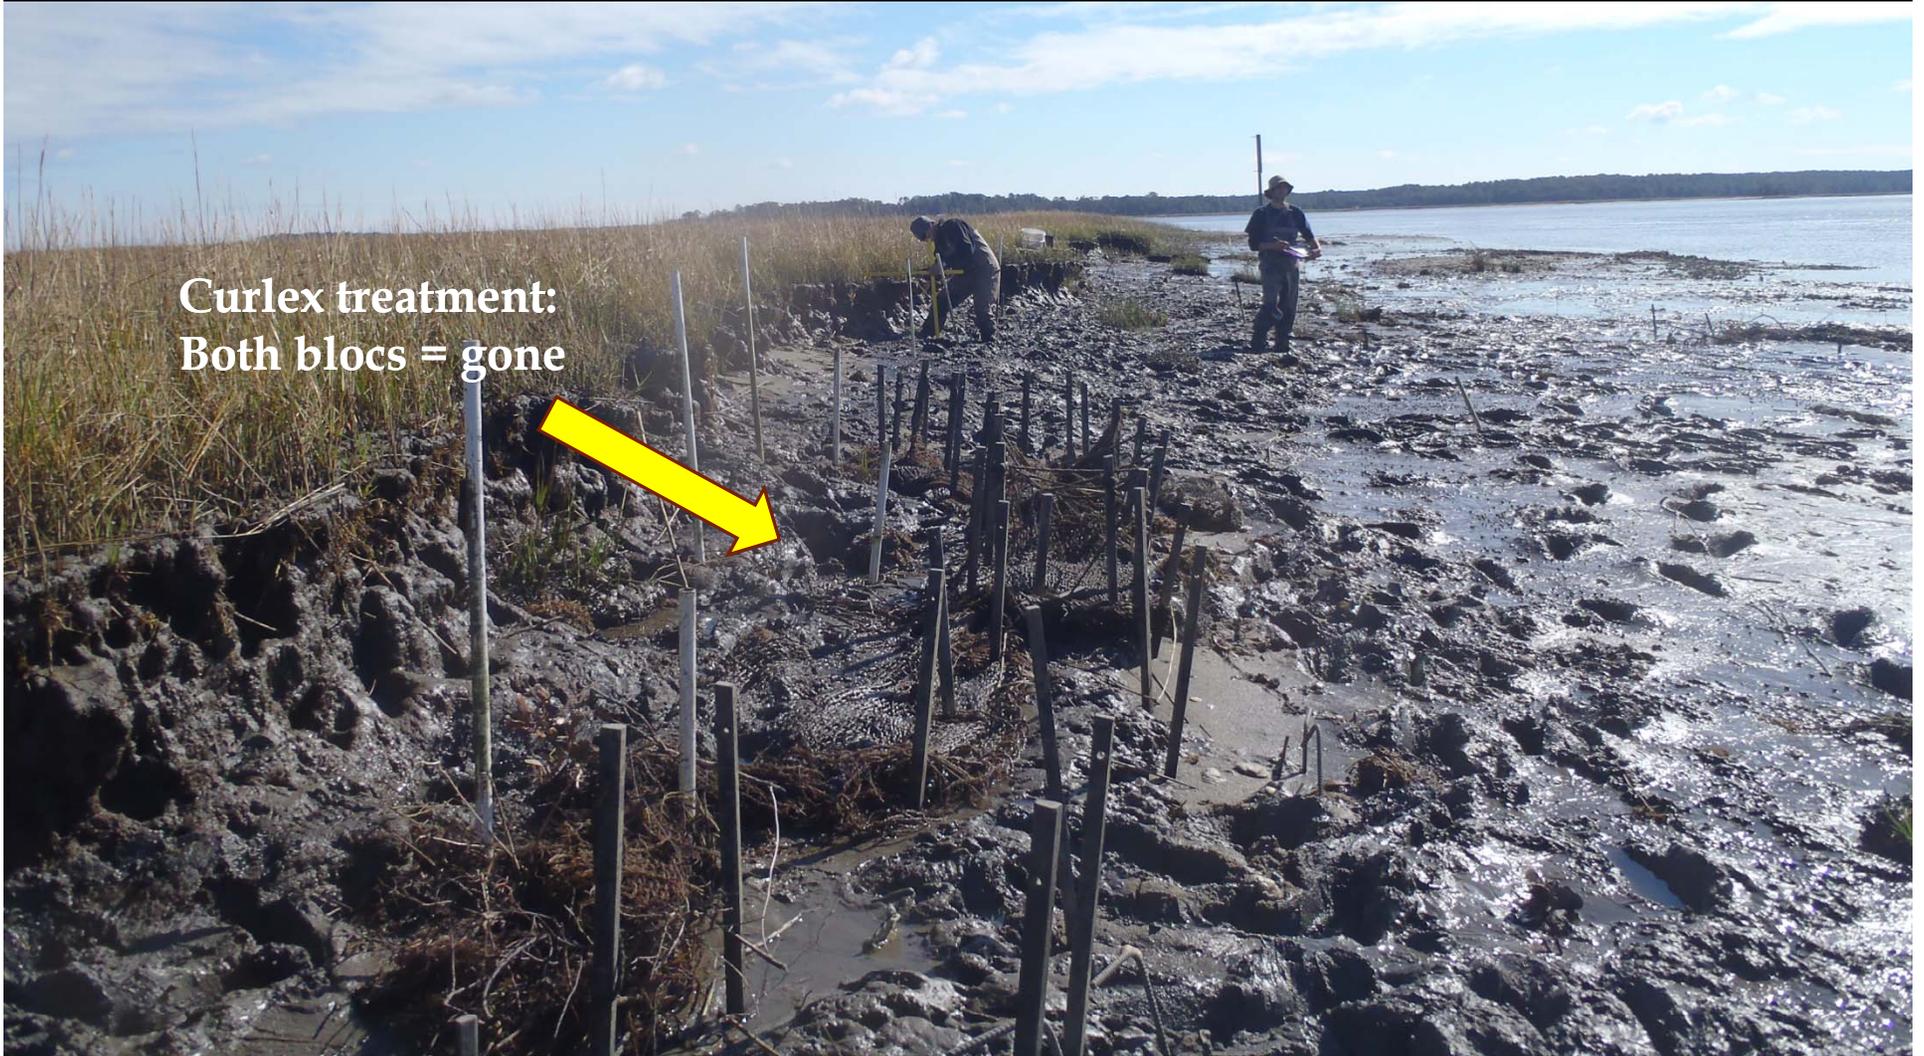
Morgan Island, Nov 14th 2016

Curlex treatment:
Both blocs = gone

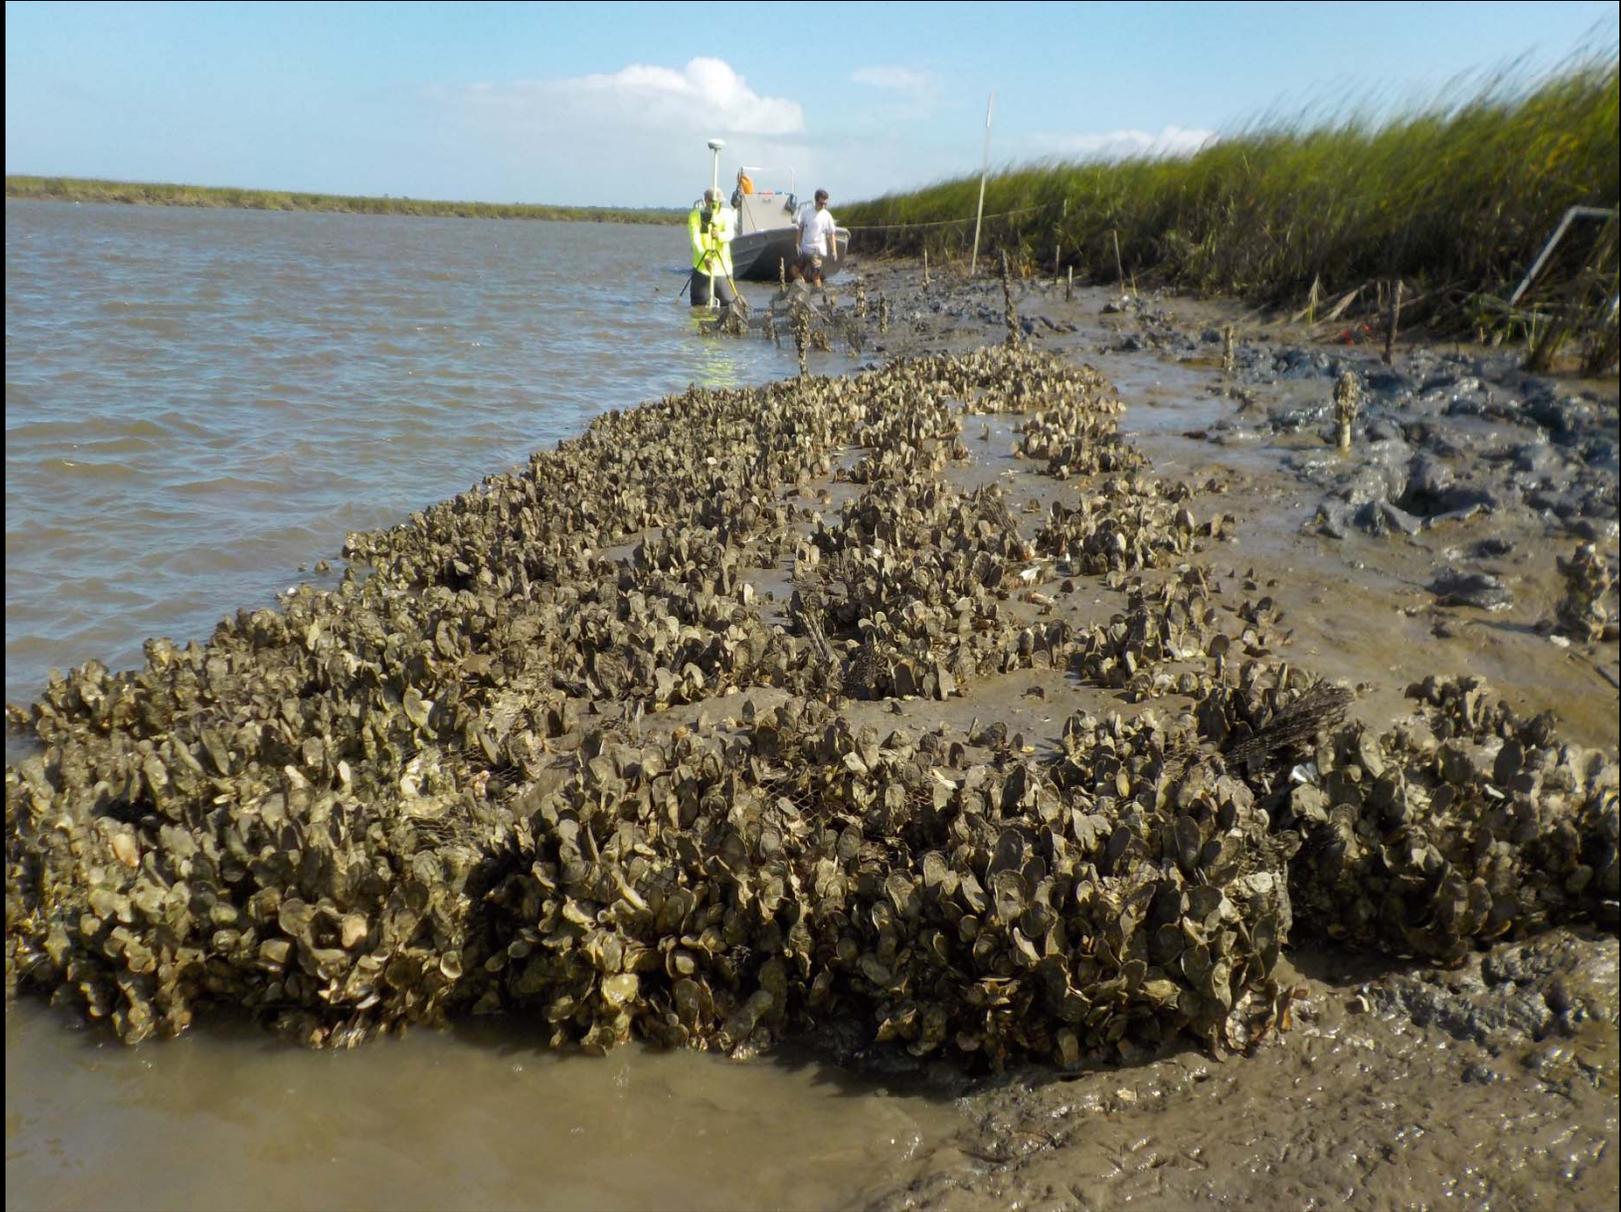
Abbapoola, Oct. 2017

Bagged oyster shell on pallets (15 months)

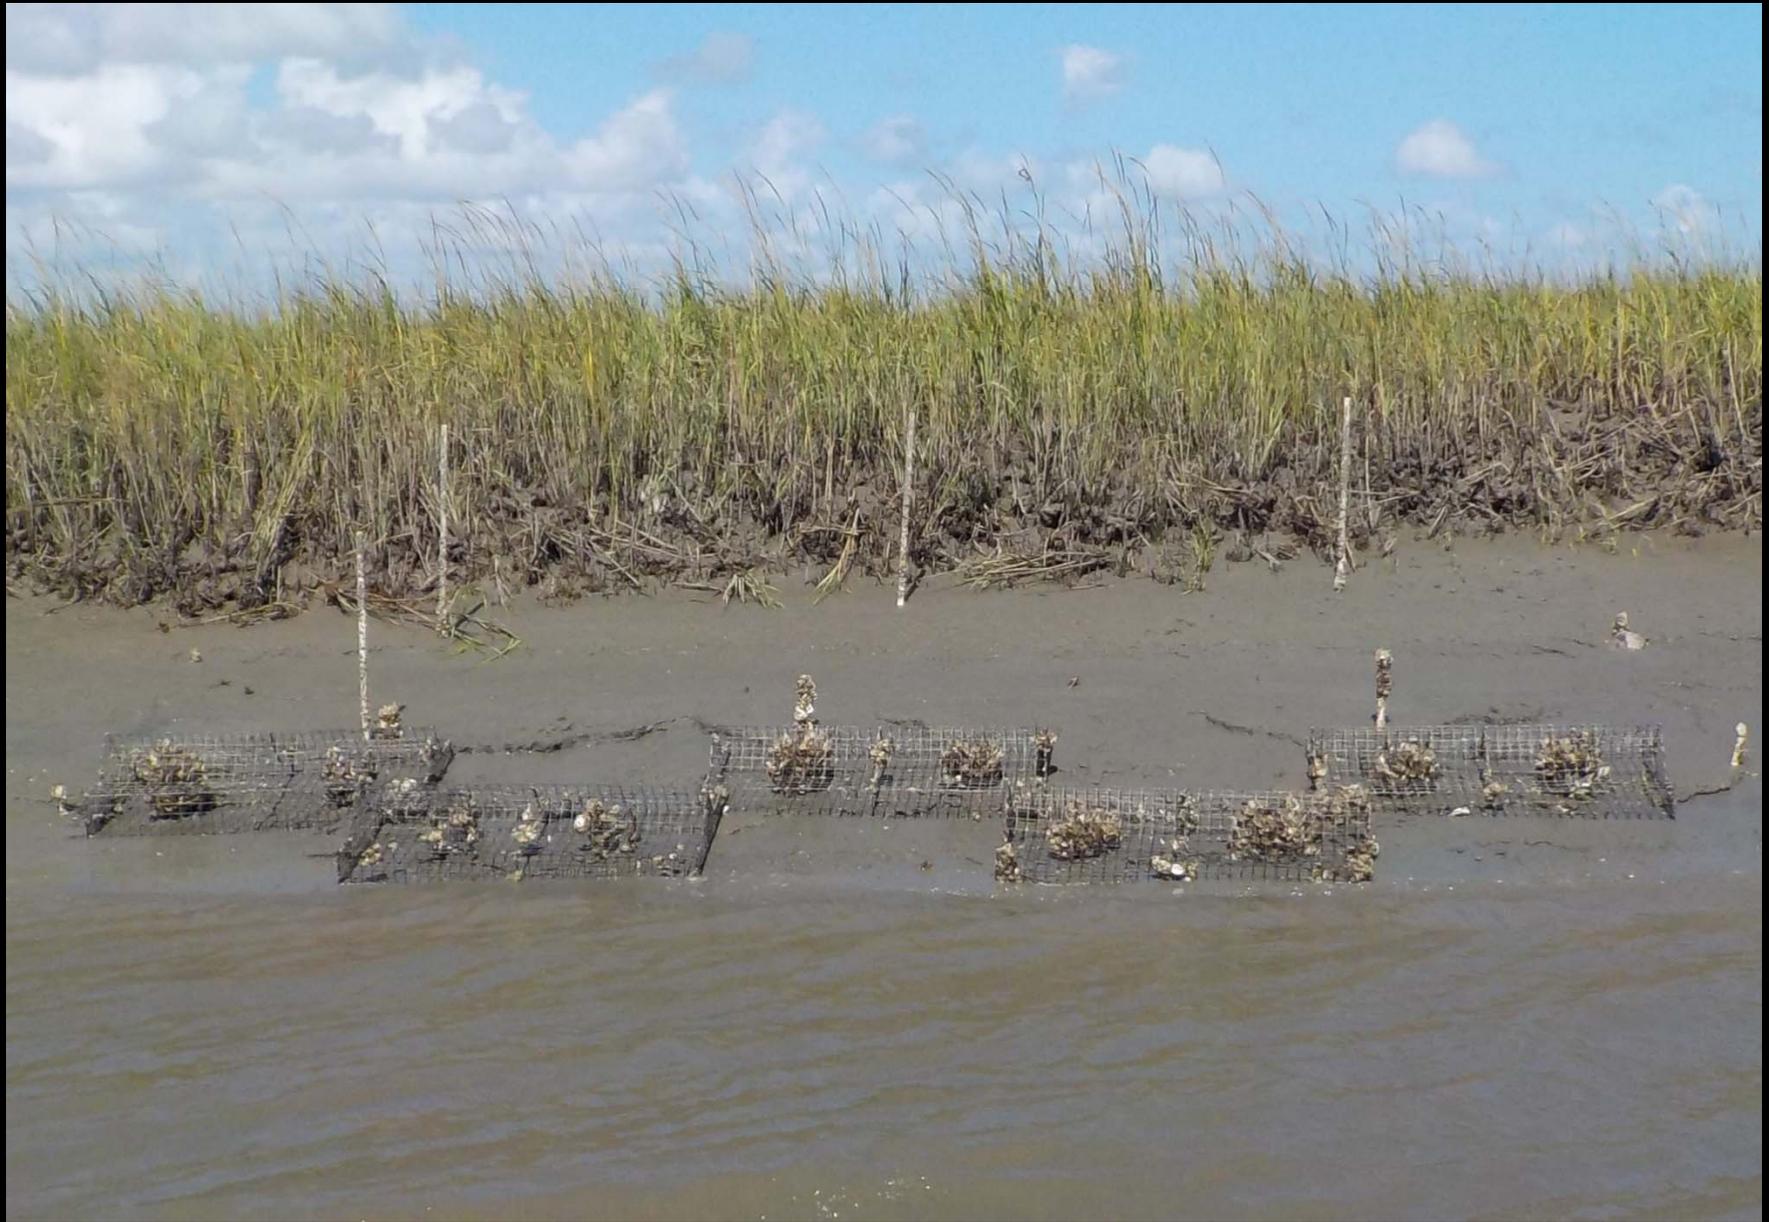
Big Bay Creek, Oct. 2017

Modified crab traps (14 months)

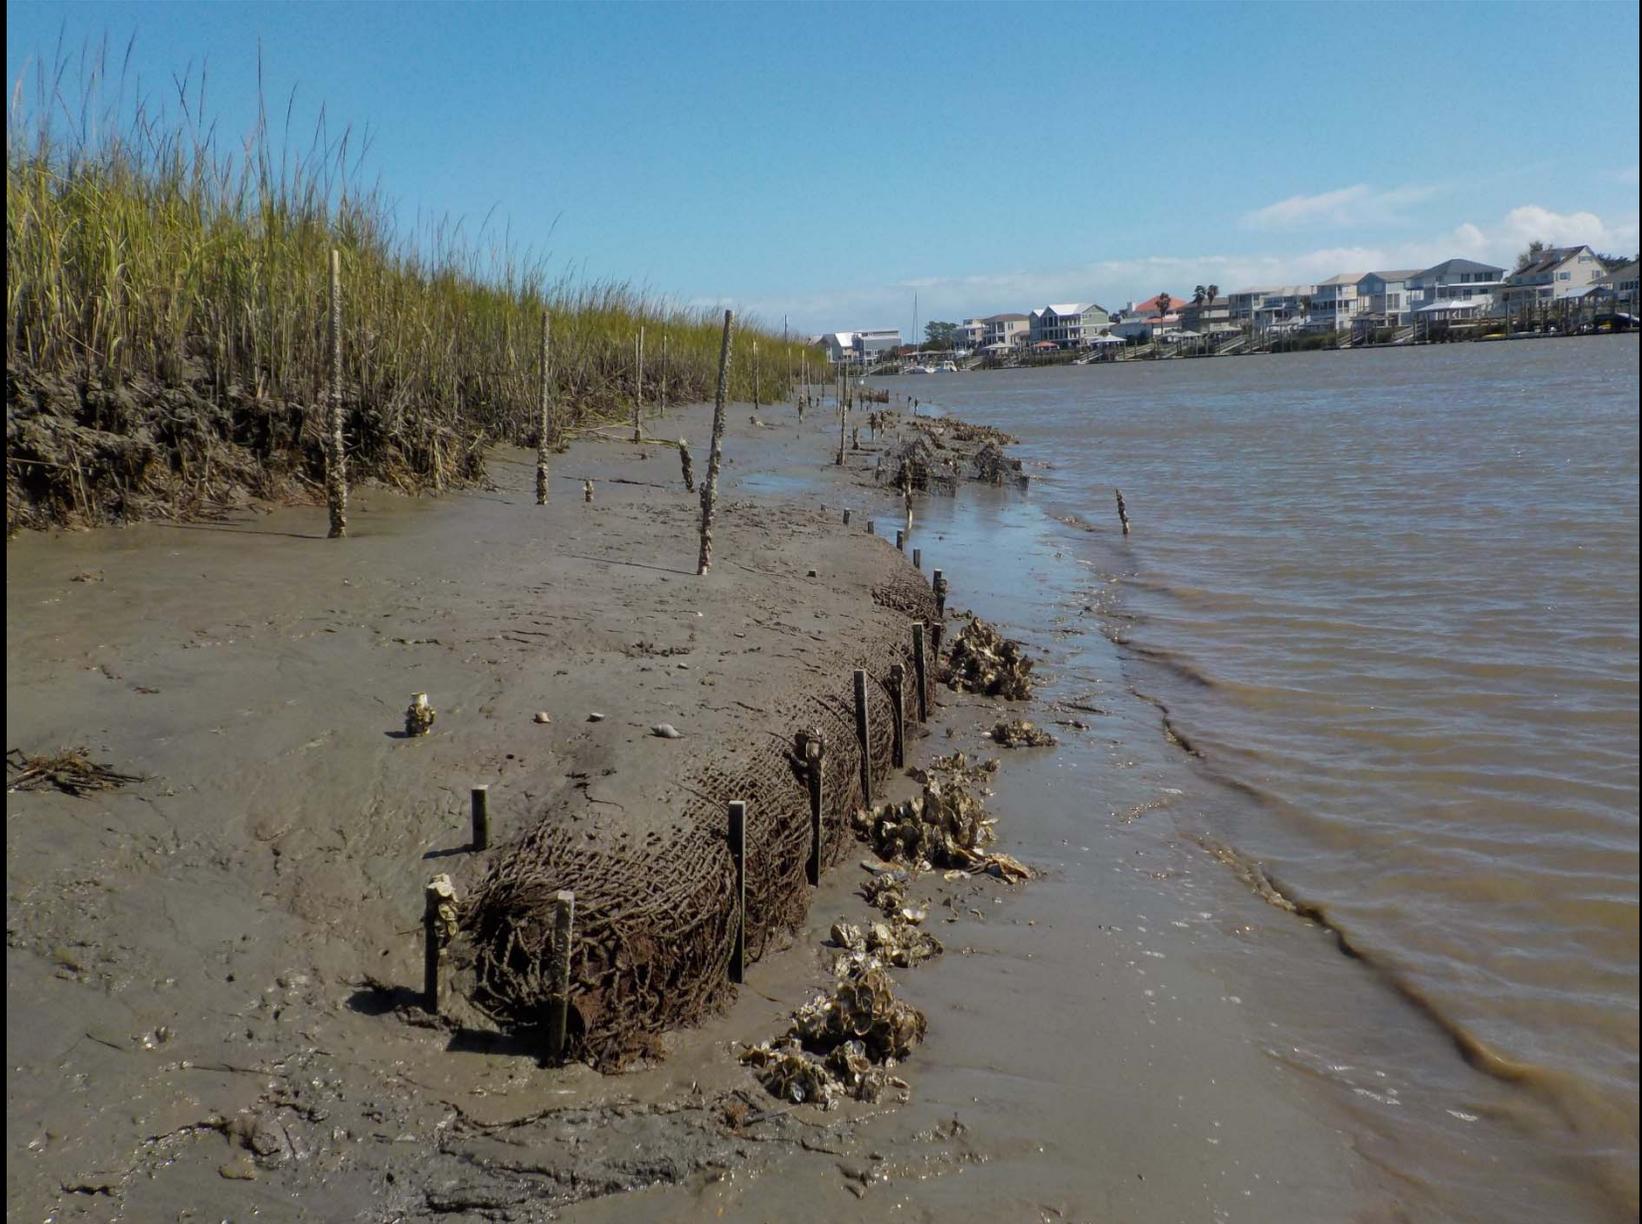
Big Bay Creek, Oct. 2017

Coir Log (14 months)

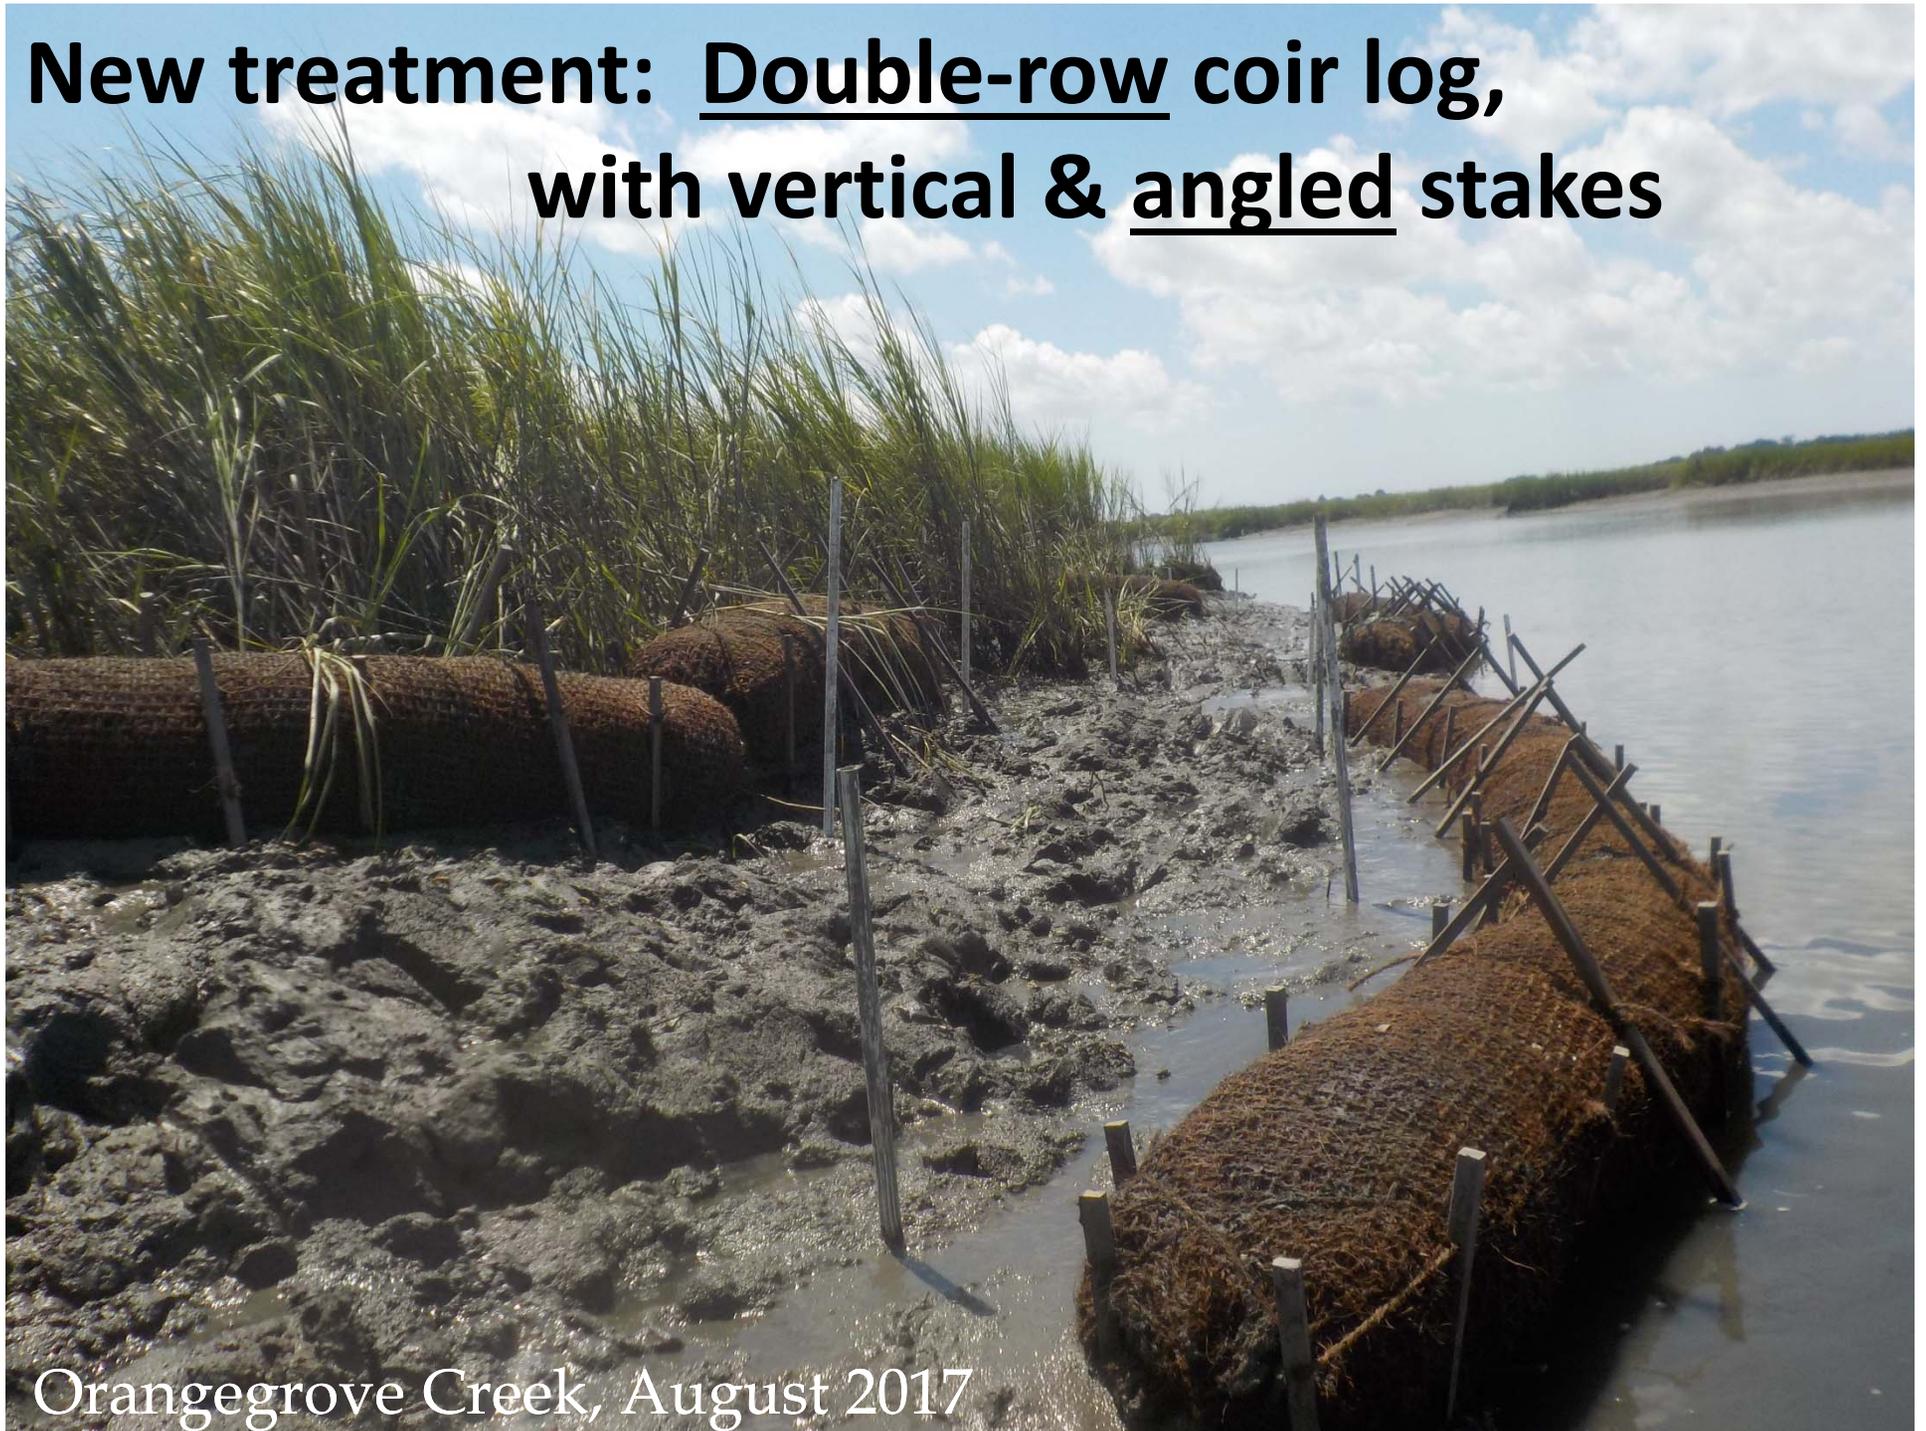
Orangegroove Creek, August 2017

**New treatment: Double-row coir log,
with vertical & angled stakes**
