Evaluating Living Shorelines To Inform Regulatory Decision- Making in South Carolina

Living Shorelines in South Carolina

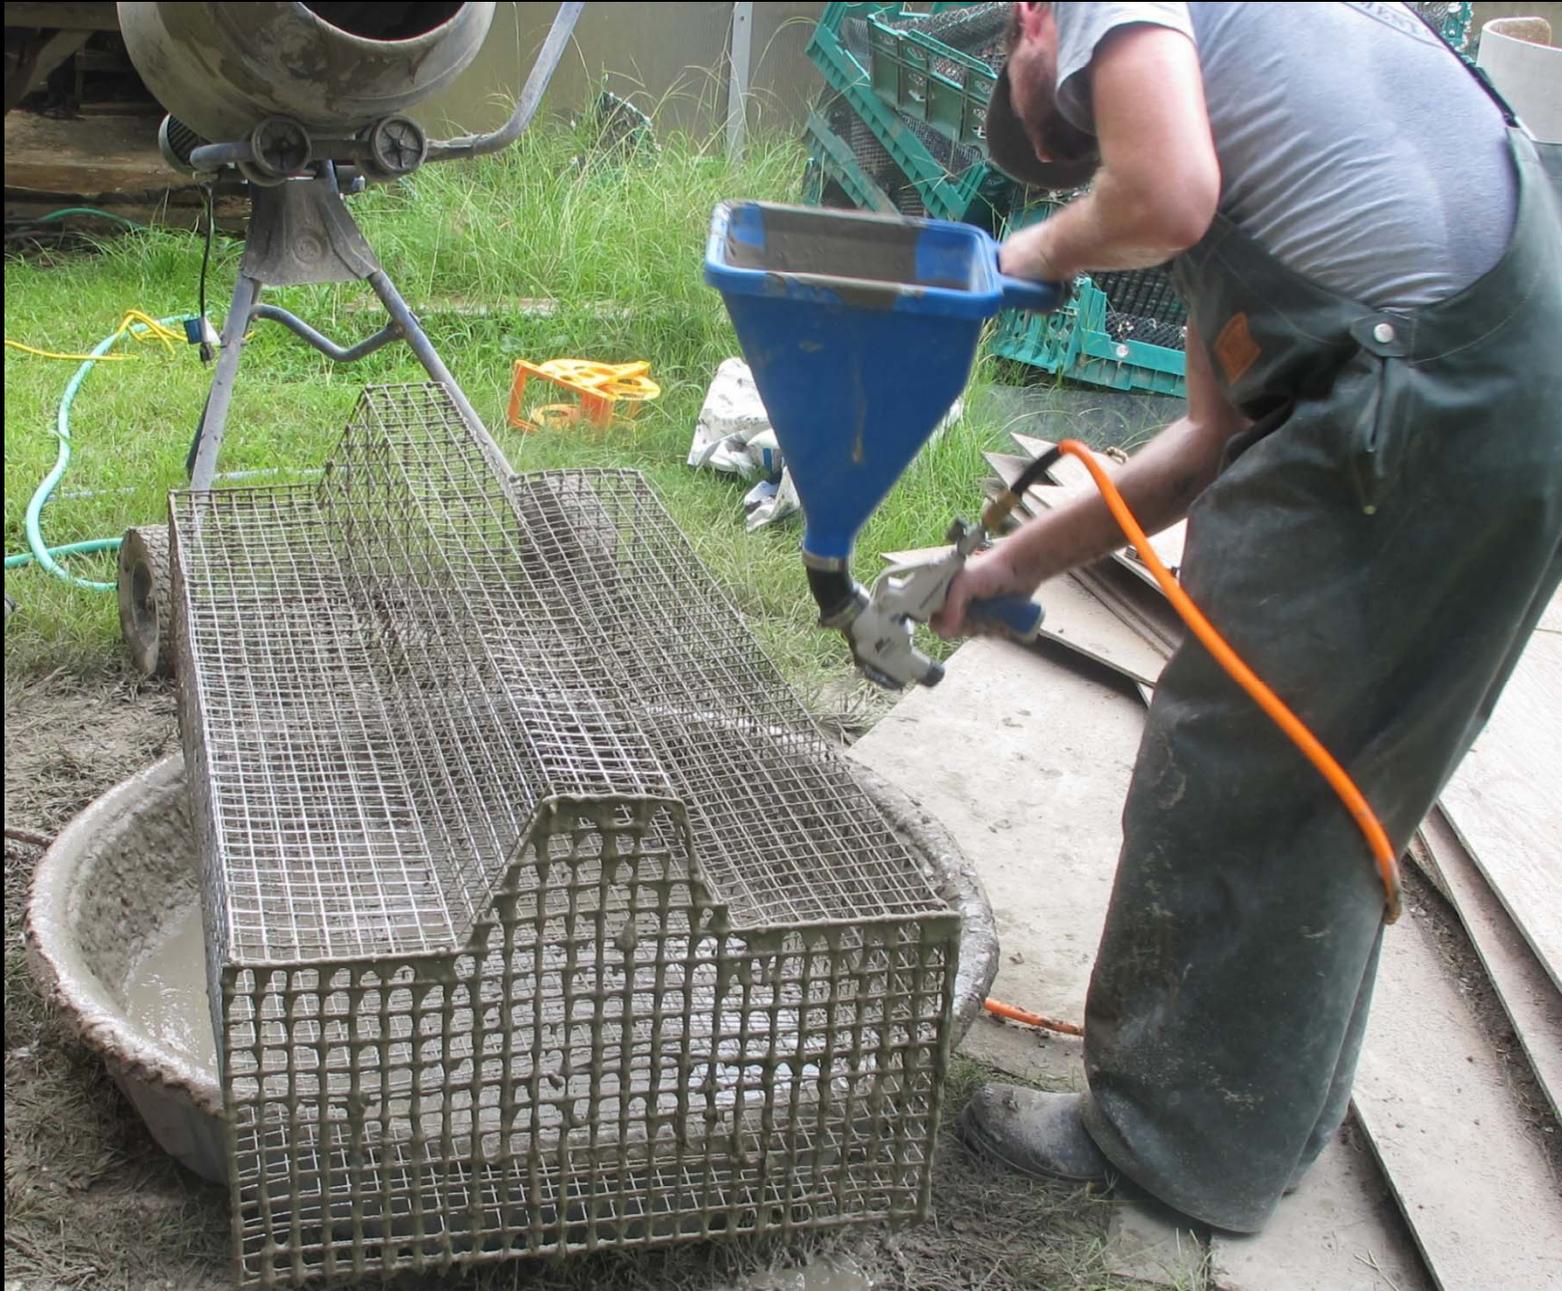
New treatment: Modified crab trap, v.2
