# South Carolina

## Annual State of the Beaches Report

2007

Ocean and Coastal  
Resource Management

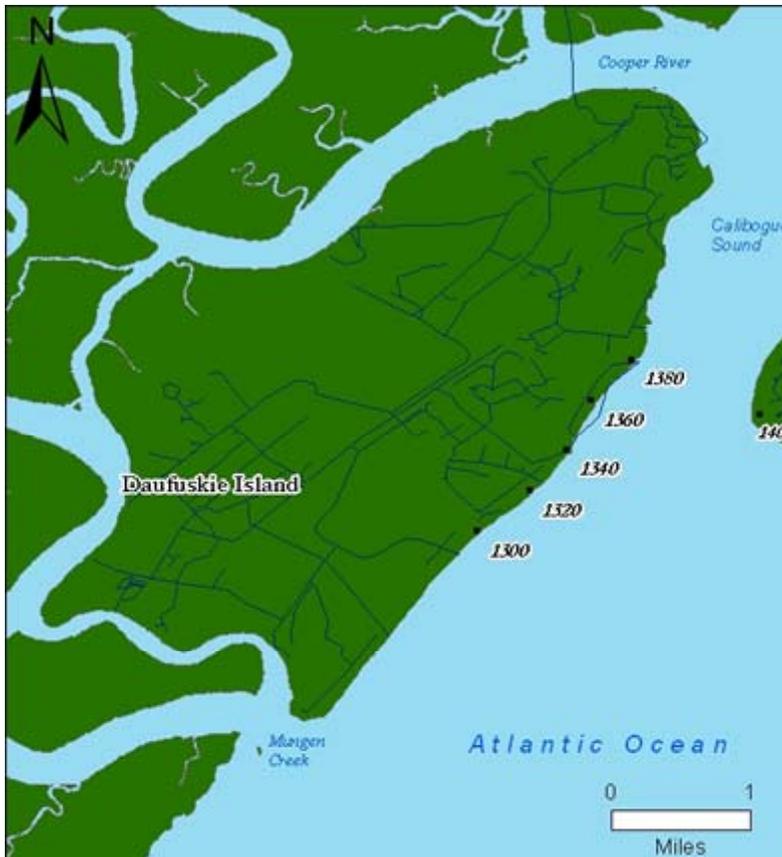
Benchmark	Profiles Collected in 2006	Profiles Collected in 2005	First Survey Year	Total Profiles through 2006
1380	None	08/05	1988	21
1360	None	08/05	1988	25
1340	None	08/05	1988	22
1320	None	08/05	1988	25
1300	None	08/05	1988	23

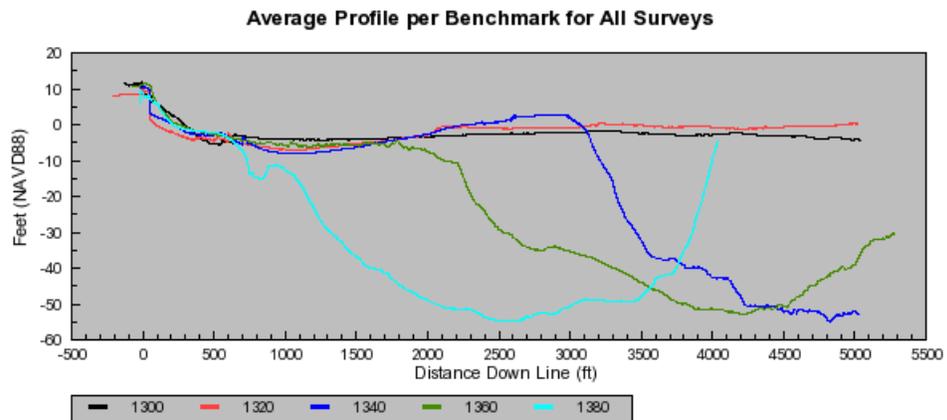
There are a total of 12 monitoring stations on Daufuskie Island, with the earliest beach survey data collected in 1988. Five of these 12 stations were surveyed most recently in October 2002 and August 2005. At station 1300, in the Oak Ridge tract just south of the bulkhead, the beach is still 100 ft wider and 8 ft higher than it was prior to renourishment. At station 1320, in the Melrose Tract about 1200 ft north of the southern end of the bulkhead, the beach is also still 100 ft wider and 8 ft higher than it was prior to renourishment. At 1340, the other station along the bulkhead in the Melrose Tract, the renourishment sand berm has cut back to about half its original width but is still about 75 ft wide. North of the bulkhead station 1360 has been fairly stable since 2002 and still shows a substantial beach renourishment sand berm. At station 1380, located at the northeast end of the development, the renourishment sand berm is also still 150 ft wide and 6 ft high.

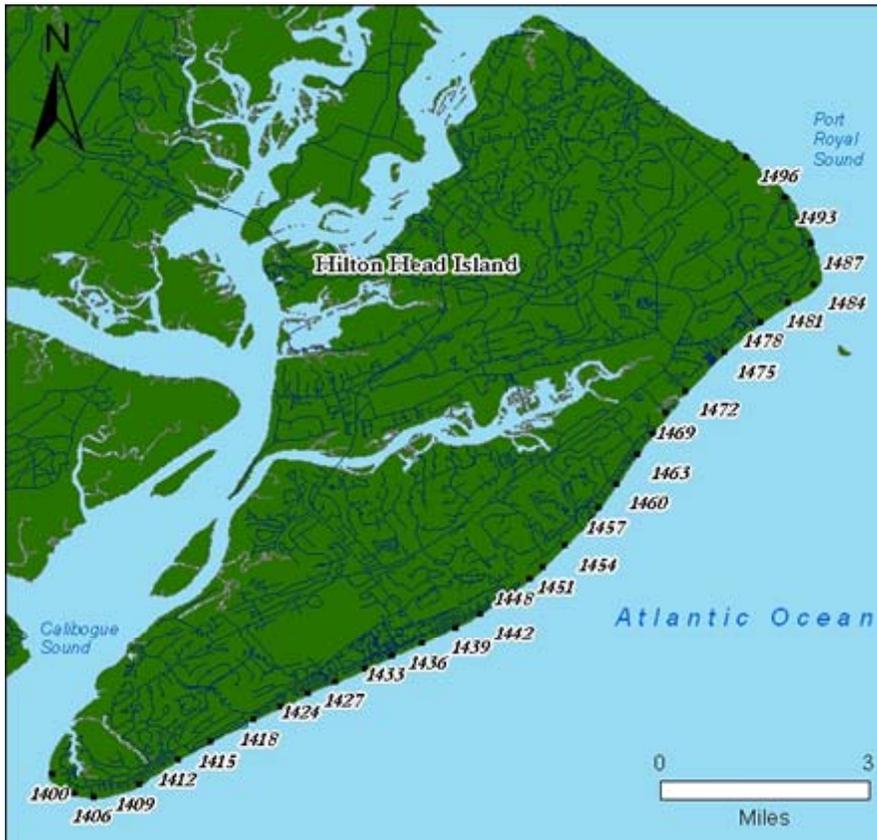
Benchmark	Total Profiles Collected in 2006	Total Profiles Collected in 2005	First Survey Year	Total Profiles
1478	None	None	1988	31
1477	None	None	1990	24
1475	None	08/03	1988	35
1474	None	08/03	1990	23
1472	None	08/03	1988	29
1468	None	08/03	1998	6
1466	None	08/03	1998	6
1465	None	08/03	1998	7
1463	None	08/03	1988	30
1462	None	08/03	1990	30

1460	None	08/03	1988	31
1457	None	08/03	1988	30
1456	None	08/03	2002	3
1454	None	08/03	1988	36
1451	None	08/03	1988	31
1448	None	None	1998	1
1446	None	08/03	1990	24
1445	None	08/03	1988	36
1444	None	08/04	1990	23
1442	None	08/04	1988	31
1440	None	08/04	1990	25
1439	None	08/04	1988	31
1438	None	08/04	1990	30
1437	None	08/04	1990	12
1436	None	08/04	1998	7
1433	None	08/04	1988	32
1430	None	08/04	1988	36
1427	None	08/04	1988	30
1424	None	08/04	1998	7
1421	None	08/04	1988	30
1418	None	08/04	1988	36
1417	None	08/04	1990	23
1415	None	None	1988	29
1412	None	None	1988	32
1409	None	None	1998	5

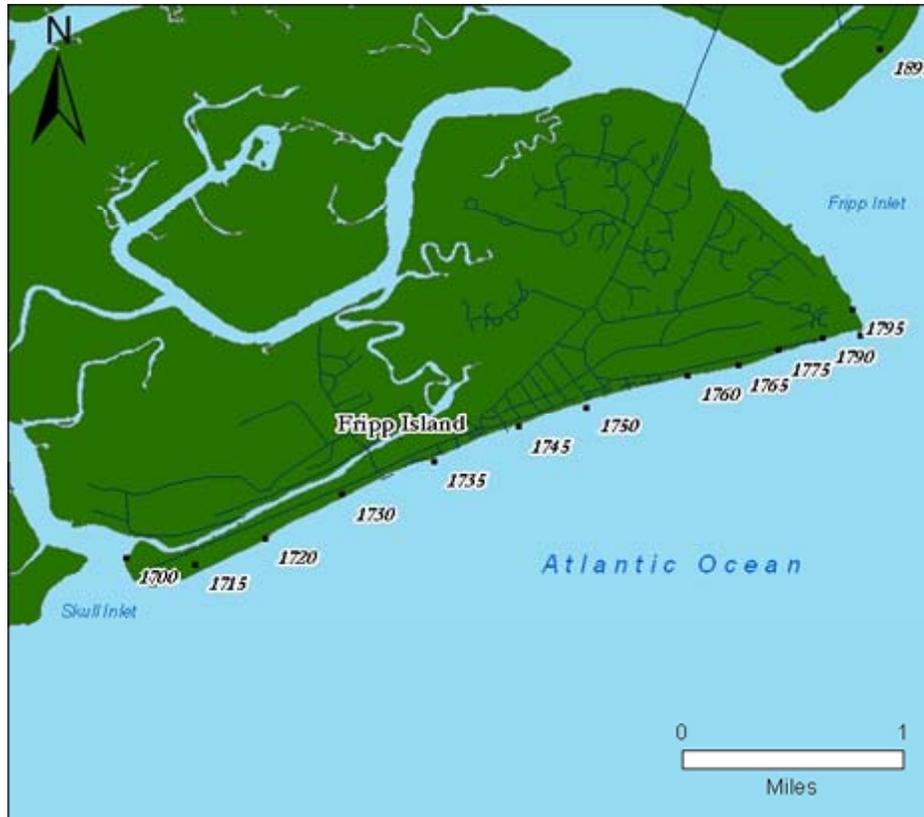
Benchmark	Profiles Collected in 2006	Profiles Collected in 2005	First Survey Year	Total Profiles
1765	None	07/13	1998	3
1760	None	07/13	1998	3
1755	None	07/13	1990	23
1745	None	07/13	1988	33
1735	None	07/13	1989	21
1730	None	07/13	1988	26
1720	None	07/13	1989	36
1715	None	07/13	1988	30

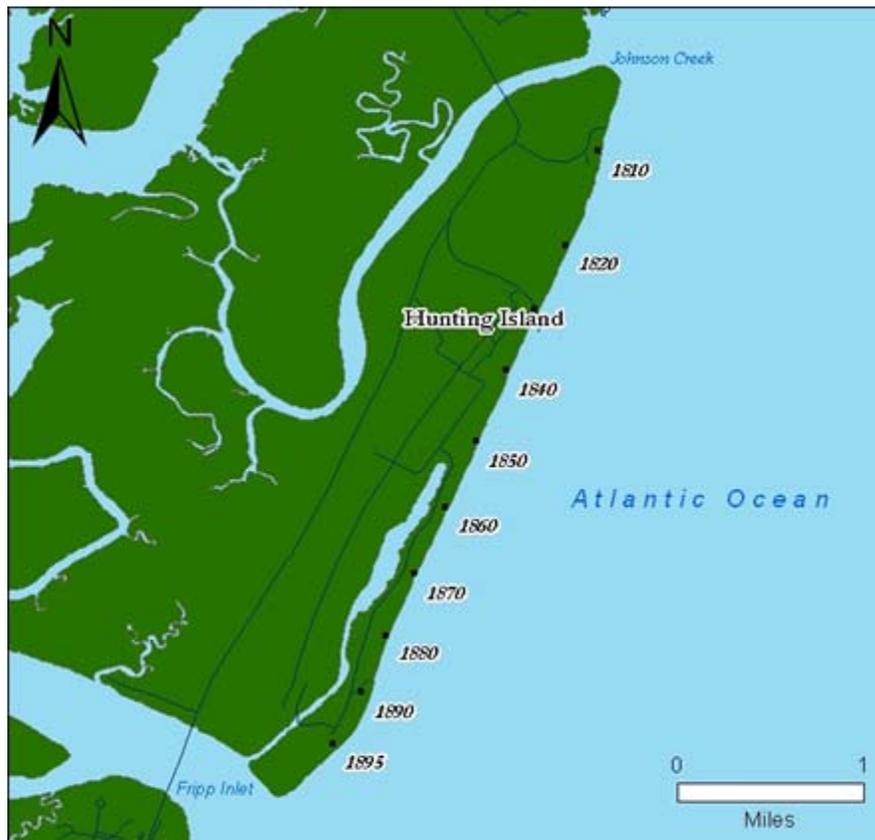
Benchmark	Profiles Collected in 2006	Profiles Collected in 2005	First Survey Year	Total Profiles
1895	None	None	1988	19
1890	None	None	1988	17
1880	None	None	1988	20
1870	None	None	1988	18
1860	None	None	1988	23
1850	None	None	1988	29

1840	None	None	1988	27
1830	None	None	1988	34
1820	None	None	1988	29
1810	None	None	1988	20
1800	None	None	1988	10

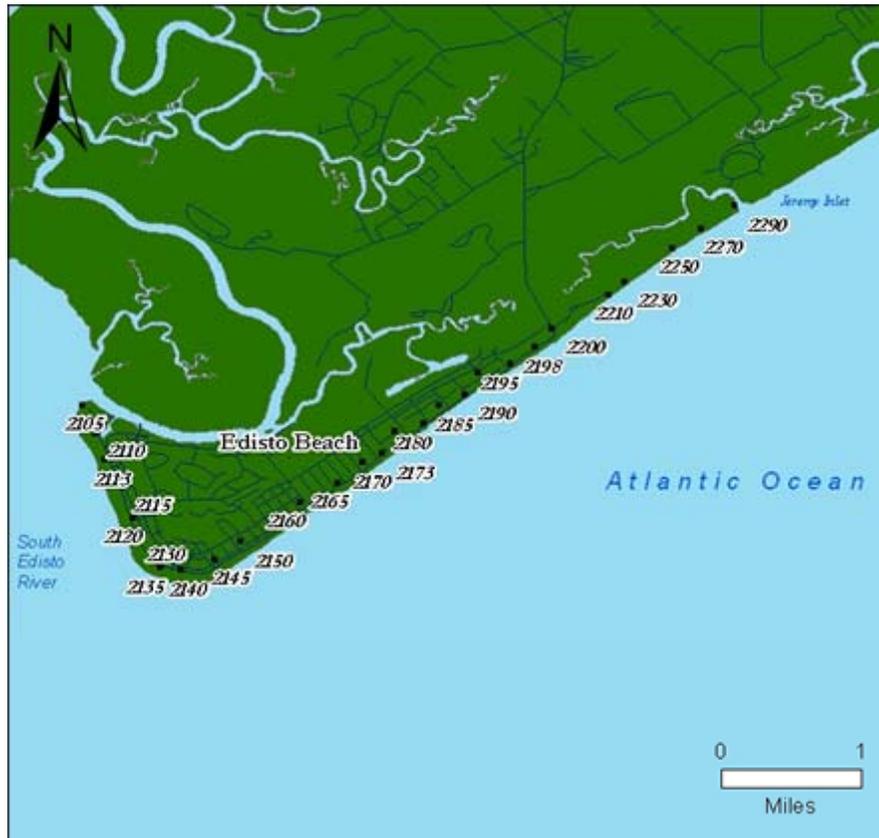
<b>Benchmark</b>	<b>Profiles Collected in 2006</b>	<b>Profiles Collected in 2005</b>	<b>First Survey Year</b>	<b>Total Profiles</b>
2230	11/29	07/12	1988	37
2200	11/29	07/12	1988	35

2198	11/29	None	1998	5
2195	11/29	07/12	1988	36
2193	11/29	07/12	1990	31
2190	11/29	07/12	1988	34
2185	11/29	07/12	1990	32
2180	11/29	07/12	1988	36
2178	11/29	07/12	1990	31
2173	11/29	07/12	1990	30
2170	11/29	07/12	1988	23
2165	11/29	07/12	1990	21
2160	11/29	07/12	1988	22
2155	11/29	07/12	1990	19
2150	11/29	None	2006	1
2145	11/29	None	2006	1
2135	11/29	None	2006	1
2130	11/29	None	2006	1
2120	11/29	None	2006	1
2113	11/29	None	2006	1
2110	None	None	1988	22

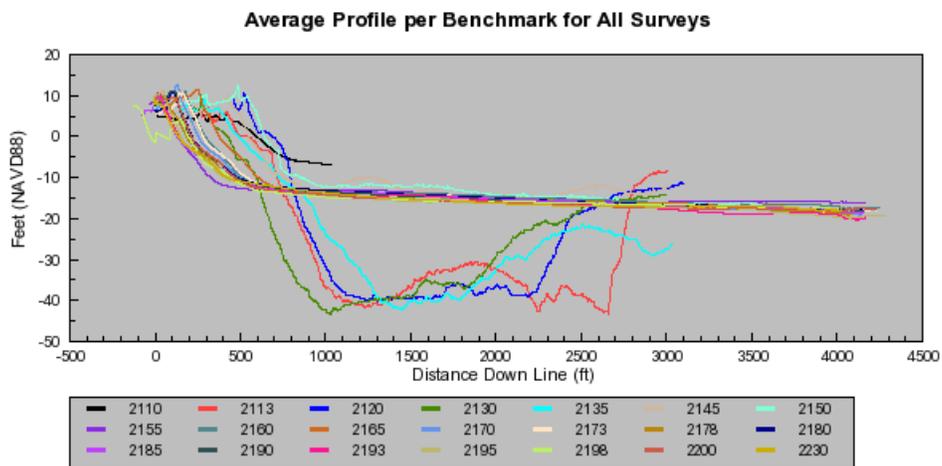
Stations 2110-2130 are located along the South Edisto Inlet shoreline. These stations are sheltered from the open ocean and generally experience only modest seasonal changes on the intertidal beach. Stations 2135 at Edisto Street and 2140 at Billow Street are located on The Point, the shoreline curve between the South Edisto River and the Atlantic Ocean. Historically this section of beach can be very dynamic but has remained stable in recent years. Profile 2230 has exhibited a slow and minor decrease in volume since 1990, from approximately 70 cubic yards per ft of beach to 50 cubic yards per ft of beach across the entire profile. However between July 2005 and late November 2006, the profile has migrated seaward approximately 70 ft.

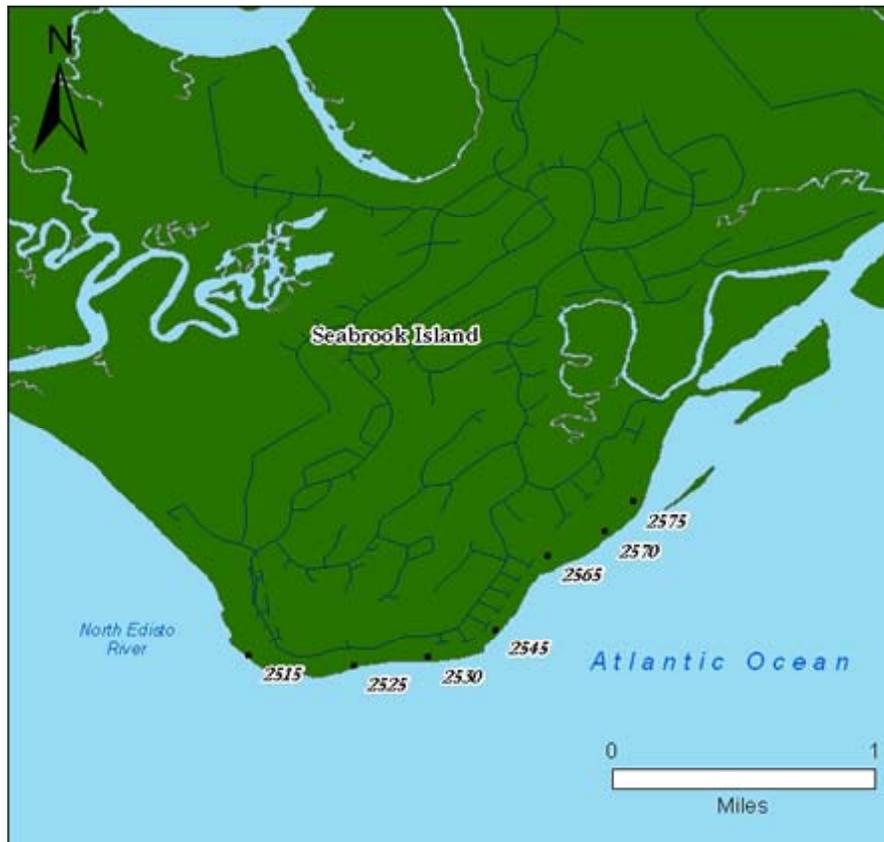
Benchmark	Profiles collected in 2006	Profiles collected in 2005	First Survey Year	Total Profiles
2570	None	09/03	1998	6
2565	None	09/03	1998	6

2545	None	09/03	1998	6
------	------	-------	------	---

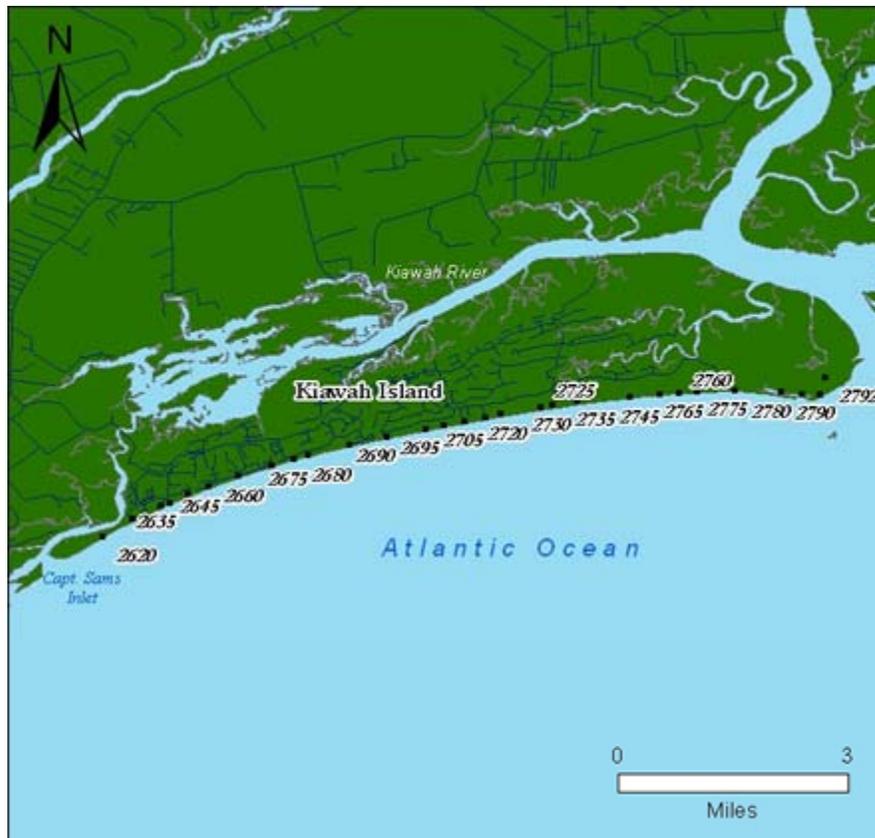
<b>Benchmark</b>	<b>Profiles Collected in 2006</b>	<b>Profiles Collected in 2005</b>	<b>First Survey Year</b>	<b>Total Profiles</b>
2775	None	None	2001	2
2765	None	None	1999	5
2760	None	None	1999	5
2755	None	None	2001	1

2750	None	05/31	1998	6
2735	None	05/31	1998	5
2730	None	05/31	1998	7
2725	None	05/31	1998	7
2720	None	05/31	1998	7
2715	None	05/31	1998	7
2705	None	05/31	1998	7
2700	None	05/31	1998	6
2695	None	05/31	1998	7
2690	None	05/31	1998	7
2685	None	05/31	1998	7
2680	None	None	1998	6
2675	None	06/01	1998	7
2665	None	None	1998	5
2660	None	06/01	1998	7
2645	None	06/01	1998	7
2640	None	06/01	1998	7
2635	None	06/01	1998	6
2630	None	06/01	1998	6
2625	None	06/01	1998	6

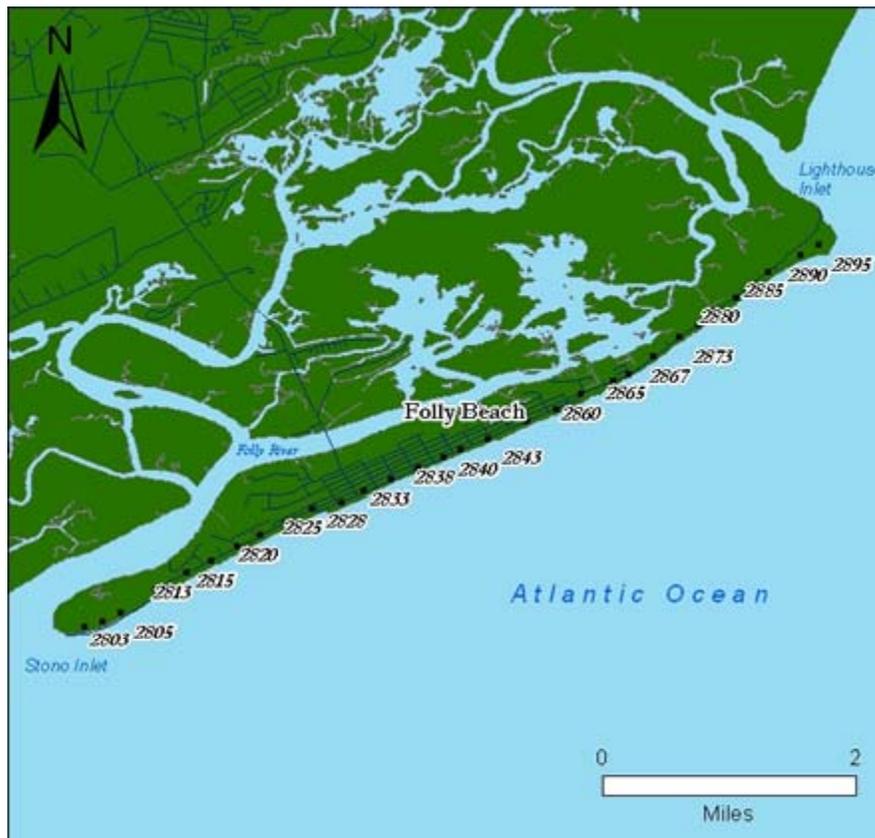
<b>Benchmark</b>	<b>Profiles Collected in 2006</b>	<b>Profiles Collected in 2005</b>	<b>First Survey Year</b>	<b>Total Profiles</b>
2890	01/24	04/13	1988	22
2885	01/24	04/13	1988	27
2883	01/24	04/13	1988	30
2880	01/24	04/13	1988	32
2878	01/24	04/13	1988	30
2873	01/24	04/13	1988	31
2867	01/24	04/13	1990	18
2865	01/24	04/13	1988	29
2863	01/24	04/13	1990	28
2860	01/24	04/13	1998	11
2855	01/24	04/13	1988	29
2850	01/24	04/13	1988	33
2843	01/24	04/13	1988	28
2840	01/24	04/13	1988	23
2838	01/25	04/13	1988	29
2835	01/25	04/13	1988	30
2833	01/25	04/13	1988	29
2832	None	None	1988	18
2830	01/25	04/13	1988	29
2828	01/25	04/22	1988	32
2825	01/25	04/22	1998	11
2823	01/25	04/22	1998	11
2820	01/25	04/22	1999	9
2818	01/25	04/22	1999	10
2815	01/25	04/22	1999	10
2813	01/25	04/22	2000	7
2810	01/25	04/22	1999	7
2805	01/25	04/22	1999	8
2803	01/25	04/22	1999	6

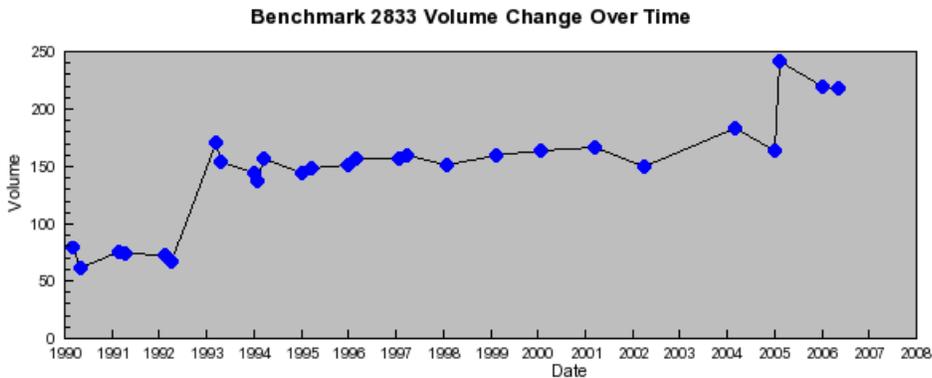
The next section of beach is the first eight blocks east of the Holiday Inn, from station 2833 up to 2843 at 8<sup>th</sup> St. East. This area has a moderate dune over or seaward of the line of rock revetments. Almost all profiles in this area were stable prior to renourishment and gained 180 to 200 ft of berm width during the project.

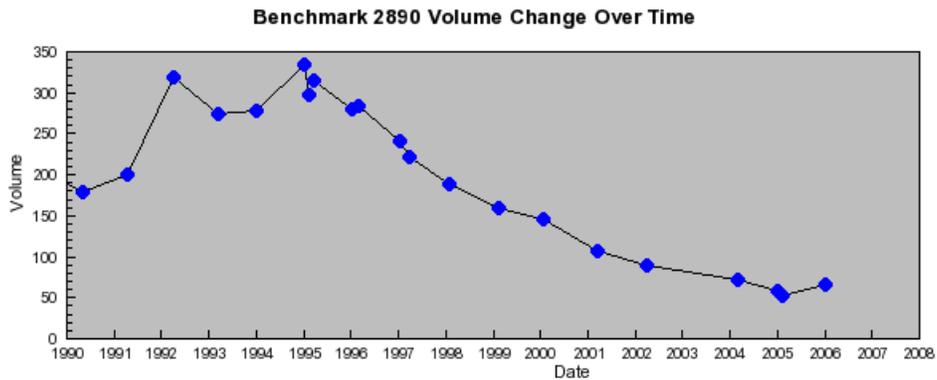
The last monitoring station, 2890 on the former Coast Guard base property, also showed considerable dune scarping and erosion on the upper and intertidal beach during the last ten years. The volume of sand present in the profile has steadily declined since the mid 1990's, and most of the 2005 renourishment project sand has been eroded away.

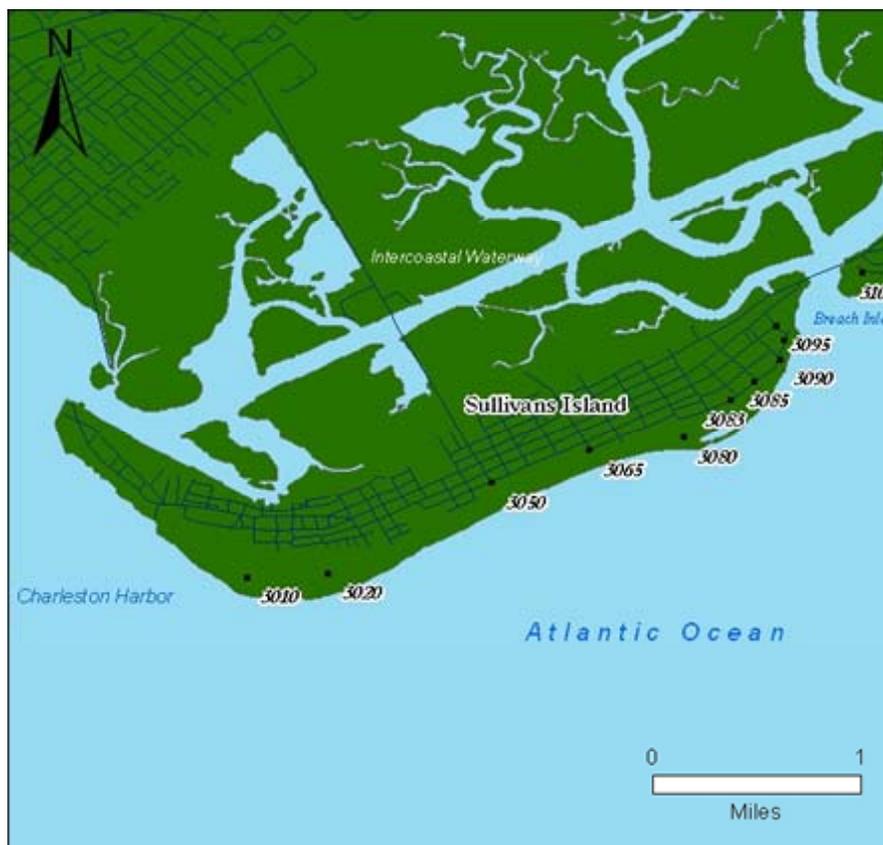
<b>Benchmark</b>	<b>2006</b>	<b>2005</b>	<b>First Survey Year</b>	<b>Total Profiles</b>
3095	None	None	1988	19
3092	10/25	None	1990	18
3090	None	None	1990	20
3085	10/25	None	1990	21
3083	10/25	None	1990	21
3080	10/25	None	1988	26
3065	10/25	None	1988	25

3050	10/25	None	1988	24
3035	10/25	None	1988	20
3020	10/25	None	1988	17
3010	10/25	None	1988	22

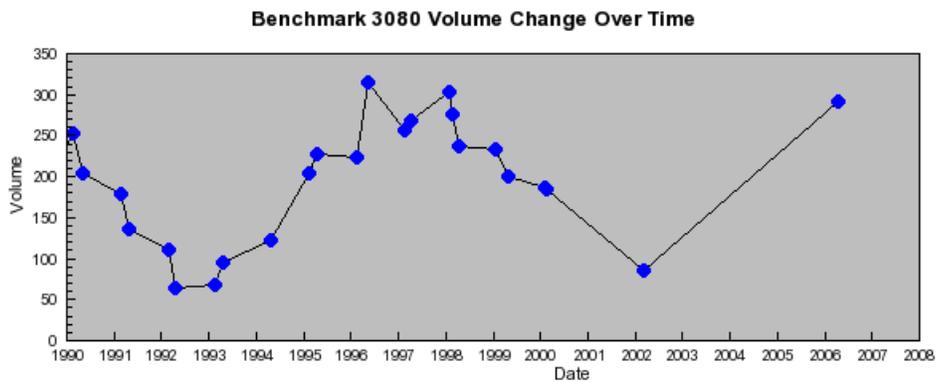
Survey monuments 3050-3080 are located along the center section of Sullivans Island. The area is outside the north jetty and sand shoals from Breach Inlet periodically attach to the beach here, so that long-term trends are accretional but the shoreline is quite dynamic. A massive sand bar welded onto the beach in this area during 2006, increasing the beach width by up to 500 ft. The long period of data collection in this region suggests an approximately ten year cycle between maximum beach widths, particularly adjacent to 3080 and 3085 and this variability is associated with bar-welding to the beach.

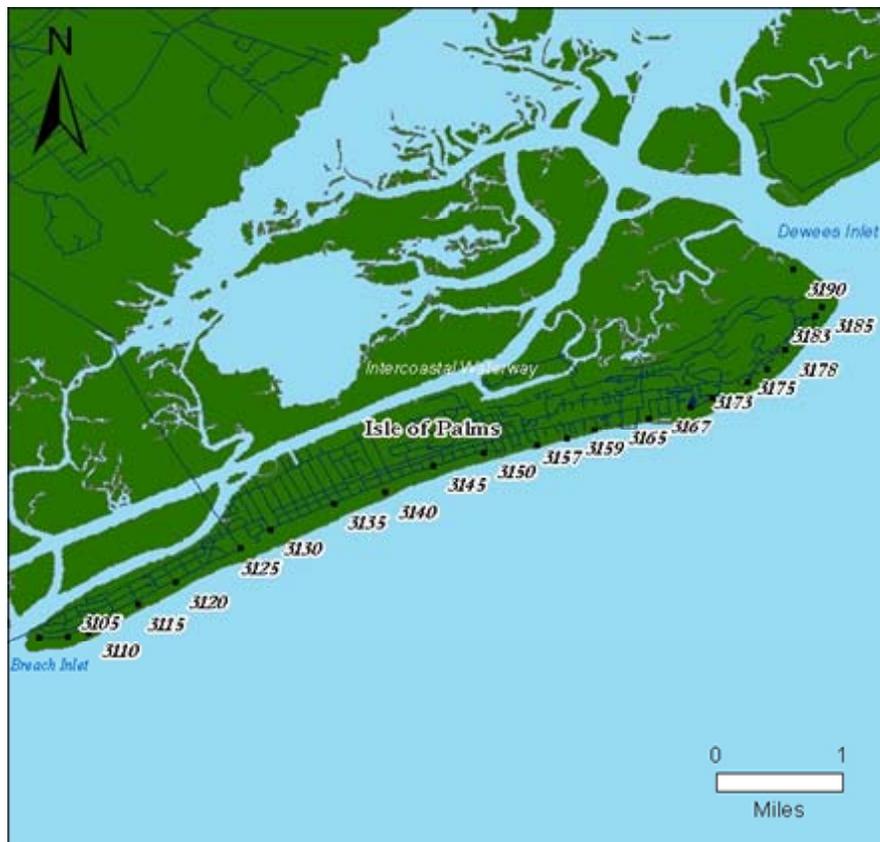
<b>Benchmark</b>	<b>2006</b>	<b>2005</b>	<b>First Survey Year</b>	<b>Total Profiles</b>
3190	None	None	1987	21
3185	None	None	1987	25
3183	None	None	1990	22
3180	None	05/24	1987	30
3178	10/26	05/24	1990	28
3175	10/26	05/24	1987	35
3173	10/26	05/24	1990	30
3170	10/26	05/24	1987	33
3167	10/26	05/24	1990	31
3165	10/26	05/24	1987	23
3160	None	None	1987	21
3159	10/26	05/24	1990	28
3157	10/26	05/24	1990	28
3155	10/26	05/24	1996	15
3150	10/26	05/24	1987	30
3145	10/26	None	1987	22
3140	10/26	05/24	1996	15
3135	10/26	05/24	1987	30
3130	10/26	05/24	1987	24
3125	10/26	05/24	1987	28
3120	10/25	05/24	1987	32
3115	10/25	05/24	1987	30
3110	10/25	None	1987	30
3105	10/25	None	1990	20
3100	10/25	None	1987	24

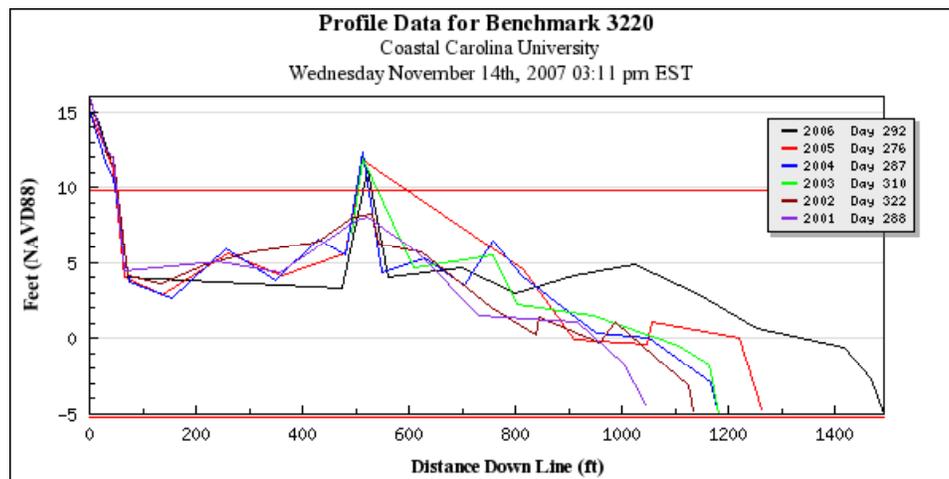
Station 3220 is located on top of a bluff along Dewees Inlet. The beach here can be very dynamic but was fairly stable in 2004 and showed only minor accretion at the seaward end of the profile.

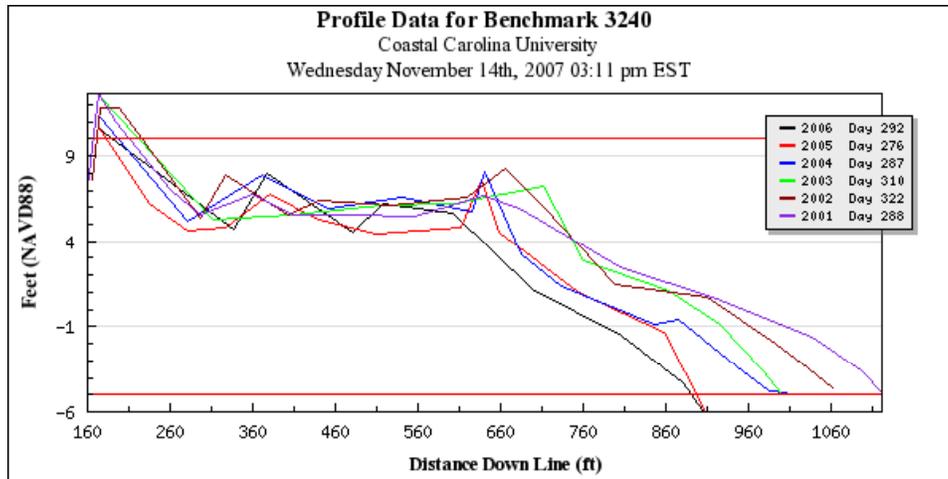
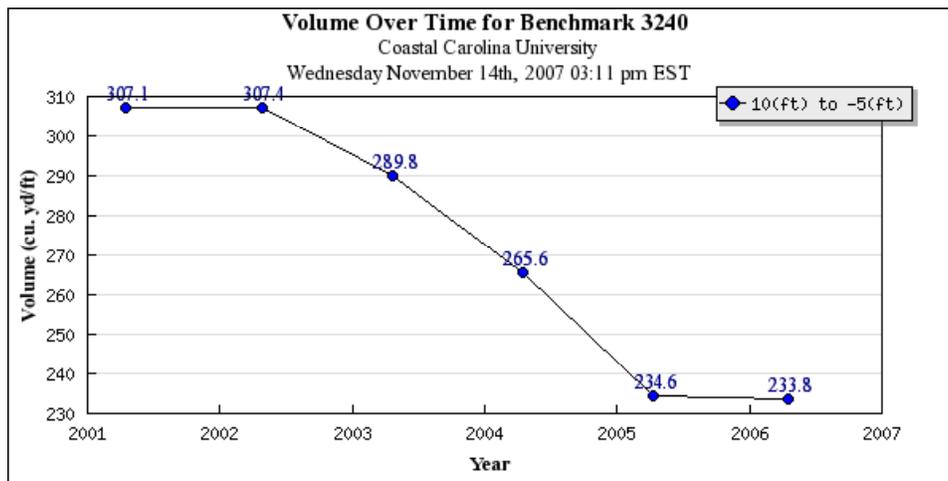
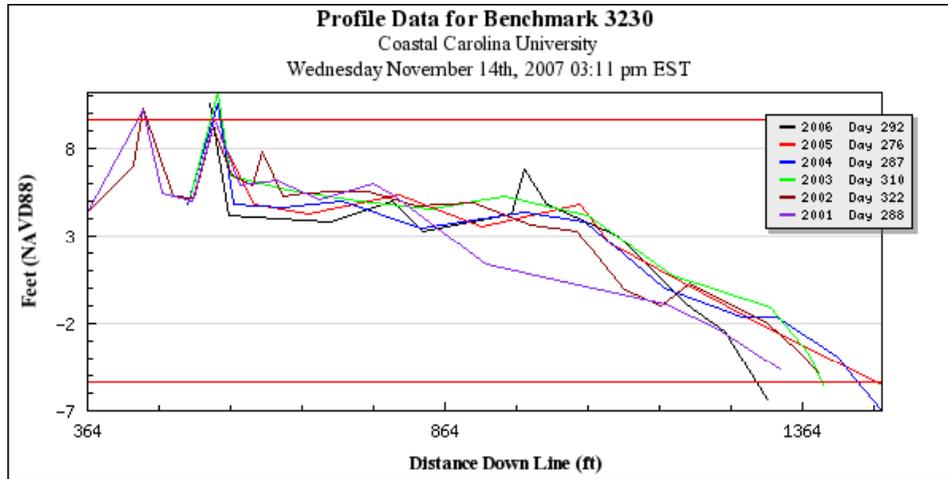
Along the developed southern half of Dewees, station 3220 showed significant accretion through October 2006. Stations 3230, 3250, and 3255 all experienced some erosion at the seaward end of the profile, between the 0 and -5 ft contours, but maintained a net increase in sand across the entire profile. Station 3240 has experienced continuous loss in the profile since 2002, with a landward shift in the berm between 2004 and 2005 and relative stability into October 2006.

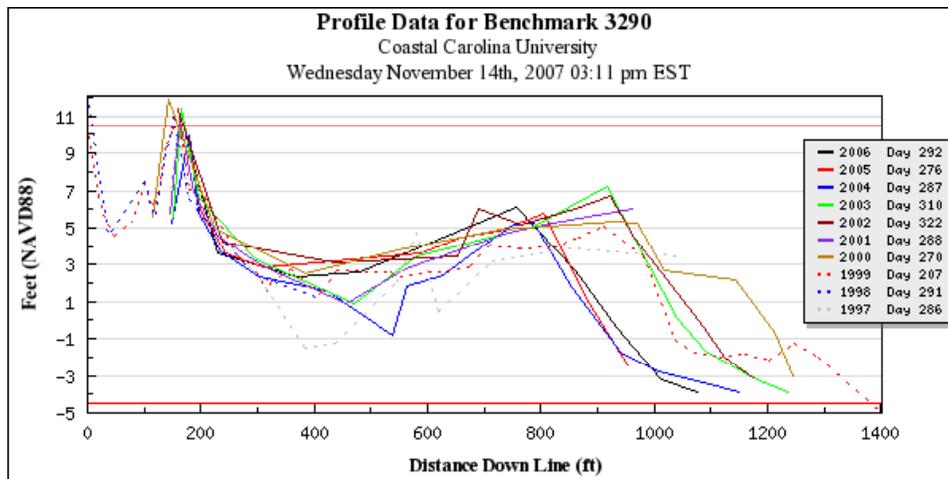
Along the undeveloped northern half of Dewees Island, station 3260 showed slight erosion just seaward of a sizable primary dune, while 3270 showed slight erosion along this same portion of the profile. Station 3280 is closer to Capers Inlet and has a very wide profile that extends several hundred ft offshore. This station showed slight erosion from 2005 to 2006. The last monitoring station, 3290, is located on Capers Inlet. The primary dune here is usually quite stable, while seaward of the dune a large sand flat, most of it intertidal, extends offshore for hundreds of ft. During the past year the primary dune was again very stable and the large offshore sandbar that attached to the beach here the previous year has exhibited little change.

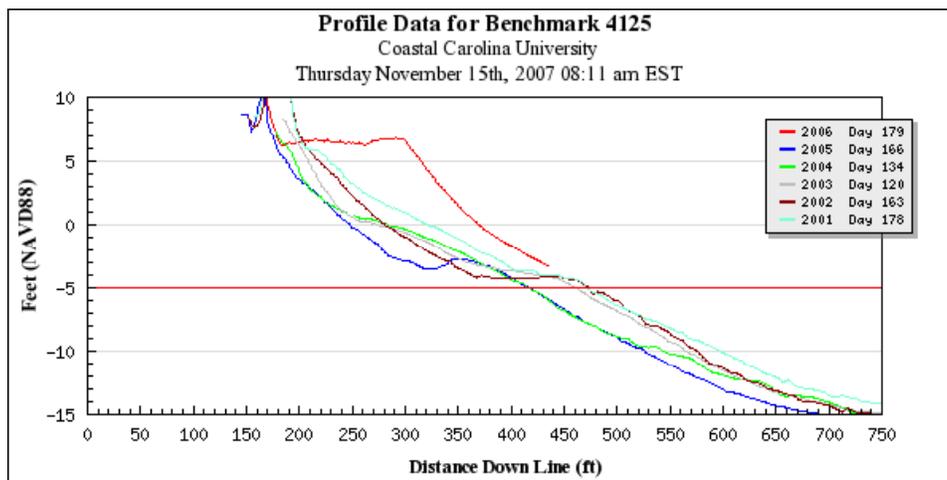
At station 4115, located near the southern end of the maritime forest closest to North Inlet, the upper beach has continued to erode and cut back by about 10 ft during the past year. At station 4125, about 1,000 ft south of the bulkhead, the long-term trend is erosional. The beach profile collected in June 2006 shows the wedge of renourishment material merging with the shoreface at -5 ft and extending the beach approximately 125 ft seaward. At the south end of the bulkhead station 4130 reflects the creation of a larger dune and extension of the profile seaward almost 200 ft due to the renourishment. This south bulkhead section of beach has historically been the most critically sand-starved beach profile at Debidue.

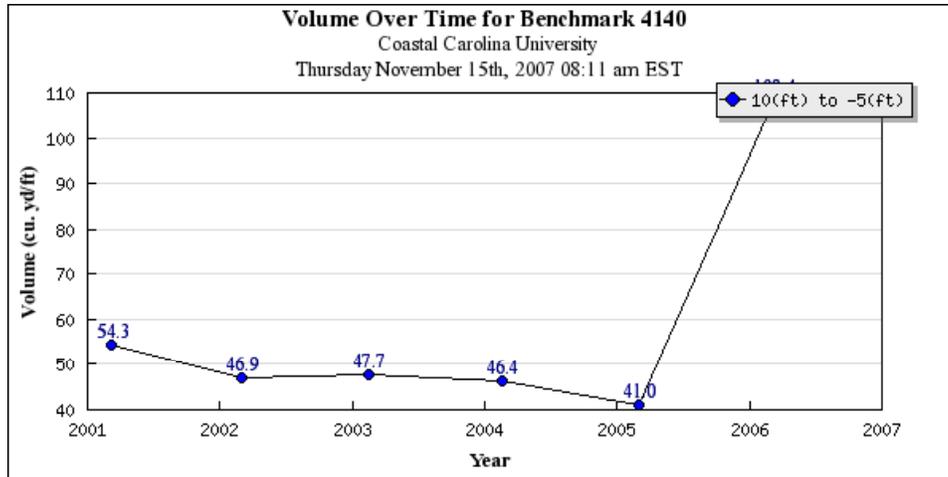
Station 4140, near the northern end of the bulkhead, is the “pivot point” on Debidue—the beach typically erodes to the south and accretes to the north. During the previous year this station saw erosion between the +7 ft and -2 ft contours, as the beach cut back by up to 25 ft. The renourishment project added approximately 200 ft of beach to the profile with approximately 68 cubic yards of fill material per ft of beach.

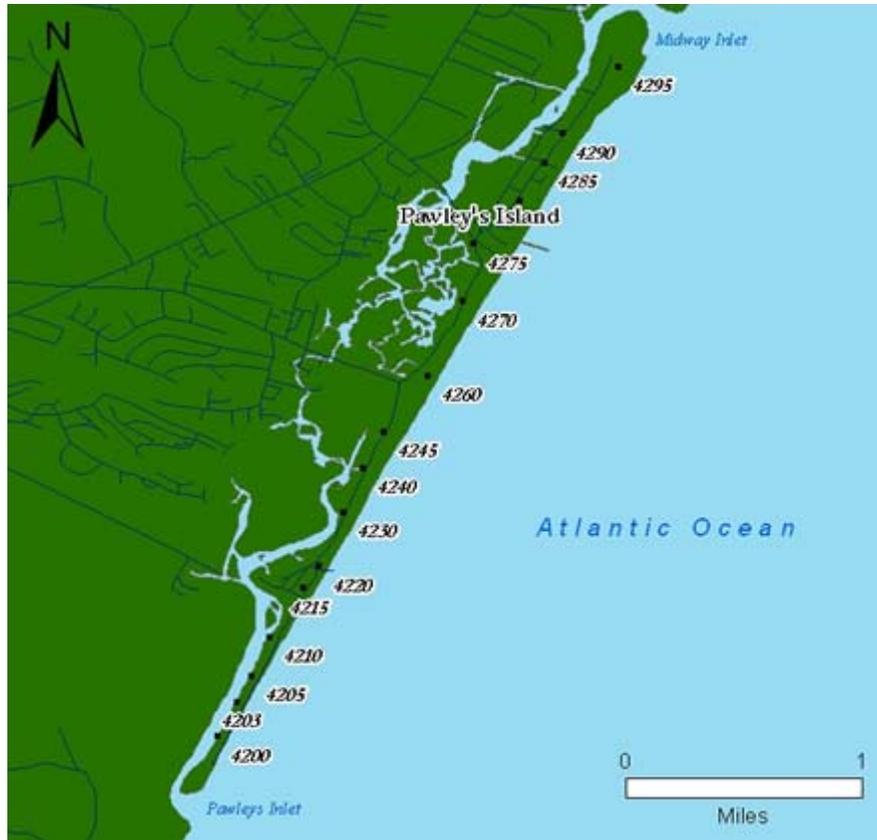
Benchmark	Profiles collected in 2006	Profiles collected in 2005	First Survey Year	Total Profiles
4295	None	None	1987	22
4290	07/06	06/30	1987	32
4285	07/06	06/30	1990	31
4280	07/06	None	1987	19
4275	07/06	06/30	1989	31
4270	07/06	None	1987	28
4260	07/06	06/30	1987	34
4245	07/06	06/30	1987	37
4240	None	None	1989	25
4230	07/06	06/30	1987	28
4220	07/06	06/30	1989	33
4215	07/06	06/30	1987	34
4210	07/06	06/30	1989	30
4205	07/06	06/30	1987	37
4203	07/06	06/30	1989	29
4200	07/06	06/30	1987	31

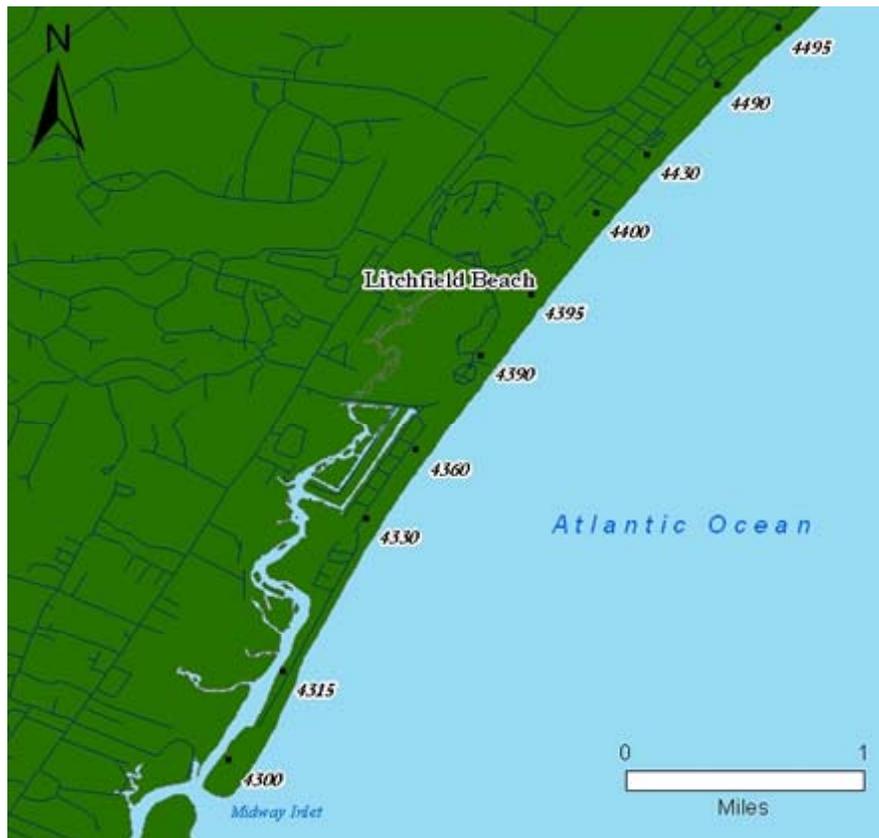
Benchmark	Profiles collected in 2006	Profiles collected in 2005	First Survey Year	Total Profiles
4495	None	None	1987	20
4490	None	07/01	1987	35
4430	None	07/01	1987	31
4400	None	07/01	1987	31
4395	None	07/01	1987	32
4390	07/12	07/01	1987	31
4360	07/12	07/01	1987	30
4330	07/12	07/01	1987	33
4315	None	None	1988	21

4300	None	None	1992	12
------	------	------	------	----

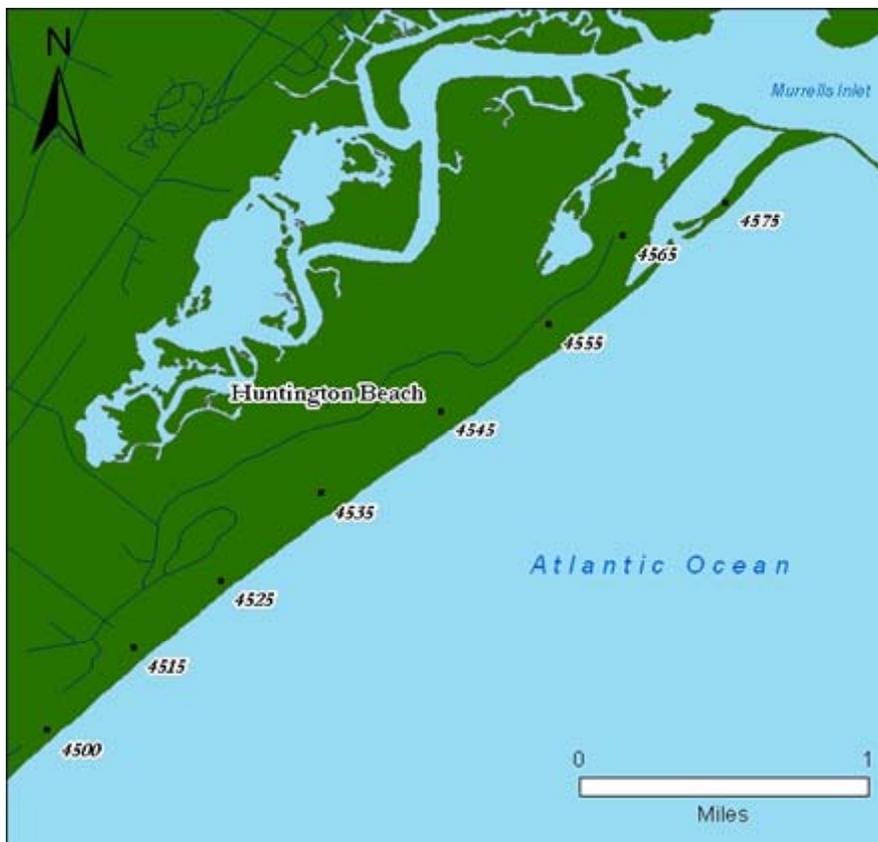
Benchmark	Profiles Collected in 2006	Profiles Collected in 2005	First Survey Year	Total Profiles
-----------	----------------------------	----------------------------	-------------------	----------------

4575	None	None	1987	17
4565	07/20	06/16	1987	33
4555	07/20	06/16	1987	33
4550	None	None	1988	1
4545	07/20	06/16	1988	32
4535	07/20	06/16	1988	31
4525	None	06/16	1988	35
4515	None	06/16	1987	33
4500	None	06/16	1987	29

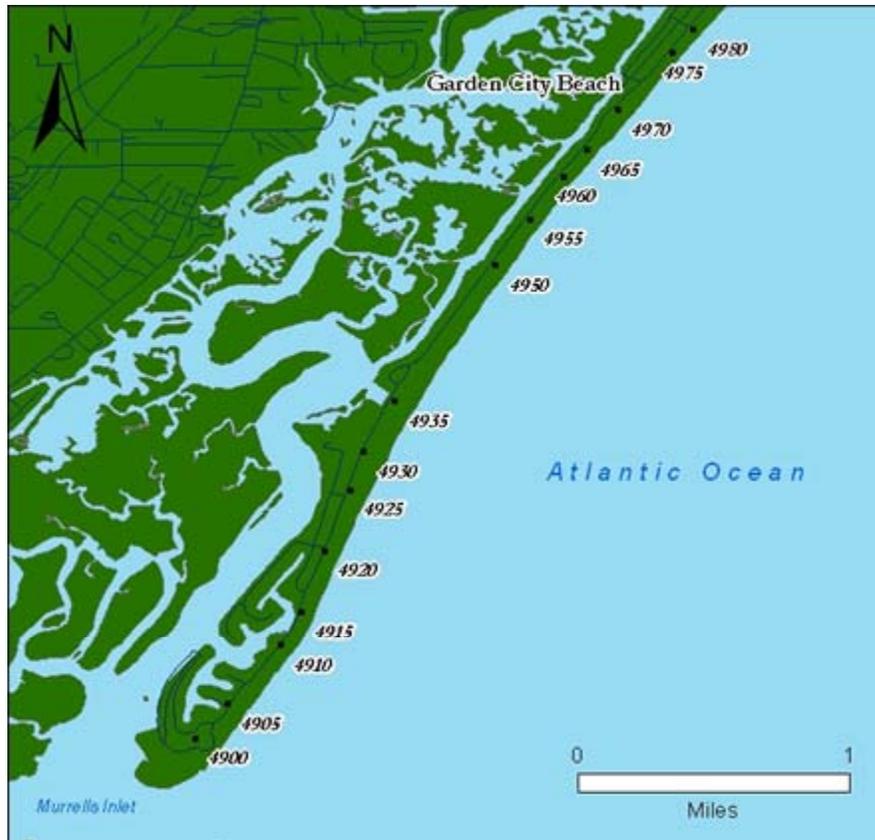
Benchmark	Profiles collected in 2006	Profiles collected in 2005	First Survey Year	Total Profiles
4980	03/30	None	1987	40
4975	03/30	None	1989	29
4970	03/30	None	1987	36
4965	03/30	None	1989	30
4960	03/30	None	1987	36
4955	03/30	None	1989	29
4950	03/30	None	1987	35
4940	03/30	None	1988	33
4935	03/30	None	1989	33
4930	03/30	None	1987	35
4925	03/30	None	1989	31
4920	03/30	None	1987	38
4915	03/30	None	1989	34
4910	None	None	1987	25
4905	None	None	1989	20
4900	None	None	1987	26
4800	None	None	1989	1

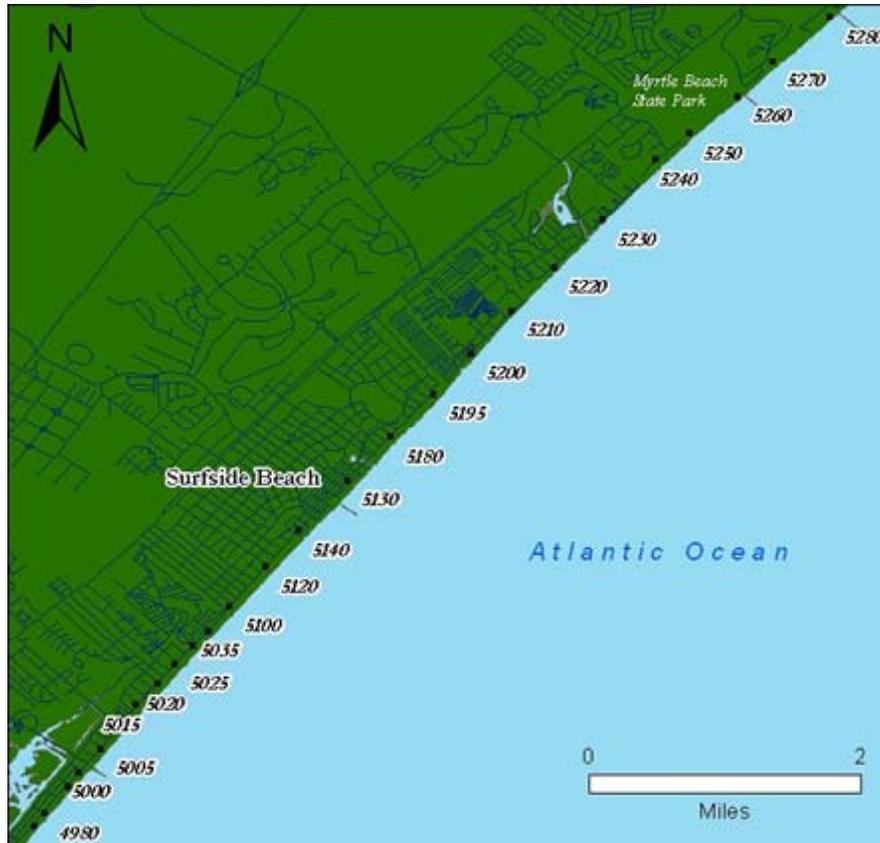
This section of the Grand Strand includes 6 monitoring stations in the Town of Surfside Beach, and 9 stations in the unincorporated region north of Surfside Beach—the campground region, Long Bay Estates, and Myrtle Beach State Park. Surveys here were completed in November 2004 and March/April 2006 (with four profiles in December 2005). The long-term erosion rates here are around one ft per year, and in general the beach is stable.

Stations 5100 at 16<sup>th</sup> Ave. South through 5195 at 16<sup>th</sup> Ave. North fall within the Town of Surfside Beach, and almost all stations here have a well-established primary sand dune. Surfside Beach was renourished in 1998 as part of the Army Corps of Engineers Grand Strand Renourishment Project, and the project reached equilibrium within a few years. In the southern portion of Surfside Beach, from station 5100 to 5130, the beach profile experienced erosion from the +7 to the -10 ft contour during the 2004 through April 2006 period while the dune remained stable. North of here, through station 5195, the profiles all showed some minor accretion on the upper beach (+7 to +5 ft), as the berm increased in width by 20 to 30 ft in the current survey period.

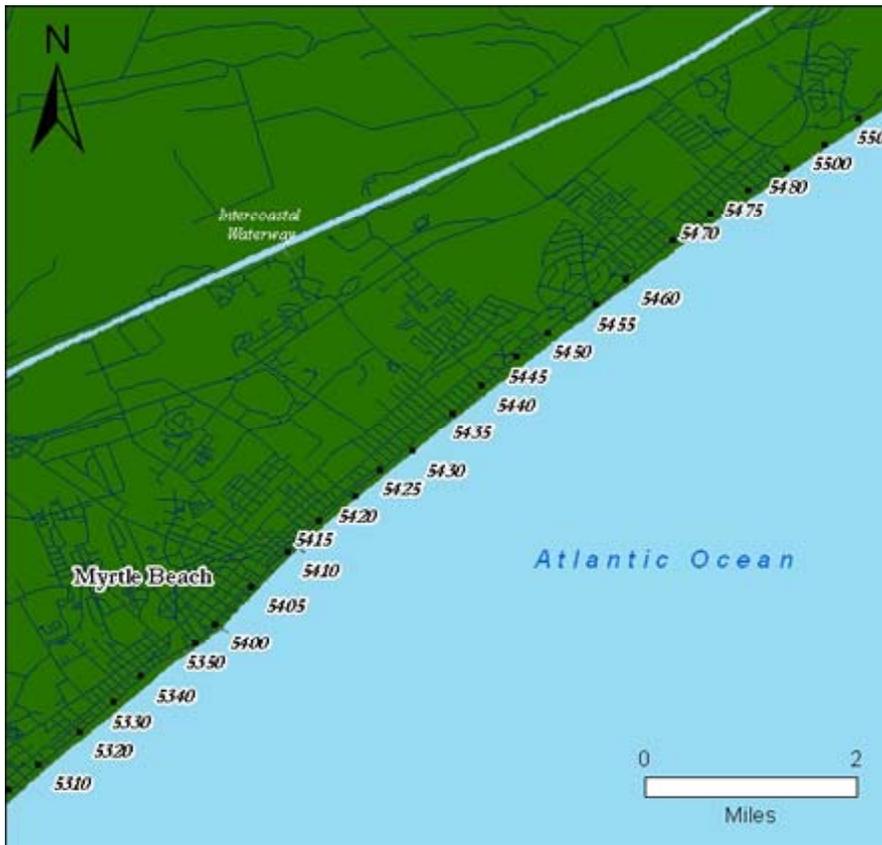
The next area is the eight-mile section of shoreline within the Myrtle Beach city limits. The long-term erosion rate here is about one-half ft per year due to its natural geologic setting against the headland. Myrtle Beach was renourished between May and December 1997 as part of the US Army Corps of Engineers Grand Strand Renourishment

Project. This fill reached equilibrium within a few years, and has since stabilized. The most recent beach surveys were conducted at 14 stations in 2006 and 43 stations in 2005.

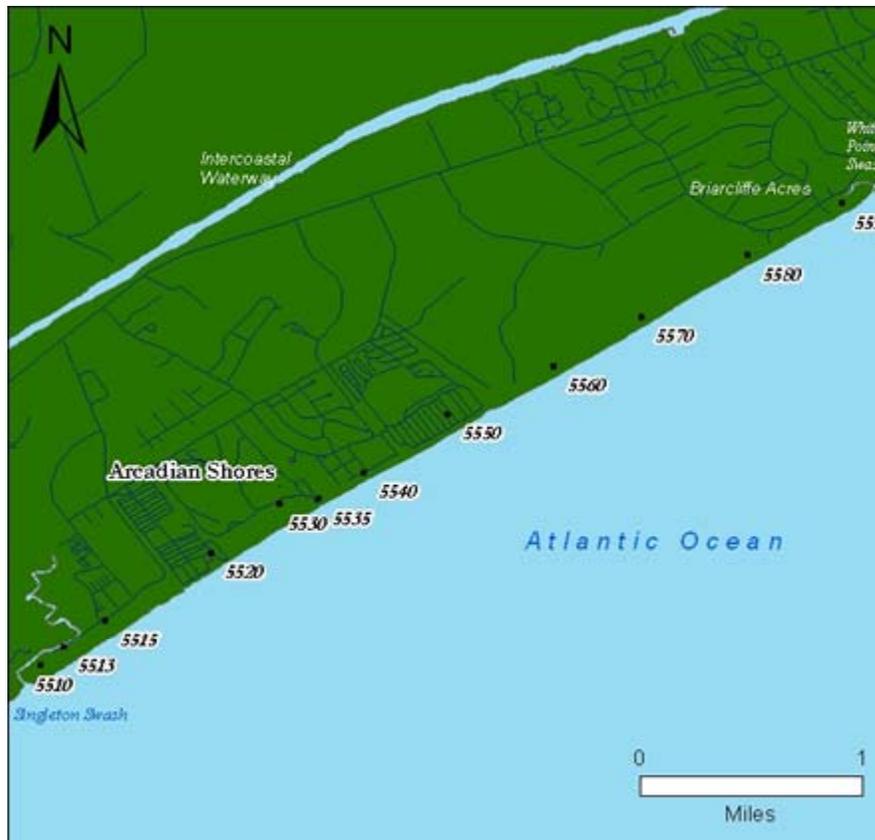
This area of unincorporated Horry County is located between the City of Myrtle Beach and White Point Swash, and includes the Shore Drive section, Arcadian Shores, the campground section, and Briarcliffe Acres. The long-term erosion rate is about one-half ft per year. There are 14 beach survey monuments located here which were most recently surveyed in November 2003, March 2005, and June 2006.

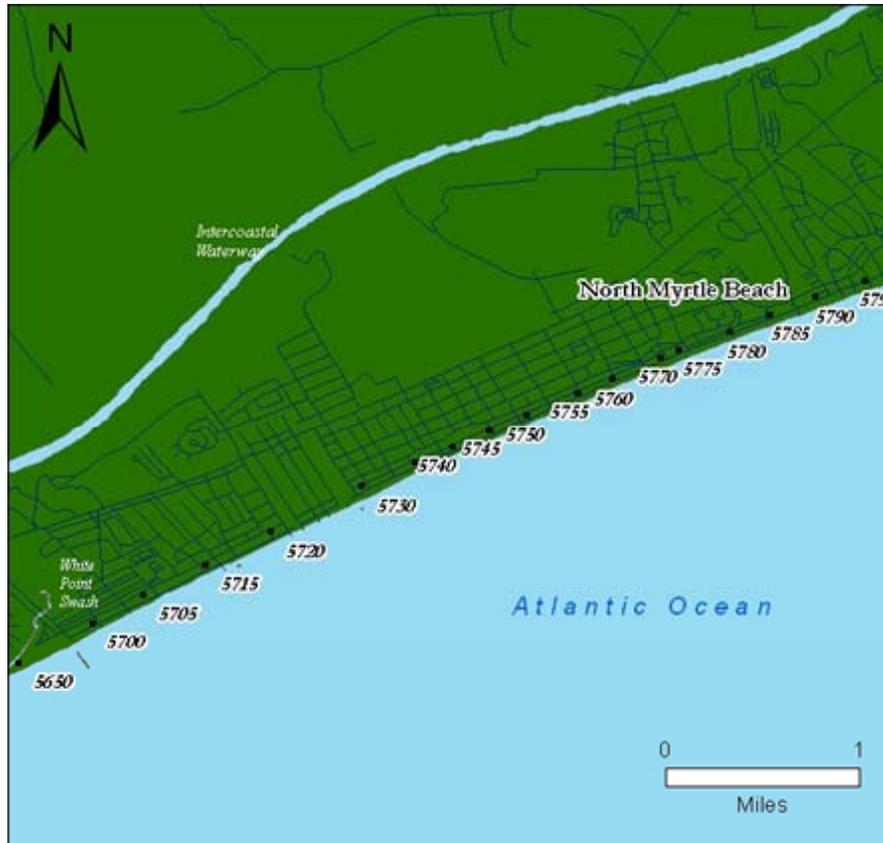
This section includes the City of North Myrtle Beach and Atlantic Beach, from White Point Swash to Hog Inlet. The shoreline is heavily developed and much of it is armored, with alternating zones of commercial and residential structures. The beach at North Myrtle Beach is typically wider and flatter than other Grand Strand beaches. The long-term erosion rate is about a half-foot per year. North Myrtle Beach was renourished by the US Army Corps of Engineers between September 1996 and April 1997, increasing the dry-sand beach width by over 100 ft and unit-width sand volumes by over 70 cubic yards per ft. The renourishment project has since stabilized, and some of the sand still remains on the upper beach. There are 43 beach survey monuments here, which were surveyed in March 2004, January or May 2005, and May 2006.
