# South Carolina

## Annual State of the Beaches Report

2007

Ocean and Coastal  
Resource Management

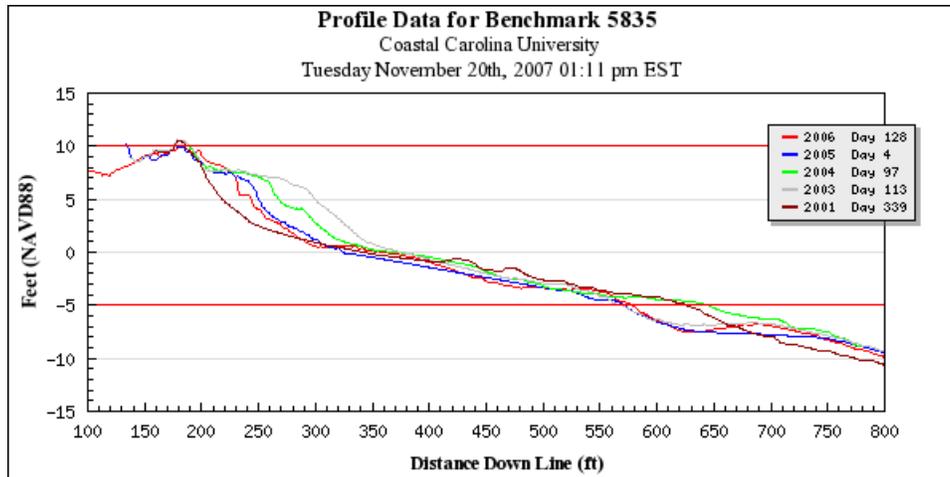
In the Cherry Grove section between stations 5835 at Sea Mountain Highway and 5850 at 32<sup>nd</sup> Ave. North the character of the beach changes. Much of this area is armored and experienced chronic sand deficits prior to renourishment. This same 7-block area south of the Cherry Grove pier has also experienced higher erosion rates following the renourishment project, and the beach here is currently not as wide as the beach north of the pier or south of 28<sup>th</sup> Ave. North. During the current survey period the profile from the berm down to the 0 ft contour cut back an additional 20 to 30 ft from the previous survey period, where the loss was about 20 ft. North of the pier, from station 5855 at 37<sup>th</sup> Ave. North to 5890 at 58<sup>th</sup> Ave. North, a few stations showed berm erosion but most were stable or even accretional on the primary dune and upper beach. Station 5895 on Hog Inlet shows the formation of a new channel and migration of the berm landward 45 ft. The profile is similar to that seen in 2004.

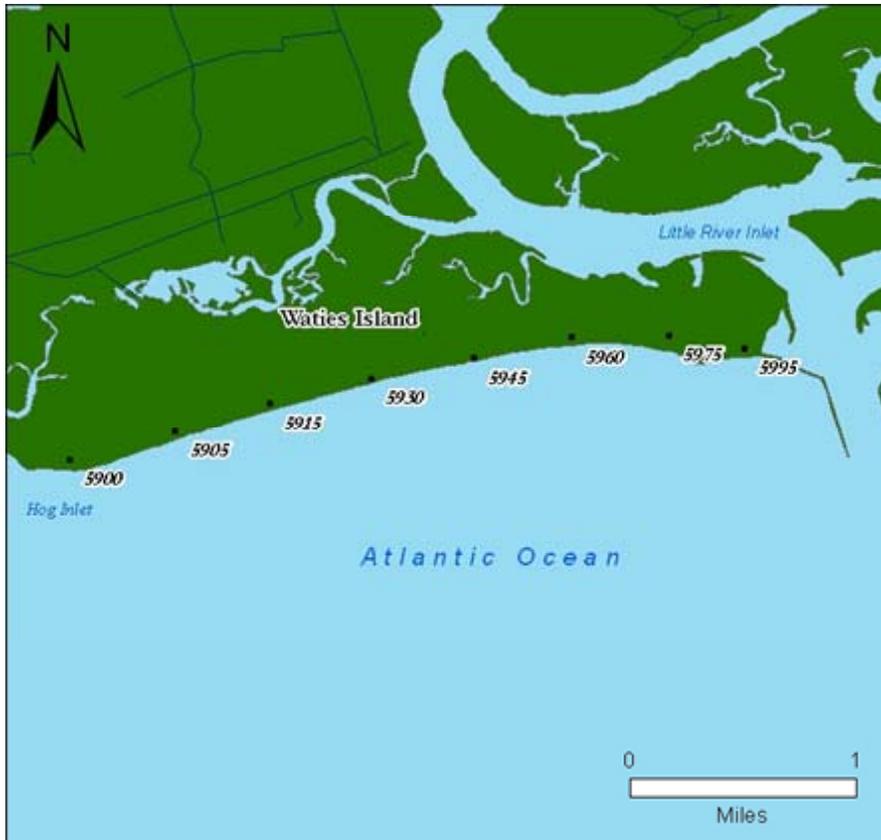
Waties Island (sometimes referred to as Waites Island) is an undeveloped three-mile long barrier island located between Hog Inlet to the southwest and Little River Inlet to the northeast. Little River Inlet was stabilized by the construction of a jetty system between 1981 and 1983. The southwest end of Waties Island is an unstabilized inlet zone, the central portion is a standard zone, and the northeastern section is a stabilized inlet zone. Most of the island has a long-term erosion rate ranging from -4 to -10 ft per year, although jetty construction has helped to stabilize the shoreline and lessen the erosion. During most of the 1990's the Hog Inlet shoreline was extremely erosional, losing several hundred ft, but has changed to an accretional mode in recent years. There are 6 monitoring stations on Waites Island, which were most recently surveyed in May 2004, January 2005, and December 2005.
