Memo

To: Mr. John Mazarella, Ms. Linda Sarro
From: Michael Trinkley
CC:
Date: April 6, 2020
Re: Archaeological reconnaissance proposed new Donmar Sand Mine, Berkeley County, South Carolina

Project Title: Archaeological Reconnaissance, Donmar Sand Mine Expansion, Berkeley County, SC

Agency Project Nos: SHPO Project No. 20-KL0073; DHEC Permit I-002198

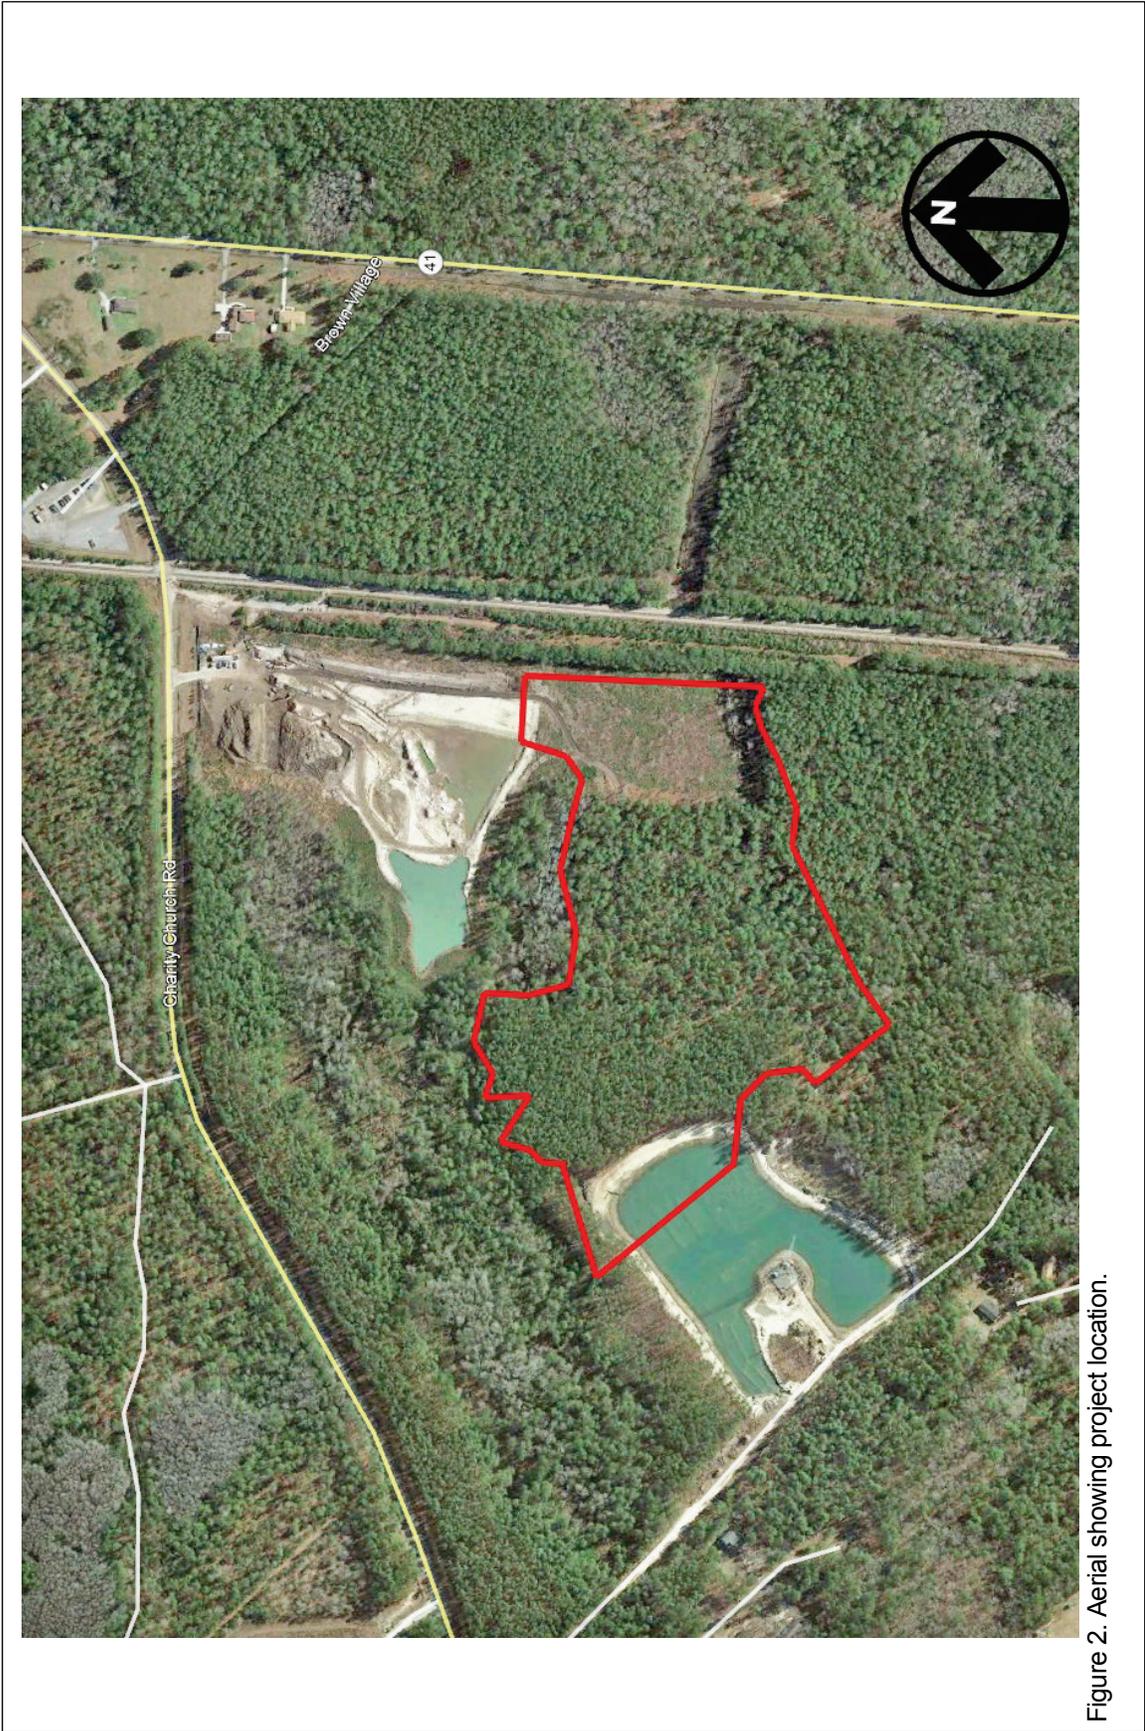
Figure 2. Aerial showing project location.

Environmental Setting: The project is located on the Coastal Plain in an area dominated by second growth pines. Elevations tend to be less than 40 feet AMSL and the topographic map reveals interspersed areas of low swamp (Figure 1). Figure 2 reveals that the pit borders a swampy run immediately to the north. Two areas of the “ridge” overlooking this slough have been previously mined. Neither area has reported the finding of any archaeological remains.

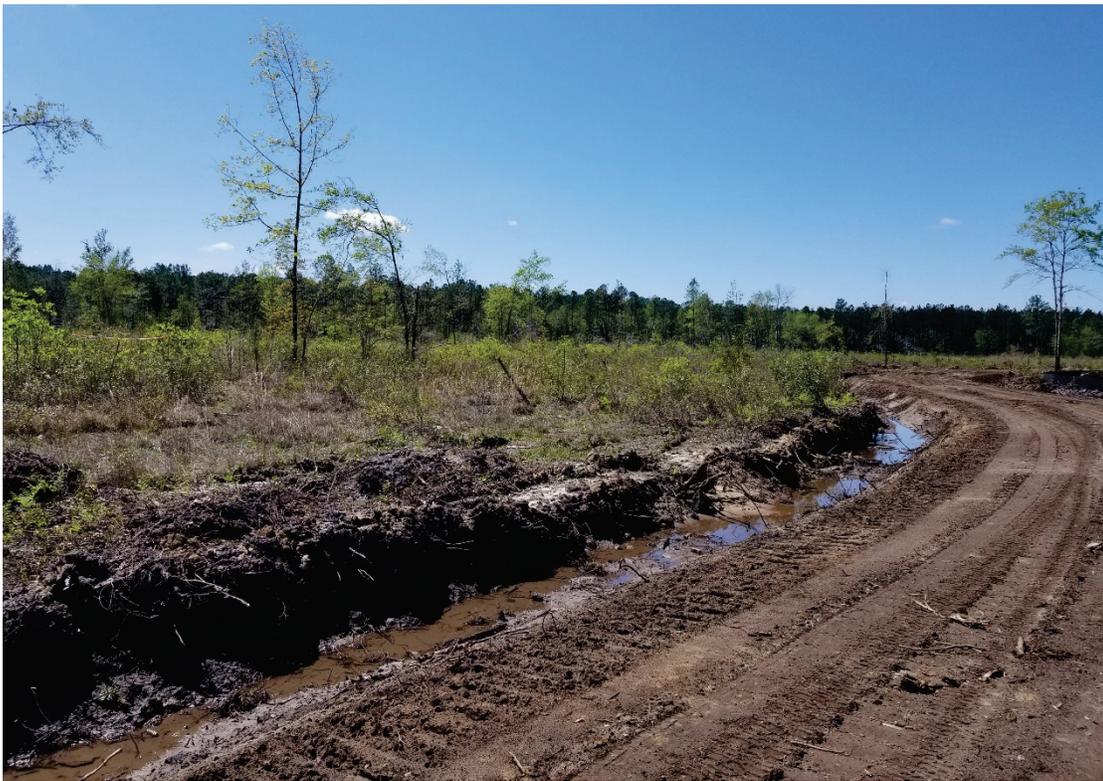
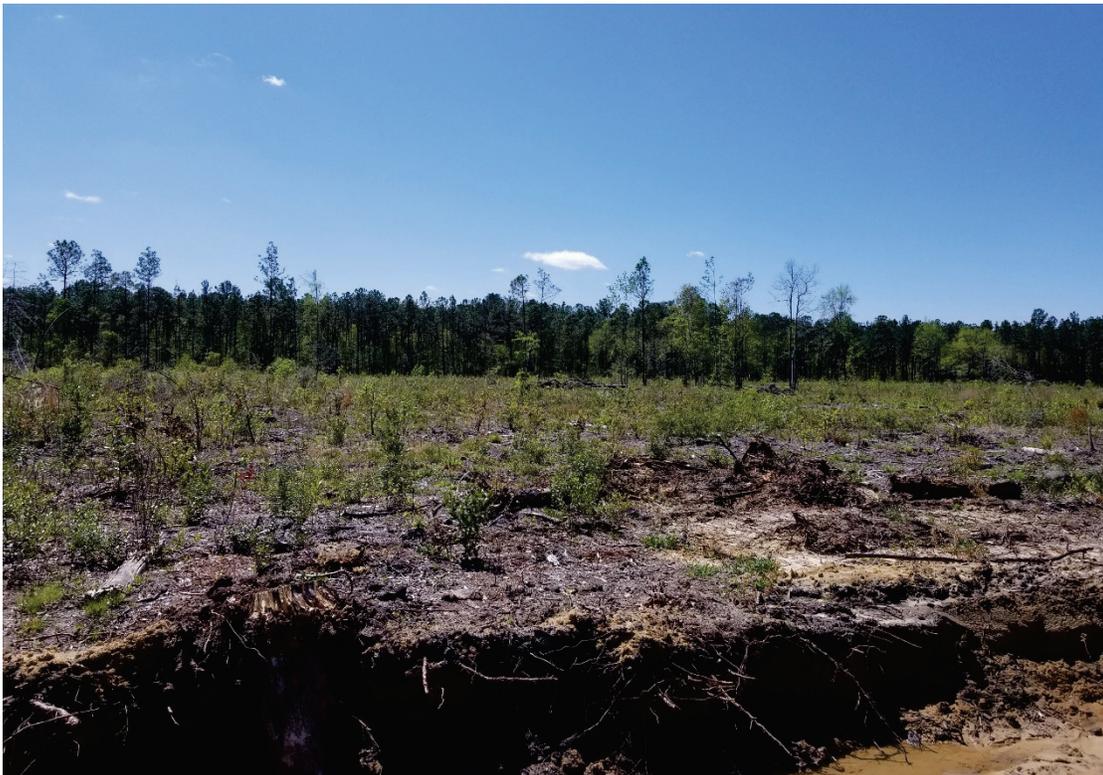
At the time of the survey, the area proposed pit had been logged. Most timber had been removed, although there were several piles of mixed soil and timber, as well as several areas where debris had been burned. An access track was present and ditches had been established to promote drainage. Consequently, at the time of this investigation, the survey area no longer resembled even its most recent historic condition (Figures 4-6).

Figure 4. General views showing project location. Upper photo shows the access road and ditching. Lower photo shows the clear cutting and general ground condition.

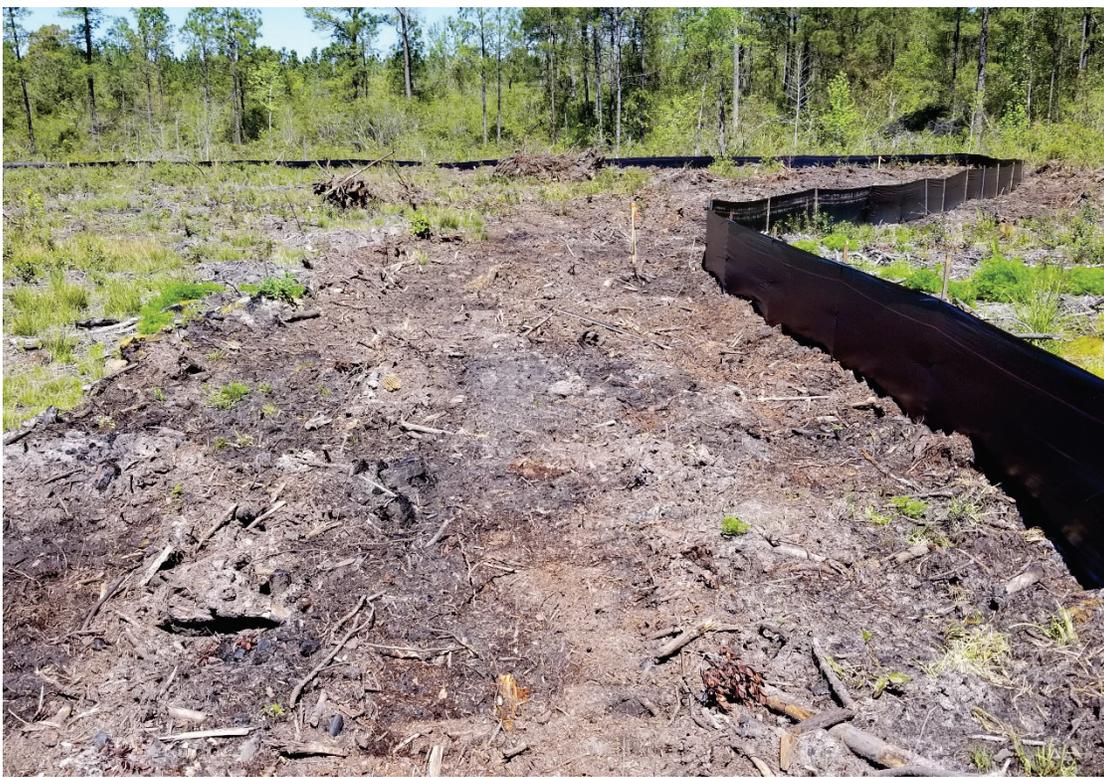
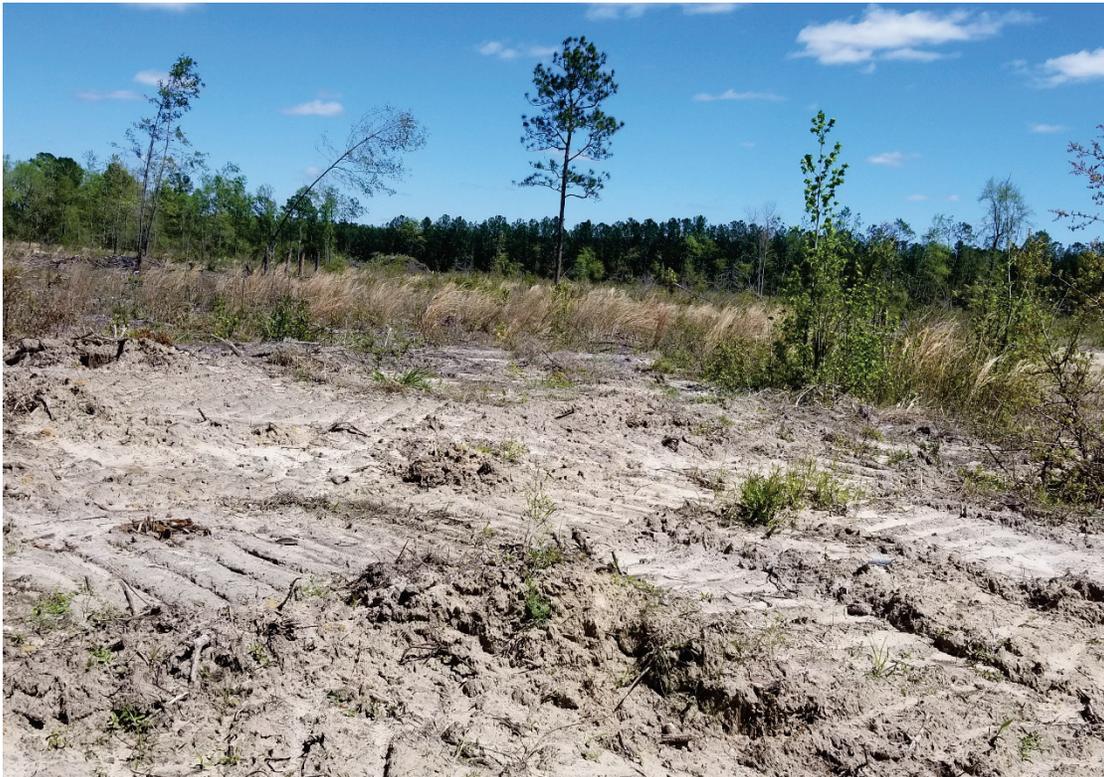
Figure 5. Ground visibility. Upper photo shows the 100% visibility along the entire periphery, marked by silt fence. Lower photo shows broom straw and open ground areas where logged.

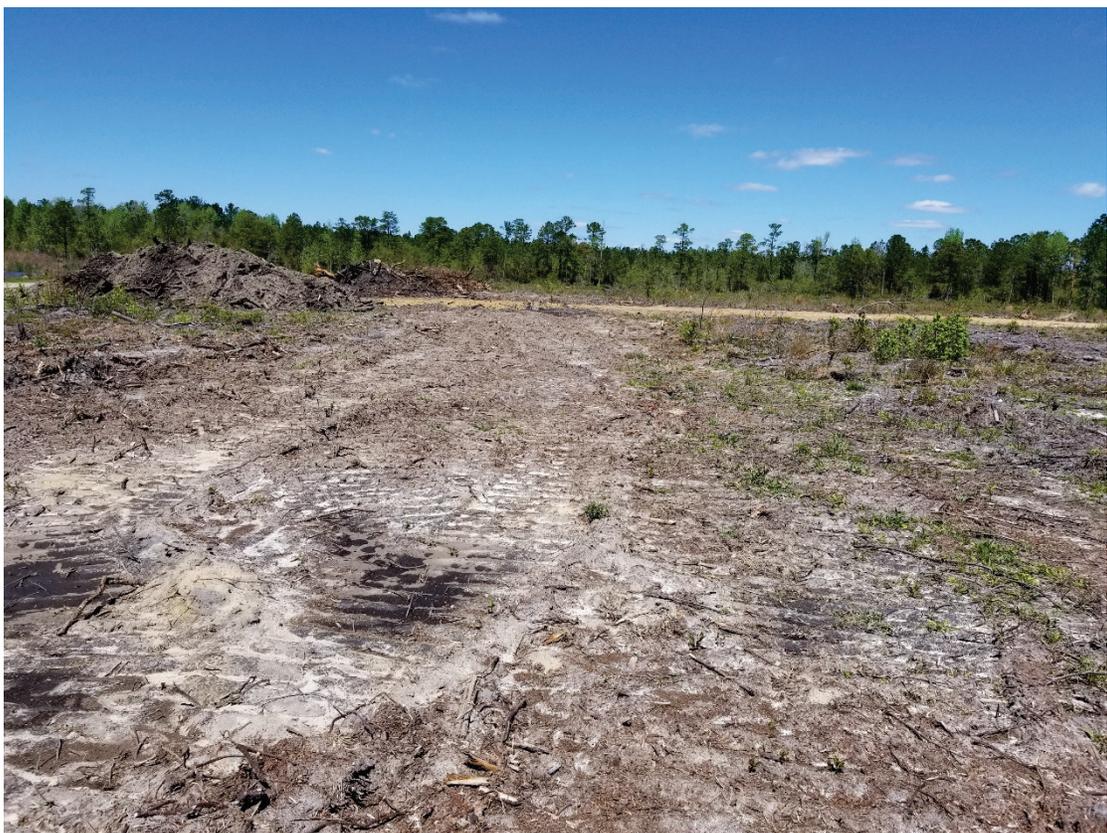
Figure 6. Open ground and soil/debris piles.

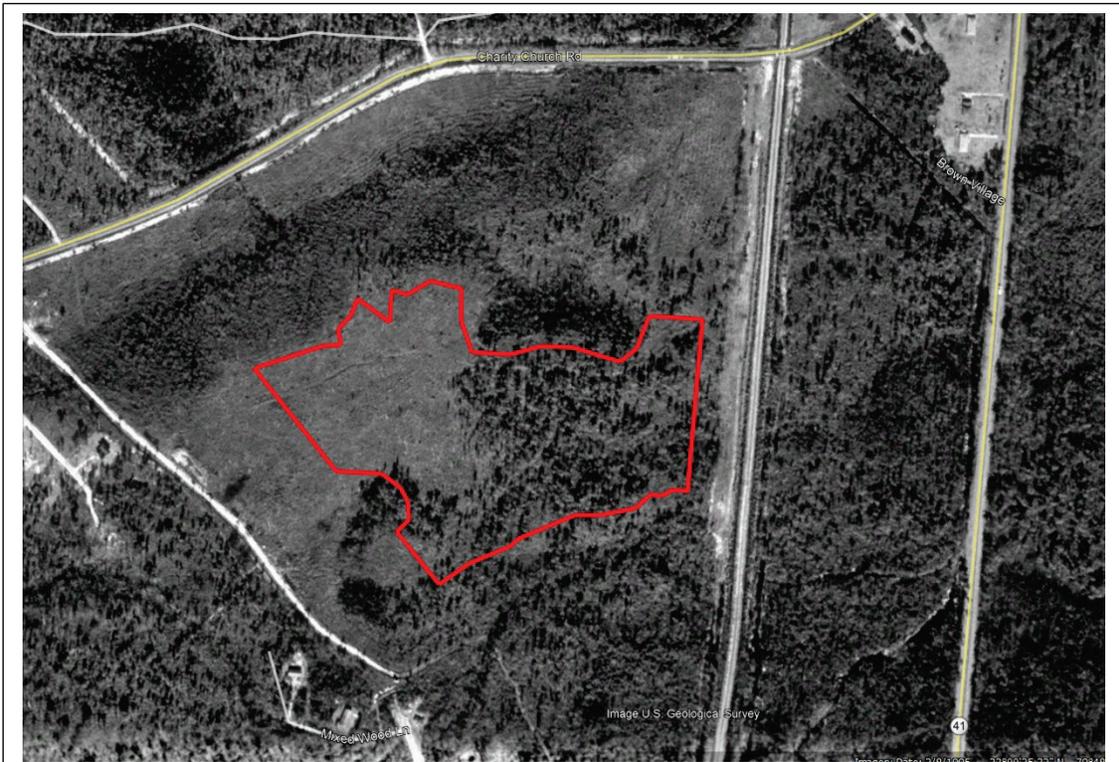
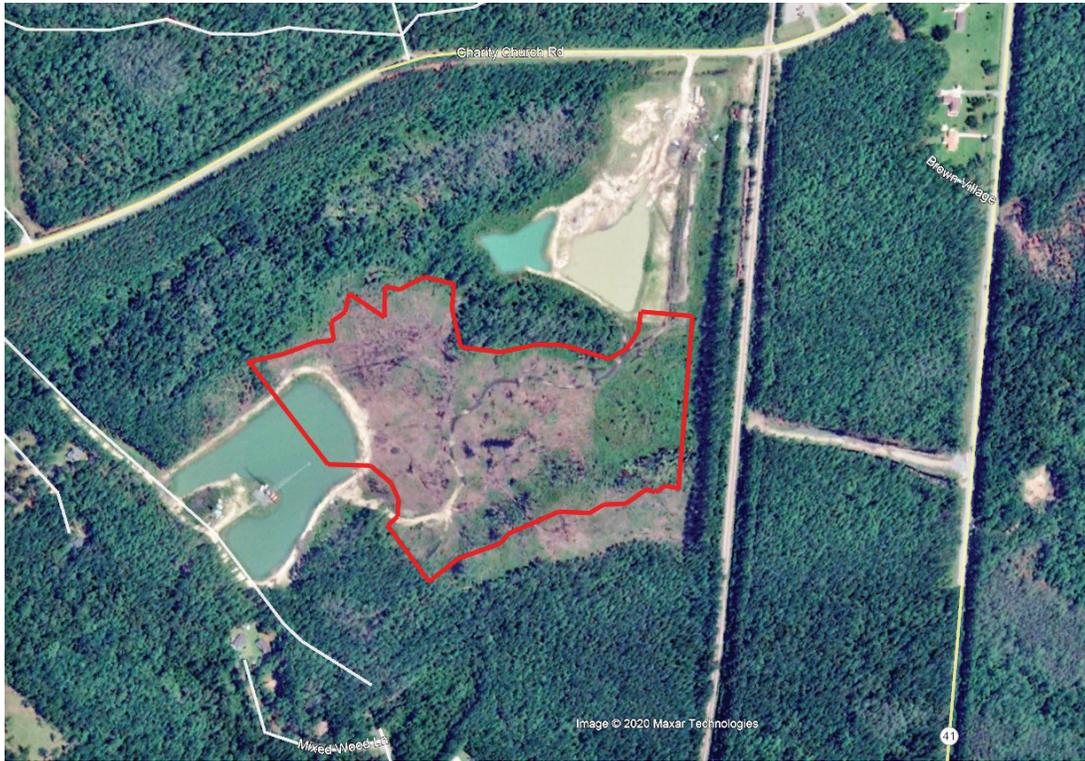
Figure 8 shows aeriels of the study area from 1999 and 2019. Although they don't reflect a great deal of time depth, they do indicate that the property has seen several episodes of logging and with each episode it is almost certain that additional ground disturbance has occurred.

Figure 8. Aerial images from 1999 and 2019. At the top is the 1999 image showing that prior to any mining, much of the western half had been cultivated. The lower photograph shows the area in 2019, after the excavation of both pits and the clear cutting of the vegetation, which by 2020 had been allowed to grow up again, necessitating yet another episode of logging.

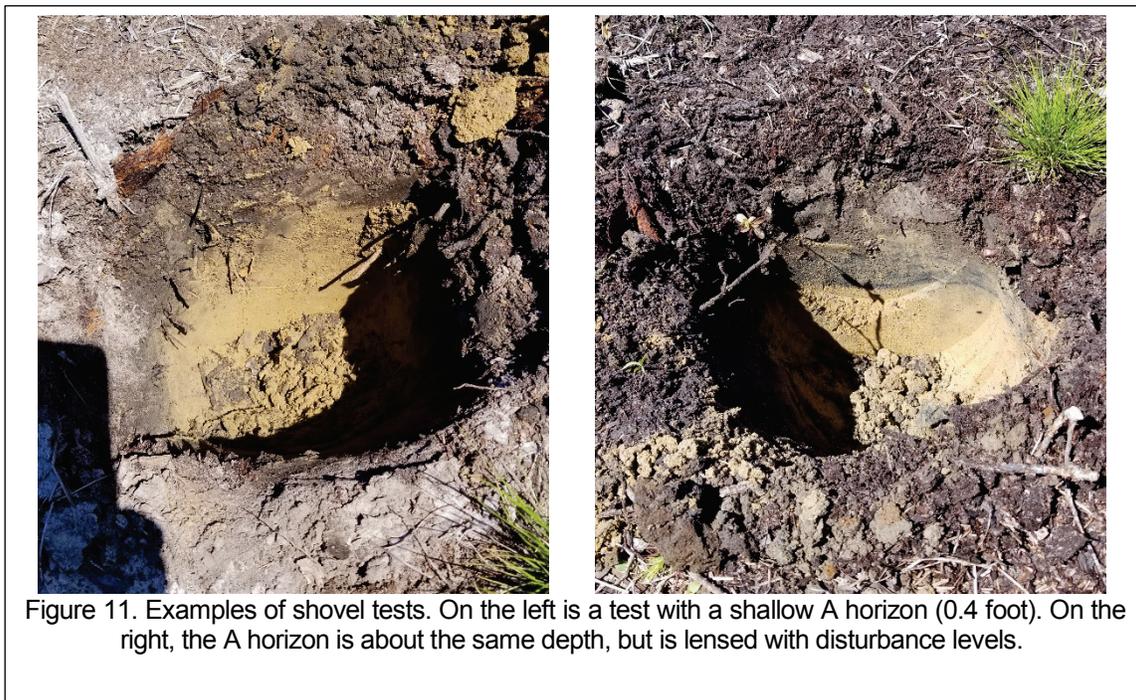
The shovel tests predominately revealed soil profiles suggestive that some amount of the A horizon had been removed and I never identified an A horizon greater than about 0.5 foot in depth. In addition, sticks and other debris were frequently found at the base of the A horizon or mixed into the B or C horizon immediately below (see Figure 11).

This anticipated damage was confirmed by 22 shovel tests that showed shallow A horizons, the presence of debris in the A and B/c horizons, and also failed to produce any cultural remains.

Figure 11. Examples of shovel tests. On the left is a test with a shallow A horizon (0.4 foot). On the right, the A horizon is about the same depth, but is lensed with disturbance levels.

As a result, we do not recommend any additional investigations in the proposed sand mine pit.
