Exhibit B

Additional Information for the Joint Permit Application Hilton Head Plantation POA

32. Description of the Overall Project and of Each Affecting U.S. Waters or State Critical Areas (attach additional sheets if needed)

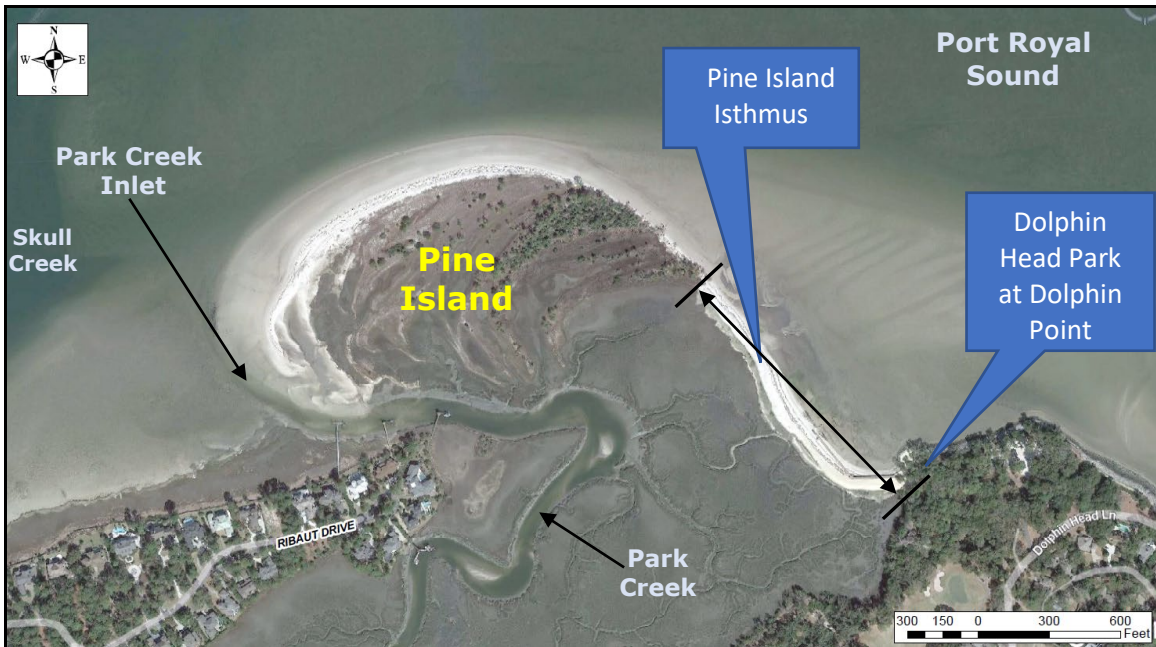
Figure 1. Project Area and Surrounding Features Overview (April 2021 GoogleEarth Aerial Imagery).

The purpose of the proposed project is to restore the entrance to Park Creek, a small tidal creek which runs through the Hilton Head Plantation marsh and connects to Port Royal Sound. Figure 1 presents an overview of the project area. The Park Creek mouth is located just west of Pine Island and allows for recreational boat access to Skull Creek and Port Royal Sound for Hilton Head Plantation residents and guests. The creek mouth/inlet has not been maintained for approximately two decades and has become exceedingly shallow and narrow over the years, now hindering navigation and impairing flushing as a result.

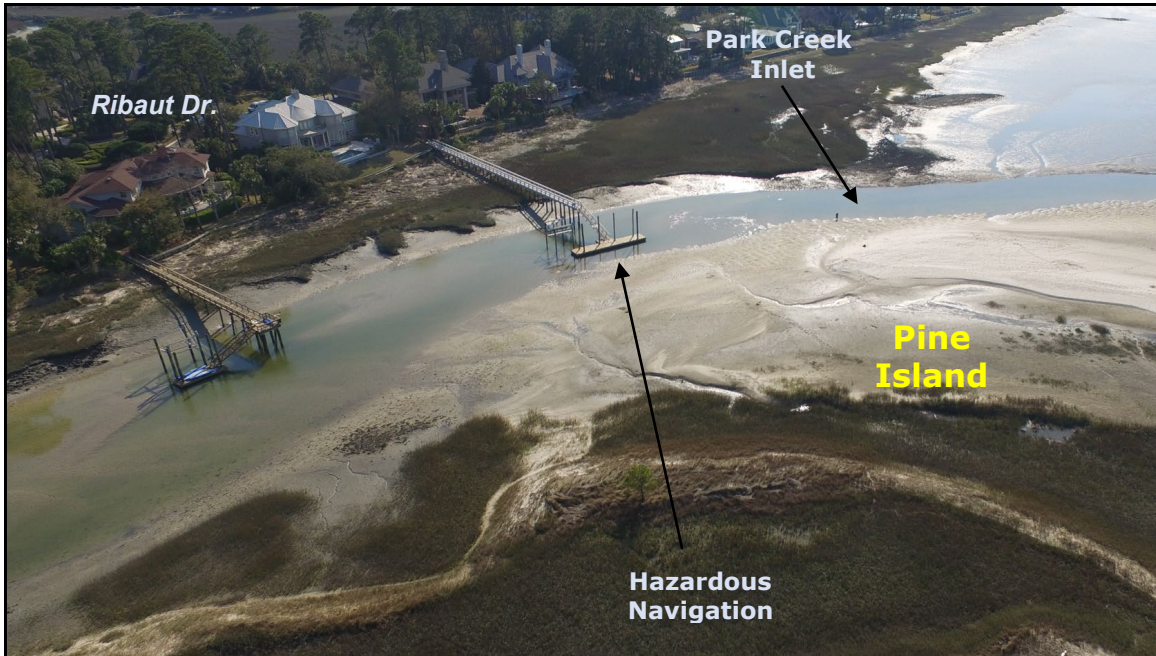
Figure 2. March 2022 drone oblique aerial imagery taken from southern end of Pine Island spit looking SSW across Park Creek inlet toward marsh and houses along Ribaut Dr.

Figures 2 and 3 present recent aerial oblique images and Figure 4 shows the ground conditions illustrating the existing shallow, narrow opening which is impassible for boats around low tide.

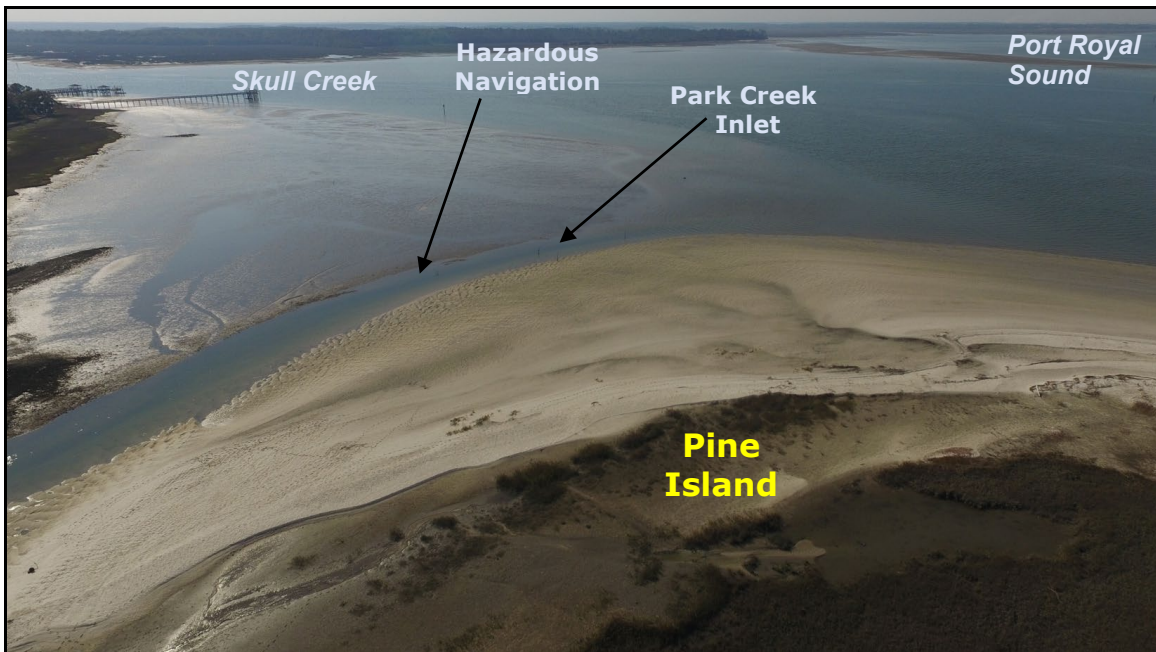
Figure 3. March 2022 drone oblique aerial imagery taken from southern end of Pine Island spit looking west across Park Creek inlet toward marsh and houses along Ribaut Dr.

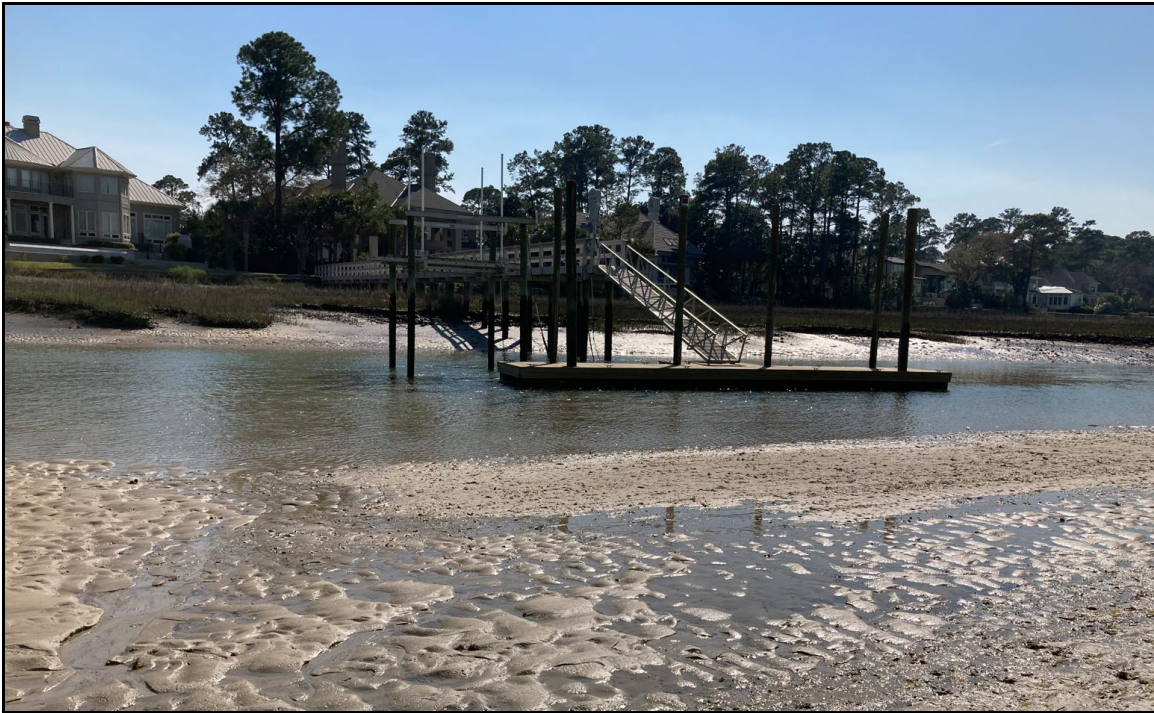
Figure 4. March 2022 drone oblique aerial imagery taken from southern end of Pine Island spit looking SSW across Park Creek inlet toward marsh and houses along Ribaut Dr.

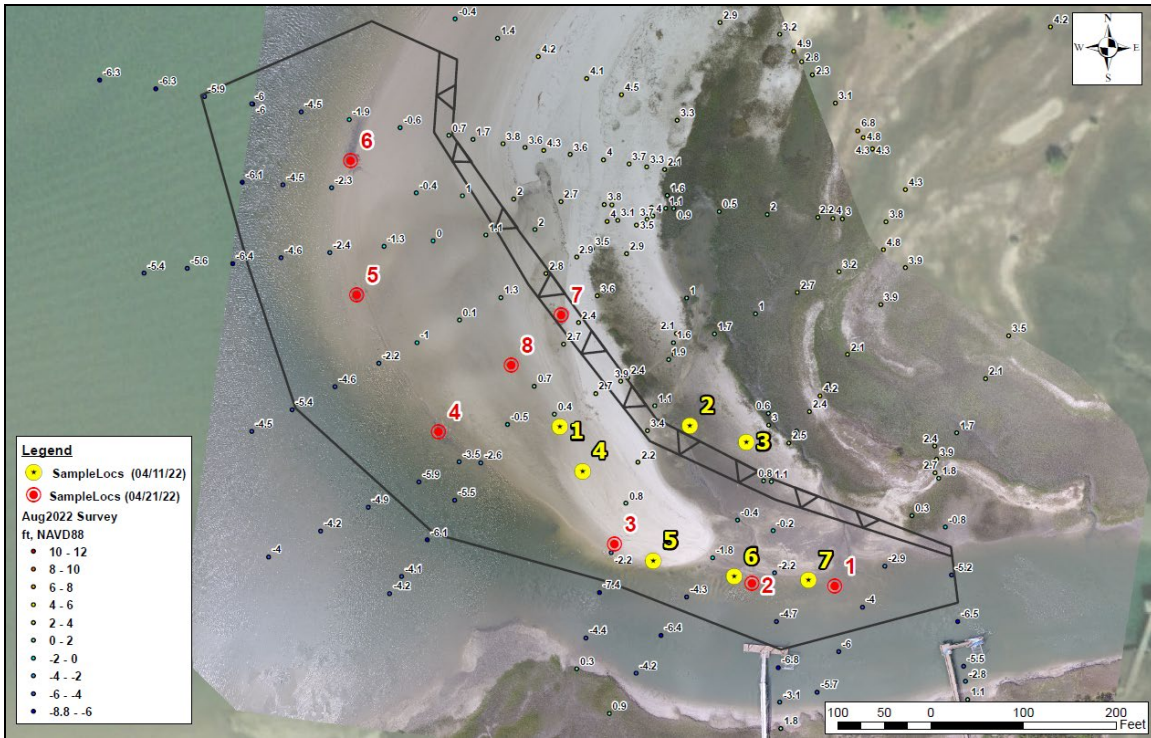
Figure 5. Park Creek Inlet Navigation Dredging and Beneficial Use Proposed Borrow Area. Bathymetry/Elevation data shown and sediment sample locations.

The test digs and grain size analysis revealed an approximate 5 ft layer of beach compatible sand on average over the area, with grain sizes ranging from 0.2 to 0.6 mm. The sand at this location is nice, coarse material with good color overall and shell content generally between 5 and 15%.

The sand samples showed 1% or less fines (passing the # 230 sieve). Non suitable dredge material will be hauled offsite for upland use at Dolphin Head Park and/or will be hauled to an upland stockpile location on HHPPOA property, located between Palm View Drive and Surrey Lane (see Figure 5a).

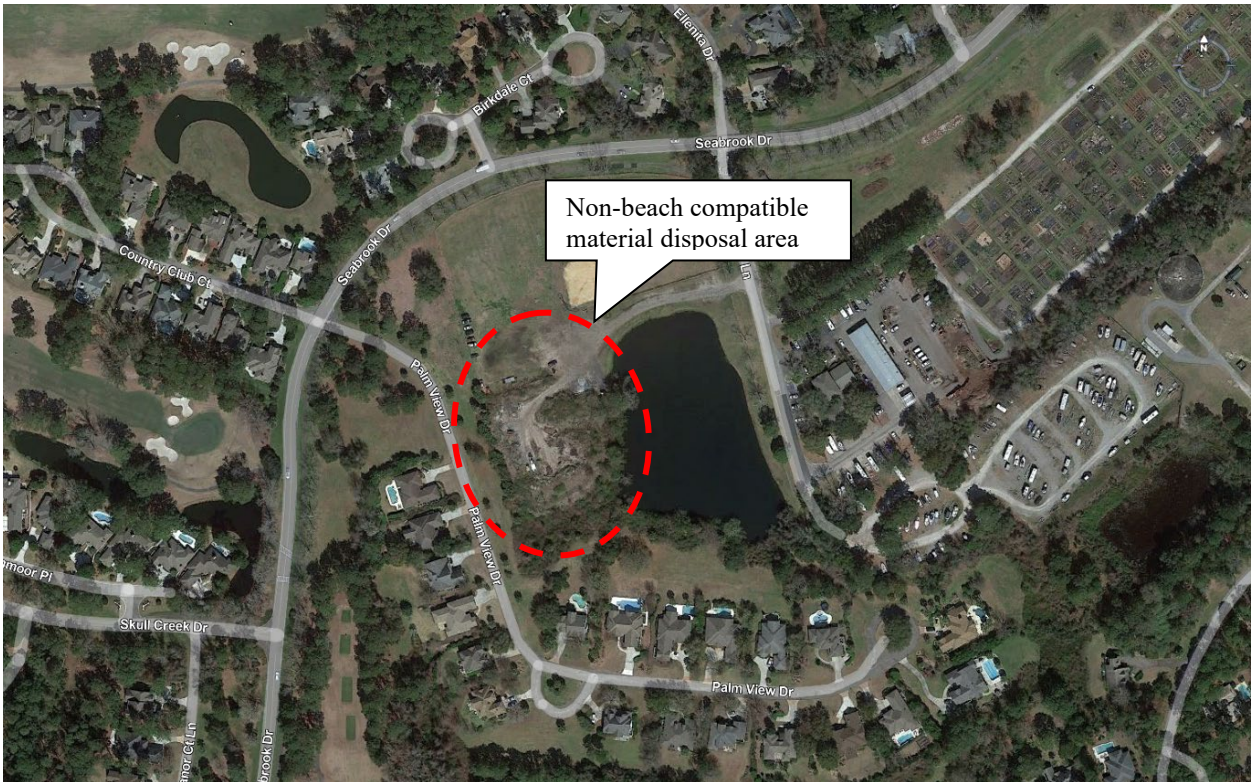
Figure 6a. Disposal area for non-beach compatible material on HHPPOA property.

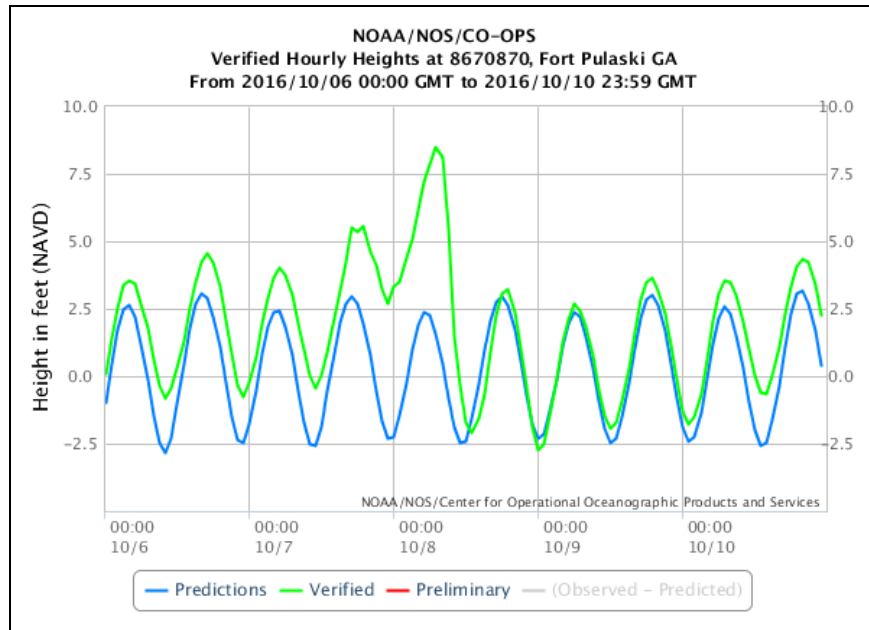
Figure 7. Predicted and Verified water levels at NOAA Fort Pulaski Station during Hurricane Matthew.

Much of the erosion along the isthmus can be attributed to dominant NE winds combined with expansive, uninterrupted fetch lengths allowing waves of significant energy to approach the site and drive sand off the upper beach. In addition to chronic long-term erosion, large storm events can bring extreme water levels and wave heights that significantly affect the entire project shoreline, such as Hurricane Matthew in 2016. The Fort Pulaski tide gauge recorded water elevations over five feet greater than the predicted tides during Hurricane Matthew on October 8, 2016 (see Figure 6).

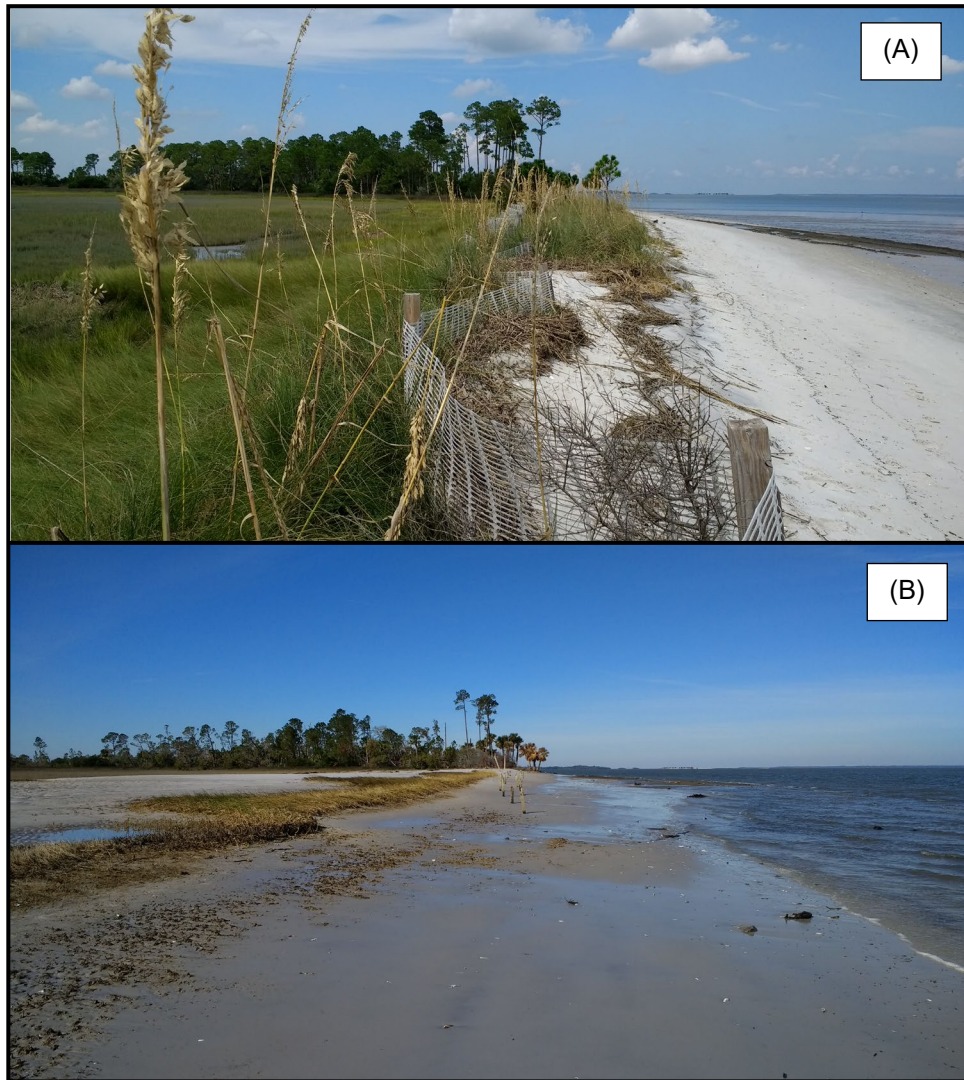
Figure 8. Vegetation loss, destruction of sand fencing, and shoreline change as a result of Hurricane Matthew. Pre-Matthew conditions (photo taken 9/28/16) shown in Panel A, post-Matthew conditions (photo taken 12/15/16) shown in Panel B.

Hurricane Matthew had significant impacts to the Pine Island isthmus as it caused severe sedimentation loss, damage to sand fencing, and a marshward recession of the previously existing marsh vegetation. Figure 7 presents ground photos of the shoreline before and after Hurricane Matthew. The MHW line eroded ~55 feet in this location and it is estimated that approximately 3 acres of marsh vegetation were lost as a result of Matthew. As mentioned previously, the beach berm along the isthmus forms a barrier which protects the marsh and helps mitigate breaches which could cause significant marsh loss and potentially severe impacts to the water volume exchange and flows through Park Creek and surrounding marsh environment.

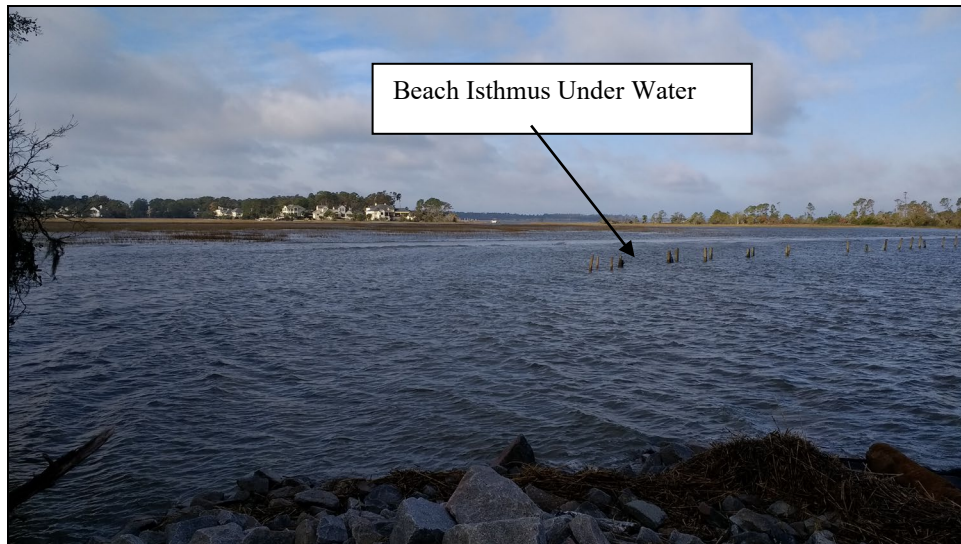
Figure 9. Photo taken along western end of existing revetment at Dolphin Head Recreation Area looking WSW (photo taken 12/15/16 during a king tide event).

Extreme high tides also play a major role in shaping the shoreline along the isthmus. A review of recorded water levels at NOAA Station 8670870 Fort Pulaski, Georgia showed average king tide elevations of ~4.9ft NAVD. The Fort Pulaski gage is ~18 miles from the project site and is typically within 0.1ft of the NOAA predicted tides and datums at the Ribaut Island, Skull Creek, SC Station (8668918). Elevated high tides have the potential to overtop the shoreline during erosional beach conditions and allow wave energy to propagate further into the marsh (see Figure 8).

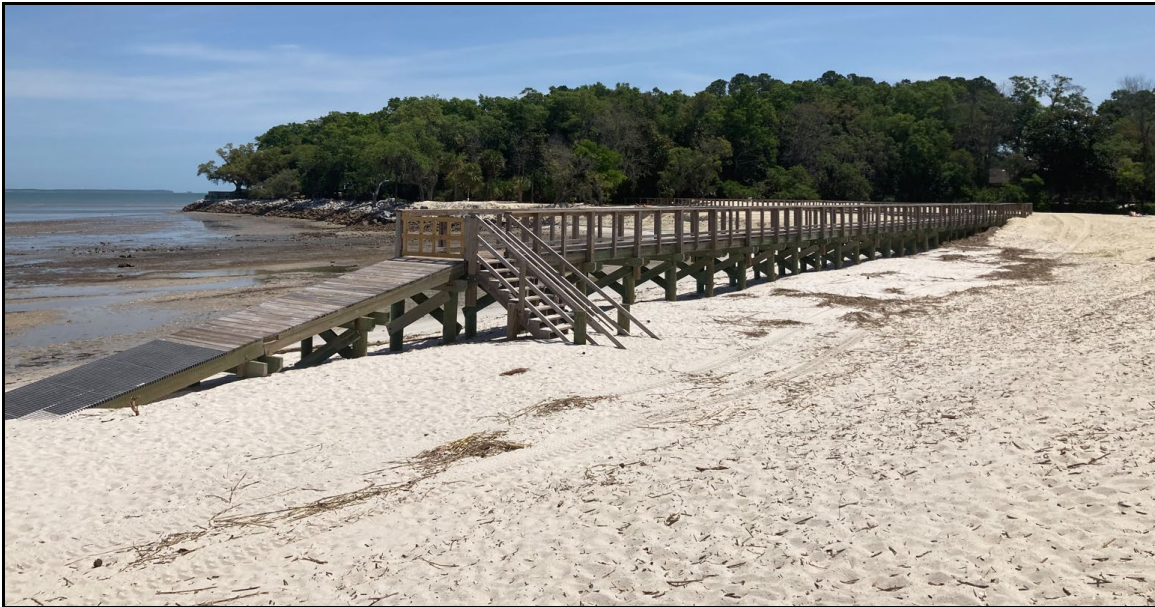
Figure 10. Photo taken from Pine Island Isthmus looking east-southeast toward wooden walkway and Dolphin Head Park (04/13/22).

The existing walkover section was authorized through the existing permit ([P/N 2004-13583(17)]) and was constructed in 2018. The wooden walkway begins at the Dolphin Head Recreational Area and extends 500 ft along the isthmus beach. Figure 9 presents a recent photograph of the existing wooden walkway terminus along the isthmus.

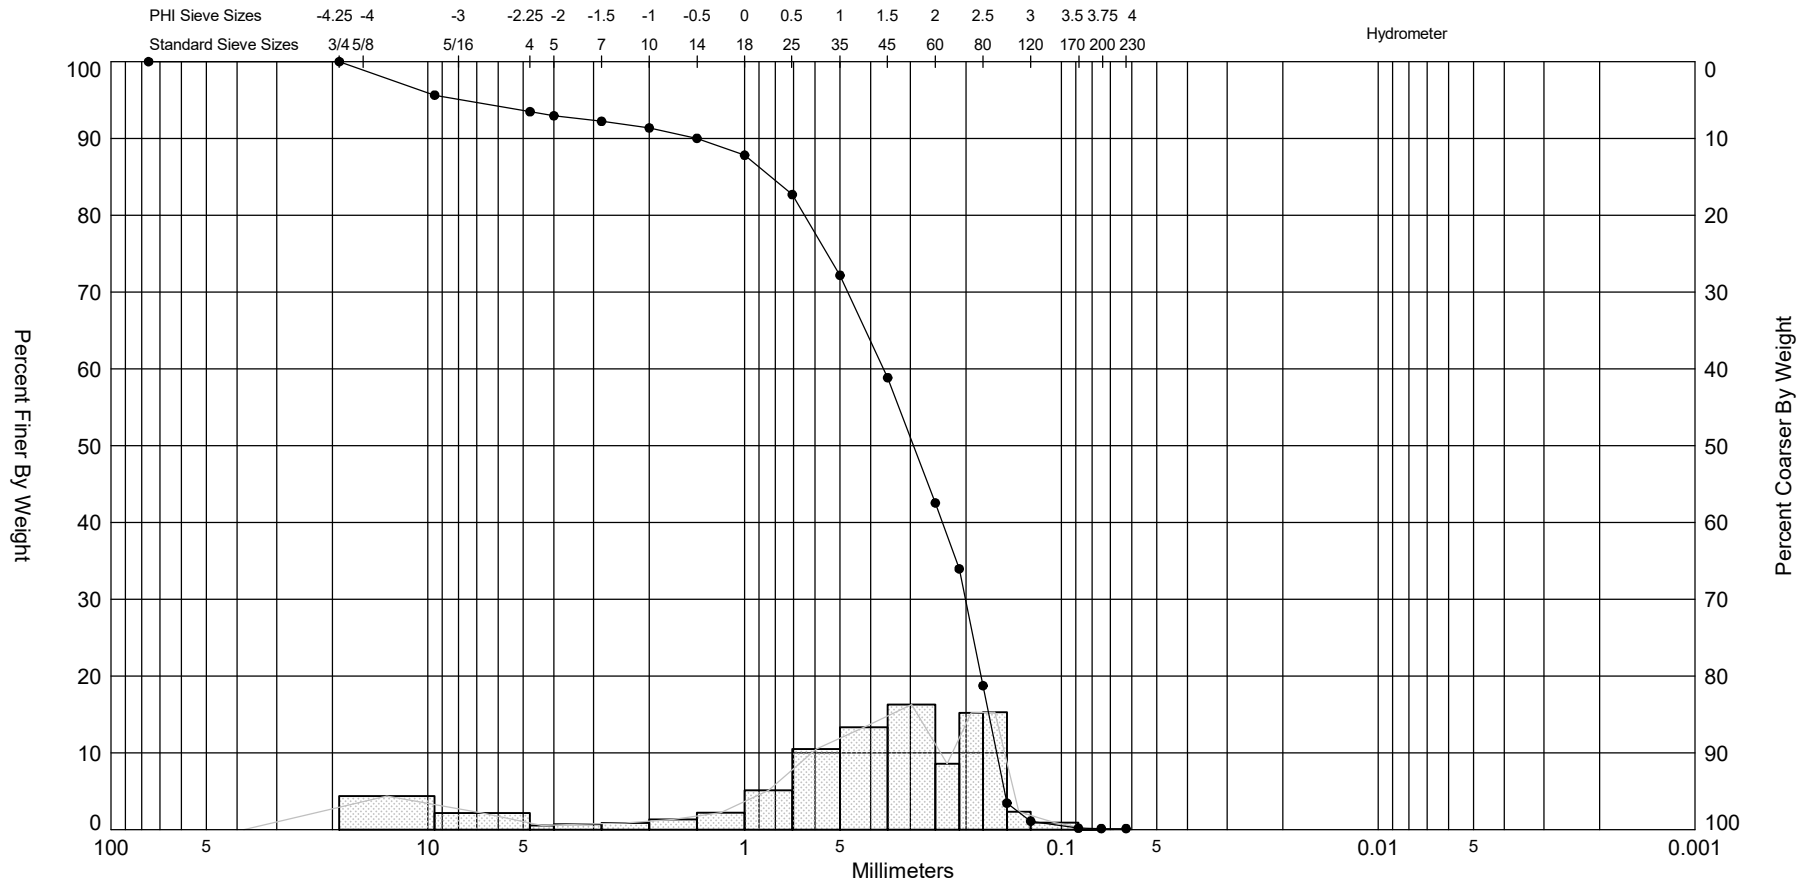
SIEVE ANALYSIS: ATM-PINE ISLAND-HILTON HEAD 2022.GPJ FL DEP ROSS.GDT 4/12/22

Sample	Symbol	Elev. (ft)	USCS	% Fines	% Organics	% Carbonates	Median	Mean	Skew	Kurt	Sort	Sample Information	
2022-PI-1-D0 #PI-1	—●—	0.0	SW	#230 - 0.14			1.77	1.32	-1.85	6.14	1.58	Project Name:	ATM - Pine Island - Hilton Head - 2022
Comments:												Analysis Date:	04-11-22
Depths and elevations based on measured values												Analyzed By:	PRD

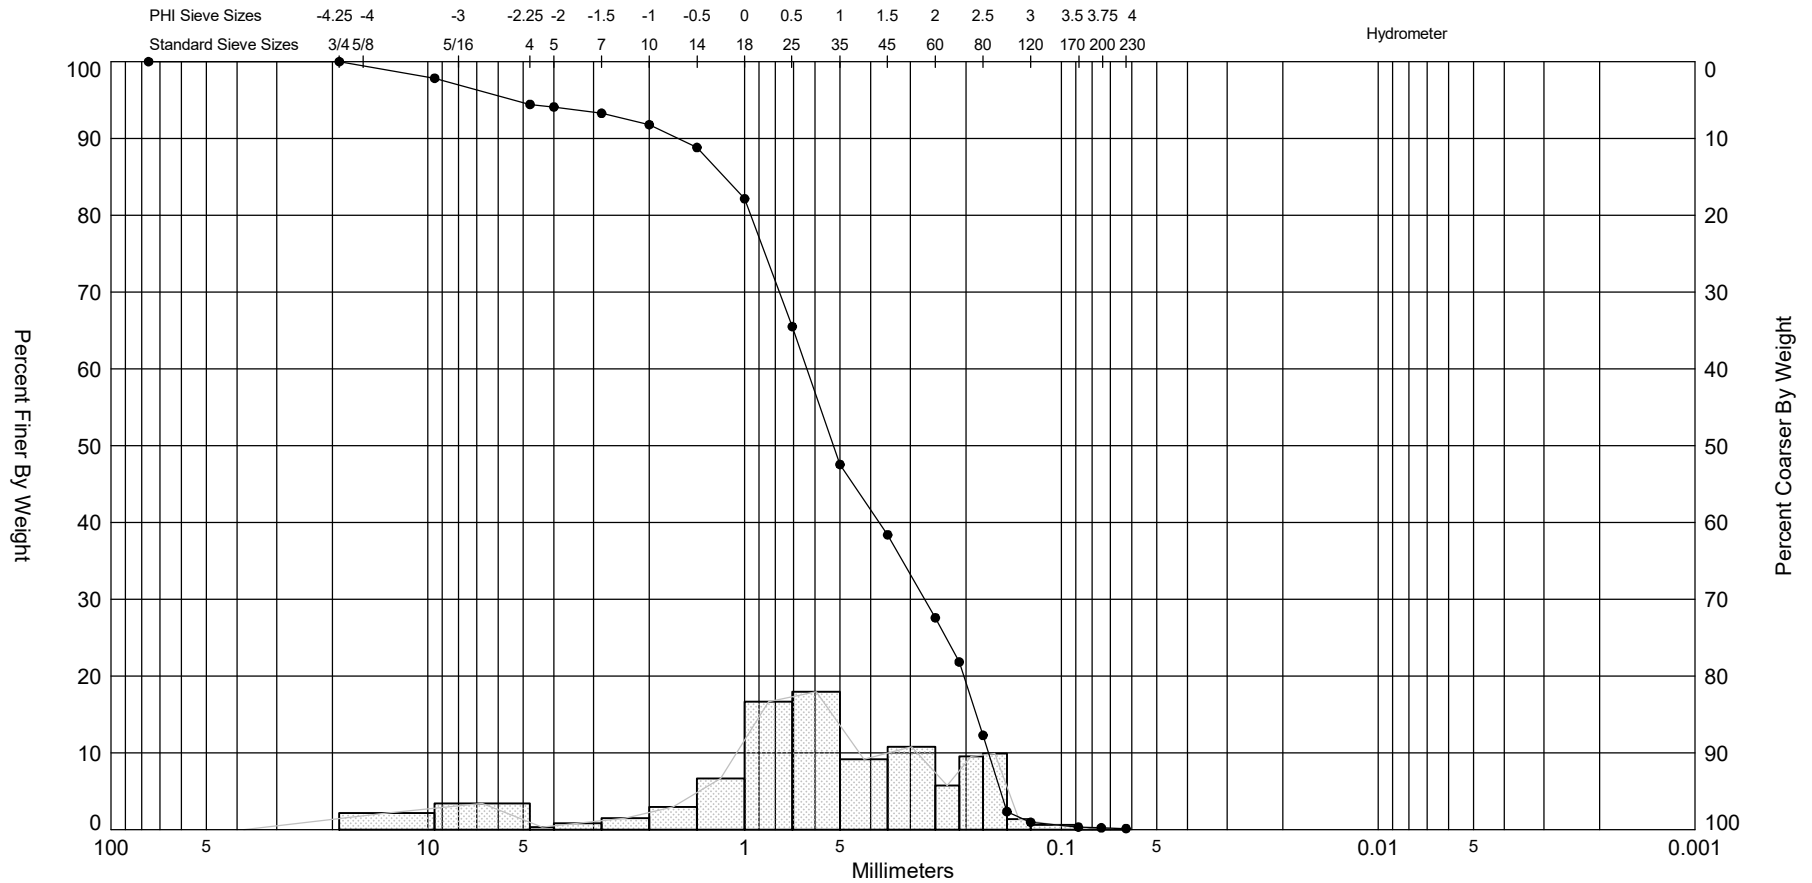
SIEVE ANALYSIS: ATM-PINE ISLAND-HILTON HEAD 2022.GPJ FL DEP ROSS.GDT 4/12/22

Sample	Symbol	Elev. (ft)	USCS	% Fines	% Organics	% Carbonates	Median	Mean	Skew	Kurt	Sort	Sample Information	
2022-PI-1-D2 #PI-1	—●—	-2.0	SW	#230 - 0.14			0.93	0.9	-1.08	4.42	1.45	Project Name:	ATM - Pine Island - Hilton Head - 2022
Comments:												Analysis Date:	04-11-22
Depths and elevations based on measured values												Analyzed By:	HDM

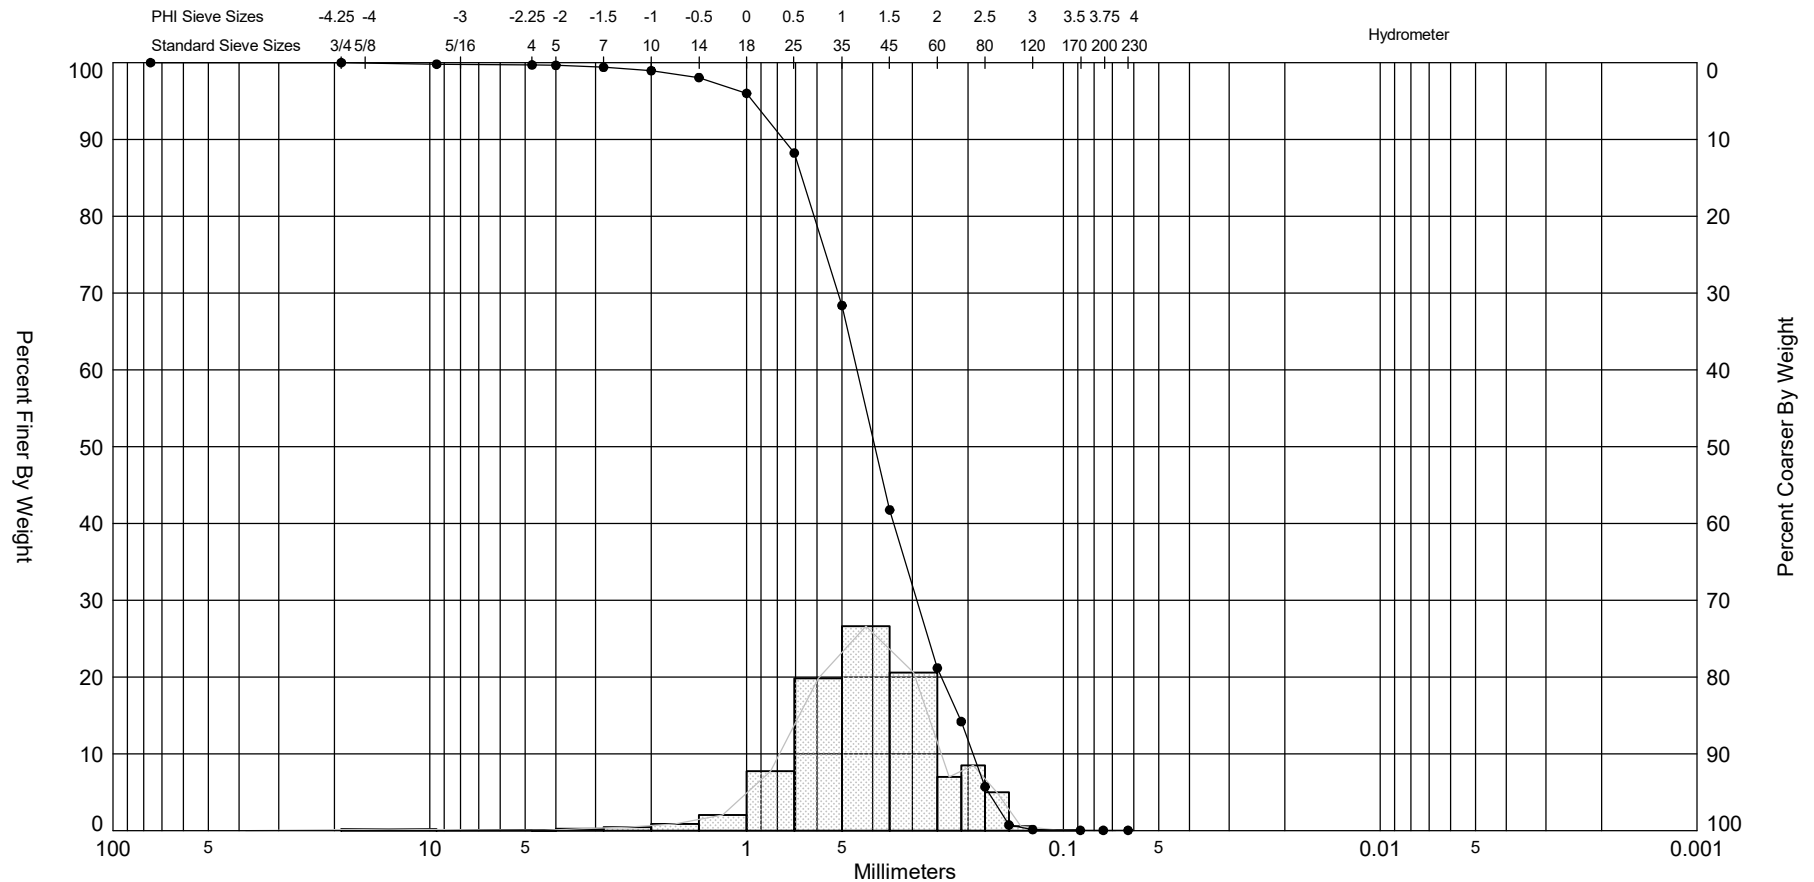
SIEVE ANALYSIS: ATM-PINE ISLAND-HILTON HEAD 2022.GPJ FL DEP ROSS.GDT 4/12/22

Sample	Symbol	Elev. (ft)	USCS	% Fines	% Organics	% Carbonates	Median	Mean	Skew	Kurt	Sort	Sample Information	
2022-PI-4-D0 #PI-4	—●—	0.0	SP	#230 - 0.04			1.35	1.33	-0.98	6.7	0.81	Project Name:	ATM - Pine Island - Hilton Head - 2022

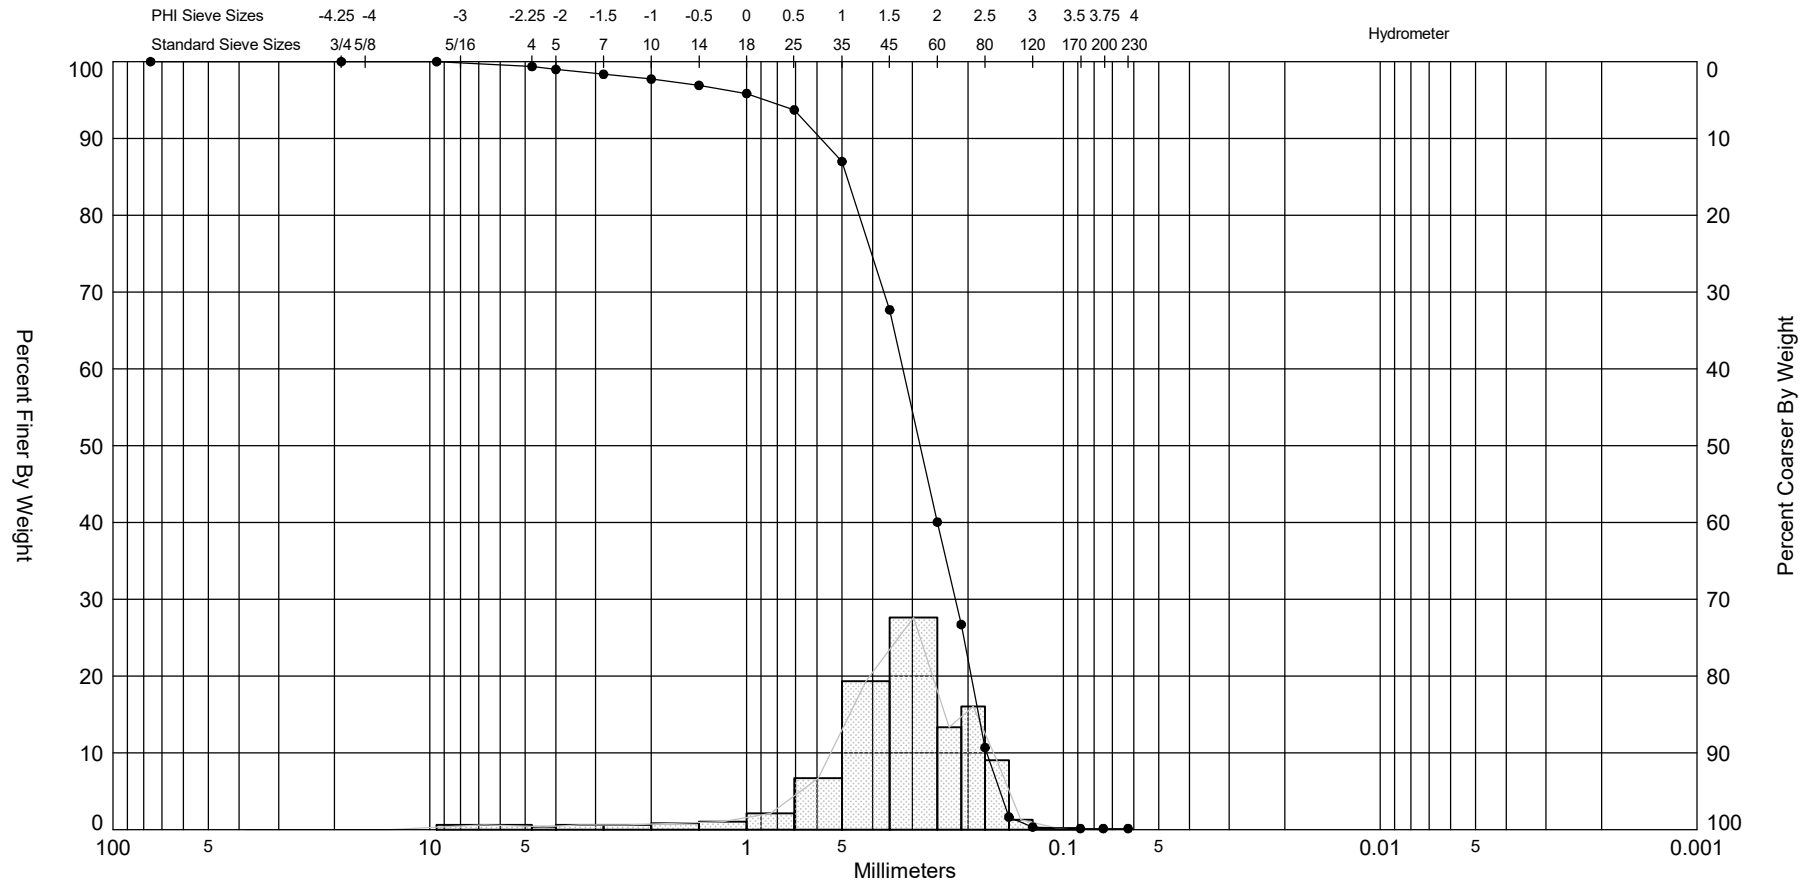
SIEVE ANALYSIS: ATM-PINE ISLAND-HILTON HEAD 2022.GPJ FL DEP ROSS.GDT 4/12/22

Sample	Symbol	Elev. (ft)	USCS	% Fines	% Organics	% Carbonates	Median	Mean	Skew	Kurt	Sort	Sample Information	
2022-PI-4-D6 #PI-4	—●—	-0.5	SW	#230 - 0.14			1.82	1.68	-2.06	9.56	0.86	Project Name:	ATM - Pine Island - Hilton Head - 2022
Comments:												Analysis Date:	04-11-22
Depths and elevations based on measured values												Analyzed By:	PRD

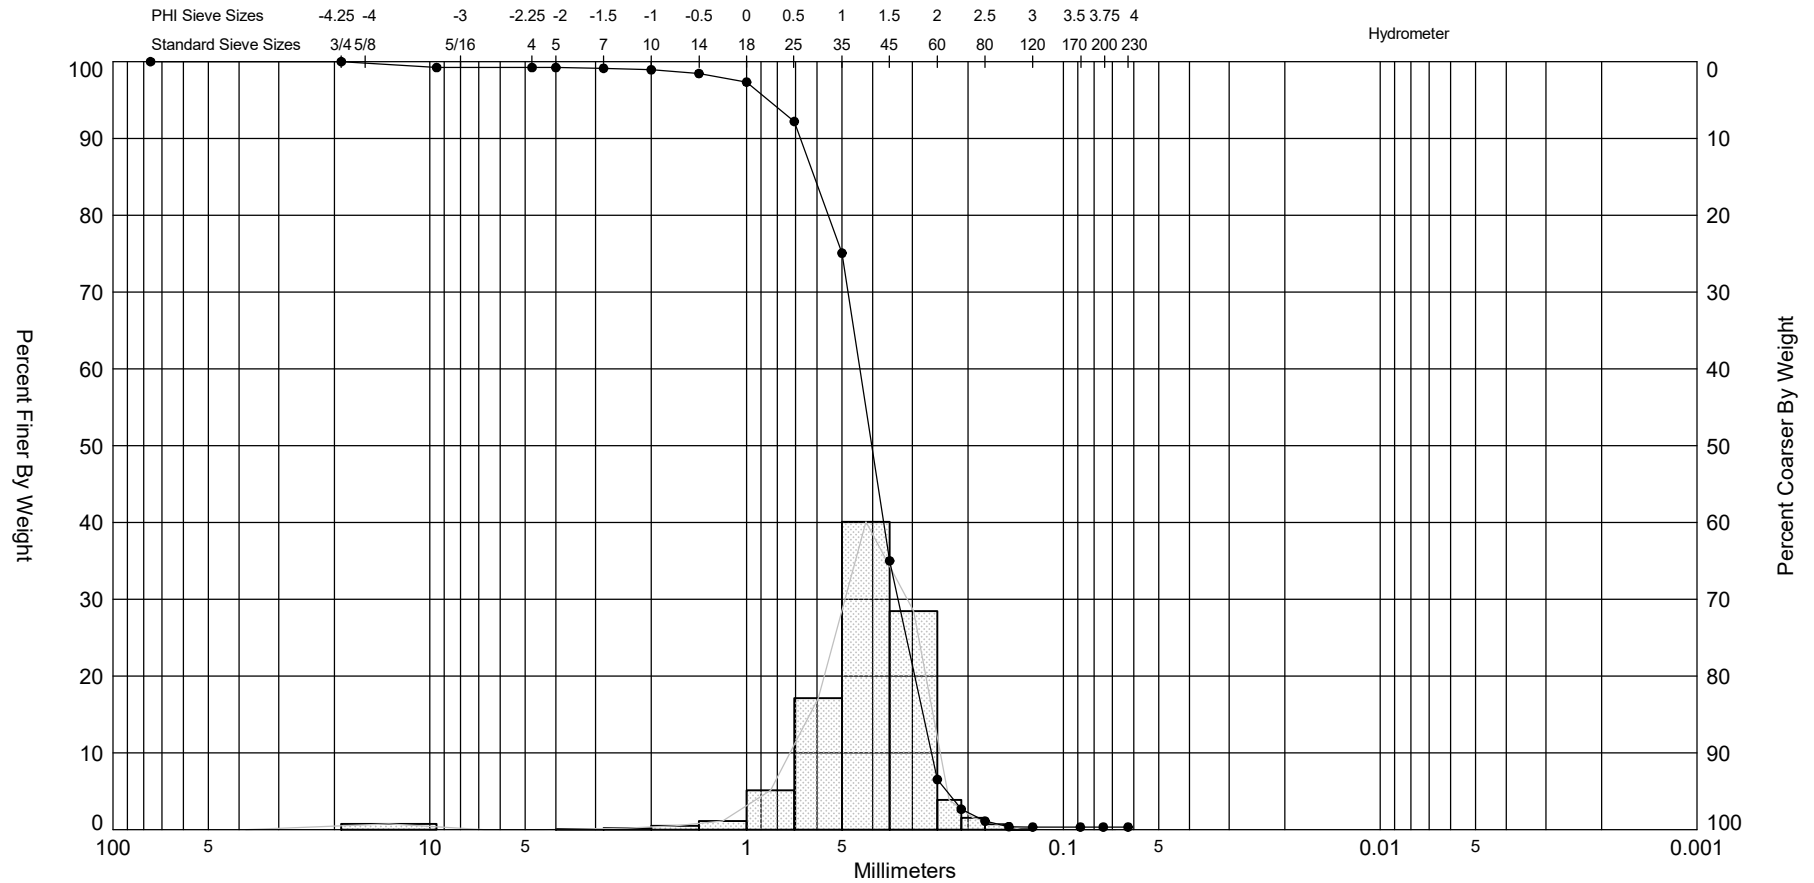
SIEVE ANALYSIS: ATM-PINE ISLAND-HILTON HEAD 2022.GPJ FL DEP ROSS.GDT 4/12/22

Sample	Symbol	Elev. (ft)	USCS	% Fines	% Organics	% Carbonates	Median	Mean	Skew	Kurt	Sort	Sample Information	
2022-PI-5-D0 #PI-5	—●—	0.0	SP	#230 - 0.34			1.31	1.24	-3.1	21.99	0.7	Project Name:	ATM - Pine Island - Hilton Head - 2022
Comments:												Analysis Date:	04-11-22
Depths and elevations based on measured values												Analyzed By:	PRD

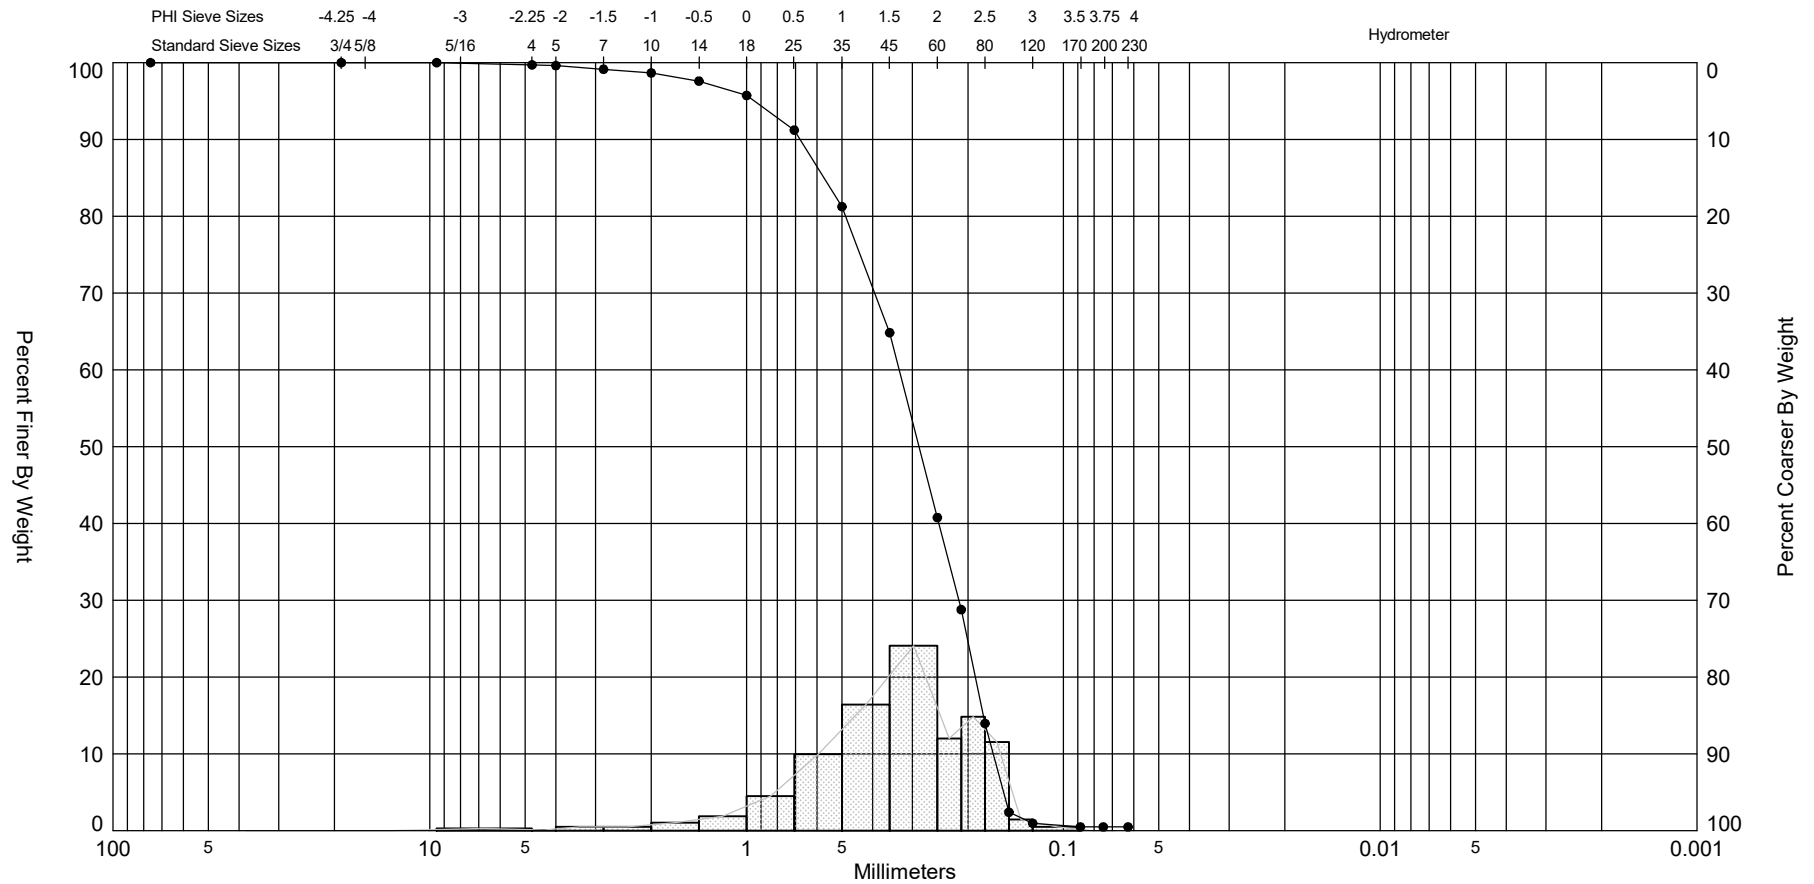
SIEVE ANALYSIS: ATM-PINE ISLAND-HILTON HEAD 2022.GPJ FL DEP ROSS.GDT 4/12/22

Sample	Symbol	Elev. (ft)	USCS	% Fines	% Organics	% Carbonates	Median	Mean	Skew	Kurt	Sort	Sample Information	
2022-PI-5-D3 #PI-5	—●—	-3.0	SW	#230 - 0.48			1.81	1.65	-1.35	6.01	0.86	Project Name:	ATM - Pine Island - Hilton Head - 2022
Comments:												Analysis Date:	04-08-22
Depths and elevations based on measured values												Analyzed By:	STP

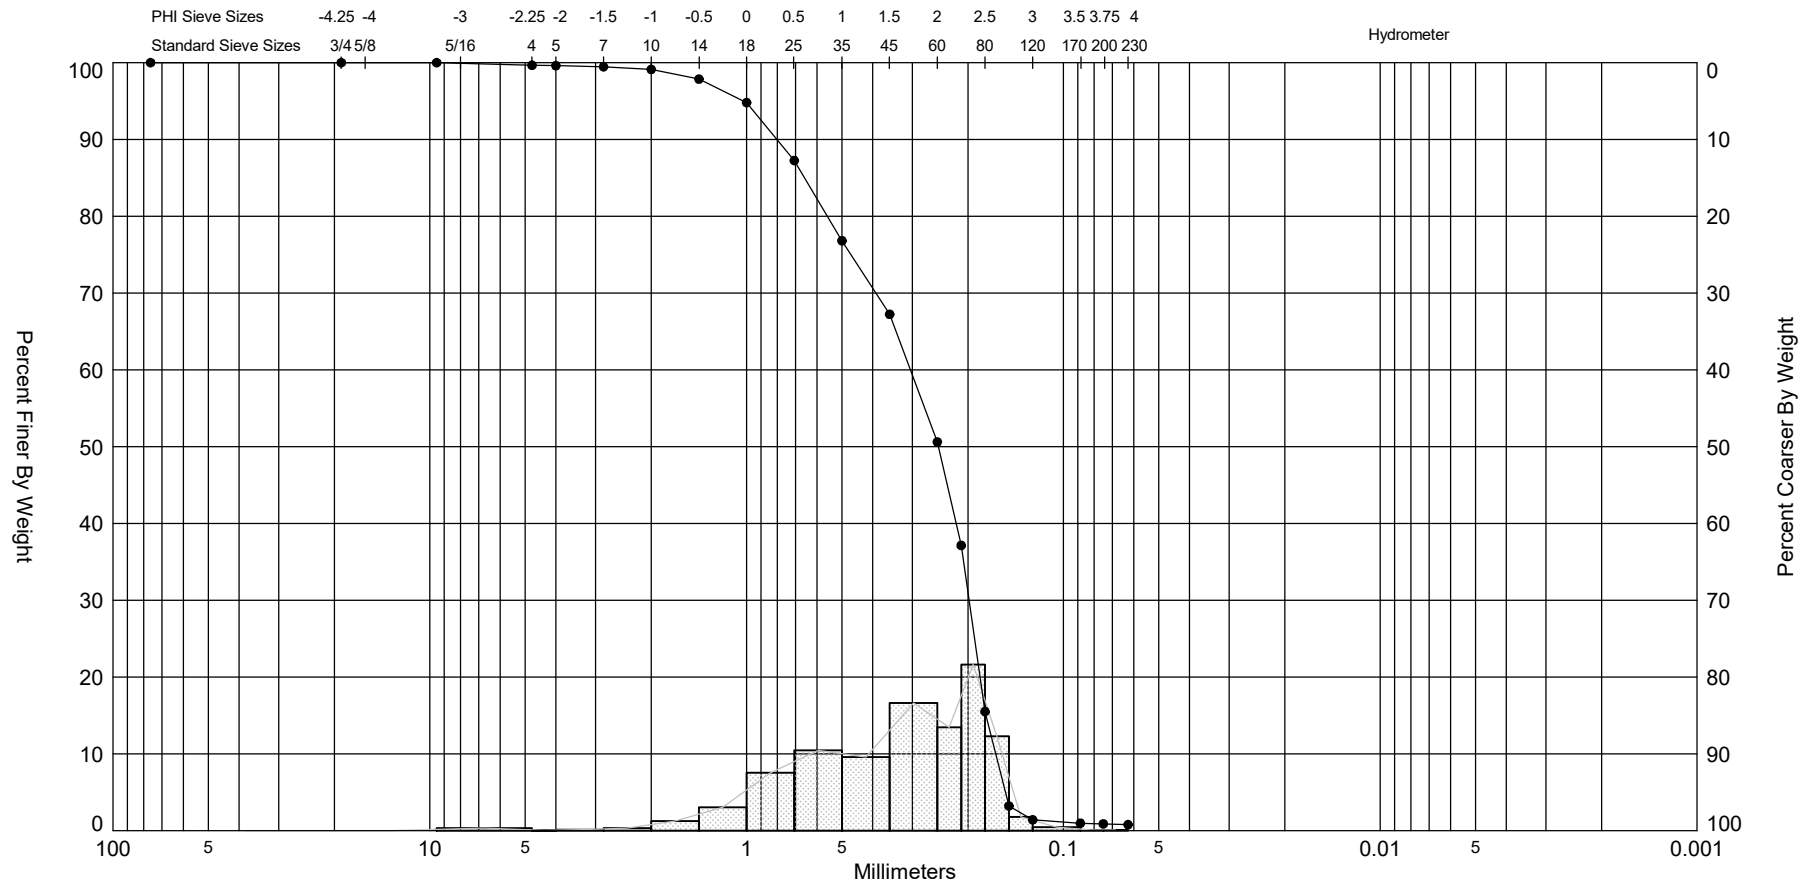
SIEVE ANALYSIS: ATM-PINE ISLAND-HILTON HEAD 2022.GPJ FL DEP ROSS.GDT 4/12/22

Sample	Symbol	Elev. (ft)	USCS	% Fines	% Organics	% Carbonates	Median	Mean	Skew	Kurt	Sort	Sample Information	
2022-PI-6-D0 #PI-6	—●—	0.0	SW	#230 - 0.78			2.01	1.68	-1.17	4.57	0.93	Project Name:	ATM - Pine Island - Hilton Head - 2022
Comments:												Analysis Date:	04-11-22
Depths and elevations based on measured values												Analyzed By:	STP

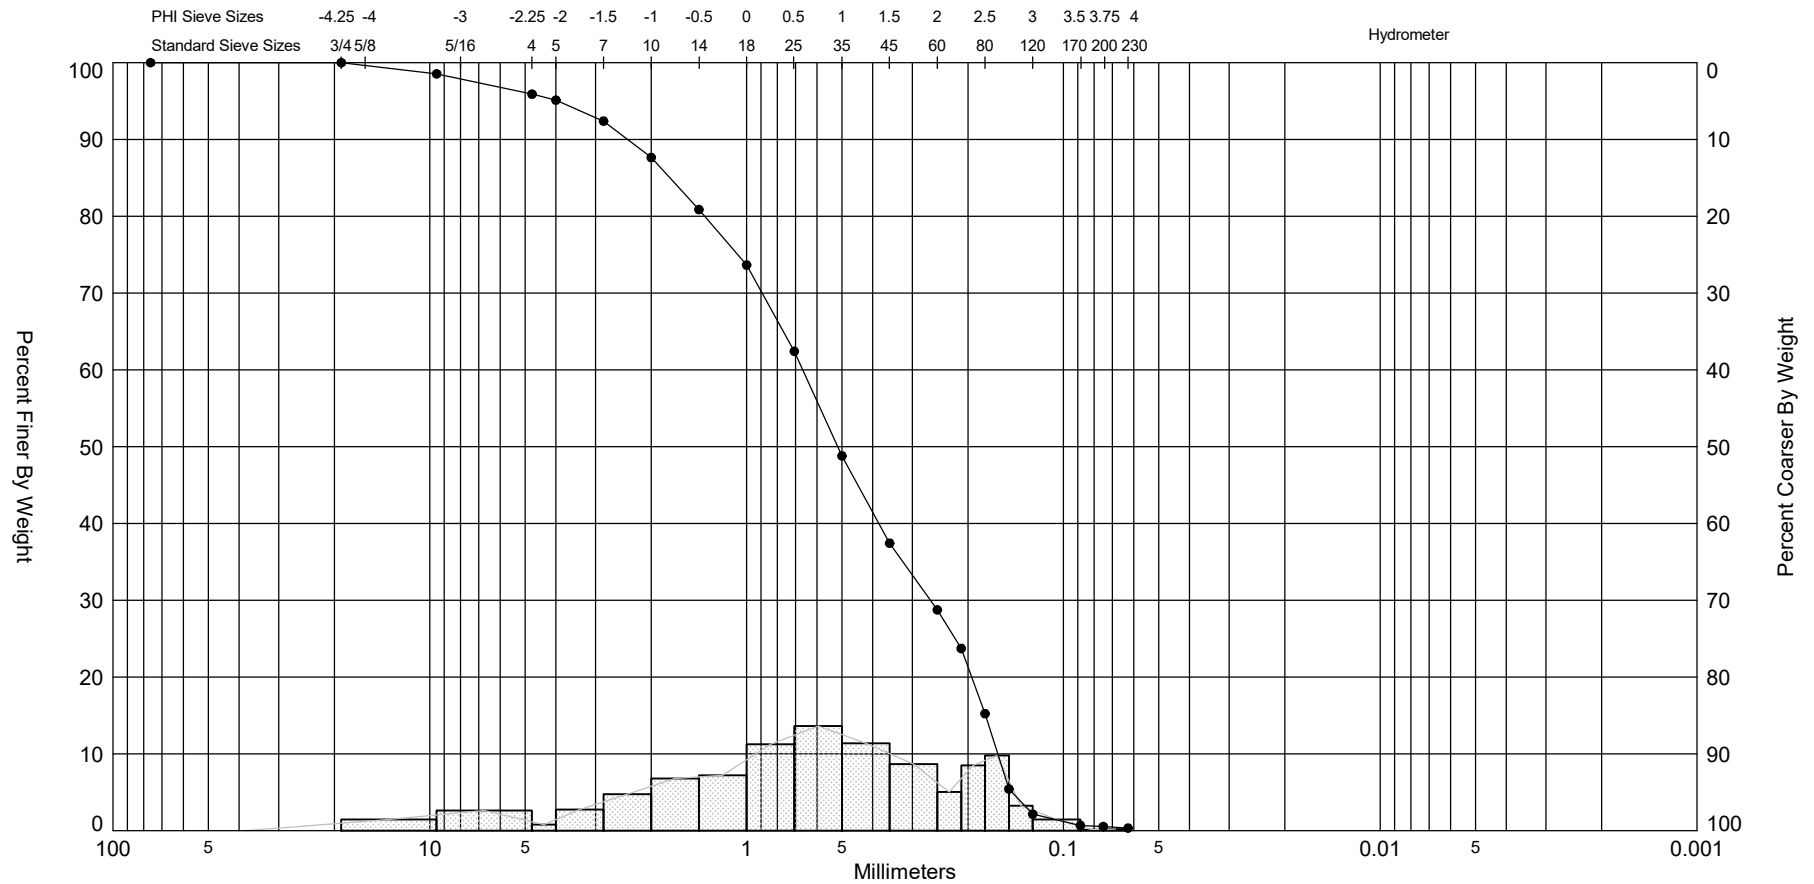
SIEVE ANALYSIS: ATM-PINE ISLAND-HILTON HEAD 2022.GPJ FL DEP ROSS.GDT 4/12/22

Sample	Symbol	Elev. (ft)	USCS	% Fines	% Organics	% Carbonates	Median	Mean	Skew	Kurt	Sort	Sample Information	
2022-PI-7-D0 #PI-7	—●—	0.0	SW	#230 - 0.34			0.96	0.83	-0.68	3.09	1.53	Project Name:	ATM - Pine Island - Hilton Head - 2022
