Exhibit B

Additional Information for the Joint Permit Application Hilton Head Plantation POA

32. Description of the Overall Project and of Each Affecting U.S. Waters or State Critical Areas (attach additional sheets if needed)

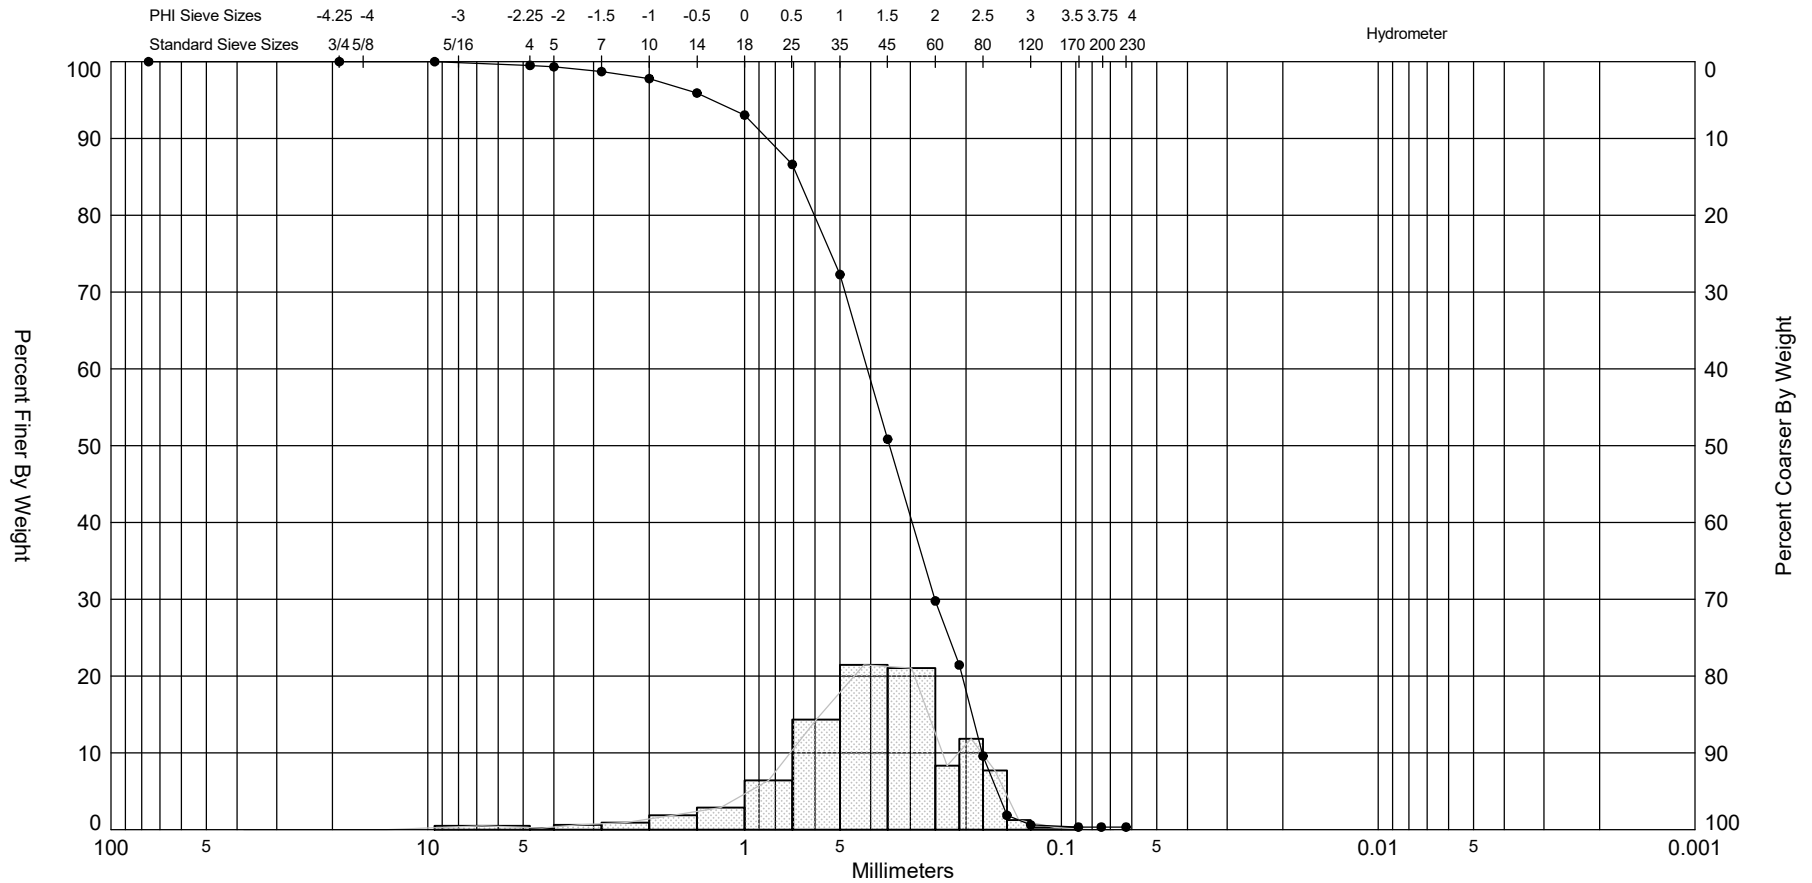
SIEVE ANALYSIS: ATM-PINE ISLAND-HILTON HEAD 2022.GPJ FL DEP ROSS.GDT 4/12/22

Sample	Symbol	Elev. (ft)	USCS	% Fines	% Organics	% Carbonates	Median	Mean	Skew	Kurt	Sort	Sample Information	
2022-PI-7-D12 #PI-7	—●—	-1.0	SW	#230 - 0.34			1.52	1.41	-1.11	5.08	0.94	Project Name:	ATM - Pine Island - Hilton Head - 2022
Comments:												Analysis Date:	04-11-22
Depths and elevations based on measured values												Analyzed By:	PRD

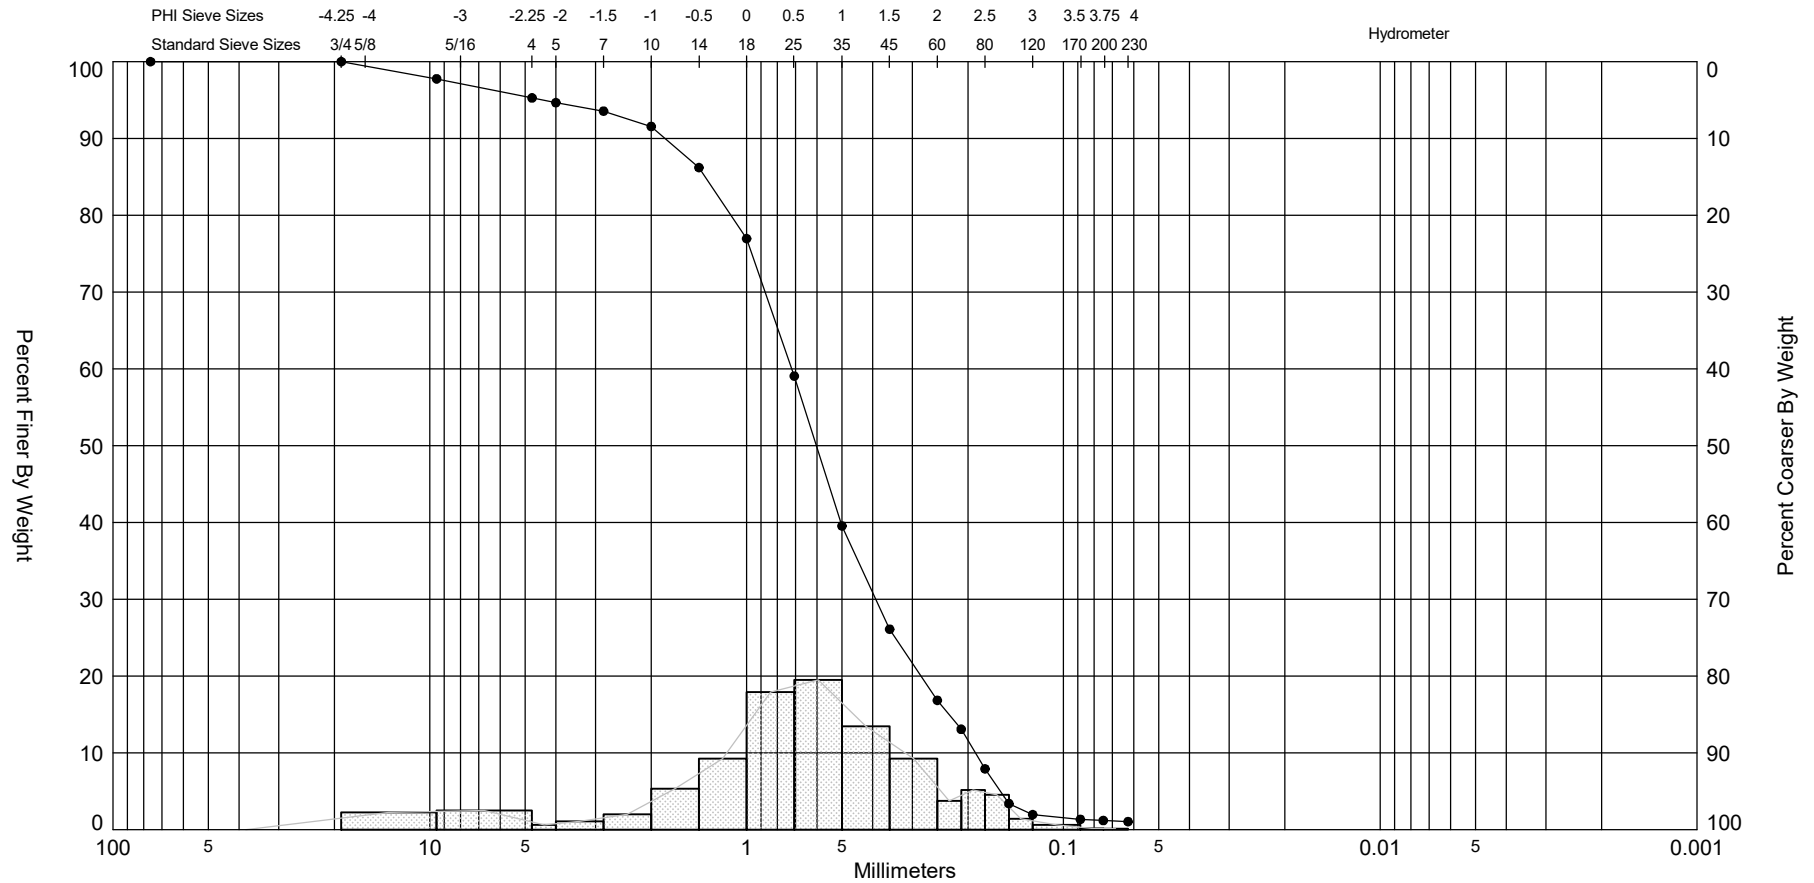
SIEVE ANALYSIS: ATM-PINE ISLAND-HILTON HEAD 2022.GPJ FL DEP ROSS.GDT 4/12/22

Sample	Symbol	Elev. (ft)	USCS	% Fines	% Organics	% Carbonates	Median	Mean	Skew	Kurt	Sort	Sample Information	
2022-PI-7-D32 #PI-7	—●—	0.0	SW	#230 - 1.05			0.73	0.65	-0.92	4.55	1.36	Project Name:	ATM - Pine Island - Hilton Head - 2022

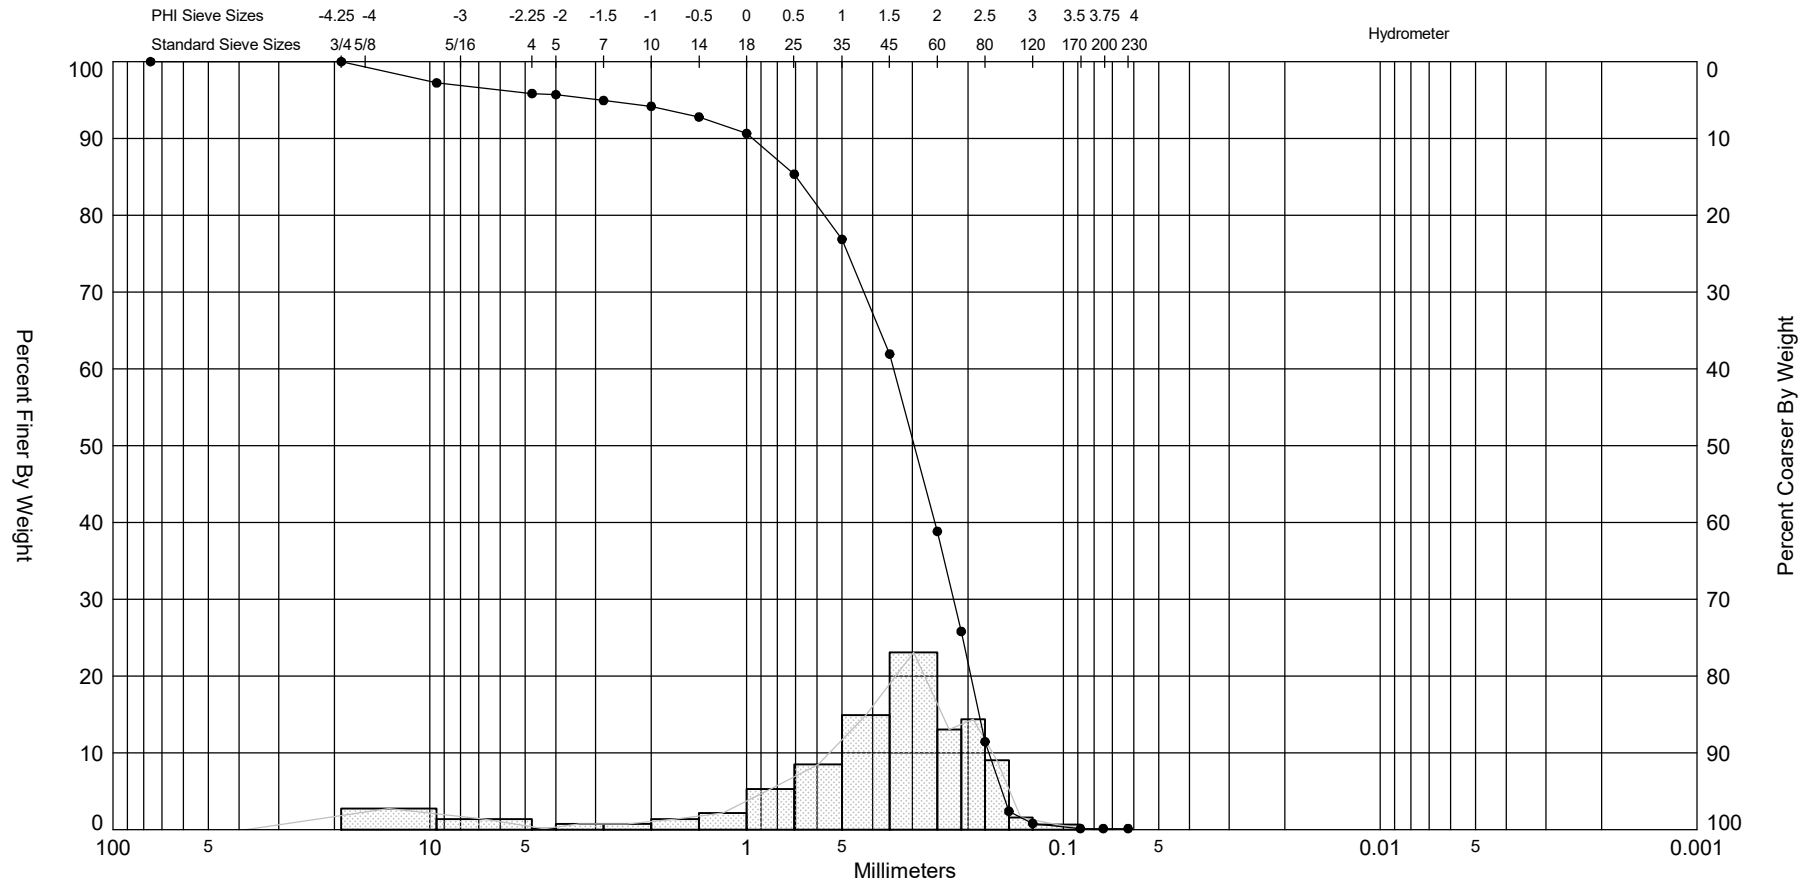
SIEVE ANALYSIS: ATM-PINE ISLAND-HILTON HEAD 2022.GPJ FL DEP ROSS.GDT 4/27/22

Sample	Symbol	Elev. (ft)	USCS	% Fines	% Organics	% Carbonates	Median	Mean	Skew	Kurt	Sort	Sample Information	
2022-PI-HOLE1	—●—	0.0	SW	#230 - 0.14			1.76	1.41	-2.17	8.28	1.33	Project Name:	ATM - Pine Island - Hilton Head - 2022
Comments:												Analysis Date:	04-21-22
Depths and elevations based on measured values												Analyzed By:	STP

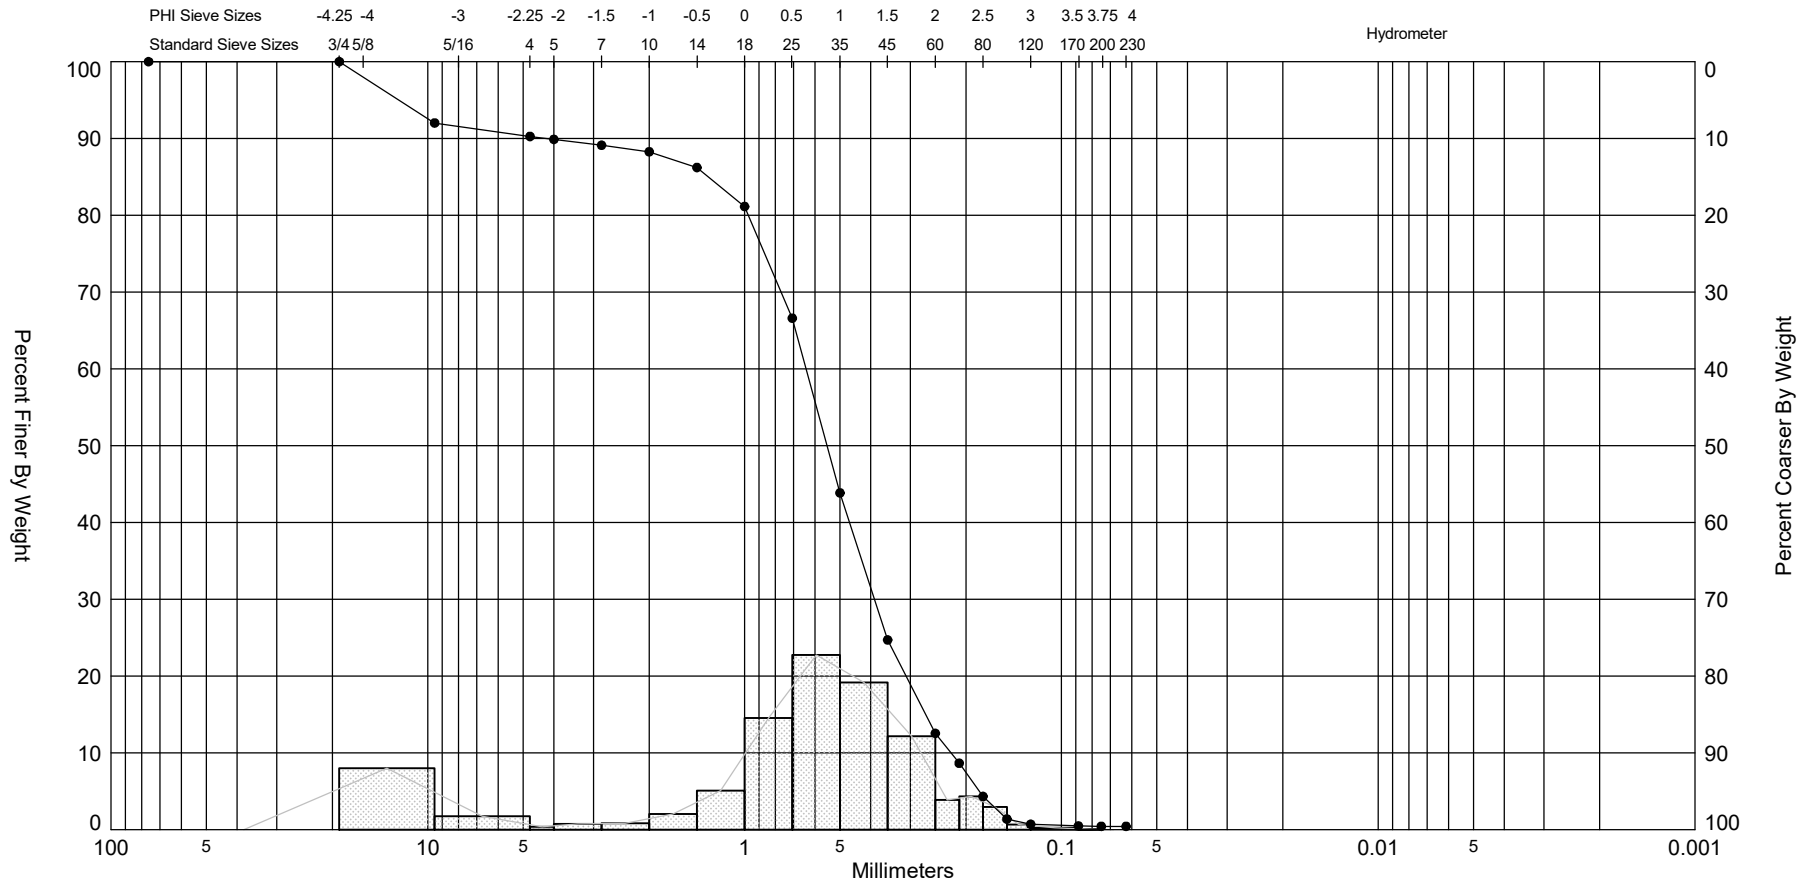
SIEVE ANALYSIS: ATM-PINE ISLAND-HILTON HEAD 2022.GPJ FL DEP ROSS.GDT 4/27/22

Sample	Symbol	Elev. (ft)	USCS	% Fines	% Organics	% Carbonates	Median	Mean	Skew	Kurt	Sort	Sample Information	
2022-PI-HOLE2	—●—	0.0	SW	#230 - 0.43			0.86	0.55	-1.51	4.88	1.6	Project Name:	ATM - Pine Island - Hilton Head - 2022
Comments:												Analysis Date:	04-21-22
Depths and elevations based on measured values												Analyzed By:	HDM

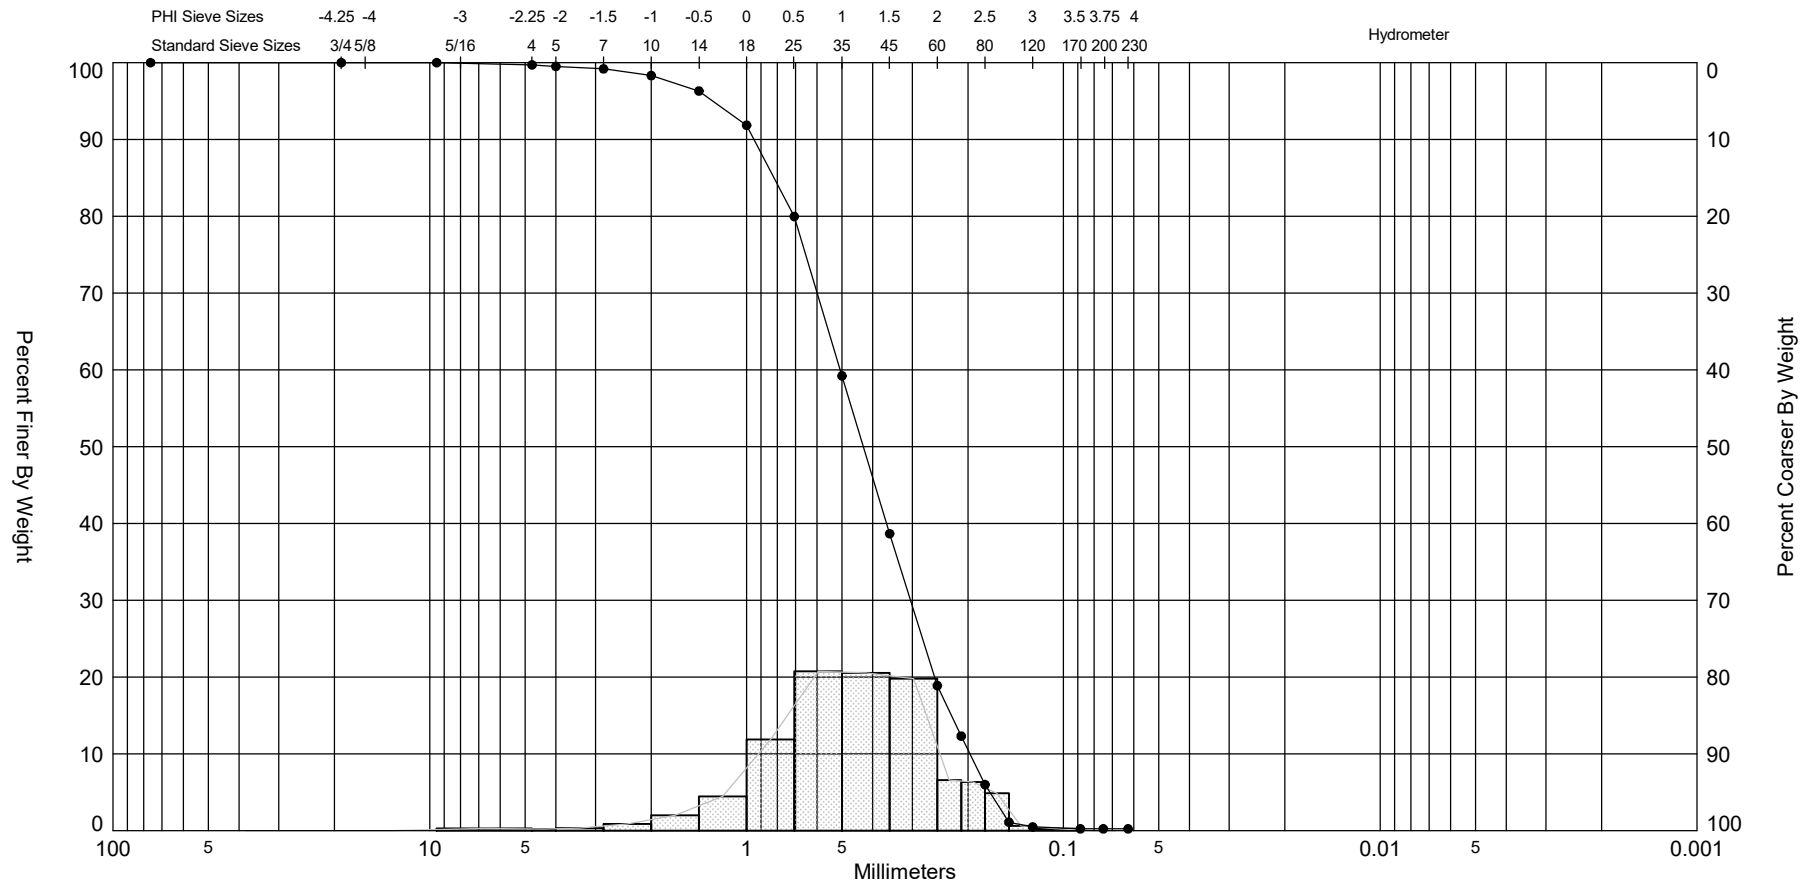
SIEVE ANALYSIS: ATM-PINE ISLAND-HILTON HEAD 2022.GPJ FL DEP ROSS.GDT 4/27/22

Sample	Symbol	Elev. (ft)	USCS	% Fines	% Organics	% Carbonates	Median	Mean	Skew	Kurt	Sort	Sample Information	
2022-PI-HOLE3	—●—	0.0	SW	#230 - 0.24			1.22	1.18	-0.62	3.98	0.89	Project Name:	ATM - Pine Island - Hilton Head - 2022

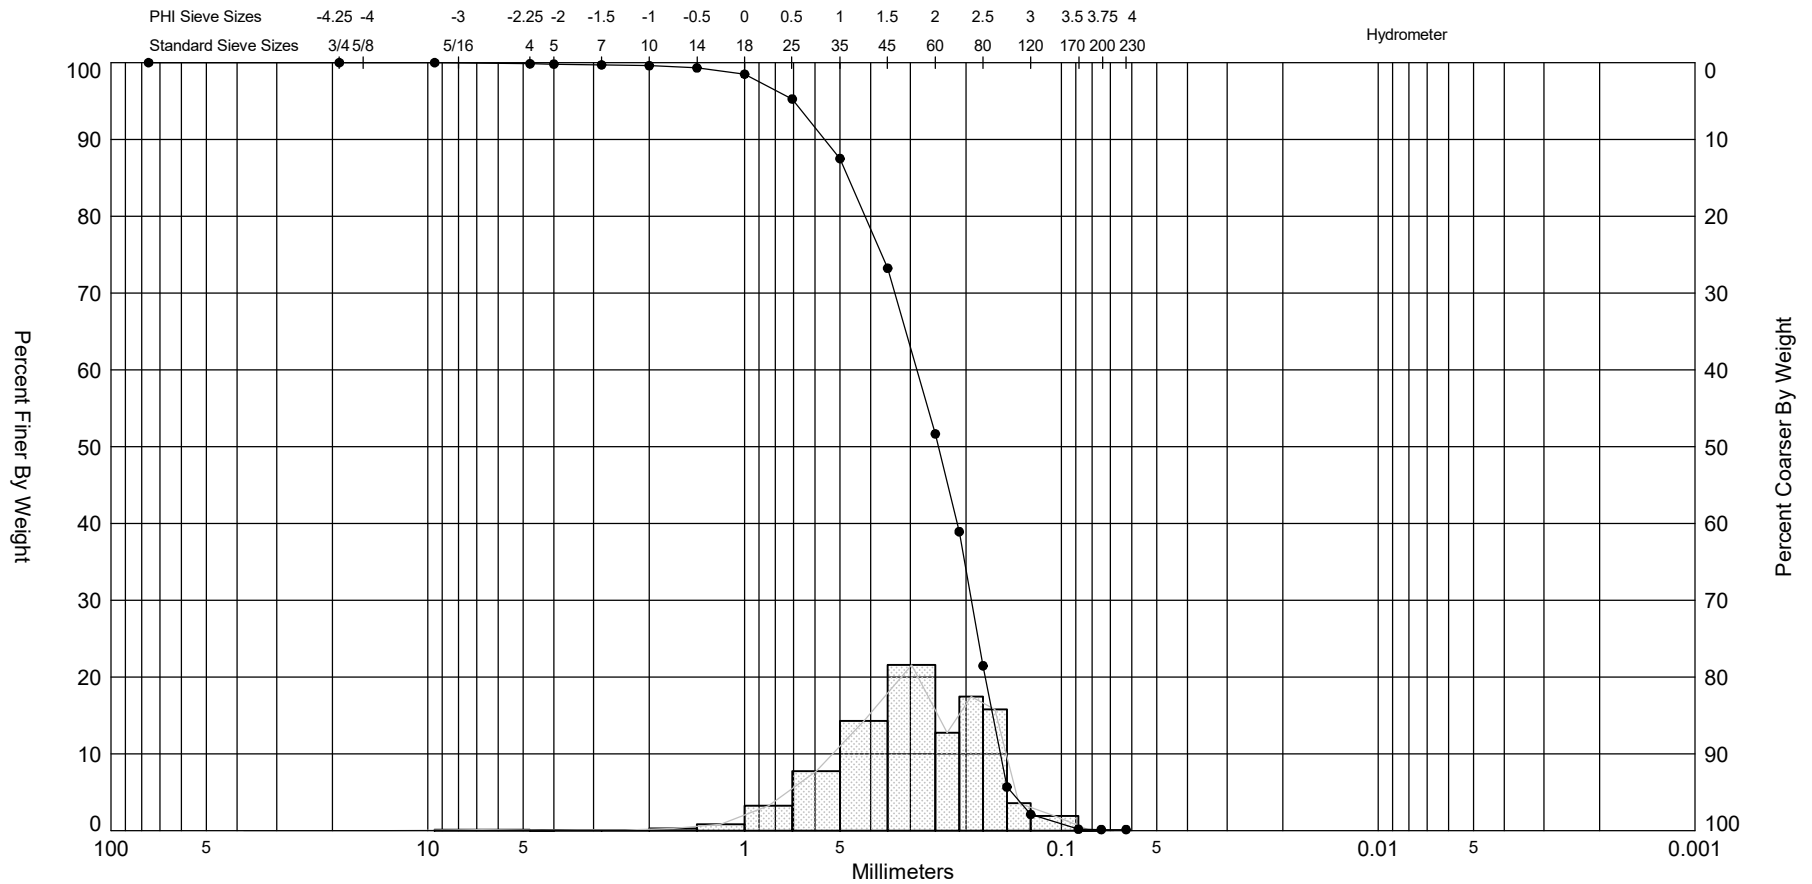
SIEVE ANALYSIS: ATM-PINE ISLAND-HILTON HEAD 2022.GPJ FL DEP ROSS.GDT 4/27/22

Sample	Symbol	Elev. (ft)	USCS	% Fines	% Organics	% Carbonates	Median	Mean	Skew	Kurt	Sort	Sample Information	
2022-PI-HOLE5	—●—	0.0	SP	#230 - 0.14			2.03	1.88	-1.13	5.75	0.76	Project Name:	ATM - Pine Island - Hilton Head - 2022

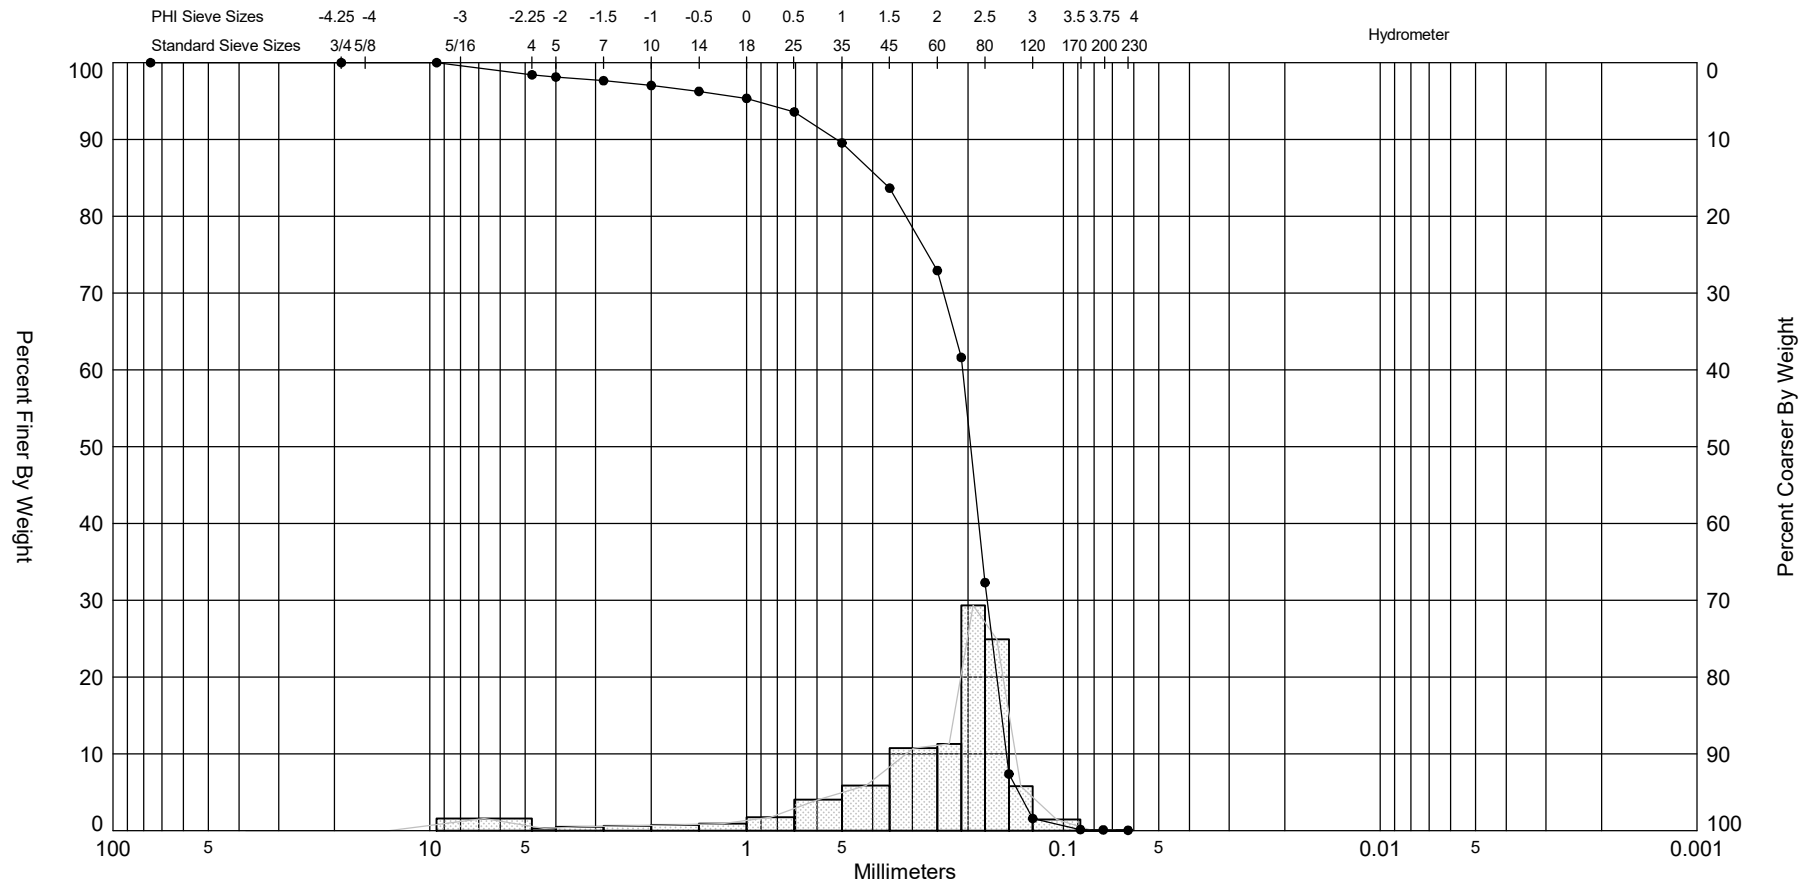
SIEVE ANALYSIS: ATM-PINE ISLAND-HILTON HEAD 2022.GPJ FL DEP ROSS.GDT 4/27/22

Sample	Symbol	Elev. (ft)	USCS	% Fines	% Organics	% Carbonates	Median	Mean	Skew	Kurt	Sort	Sample Information	
2022-PI-HOLE6	—●—	0.0	SW	#230 - 0.05			2.35	2.03	-2.73	11.72	1	Project Name:	ATM - Pine Island - Hilton Head - 2022
Comments:												Analysis Date:	04-21-22
Depths and elevations based on measured values												Analyzed By:	STP

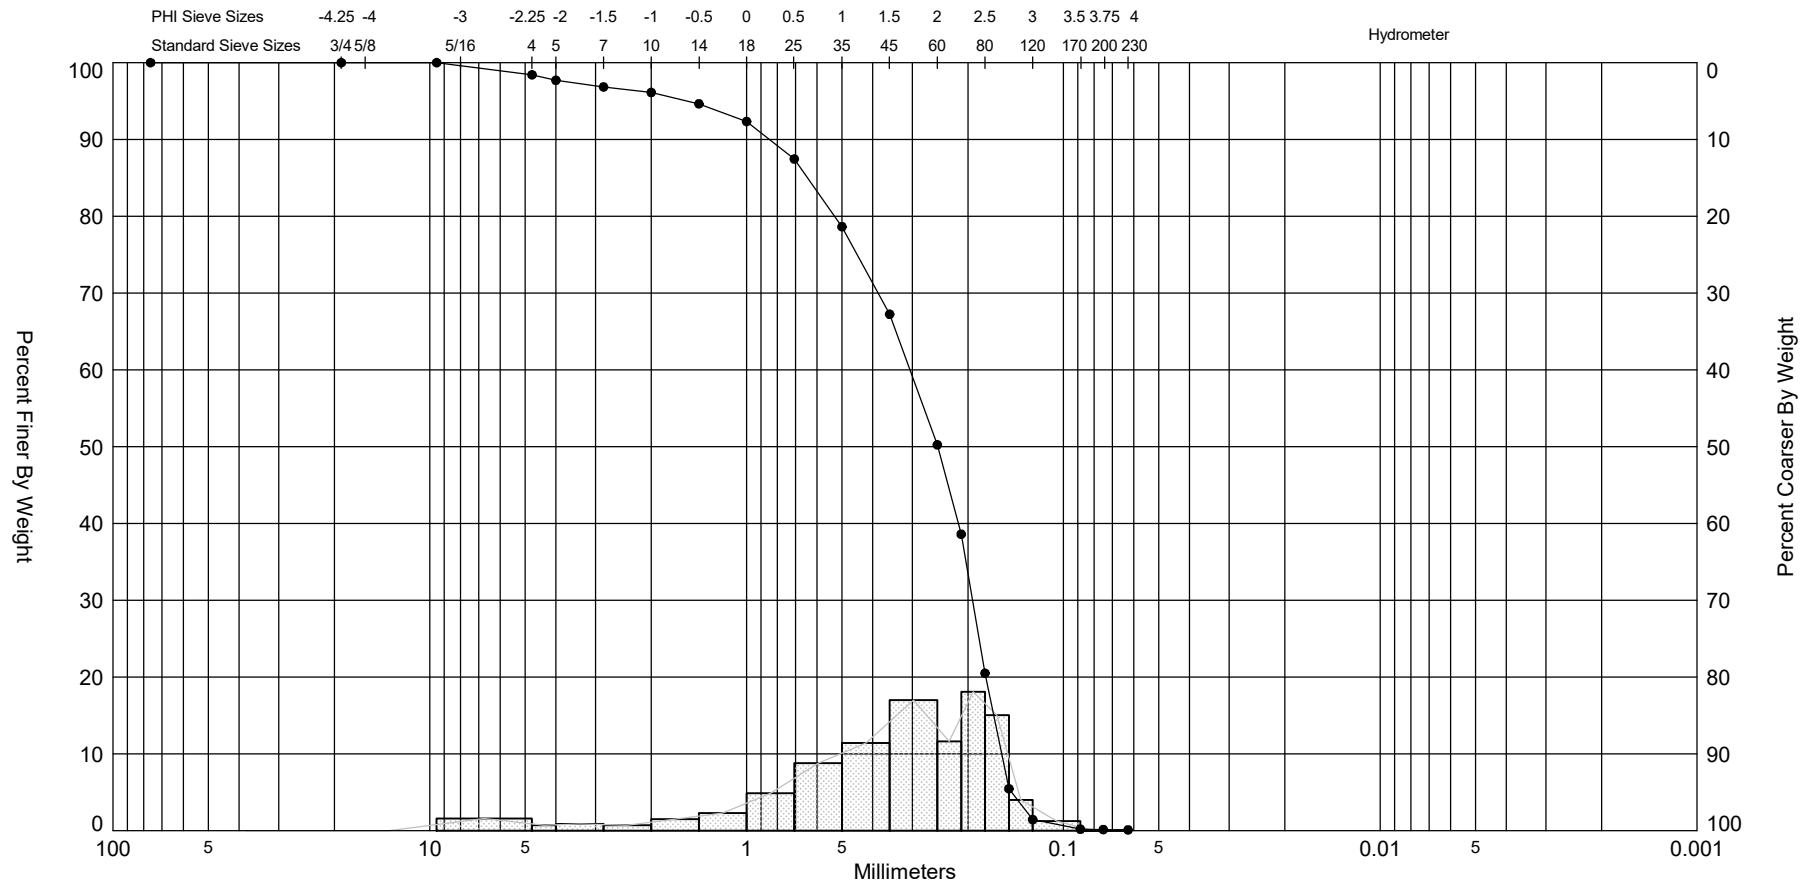
SIEVE ANALYSIS: ATM-PINE ISLAND-HILTON HEAD 2022.GPJ FL DEP ROSS.GDT 4/27/22

Sample	Symbol	Elev. (ft)	USCS	% Fines	% Organics	% Carbonates	Median	Mean	Skew	Kurt	Sort	Sample Information	
2022-PI-HOLE8	—●—	0.0	SW	#230 - 0.10			2.01	1.65	-1.69	6.35	1.13	Project Name:	ATM - Pine Island - Hilton Head - 2022
Comments:												Analysis Date:	04-21-22
Depths and elevations based on measured values												Analyzed By:	HDM
