Town of Seabrook Island  
Comprehensive Beach Management Plan

# Town of Seabrook Island Comprehensive Beach Management Plan

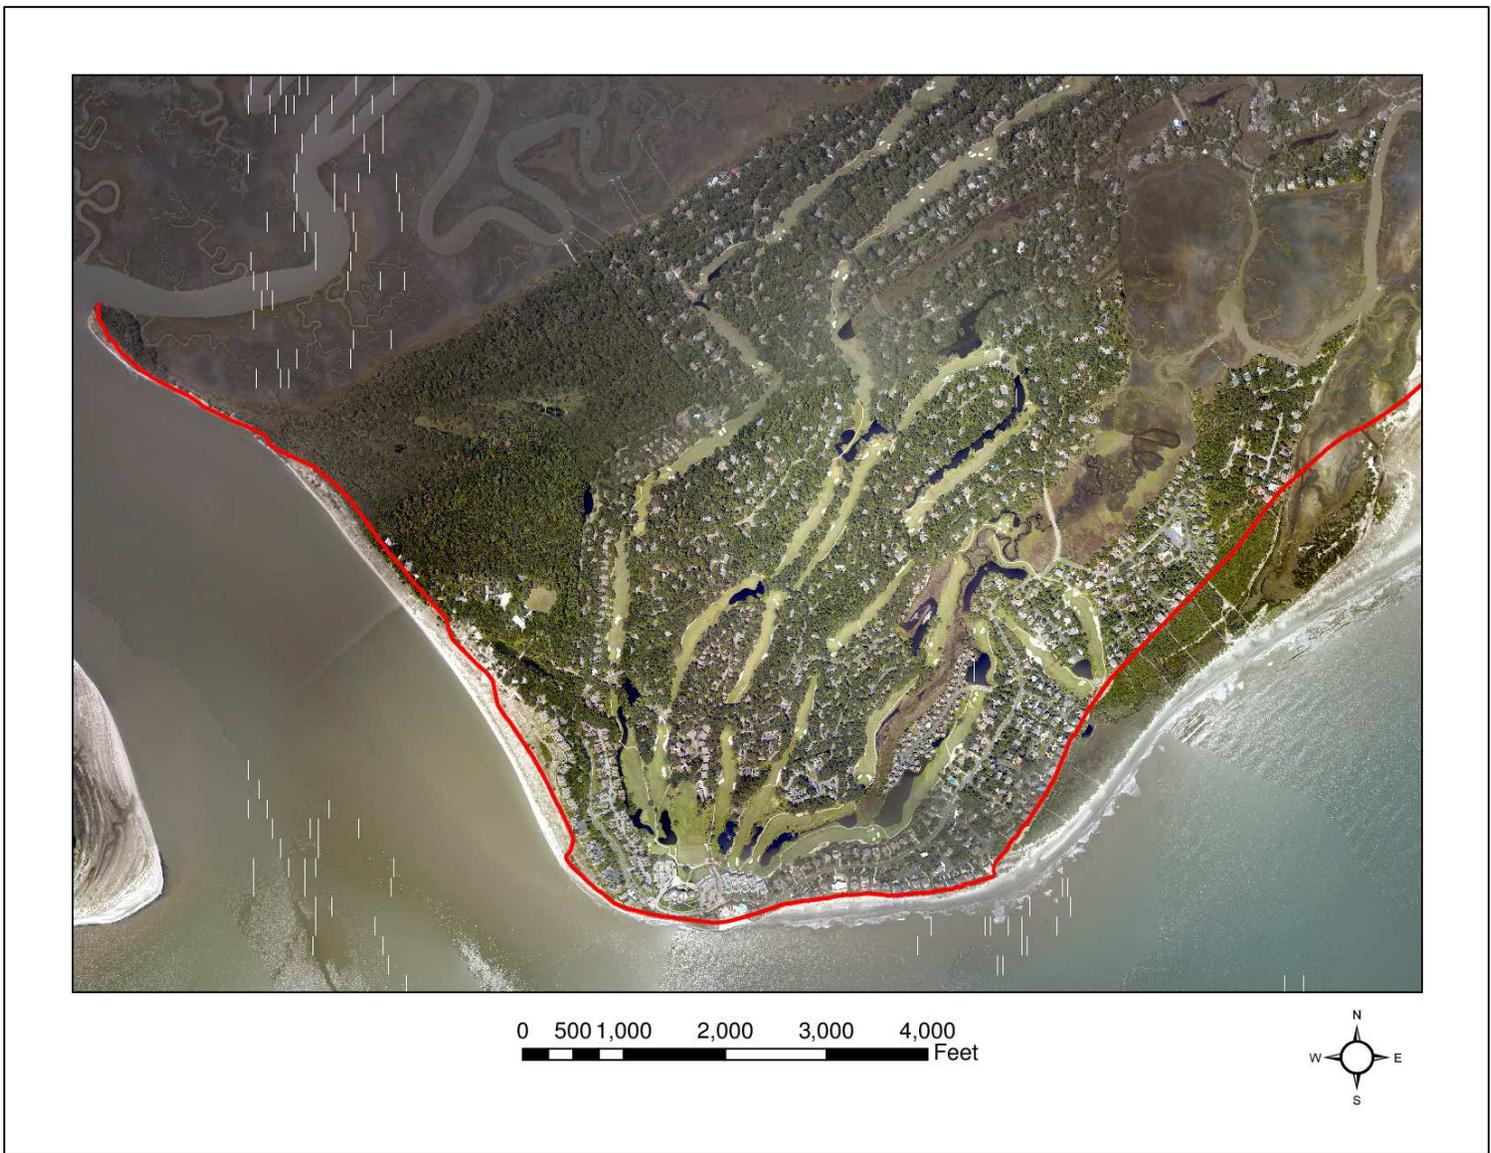
**FIGURE 5.1k** Official 2018 OCRM Setback Line for a portion of Seabrook Island superimposed on a 2019 rectified aerial orthophotograph. Image taken close to high tide.

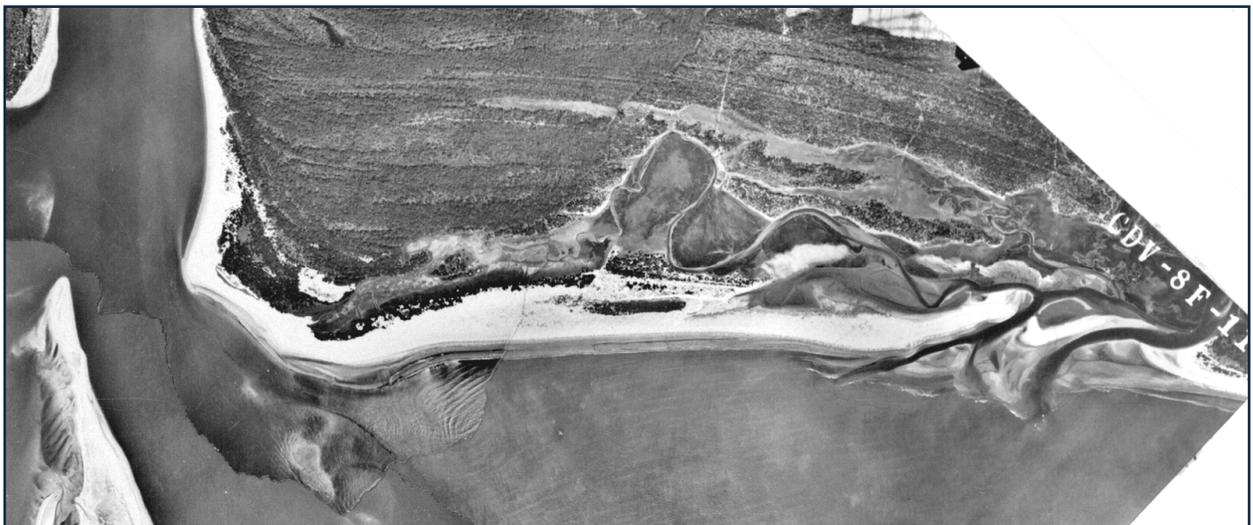
**FIGURE T-2.** Vertical photograph (1949) of Seabrook Island before development. Sometime in 1948, Captain Sams Inlet breached the Kiawah Spit near present-day Beachwalker Park (right side of image). The northeastern channel became dominant in the 1950s.

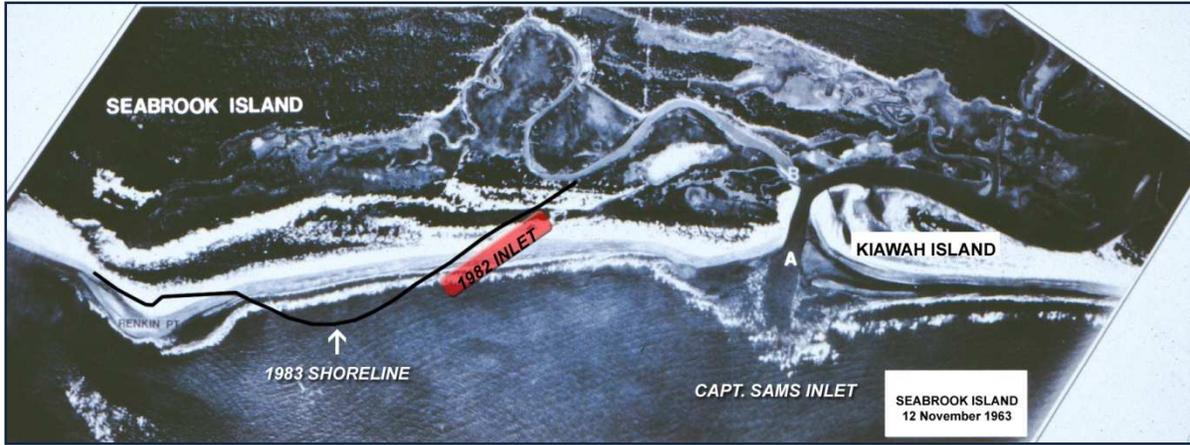
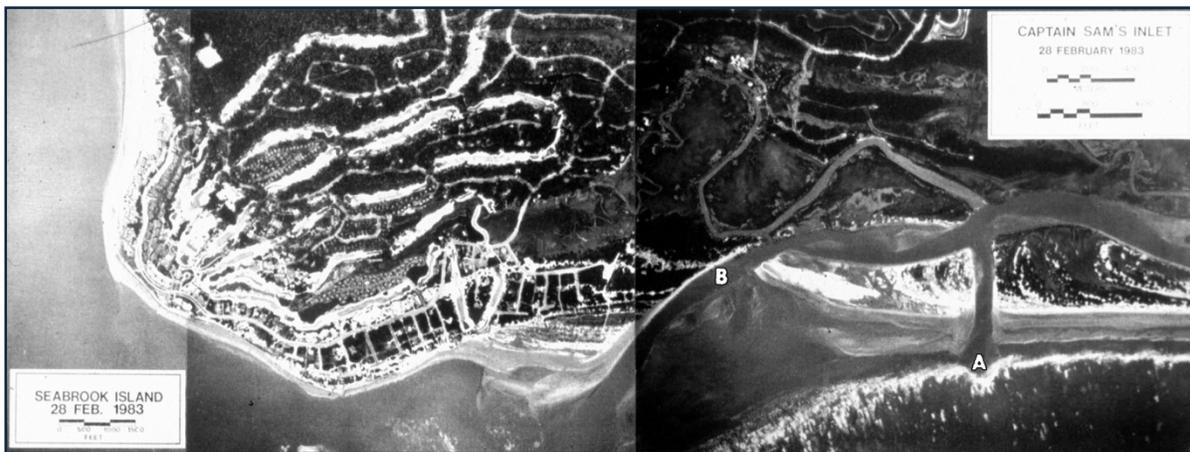
**FIGURE T-3.** Seabrook Island and Captain Sams Inlet in 1963 (upper) and 1983 (lower). The 1963 condition served as a model for the plan to relocate Captain Sams Inlet. Lower photo shows the new channel (A) open before the old channel (B) was closed on 4 March 1983.

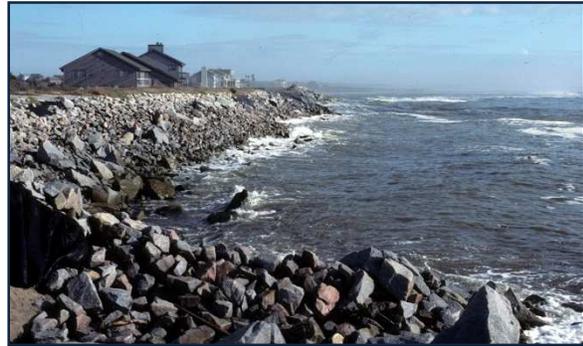
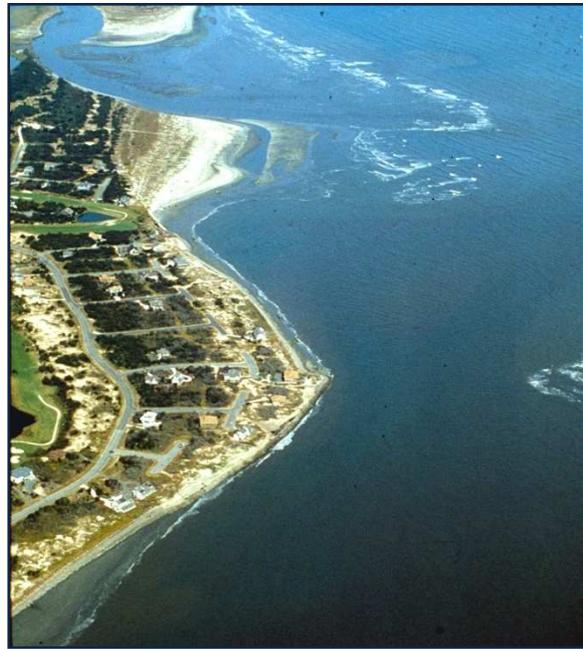
**FIGURE T-5.** During the early 1980s, much of Seabrook lacked any beach even at low tide. [UPPER] View north from Renken Point at mid tide. [LOWER] Oblique aerial (1982) looking north at low tide showing no beach around Renken Point.

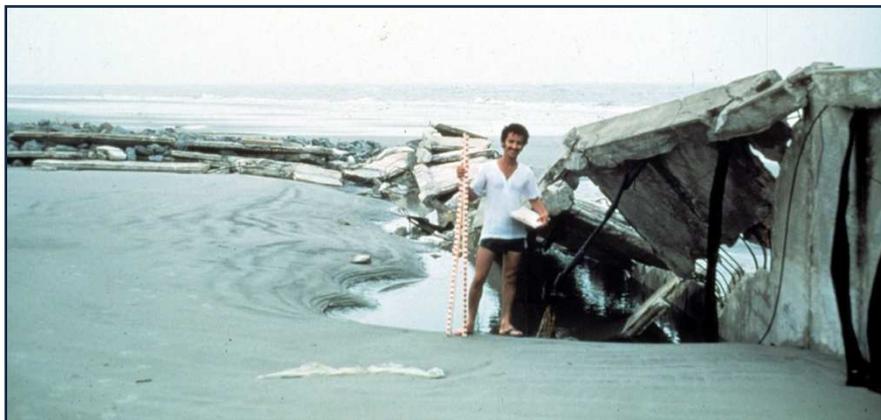
**FIGURE T-6.** Collapse of the concrete seawall at Renken Point in September 1979 during Hurricane *David*.

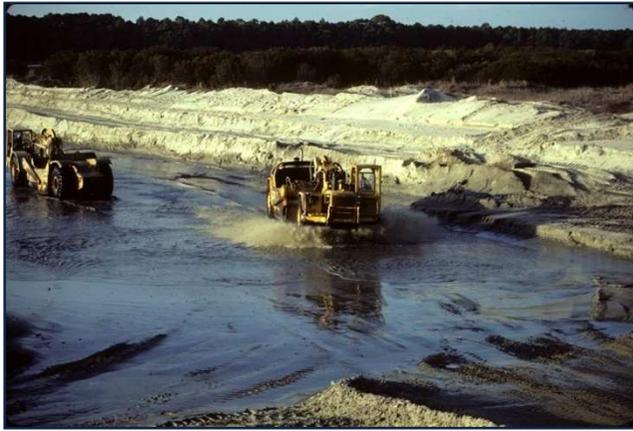
**MAR 1983** First relocation of Captain Sams Inlet ~1.5 miles north to its 1963 position. Old inlet closed by trucks hauling sand from the new channel basin. Cost of project is (~)\$300,000 (Fig T-7).

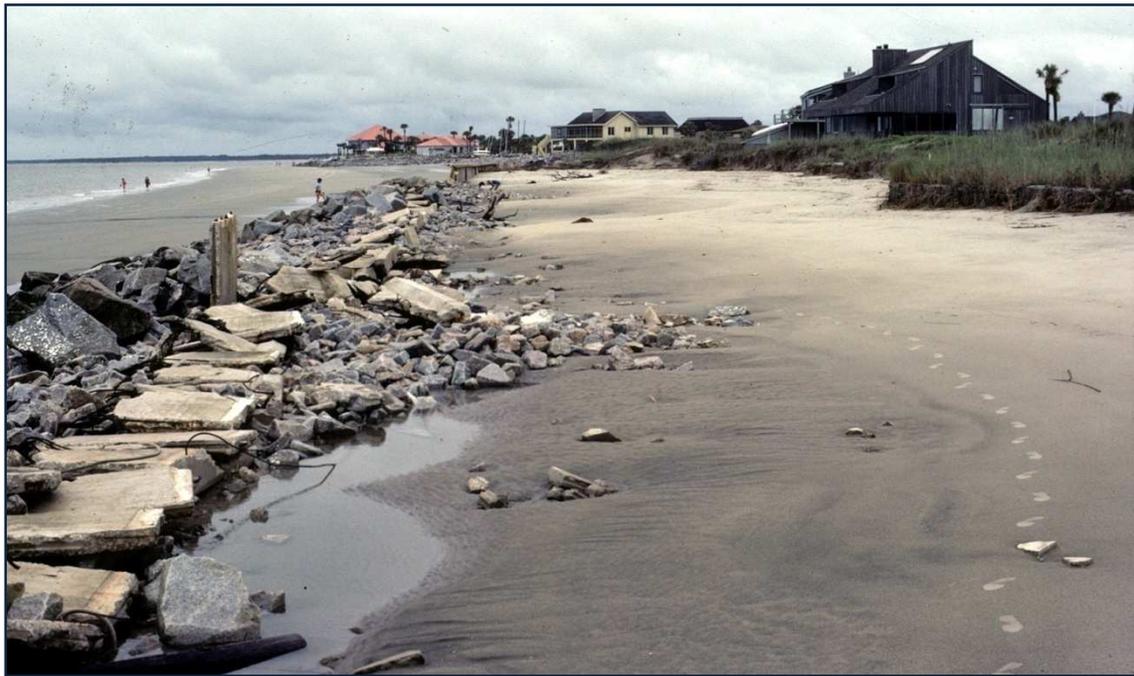
**FIGURE T-8.** [UPPER] Encroachment of the northern channel (deep blue area) of North Edisto Inlet and lack of maintenance leads to [LOWER] collapse of a section of seawall near Beach Court in 1983.

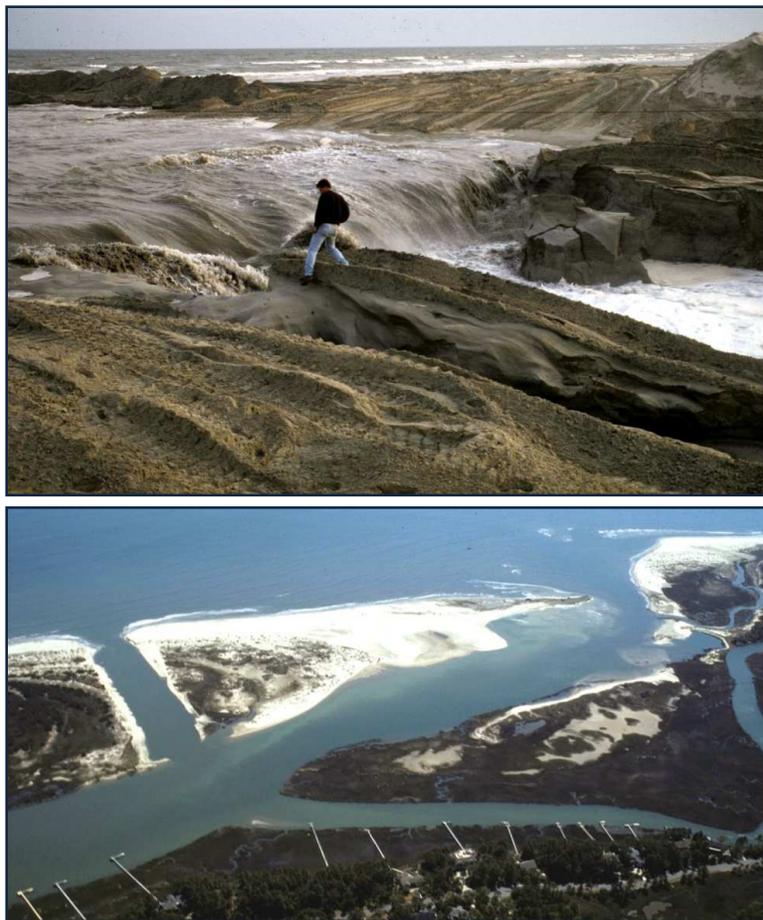
**FIGURE T-10.** The second relocation of Captain Sams Inlet in April 1996. [UPPER] First tide into the channel basin on 4 April during a rising tide. [LOWER] The new channel (left side) before completion of the closure dike across the old channel.

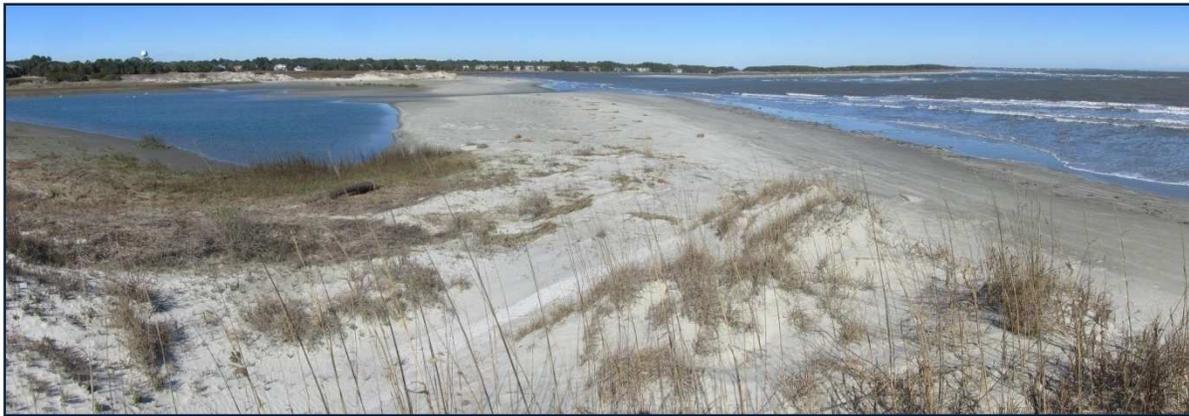
**FIGURE T-11.** Composite image of Captain Sams Inlet area from the Seabrook side in January 2014. The lagoon formed in the abandoned 1996 channel is on the left side of the image.

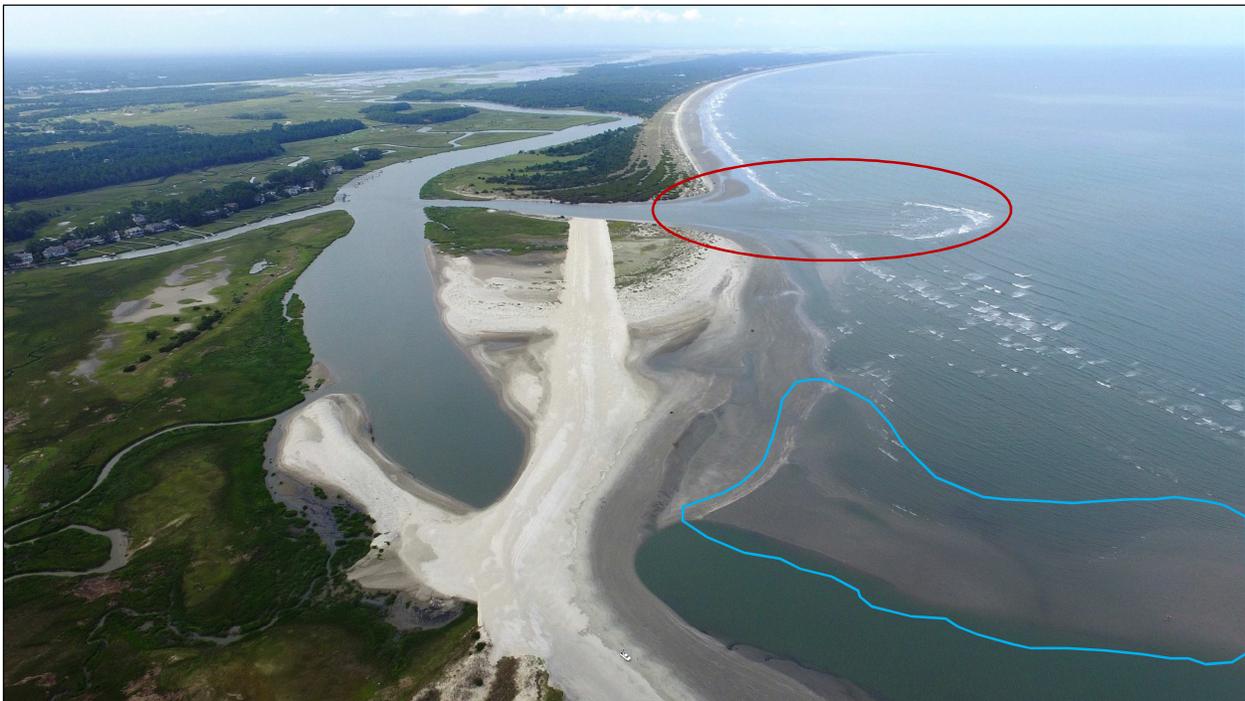
**FIGURE T-12.** Oblique aerial image of Captain Sams Inlet area from the Seabrook side in July 2015, following the third inlet relocation project. The ebb tidal spit along the east bank of the old inlet channel is clearly visible in the foreground (blue highlight), and the new channel’s associated ebb tidal delta is visible in the breakers adjacent to Kiawah Spit (red highlight).

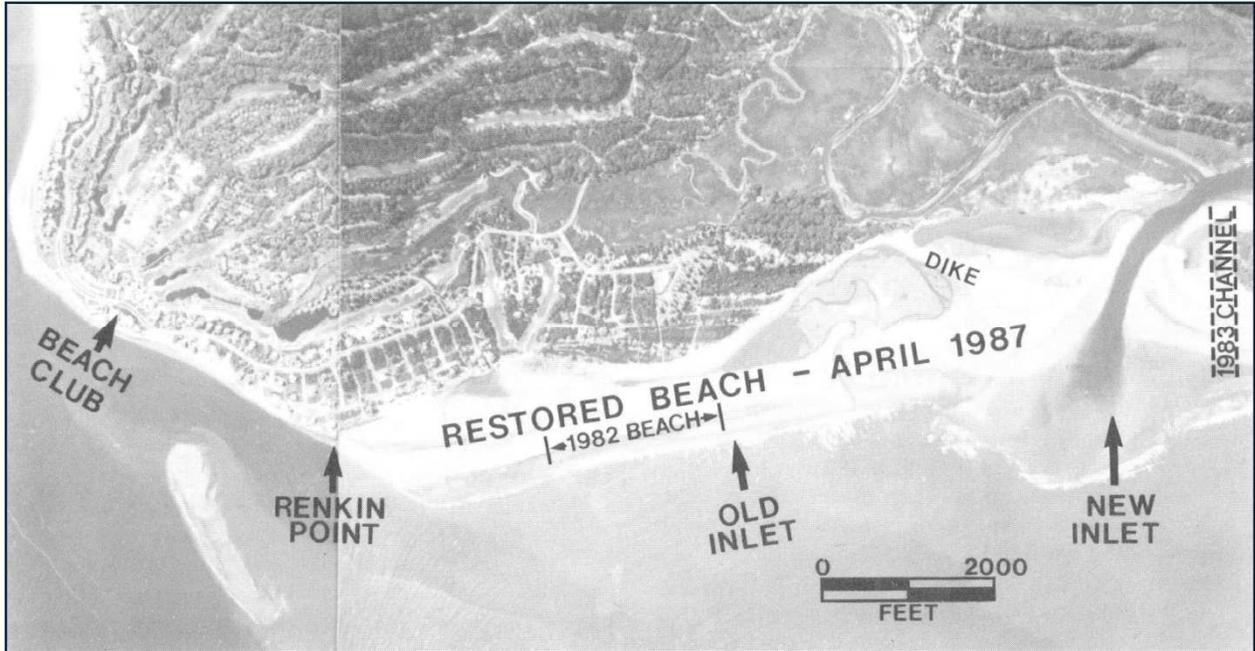
**FIGURE 5.1.2e.** Seabrook Island in April 1987 after natural restoration by inlet relocation. Area south of Renken Point remained unrestored. (Photo: Courtesy of Seabrook Island POA) [After Kana 1989]

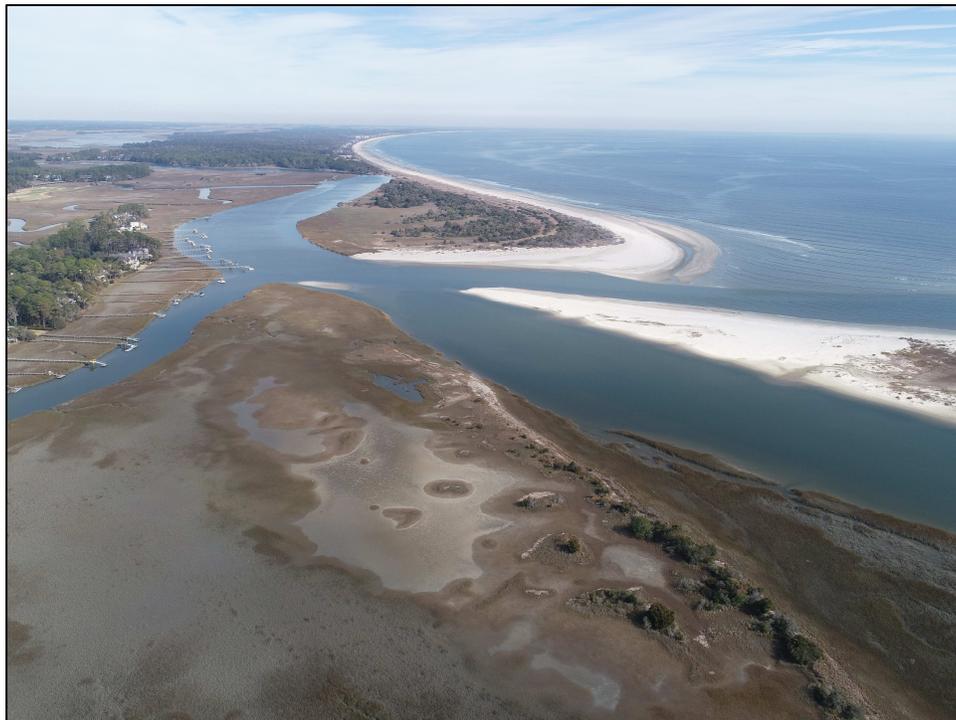
**FIGURE 5.1.2I. [UPPER]** Volume changes in reach 12 along Kiawah Spit since 2005. The western half of the reach has eroded since 2010, while the eastern half (including the area near the neck of the spit) has accreted. **[LOWER]** Kiawah Spit at low tide in January 2019. The large dry-sand beach on the down-stream side of the spit suggests it is growing southwest towards Seabrook as the inlet channel migrates down shore.

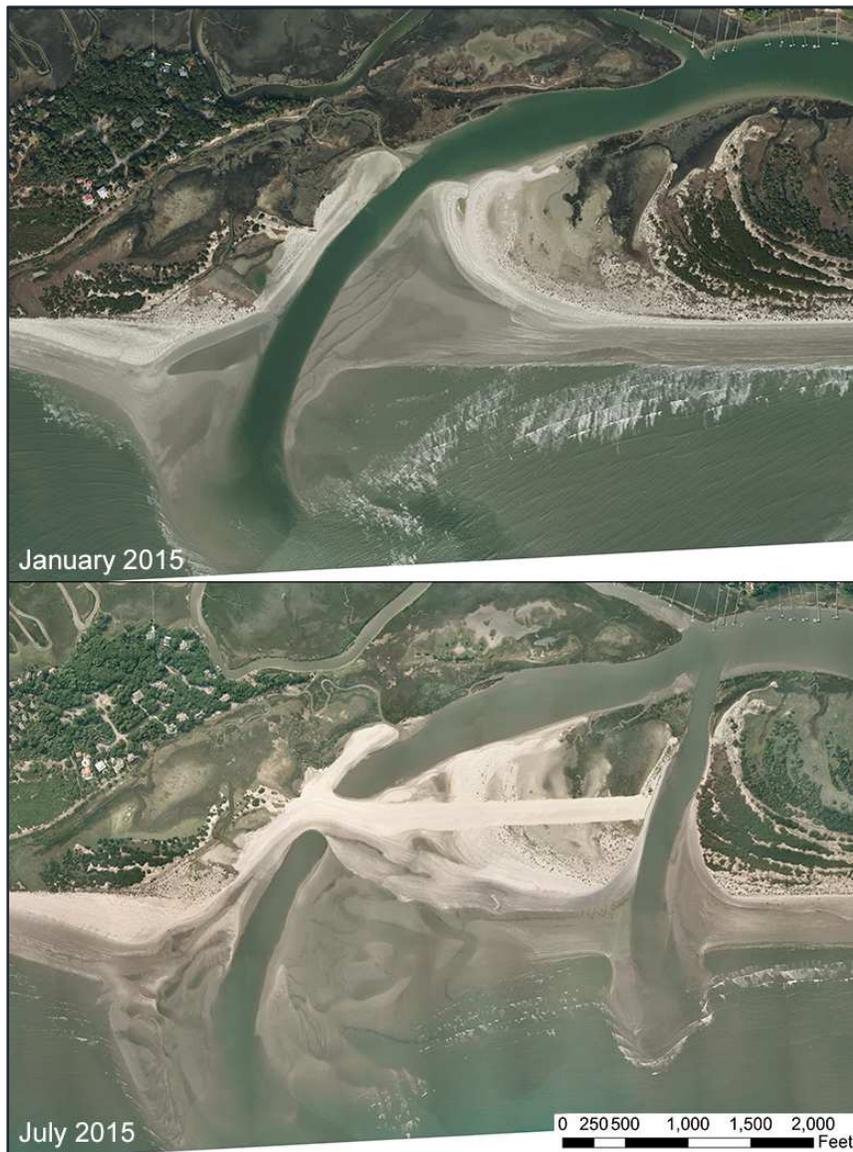
**FIGURE 5.1.3a.** Captain Sams Inlet before and after inlet relocation in 2015. Kiawah spit is to the right and Captain Sams Creek is at the upper right corner of each image. Ortho-rectified aerial photos were prepared by Independent Mapping Consultants Inc (Charlotte NC).

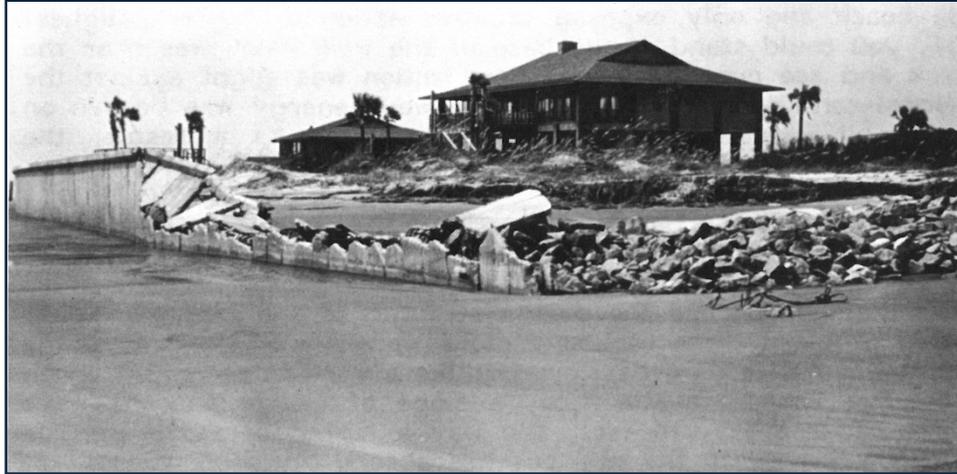
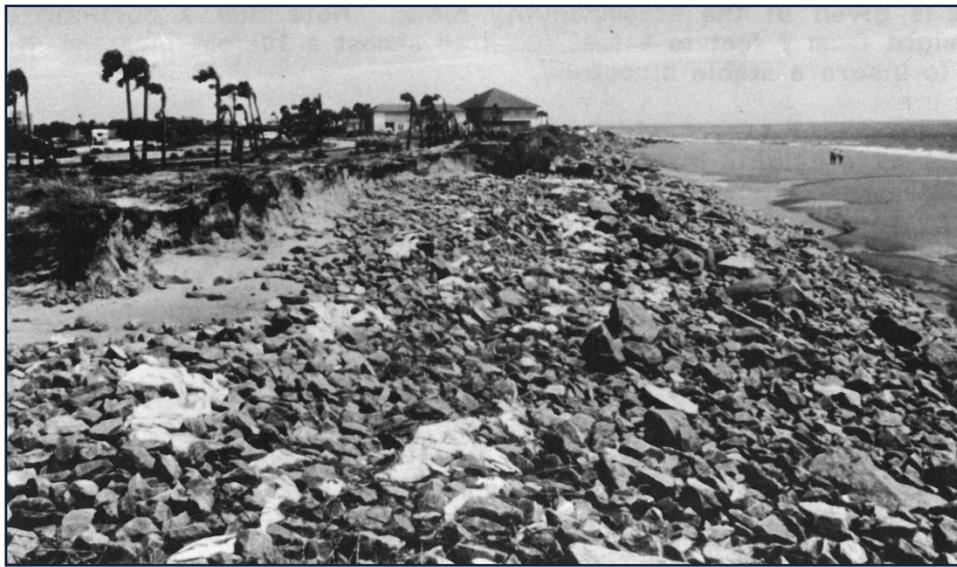
**FIGURE 5.2.3a.** Damages along Seabrook Island due to Hurricane *David* (5 September 1979). **[UPPER]** The concrete seawall and armor-stone “wingwall” at Renken Point on 7 September 1979. **[LOWER]** Collapsed riprap revetment south of the Beach Club on 5 September 1979. [Photos by WJ Sexton]

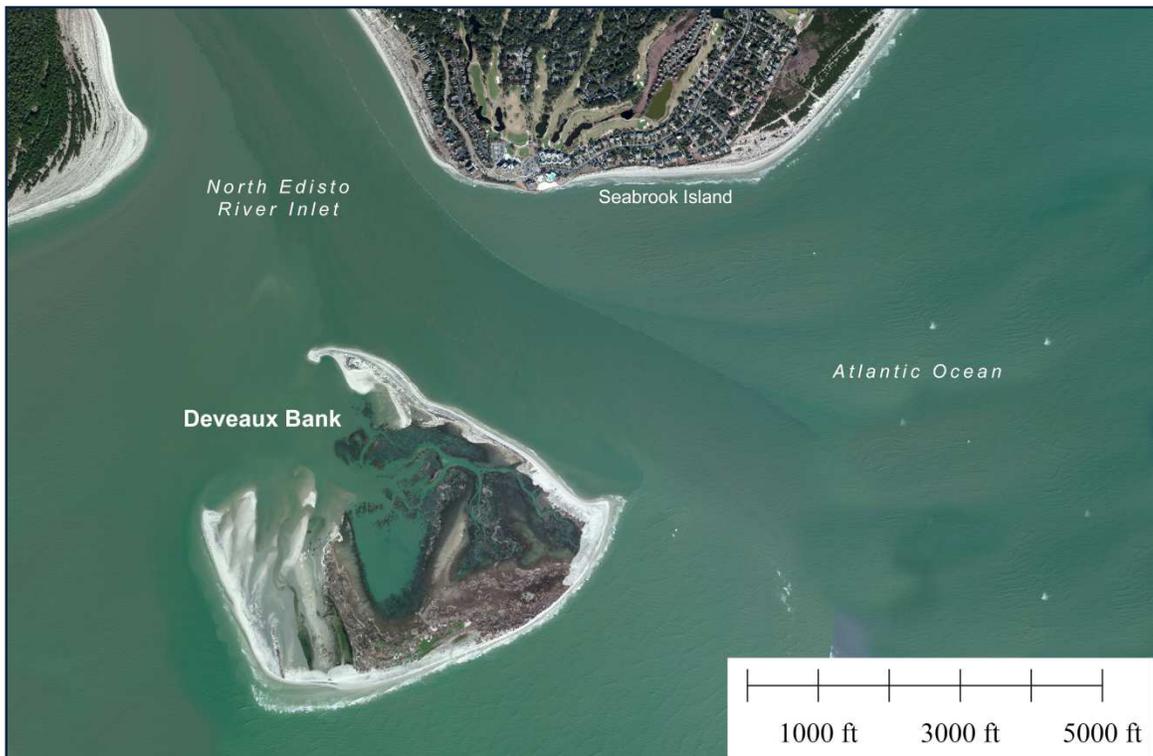
**FIGURE 5.2.3b.** Aerial photo of Deveaux Bank in 2012. Deveaux Bank is presently a well-established island, which serves as a natural breakwater to the south shoreline of Seabrook Island.
