# JORDAN POND DAM : D3532

## Dams Preliminary Inspection Form

Inspector: Kaitlin Mahoney

Start Date: 09/28/2018      Completed Date: 10/24/2018

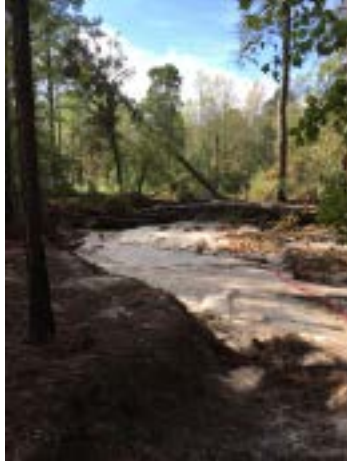
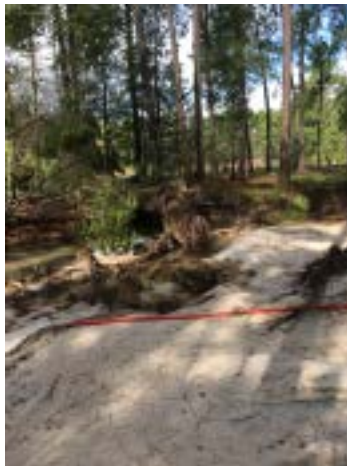
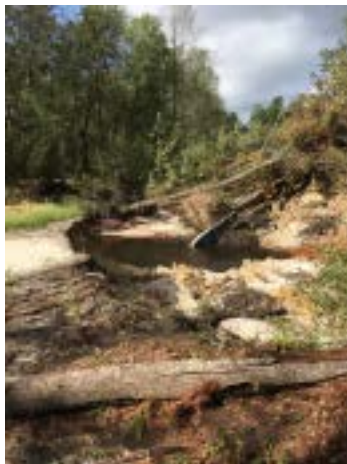
<b>Spillways: Erodible Channel</b>	
<i>1. Location</i>	
<i>2. Grass Cover</i>	No Deficiency
<i>3. Deleterious Vegetation</i>	No Deficiency
<i>4. Trees</i>	Action Required
<p>Large trees present around aux spillway need to be investigated by PE</p> <div style="display: flex; align-items: flex-start;">

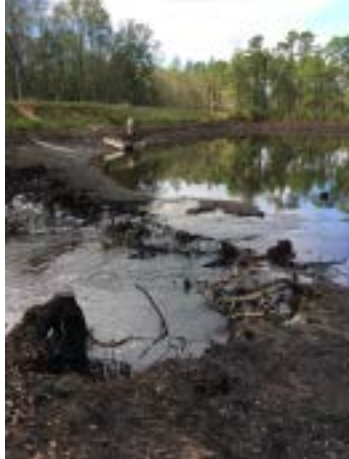
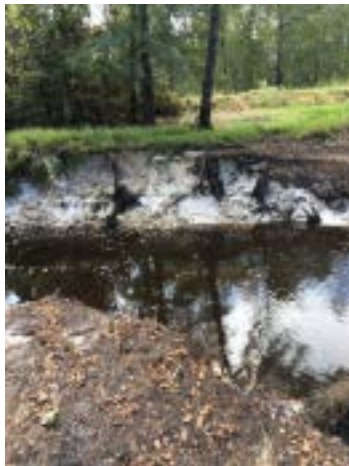
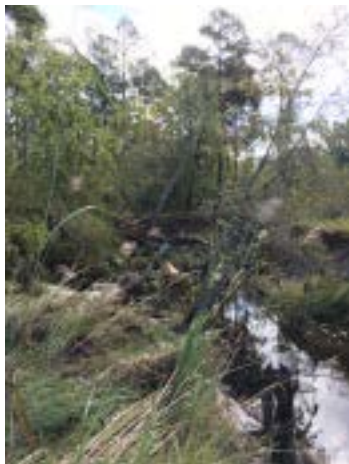
<b>Spillways: Erodible Channel</b>	
<i>9. Debris</i>	Action Required
Fallen trees in spillway breach	
<i>10. Flowing?</i>	<input checked="" type="checkbox"/> Yes <input type="checkbox"/> No <input type="checkbox"/> NA
<i>11a. Alterations/Repairs Present</i>	<input type="checkbox"/> Yes <input checked="" type="checkbox"/> No <input type="checkbox"/> NA
<i>11b. (If Present:) Alterations/Repairs Condition</i>	
<i>12. Other:</i>	
<i>13. Spillway: Erodible Channel Condition</i>	Needs Permitted Repair(s)
<b>Violation Determined: 9/28/2018 DAMMAINTREP</b>	
<p><i>14. Additional Comments (Refer to item number if applicable)</i></p> <p>Pee Dee Electric Co-Op trenched through emergency spillway to get power to neighboring house. It appears that the auxiliary spillway has rerouted itself to follow the power line instead of going further out and away from the dam. Breach appears to be caused by trench that was dug for power line, however further investigation by licensed professional engineer may be required to make such determination. The trench is next to the breach, however it seems to have weakened the structure and caused water to flow toward the toe of the dam instead of to the left away from the dam.</p> <p>A permit and professional engineer will be required for repairs to the spillway</p>
