DAVIDS MILLPOND DAM : D3450

Dams Preliminary Inspection Form

Inspector: Hannah Vinson

Start Date: 09/27/2018 Completed Date: 10/01/2018

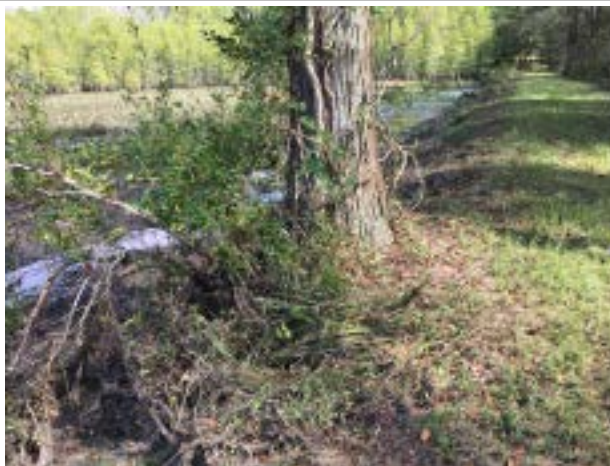
3. Trees

Monitor

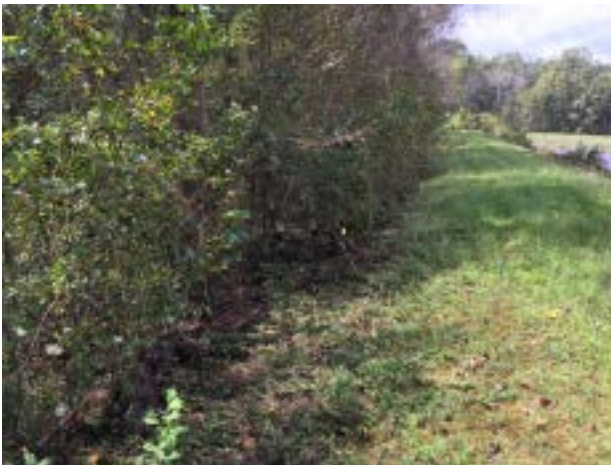
Photo Taken: 9/26/2018 1:07:50 PM GPS Latitude: 34.6443722222222 GPS Longitude: -79.7504666666667 GPS Altitude: 40.5715372907154 meters GPS Azimuth: 97.6252723311547 degrees
<i>3. Trees</i>	Action Required

Photo Taken: 9/26/2018 1:22:27 PM GPS Latitude: 34.6443722222222 GPS Longitude: -79.7486416666667 GPS Altitude: 39.2135964912281 meters GPS Azimuth: 254.000061035156 degrees
<i>4. Animal Activity</i>	No Deficiency
<i>5. Surface Cracking</i>	No Deficiency
<i>6. Subsidence, Sinkhole</i>	No Deficiency
<i>7. Slide, Slough, Scarp</i>	No Deficiency
<i>8. Groins</i>	No Deficiency, Action Required
<i>9. Erosion</i>	No Deficiency
