**Subject: Summarization of Terracon Geotechnical Report and WSP's Recommendations
Senate Street Pavement Investigation, Congaree River Remediation Project
Columbia, South Carolina**

Geotechnical Engineering Report

Congaree River Remediation – Senate Street Pavements
Columbia, SC

October 18, 2021

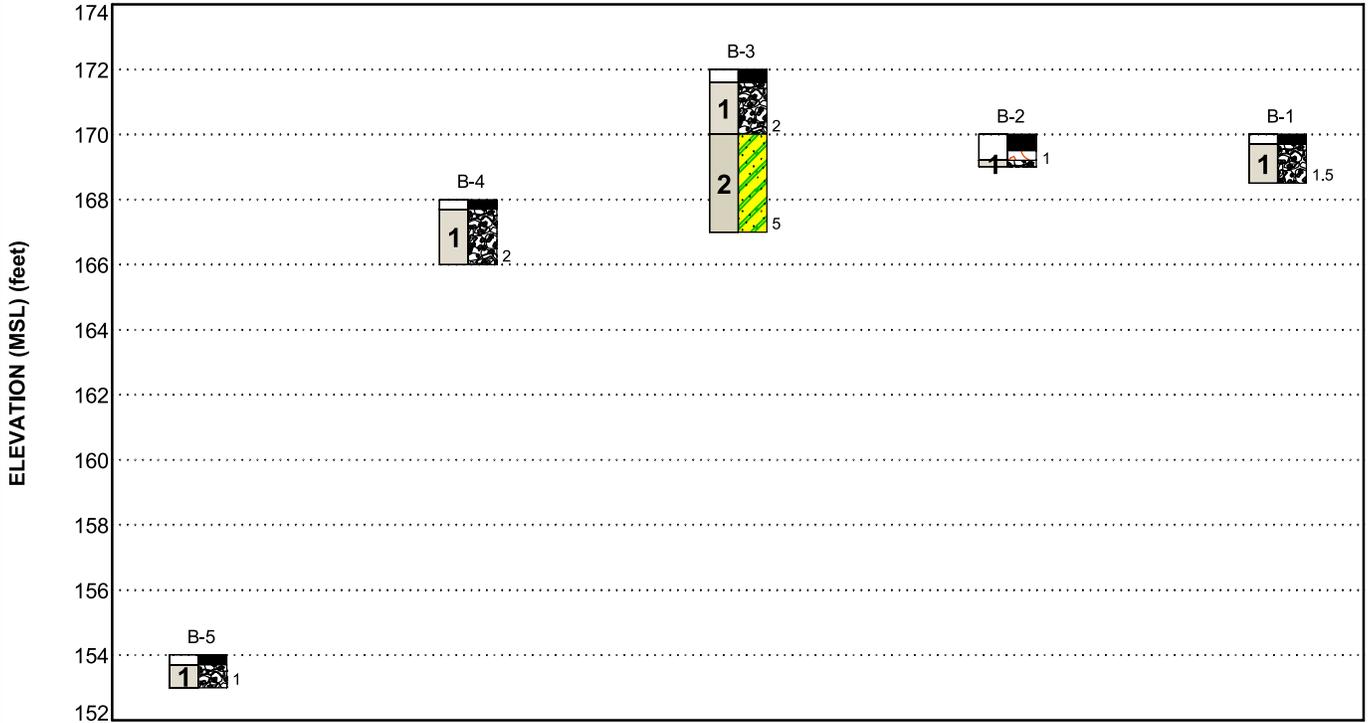
GEOMODEL

This is not a cross section. This is intended to display the Geotechnical Model only. See individual logs for more detailed conditions.

Model Layer	Layer Name	General Description
1	Existing Fill	Medium dense silty sand (SM)
2	Clayey Sand	Medium dense clayey sand (SC)
