**Results of the  
Comprehensive Performance Evaluation  
for the  
City of Denmark Water System  
Denmark, South Carolina**

**March 25 - 29, 2019**

**Process Applications, Inc.  
2627 Redwing Road, Suite 340  
Fort Collins, Colorado 80526**

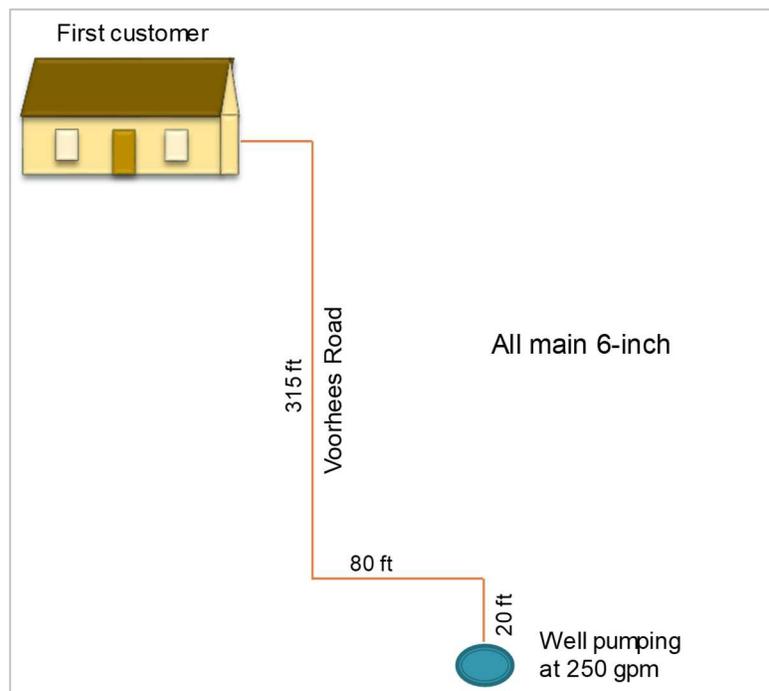
**FIGURE 8. West Voorhees piping arrangement and flow.**

Figure 8 shows the piping arrangement and flow for the West Voorhees well. For the analysis of the West Voorhees well, it was assumed the well was pumping at full capacity (250 gpm). Chlorine is injected directly downstream of the well. The average daily chlorine residual recorded by the operator on the log in the well house was considered the current chlorine residual for the purpose of calculating disinfection capacity.

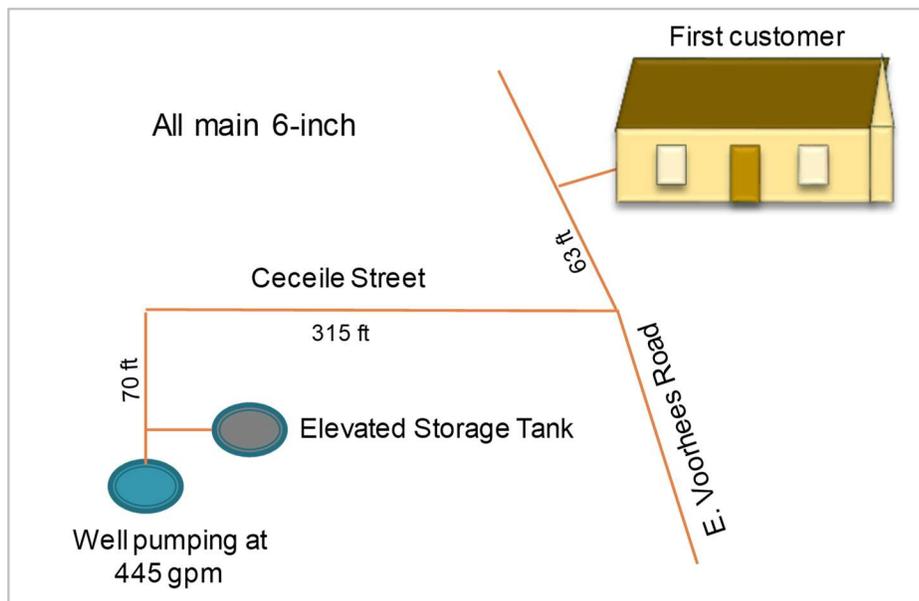
**FIGURE 9. East Voorhees piping arrangement and flow.**

Figure 9 shows the piping arrangement and flow for the East Voorhees well. For the analysis of the East Voorhees well, the well pumping capacity that was recorded by the flow meter during the CPE (445 gpm) was used. Chlorine is injected directly downstream of the well. The average daily chlorine residual recorded by the operator on the log in the well house was considered the current chlorine residual for the purpose of calculating disinfection capacity. It was assumed that 50% of the flow would be directed to the elevated tank and 50% of the flow would go to the distribution system when the well was pumping; as a result, 222.5 gpm was used to calculate the contact time for the segments prior to and along Ceceile Street. The elevated tank was not included in the analysis due to the fact that all flow is not necessarily routed through the tank prior to entering the distribution system. When the flow reached East Voorhees Road, it was assumed that 50% of the flow was directed to the northwest and 50% of the flow was directed to the southwest along East Voorhees. As a result, a flow of 112 gpm was used to calculate contact time for the segment between Ceceile Street and the first customer to the northwest on East Voorhees Road.

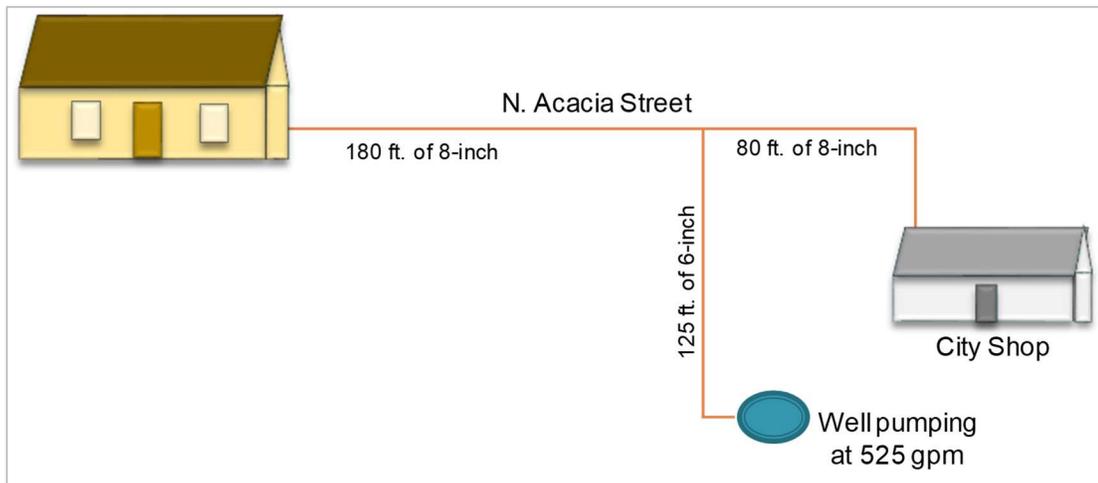
**FIGURE 10. Acacia piping arrangement and flow.**

Figure 10 shows the arrangement of piping and flow for the Acacia well. For the analysis of the Acacia well, it was assumed that the well was pumping at full capacity (525 gpm). Chlorine is injected directly downstream of the well. The average daily chlorine residual recorded by the operator on the log in the well house was considered the current chlorine residual for the purpose of calculating disinfection capacity. It was assumed that 525 gpm was flowing through the segment between the well and North Acacia Street; 525 gpm was used to calculate the contact time for this segment. When the water reached North Acacia Street, it was assumed that 20 gpm was diverted to the northwest to serve the city shop building. As a result, the remaining flow of 505 gpm was assumed to flow to the southeast along North Acacia Street and was used to calculate contact time for the segment between the well yard piping and the first customer to the southeast at the intersection of N. Acacia and N. Mimosa.

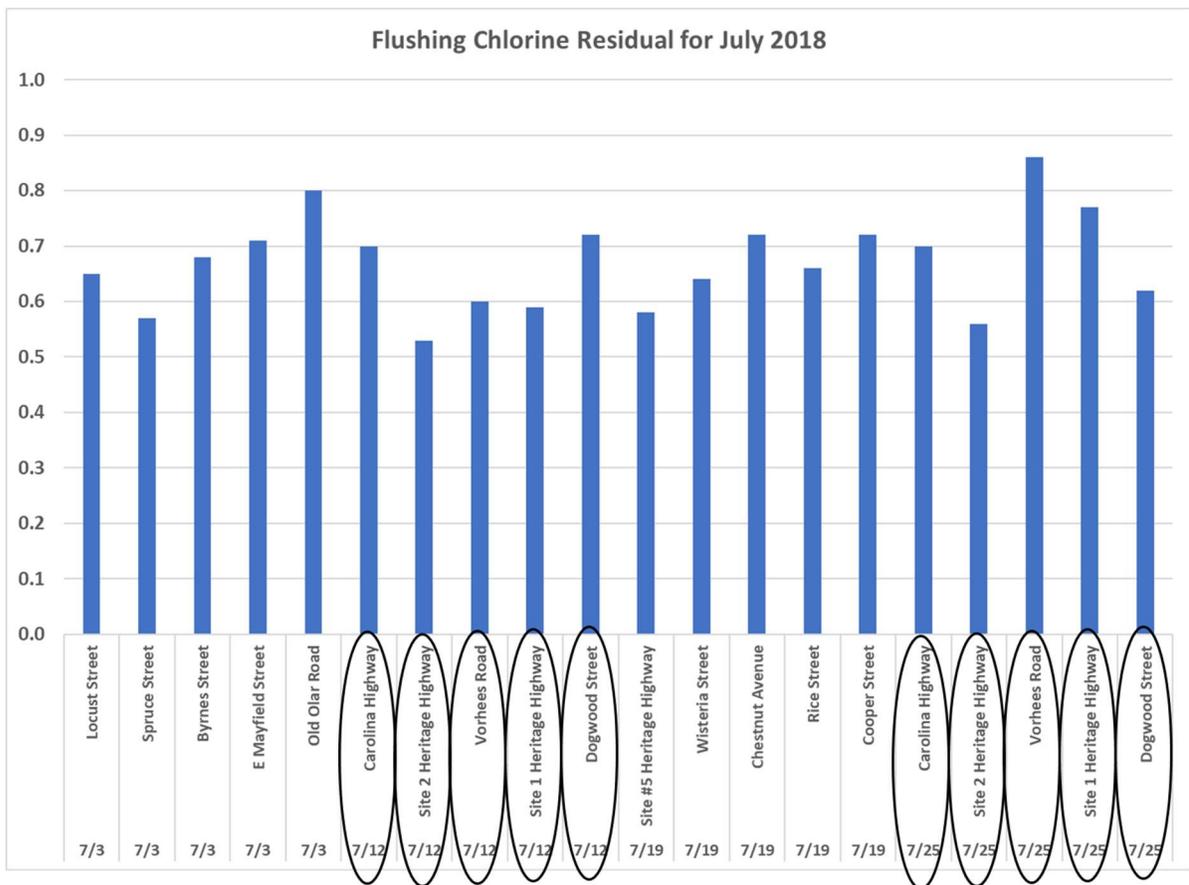
**FIGURE 16. Free chlorine residual at flushing sites (post flushing) during July 2018.**

time). As an example, during 2018 the following sample locations were sampled for coliforms on July 25: Site 2 Heritage Hwy, Site 1 Heritage Highway, Voorhees Road, Dogwood Avenue, and Carolina Highway. Results of the chlorine residual testing at the flushing hydrant sites in July 2018 are shown in Figure 16. The area near these five sample sites was flushed twice during the month (i.e., two weeks before the total coliform sampling event and again on the day of the sampling event). The chlorine residual values following hydrant flushing varied from 0.5 to 0.85 mg/L. The operator reported that chlorine residual is measured before flushing the hydrants, but the results are not recorded. Recording these chlorine residuals prior to extensive hydrant flushing would provide a better indication of the minimum residuals in the system. Sufficient flushing of the hydrant is required to displace water in the hydrant barrel and service line to assure that a representative sample is collected from the distribution system. Excessive flushing before a residual sample is collected is discouraged, however, because the sample may not be representative of water near the hydrant. Additional information on representative sampling is provided in the next section.

The impact of hydrant flushing on the coliform sampling sites that had low chlorine residuals in July and August (see Figure 15) can be further assessed. While the area near the coliform sampling sites was flushed twice in July, this was not enough to raise the chlorine residual to 0.2 mg/L at the Dogwood site on the day of sampling. The August sites (Cooper St., Chestnut Ave.) were sampled on August 8th. These sites were flushed on July 19th, but it appears that the August coliform sampling was performed earlier than usual, and this did not allow for the customary flushing of the area prior to sampling as would have been expected. The low chlorine residuals recorded at the Cooper Street and Chestnut Avenue sites during the August sampling indicate that the system was unable to maintain a chlorine residual of 0.2 mg/L without recent and targeted flushing. This indicates that the flushing program is impacting the results of the coliform sampling and that a sufficient chlorine residual is not being maintained above the optimization goal at all times.
